Single-Bubble Cavitation-Induced Pitting on Technical Alloys

Jonas Kühlmann¹ · Sebastian A. Kaiser¹

Abstract

Keywords Cavitation damage · In situ microscopy · Laser-induced cavitation · Wear of technical alloys

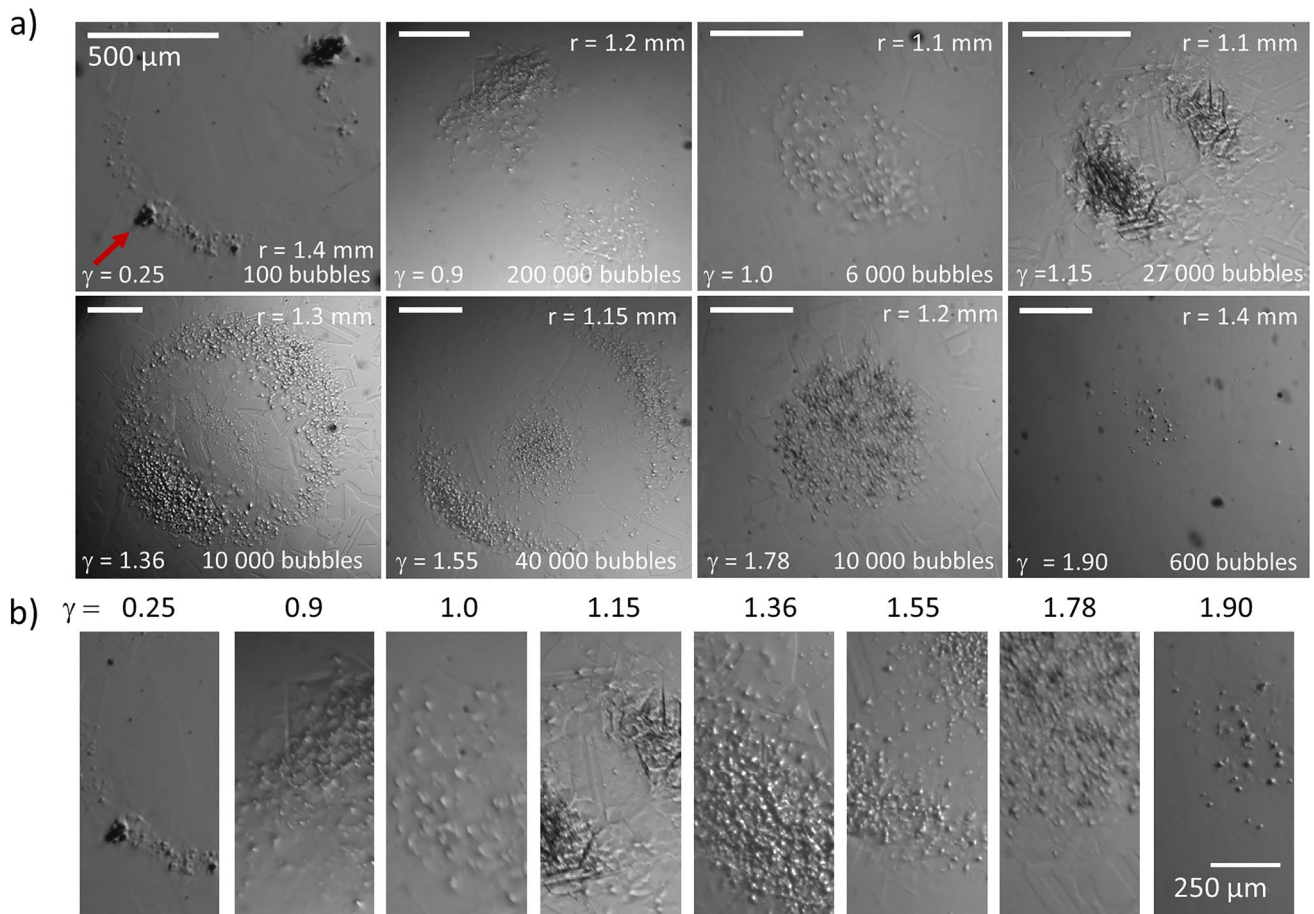
Fig. 2 In situ images of pits at various stand-off distances for a bubble radius of about 1.2 mm. The stand-off distance, number of bubbles, and the exact radius are given in each image. The laser is incident from the bottom left corner (red arrow). **a** Overview images showing the entire damaged area. The images are shown at different

magnifications. Each scale bar corresponds to 500 μm. **b** Sub-regions of the images in **a** at higher magnification. Here, each image has the same magnification, represented by the 250 μm bar (Color figure online)

Figure 2 shows the regions in which successive bubble collapses caused damage in form of pits at stand-off distances from 0.25 to 1.90. The in situ images were selected so that the damaged region and individual pits are clearly visible. For $\gamma = 0.25$ (Fig. 2a), the pits form a ring with two regions along the laser beam propagation axis where the damage is significantly increased. The damage in these regions is composed of multiple pits. For $\gamma = 0.9$, two regions away from the laser axis contain the majority of the pits. For a stand-off distance of 1.0, pits occur in a much smaller region that is elliptical with the long axis perpendicular to the laser direction. For $\gamma = 1.2$, a circular damage pattern can be seen with more damage along the laser axis, although the damage is more pronounced towards the laser incidence. A similar damage pattern is observed for $\gamma = 1.36$, except that the circle is significantly larger. At $\gamma = 1.55$, the pits occur in a ring similar to $\gamma = 1.36$, but an additional circle of pits formed around the center of this ring. At a stand-off distance of 1.78, only one circle of pits is seen directly below the center of the bubble. Finally, Fig. 2a shows damage at the upper end of the stand-off distances that cause pits. Here, at $\gamma = 1.9$, pitting occurred only in a relatively limited area, again directly below the bubble center.

from 100 ($\gamma=0.25$) to 200,000 ($\gamma=0.9$). The damage patterns in Fig. 2 are consistent with recordings of equivalent experiments on aluminum by P&L 1998 [20] and Isselin et al. [22]. This is also true for the asymmetries typical of laser-induced single bubbles [42–44]. These asymmetries in the likelihood of a pit occurring in a particular spot are probably caused by the asymmetry of the plasma. However, the ring-shaped patterns (e.g., at $\gamma=1.36$) show that this asymmetry seen in damage patterns is not universal and pits can occur everywhere along the ring.

Figure 2b shows sub-regions of the damage shown in Fig. 2a with all images on the same spatial scale. This type of presentation facilitates a comparison of the lateral dimensions of pits. For all $\gamma>0.3$, the pits are quite similar in size. This is true for both pits at a fixed distance as well as for pits across different stand-off distances. This may imply that the surface loading by the fluid dynamics is not so different across these cases, which in turn points towards the

mechanism in the flow being similar. For $\gamma=0.25$, however, the pits look distinctly different. The special nature of very small stand-off distances with $\gamma<0.3$ has recently been highlighted by Reuter et al. [35] who identified a self-focusing mechanism of the shockwaves that leads to strong deformation of the material. This might be the cause of the more pronounced damage region on the laser axis in Fig. 2b. This region is also composed of multiple pits that occurred in a small area. Note that the images shown in Fig. 2 for $\gamma=0.25$ are at a lower number of bubbles than the other images.

In other works, the liquid jet associated with the first collapse was seen as at least partly responsible for the pitting, especially at small stand-off distances [20, 21]. However, these findings came from soft materials. On 316L, even at small stand-off distances and high bubble counts (Fig. 2d 200,000 bubbles), no surface changes were observed that could be attributed to the central jet, consistent with Reuter et al. [30]. Such damage should be seen in the area that is below the center of the first ring collapse in Fig. 6. The most likely explanation is that the load on the surface caused by the jet is not sufficient for pitting in technical alloys. Instead, here, SCAs in the second or first collapse are responsible for pitting.

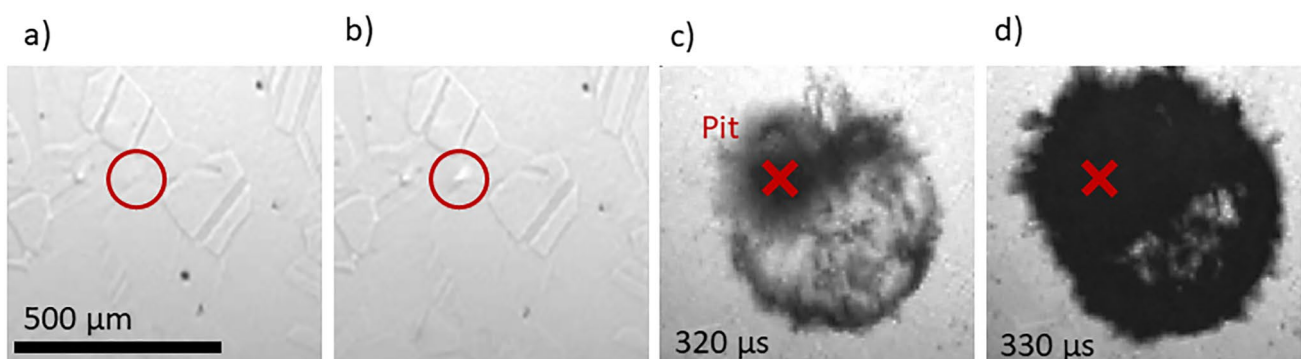
Fig. 3 316L surface **a** before and **b** after the bubble collapse. **c** and **d** Bubble ($\gamma = 1.15$, $r = 1$ mm) around the second collapse on the surface (Color figure online)

The surface changes are now correlated with the corresponding bubble collapse. The method for that was presented in detail in our previous work [37] and is summarized in Fig. 3. For this evaluation images from the beginning of a bubble series when only a few pits have formed, were used (unlike the examples in Fig. 2 where pits overlap, making counting impossible). First, a pit was searched for in the high-resolution images before and after the bubble collapse. If a pit was found, its location was identified in the high-speed data, and these were examined in more detail. Figure 3a, b shows the surface before and after the collapse. The pit is marked with a red circle. Figure 3c, d shows selected images from the second collapse of the bubble. The position of the pit is marked with a red x in these high-speed images. Here, the pit is located where an SCA was found in the collapse. Our previous work examined how the phenomena in the second collapse of bubbles with $\gamma = 1.35 \pm 0.05$ are related to the pitting [37]. The same procedure is now applied to stand-off distances from 0.3 to 1.9. The findings are first discussed for $\gamma > 1$, where only the second collapse occurs close to the

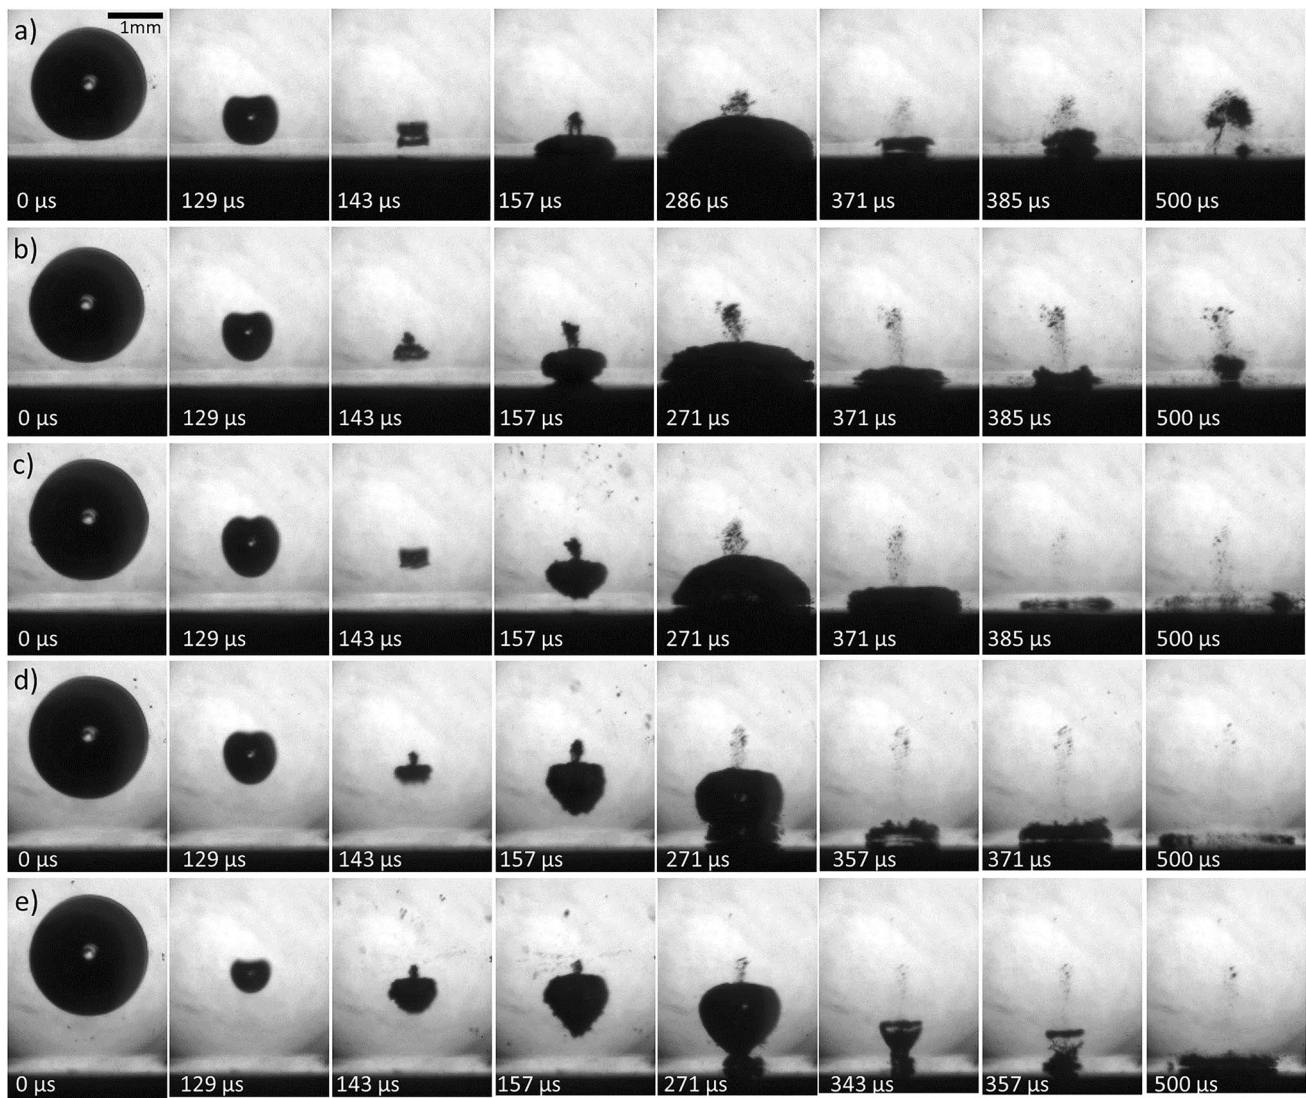
Fig. 4 Selected images from the side view of bubble collapses ($r = 1.4$ mm) at **a** $\gamma = 1.1$, **b** $\gamma = 1.25$, **c** $\gamma = 1.35$, **d** $\gamma = 1.6$, and **e** $\gamma = 1.8$

Figure 4 shows the side view of selected bubble dynamics from $\gamma = 1.1$ to 1.8 of bubbles at $r = 1.4$ mm. The dynamics of the bubble collapse processes were described in detail in other work [20] and are used here just as a reference for the reader. As can be seen in Fig. 4a–e, at none of these stand-off distances does the first collapse occur close to the sample surface. Therefore, the second collapse is considered relevant for pitting.

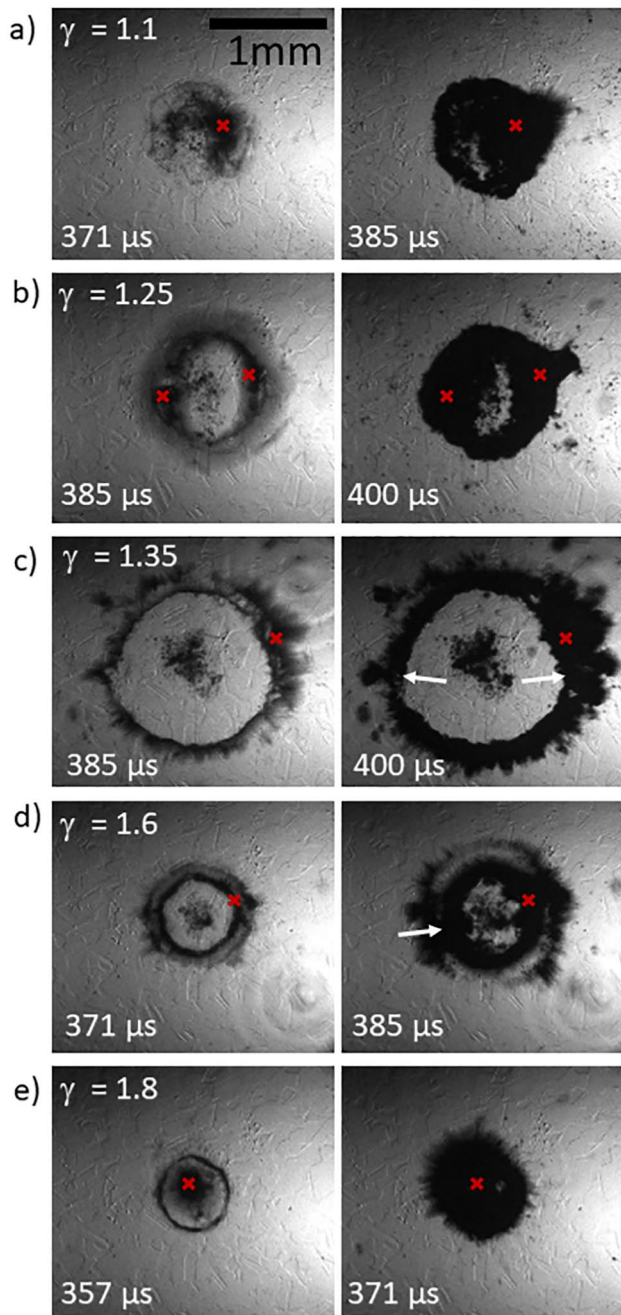
Fig. 5 Two selected images from the top view of the dynamics around the second collapse of the bubbles shown in Fig. 4. Pits are marked with a red x and SCA-like structures that did not cause pits are marked with white arrows (Color figure online)

Figure 5 shows the dynamics around the second collapse of the same bubbles as shown in Fig. 4, now in top view. All bubbles shown here caused at least one pit. The position of the pits is marked with a red x. A collapse ring with different radii for different γ can be seen for all stand-off distances. The collapses at $\gamma = 1.25$ to 1.8 (Fig. 5c–e) also have a “spot” of gas phase in the center of the ring. A more complete view of the dynamics from the top view can be found in Fig. 14 in the “Appendix”.

In each of the examples shown in Fig. 5, a pit could be assigned to an SCA in the second collapse. In fact, from $\gamma = 1.1$ to 1.8 this was the case for thousands of image series we visually examined. Pits usually occur in the center of the SCA. As in the example in Fig. 5b, when two pits occurred, two SCAs are seen. It is not true that each SCA necessarily leads to a pit, but each pit can be attributed to an SCA. SCAs that did not cause pitting can for example be seen in Fig. 5c, d on the torus opposite of the pitted region (white arrows). In Fig. 5e inward motion blur indicates an SCA that is not on the torus ring but closer to the center. The overall damage patterns in Fig. 2a indeed show that for $\gamma = 1.55$ –1.9 damage occurs more centrally.

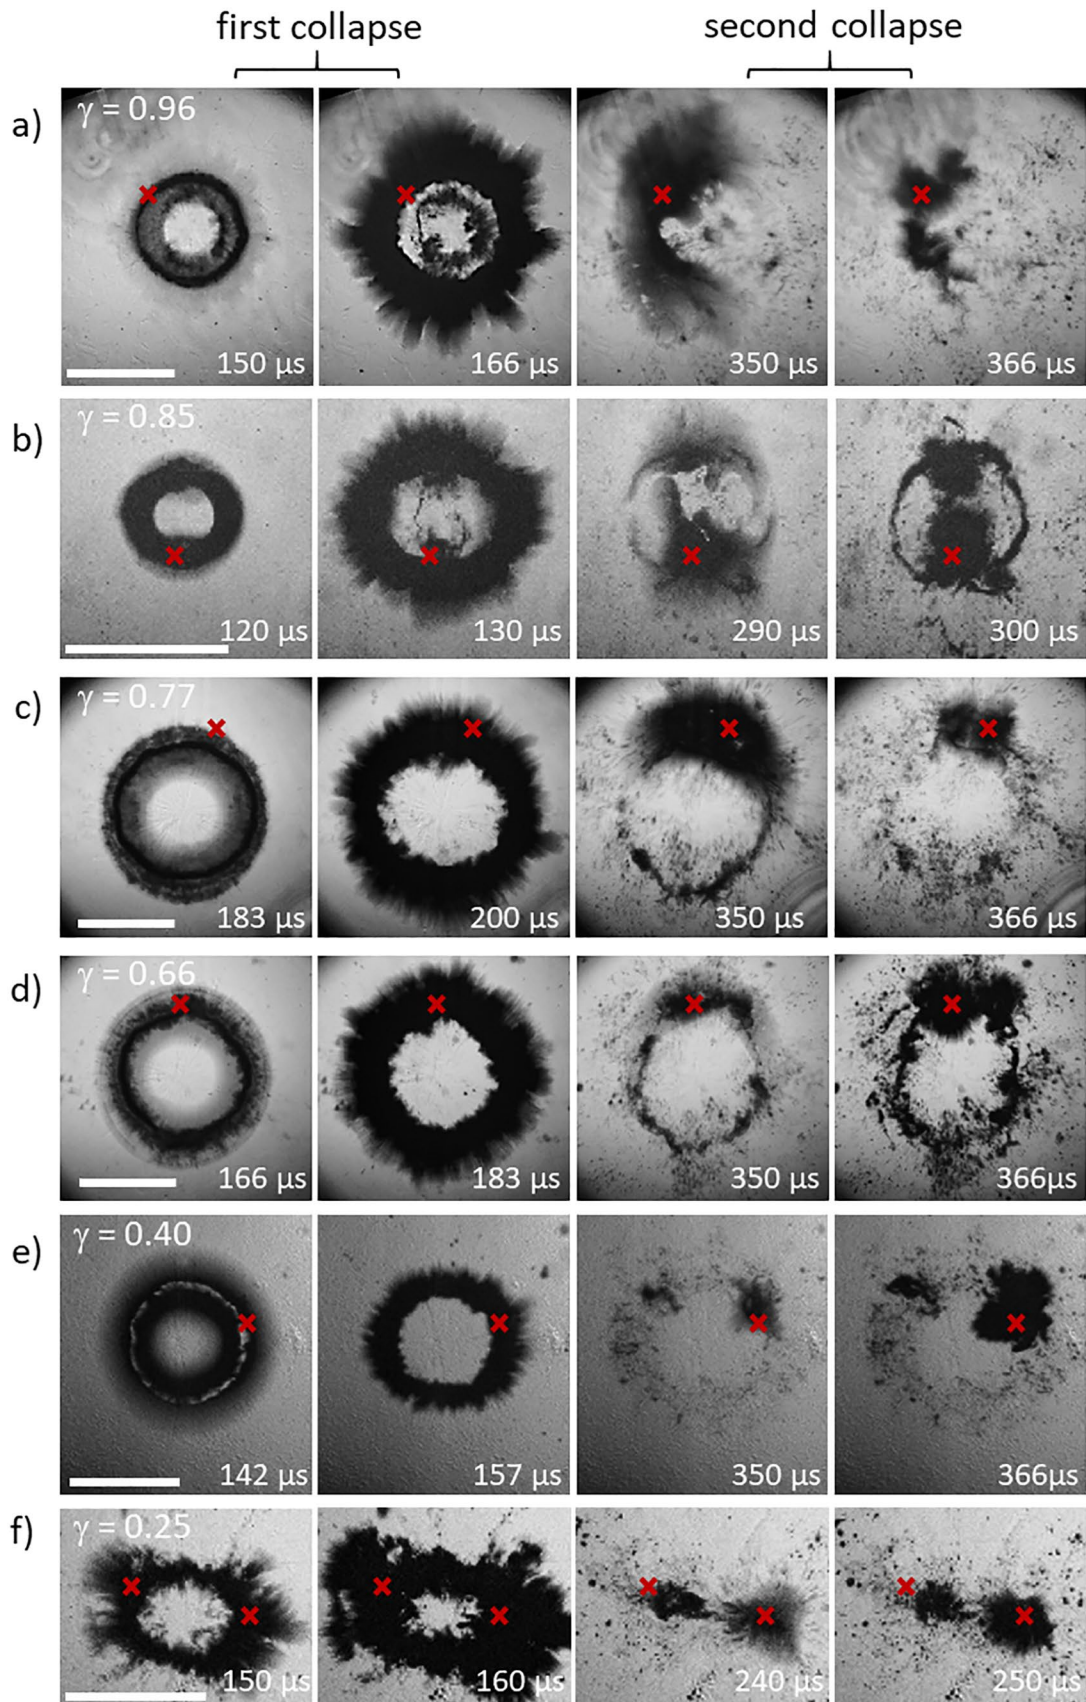
◀**Fig. 6** Selected frames at the first and the second collapses. The ringed-shaped features on the upper left of **a** and bottom right on **c** are waves on the free top surface of the water in the cuvette that do not influence the bubble (Color figure online)

Figure 6 shows the first and second collapses of bubbles with $\gamma < 1$. Each of these bubbles caused at least one pit whose location is marked with a red x. The first collapse is always toroidal with a high degree of symmetry, whereas the second collapse is strongly asymmetric, with SCAs so pronounced that only a faintly toroidal shape can be seen. For $\gamma = 0.25$, the first-collapse toroid is elliptical and has two SCAs, and the second collapse occurs entirely in two distinct SCAs away from the laser axis. In all cases, the pits are located in the center of the SCAs in the second collapse—just as for the larger distances discussed in the previous section. For $\gamma = 0.4$, this is approximately so, but for $\gamma = 0.25$ (Fig. 6e, f), one of the two pits is

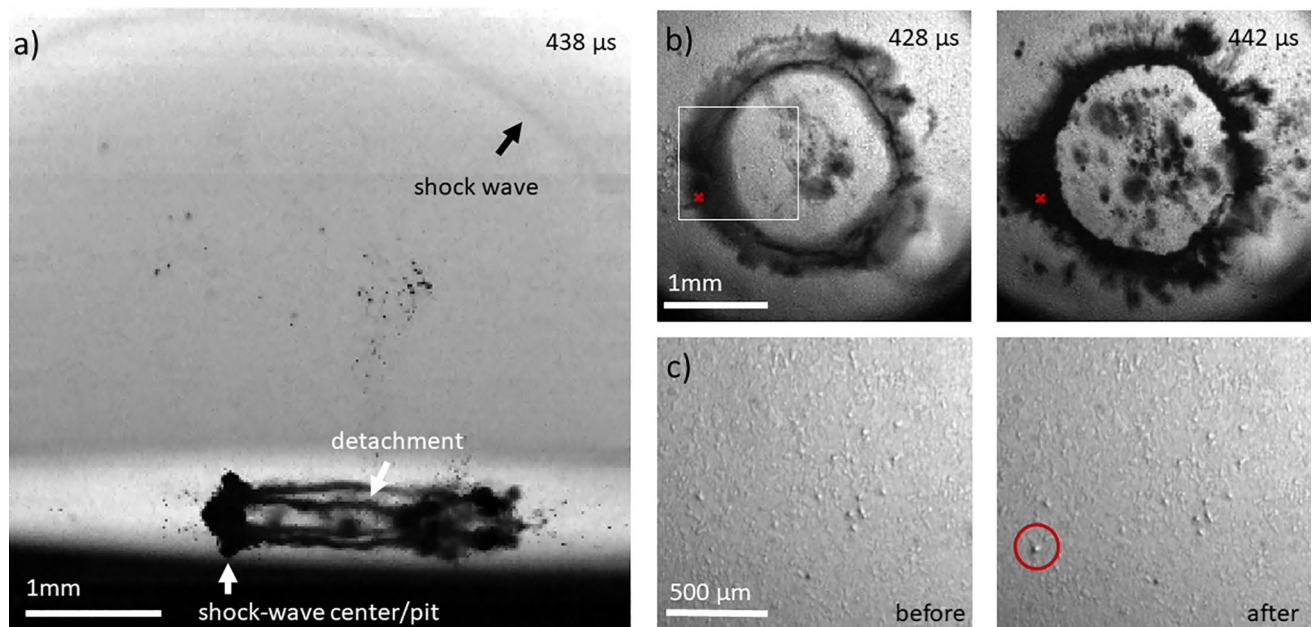
Fig. 7 Second collapse of a bubble with $\gamma=1.4$. **a** Side view, **b** top view close to and after the collapse, and **c** detail (corresponding to the white rectangle in sub-figure **b**) of the surface before and after the bubble. The resulting pit is marked with a red circle; the pit location

is marked with a red x in the high-speed images in **b**. Note that the sample shown here had previously been subjected to bubbles of various stand-off distances, which is where we cannot see a simple and regular pit pattern as in, e.g., Fig. 2 (Color figure online)

Figure 7 shows the second collapse from the side (Fig. 7a) and from the top (Fig. 7b), as well as the sample surface just before and after this collapse. In the side view of the collapse, in addition to the collapse ring itself, two other features can be observed. One is that the bubble torus is detached from the surface [Fig. 7a white arrow. Figure 17 in the “Appendix” includes a second example in which this detachment is clearer (but the shockwave is less clear). The Supplementary Material includes the two corresponding

video sequences]. The vertical distance between the gas-phase shadow and its reflection on the sample surface indicates that the distance between gas phase and sample surface is several tens of micrometers. In none of the about 300 bubbles recorded with the shorter, 200-ns illumination did the damage occur in the region exhibiting this vertical detachment. The detachment was also found by Reuter et al. for a similar γ [35]. The second feature is a shock wave with its center at the torus of the second collapse on the side of the laser incidence. There is some spatial uncertainty, but combined the side and top view indicate that this shock wave was apparently emitted by the very SCA that is associated with the pit found after the bubble. Since the energy per unit area of a spherically propagating shock wave decreases with the square of the distance from the origin, only locations on the sample surface close to the origin are affected. The emission of shock waves from such an asymmetric region of the torus was already found by P&L 1998 [20] but now can be associated with the formation of a single, specific pit.

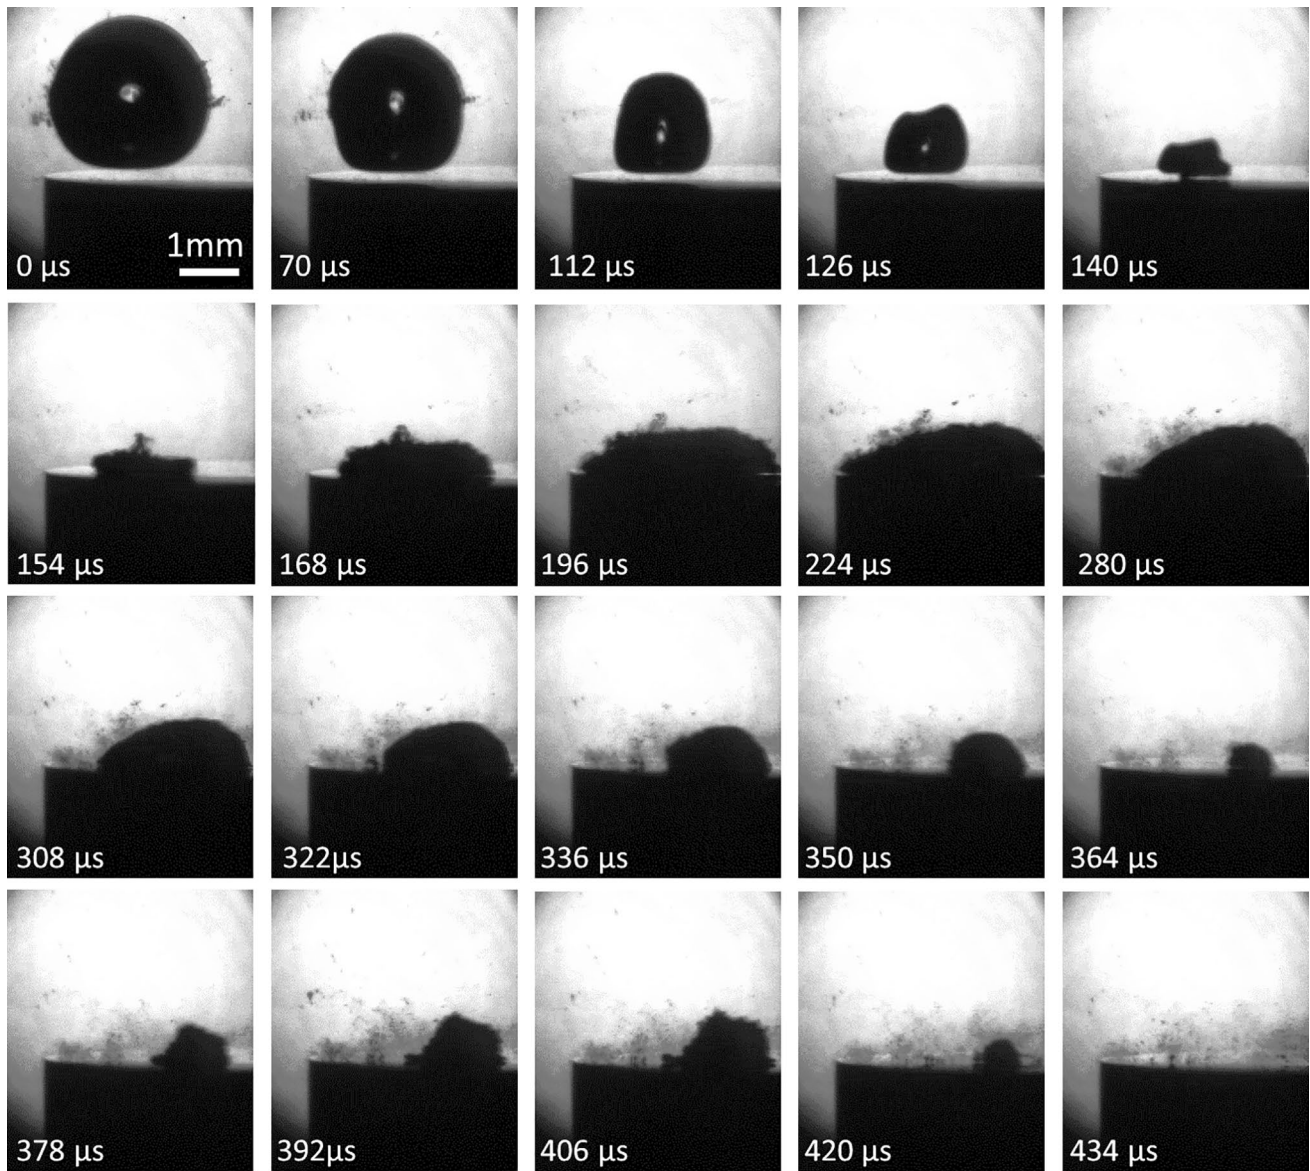
Fig. 8 Side view of a bubble dynamics of a collapse near the edge of the sample

The damage of the sample surface is related to asymmetries in the collapse that in turn stem from asymmetry in the experiment, i.e., in the laser-induced plasma. Since we could not eliminate these asymmetries, we instead introduced further, controlled ones. To that end, bubbles were created near the edge of the sample. The presence of the edge has a strong influence on the bubble dynamics that are globally described by the Kelvin impulse [17]. Figure 8 shows the dynamics of such a bubble from the side. Even before the first collapse (126 μs), the bubble shrinks faster on the side closer to the edge, and it moves away from the edge of the sample. From 308 to 364 μs , we see that the collapse does not occur simultaneously. Rather, the region closest to the edge collapses first, and that farthest away last. Figure 9 shows this process again from above. Both the top view and the side view show that the second collapse of the bubble at 364 μs occurs in a limited area and is shifted towards the sample center. In this area, an SCA can be observed. This is also the area where this bubble caused damage, as marked in Fig. 9 at 364 μs . In repeated bubbles as in Figs. 8 and 9, no pit or SCA occurred in any other location. Thus, it is reasonable to conclude that SCAs are related to the fact that the bubble does not collapse simultaneously everywhere. Although the

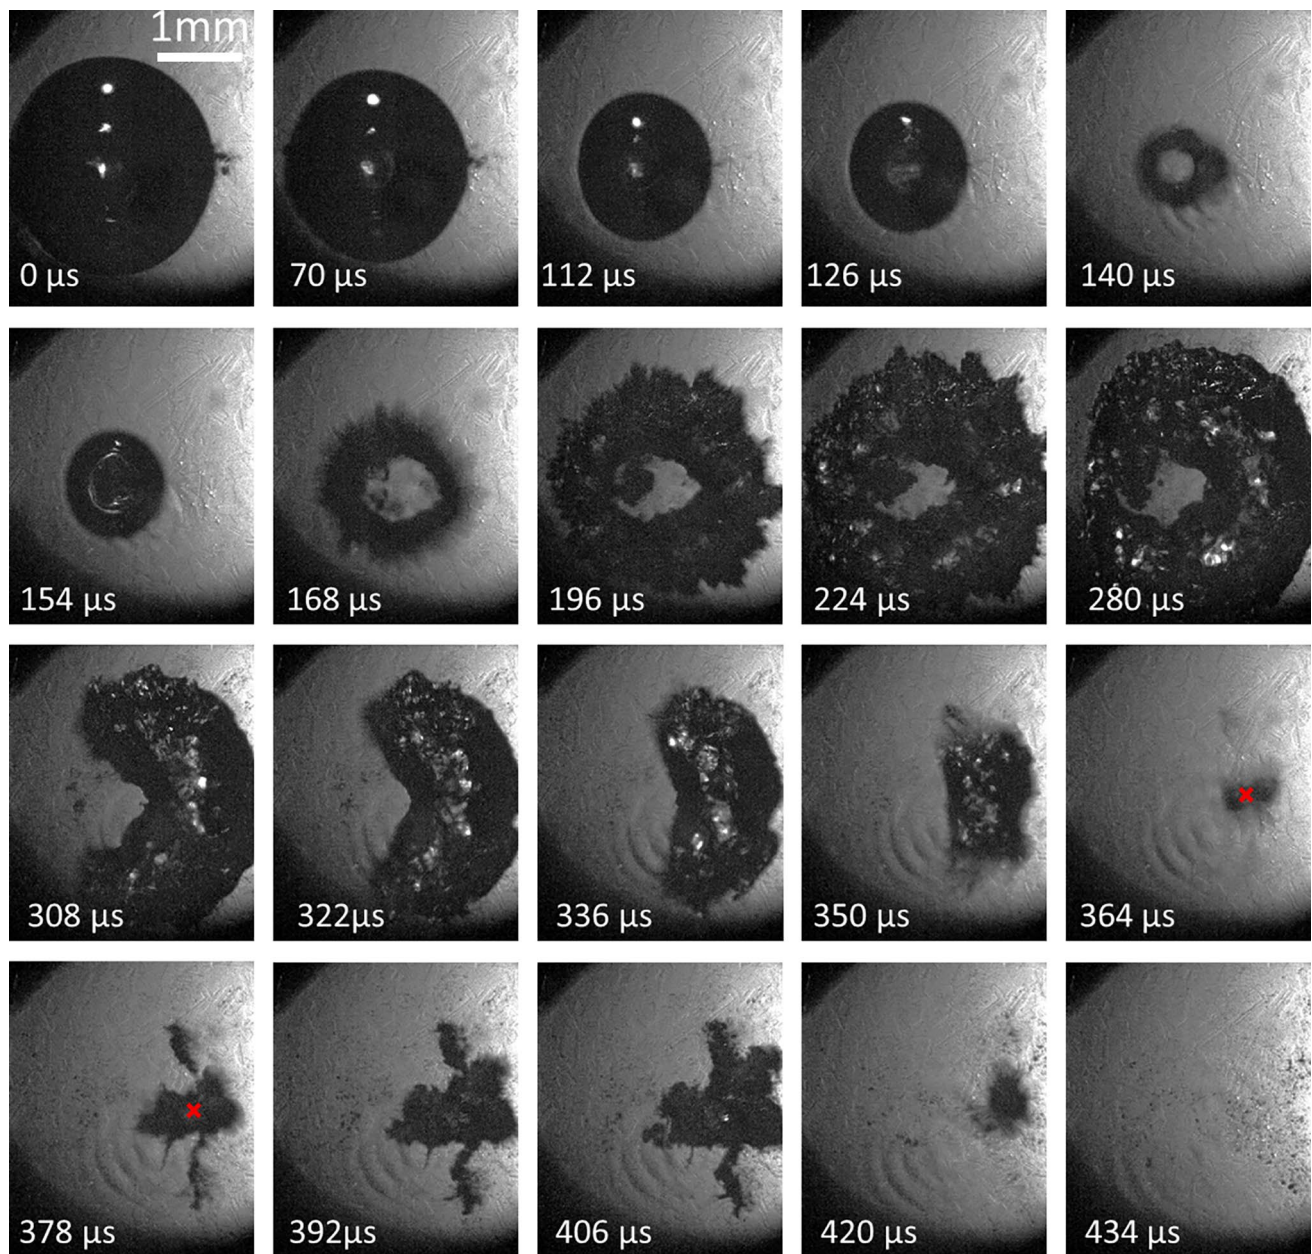
Fig. 9 Top view of the bubble dynamics of the collapse from Fig. 8. The pit is marked with a red x The edge of the sample is on the left (Color figure online)

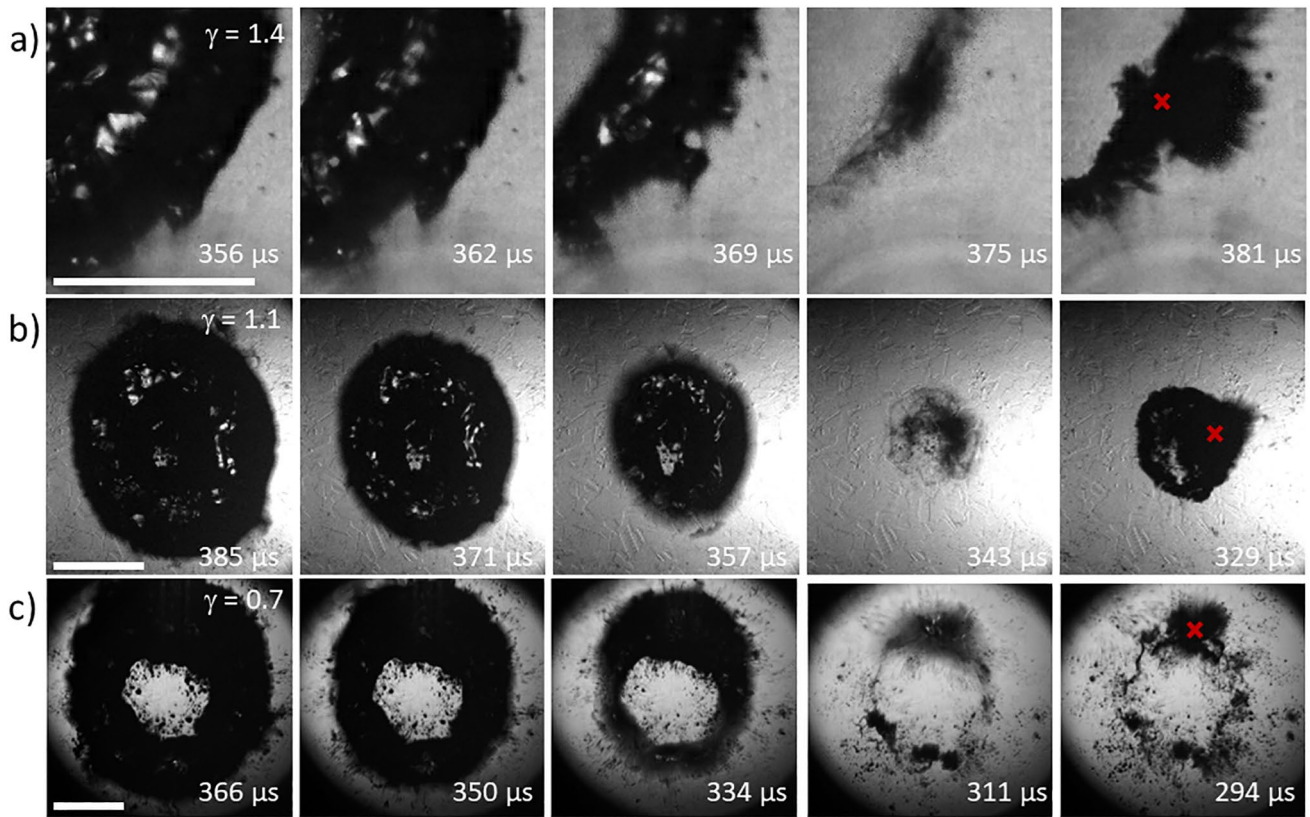
Fig. 10 Three bubble shortly before and at the second collapses **a** $\gamma = 1.4$, **b** $\gamma = 1.1$, and **c** $\gamma = 0.7$. Pits are marked with a red x (Color figure online)

Figure 10 shows three bubbles with different stand-off distances shortly before and at the second collapse. These bubbles were induced above the sample center. All bubbles caused a pit that could be linked to an SCA. Figure 10a shows only a part of the toroidal collapse from the case with $\gamma = 1.4$. It can be seen that the ring section does not narrow uniformly ($-13 \mu\text{s}$, $-6 \mu\text{s}$, $0 \mu\text{s}$). Instead, shrinkage is slowest in the region where the SCA occurs and the pit is formed. In Fig. 10b, c, two bubble collapses are shown where this phenomenon can be seen even earlier before the second collapse (Fig. 10b: $t = -28 \mu\text{s}$, Fig. 10c: $t = -33 \mu\text{s}$). The non-simultaneous shrinking process of these bubbles and the coincidence with SCAs indicates that even in bubbles where a strong asymmetry is not intentionally introduced (as in Fig. 9), SCAs and thus pits, are connected to the temporal non-uniformity of the collapse of the bubble. These findings are consistent with the “energy focusing” seen by Reuter et al. [35] (there, “Appendix H”). In particular, their subsonic energy focusing in the second collapse is consistent with our findings concerning the likely effect of the second collapse being non-simultaneous [35].

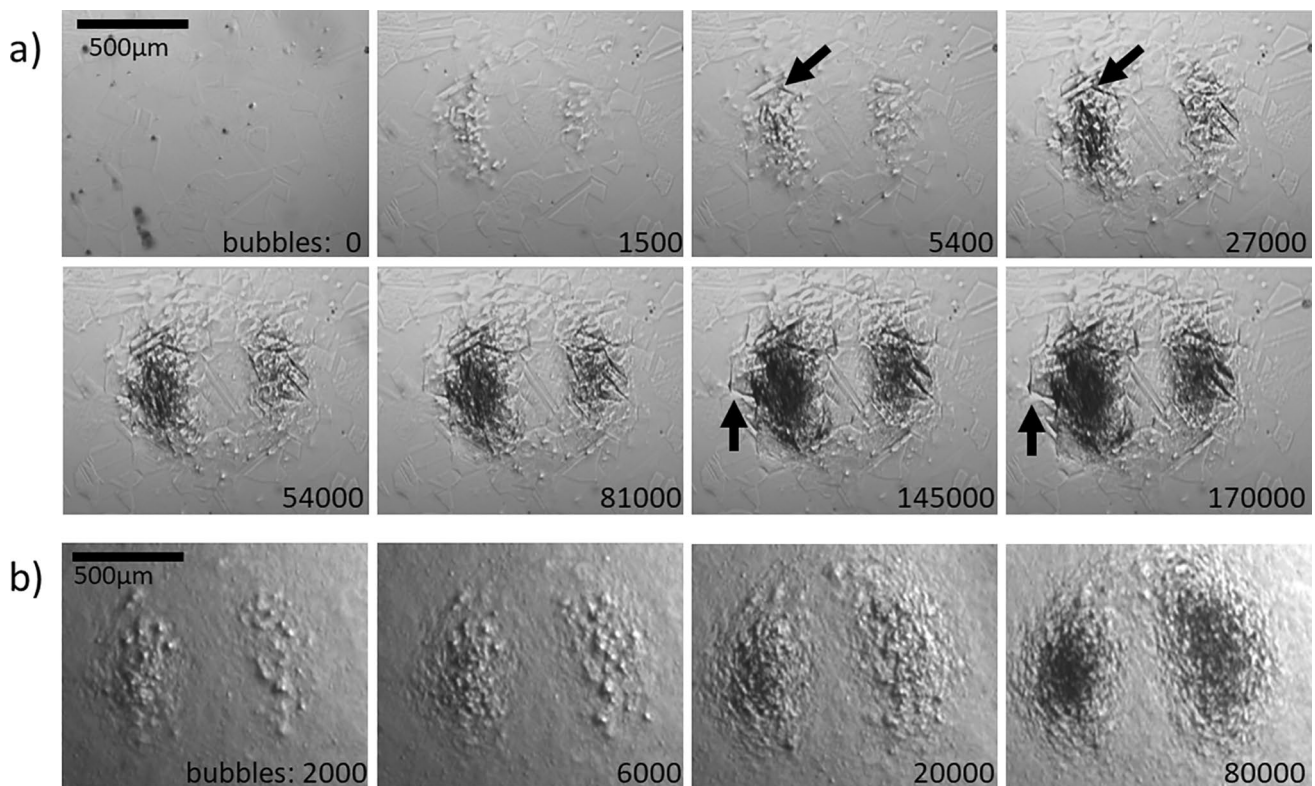
Fig. 12 In situ images of the damage progression on **a** 316L at $\gamma=1.15$ and $r=1.1$ mm, and **b** NAB at $\gamma=1.09$ and $r=1.3$ mm. The laser incidence is from the right. The arrows mark features discussed in the text

Figure 12 shows the damage progression on 316L and NAB at approximately $\gamma=1.1$ up to 170,000 and 80,000 bubbles,

respectively. The pits form mainly in two regions on the laser axis. In both samples, a ring corresponding to the region of the second collapse can be seen at this γ (see Figs. 4, 5). The larger radius in the NAB damage pattern is due to the slightly larger maximum radius of the bubbles. On 316L, material damage can be seen beyond the pits at the grain boundaries (black arrows). This type of damage was also found in experiments in our previous work for $\gamma=1.4$. It is a step in the transition from single pits to eventual material loss [39]. Comparable damage does not occur in the bronze

From Fig. 12, but also from comparison of the damage patterns shown in Fig. 2 to damage on aluminum in the

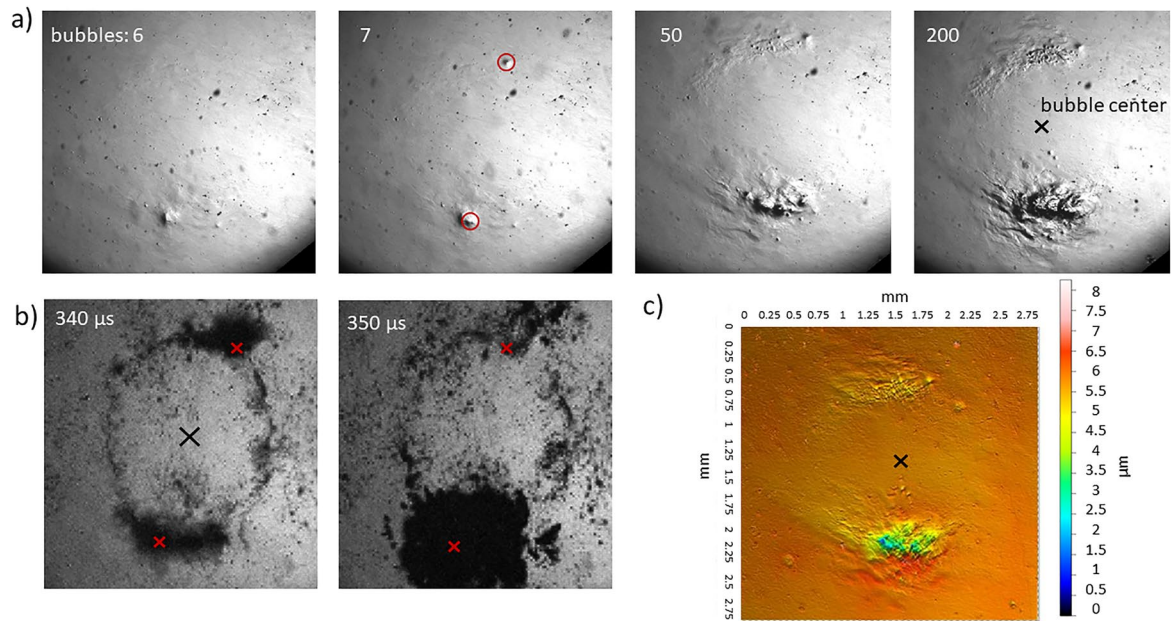
Fig. 13 Aluminum surface after 6, 7, and 50 and 200 bubbles imaged in situ (a) and surface elevation from ex situ confocal microscopy after 200 bubbles (c) at $\gamma=0.74$ and $r=1.4$ mm. In addition, the second collapse of the seventh bubble is shown (b). The red circles mark the pits caused by the seventh bubble. The red x marks the pit loca-

tion in the images of the second collapse. The projection of the bubble center on the surface is marked with a black x. All images refer to the same spatial scale as c. The laser incidence is from the right (Color figure online)

Some experiments were also carried out on aluminum, which we previously had only done at $\gamma=1.4$ [37, 38]. The correlation of SCAs and pits on aluminum can be seen in Fig. 13b. For this particular bubble, two SCAs and two pits occurred. As on steel (Figs. 2a, 6b, c), the pits occur in two opposite regions away from the laser axis. The images for 50 and 200 bubbles in Fig. 13a show a phenomenon also observed in previous work on aluminum: at constant stand-off distance, the pit size varies more than on the technical alloys [37, 38]. Large scatter in pit metrics caused by single bubbles on aluminum was also found by P&L 1998 [20] and Sagar et al. [23]. This is probably caused by the variation in the load exerted by the individual collapse events. Compared to the technical alloys, on aluminum far, weaker parts of the collapse are sufficient to cause plastic deformation, and thus, there is a greater variation in the load that causes pitting.

In Fig. 13, the center of the bubble projected onto the surface of the sample is marked with a black x in some of the images. This is the point where the liquid jet of the bubble hits the surface [20]. Both the surface quantitative elevation

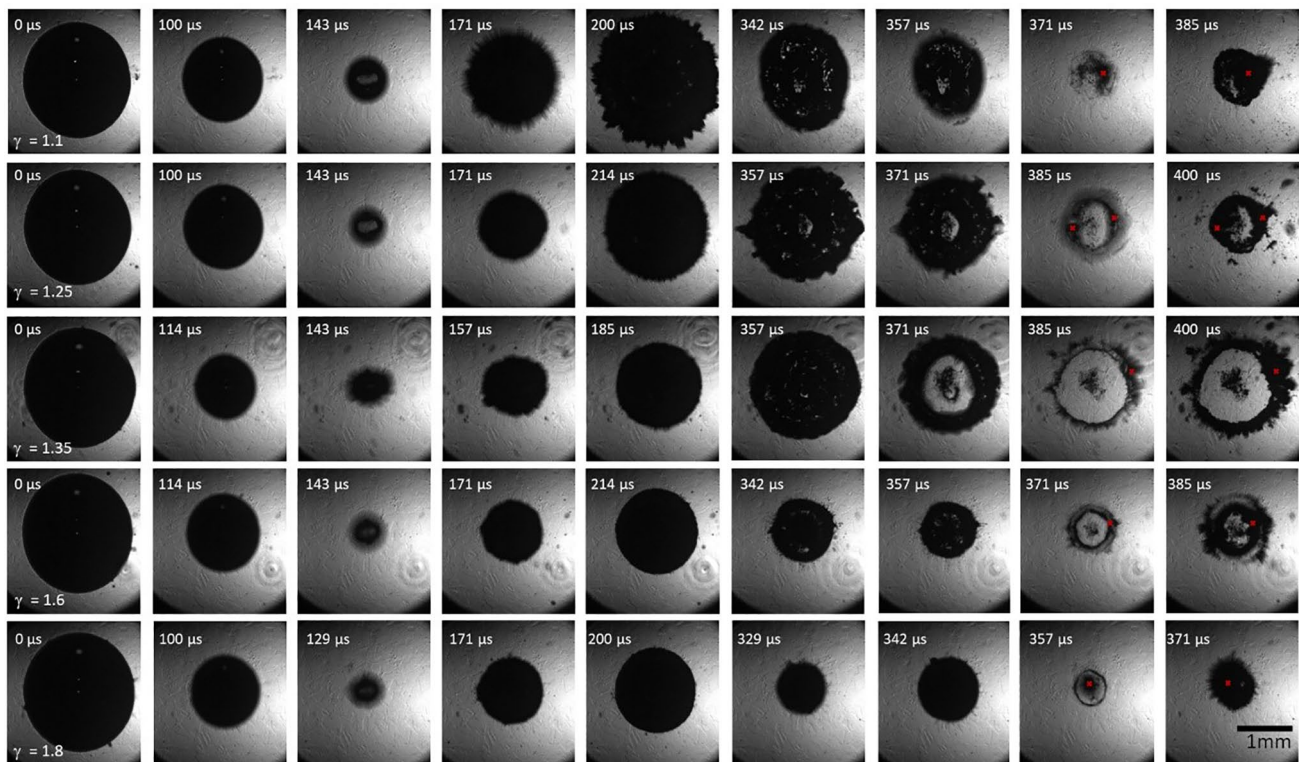
Fig. 14 Additional images of the collapse process of the bubbles shown in Figs. 4 and 5

Figure 14 shows additional images of the bubble collapses in Figs. 4 and 5 in top view. The visual appearance is consistent with other works [20]. The depth of field is very shallow, and therefore, only the surface and the bubble dynamics very close to it are in focus. The bright-dark rings in the upper-right corner of Fig. 14 ($\gamma=1.35$) and the lower-right corner of upper-right corner Fig. 14 ($\gamma=1.6$) are caused by ripples in the water/air interface. They are far away from the bubble and do not affect it.

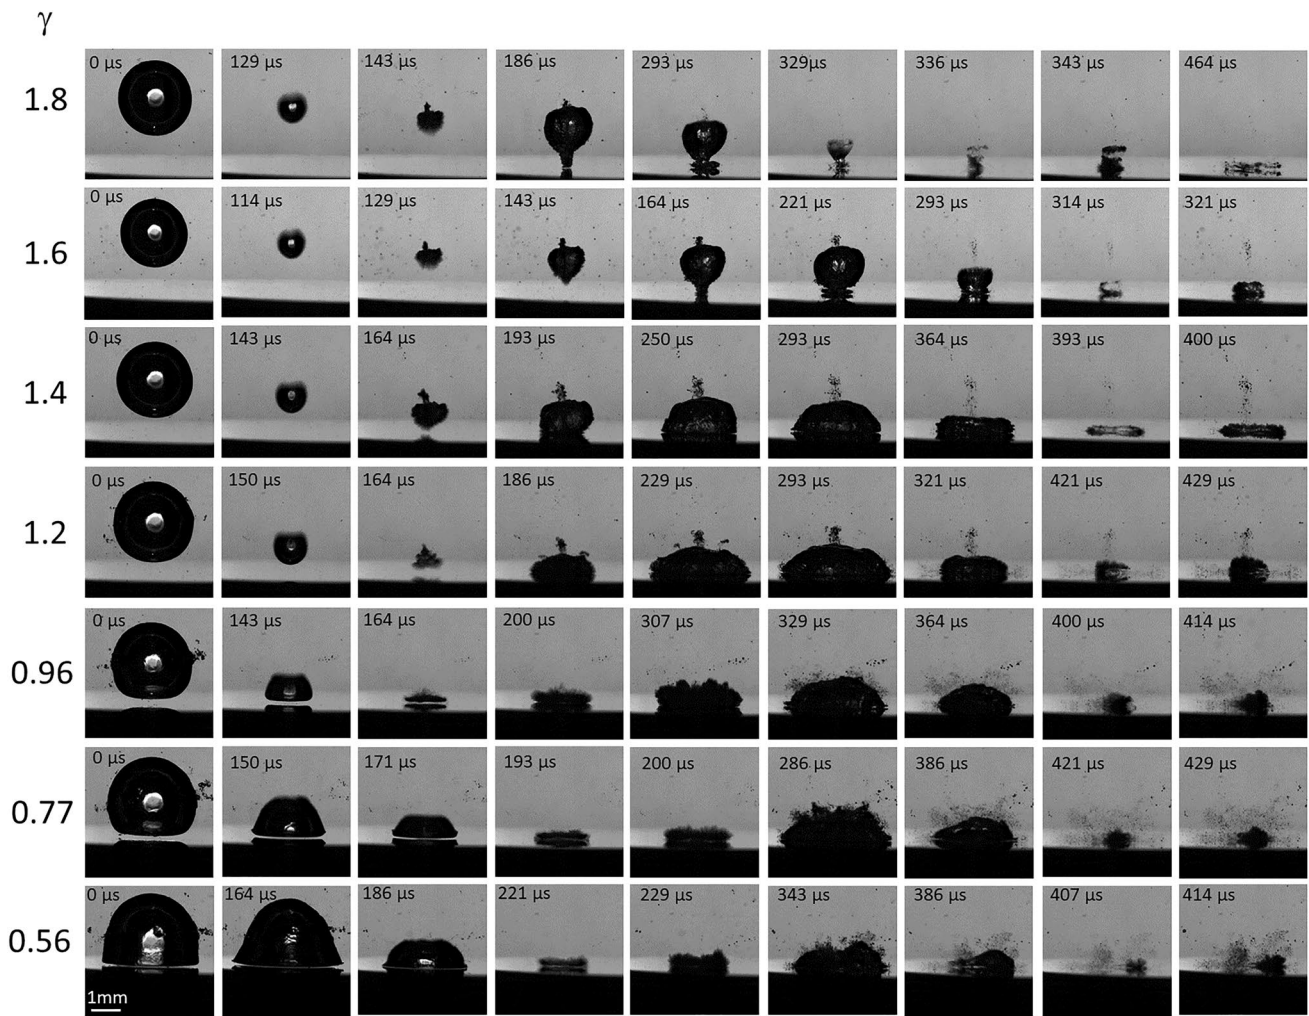
Fig. 15 Selected side-view images of bubble collapses on NAB at different stand-off distances

Figure 15 shows images of bubble collapses at different stand-off distances. Each of the bubbles shown here caused at least one pit. The dynamics are consistent with other work [19, 20, 27]. A discussion of the dynamics can be found in [20].

Results for the other technical alloy tested here, NAB, can be found in the “Appendix” in Figs. 15 and 16. The findings are similar, which confirms that the fluid dynamics of the bubble is decisive for damage in the form of pits on the surface where SCAs occur in the second collapse. In the sections “Pitting rate” and “Influence of the material,” we will compare 316L and NAB in terms of the pitting rate and the accumulated damage of many pits.

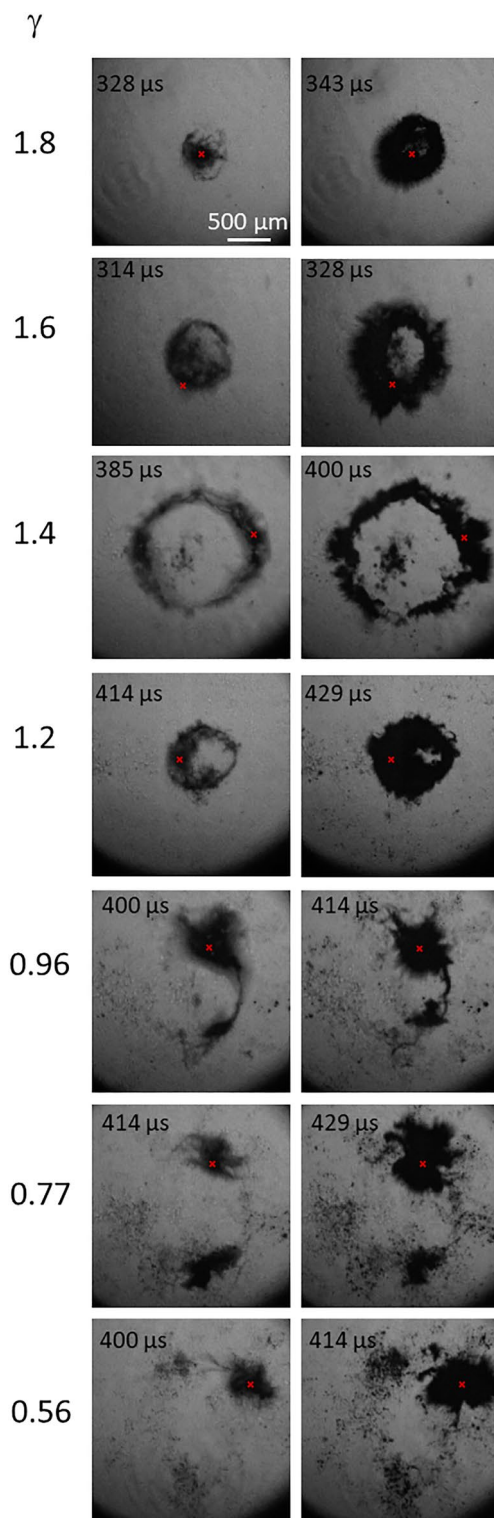
Figure 16 shows the second collapse of the bubbles shown in Fig. 17. Pit locations are marked with a red x.

Fig. 16 Top view of the second collapse of the bubbles shown in figure. The red x marks the location of the pit found after that bubble (Color figure online)

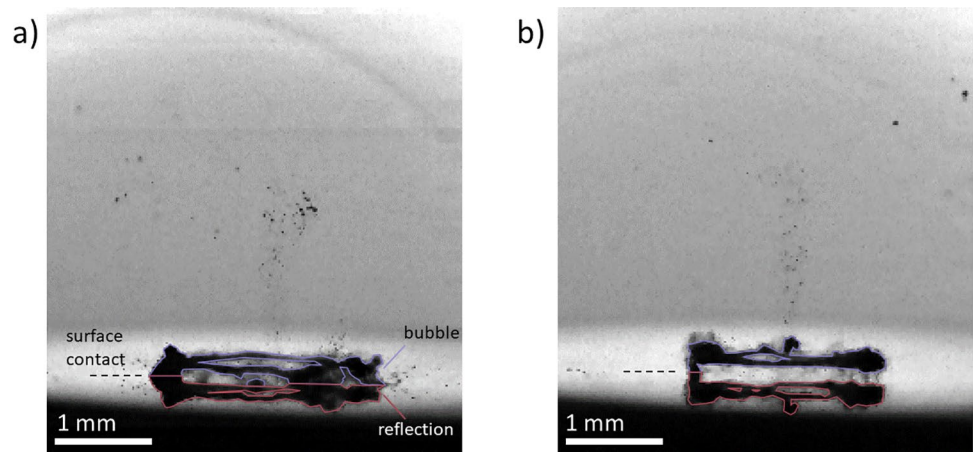
Figure 17 shows two bubbles at the second collapse. The first bubble is the same shown in Fig. 7 and the second is a bubble from the same bubble sequence that did not cause

a pit. The edges of the gas phase are marked in color to aid distinguishing the bubble shape from its reflection on the surface. While the bubble in Fig. 17a is only partially detached from the solid surface, detachment appears almost over the complete torus of the bubble in Fig. 17b.

Fig. 17 Second collapse of two bubbles with short illumination. **a** The same bubble as in Fig. 7. **b** A bubble that did not cause a pit. The edge of the gas phase is marked in blue for the bubble and red for the reflection (Color figure online)
