Single-Bubble Cavitation-Induced Pitting on Technical Alloys

Jonas Kühlmann¹ · Sebastian A. Kaiser¹

Abstract

Keywords Cavitation damage · In situ microscopy · Laser-induced cavitation · Wear of technical alloys

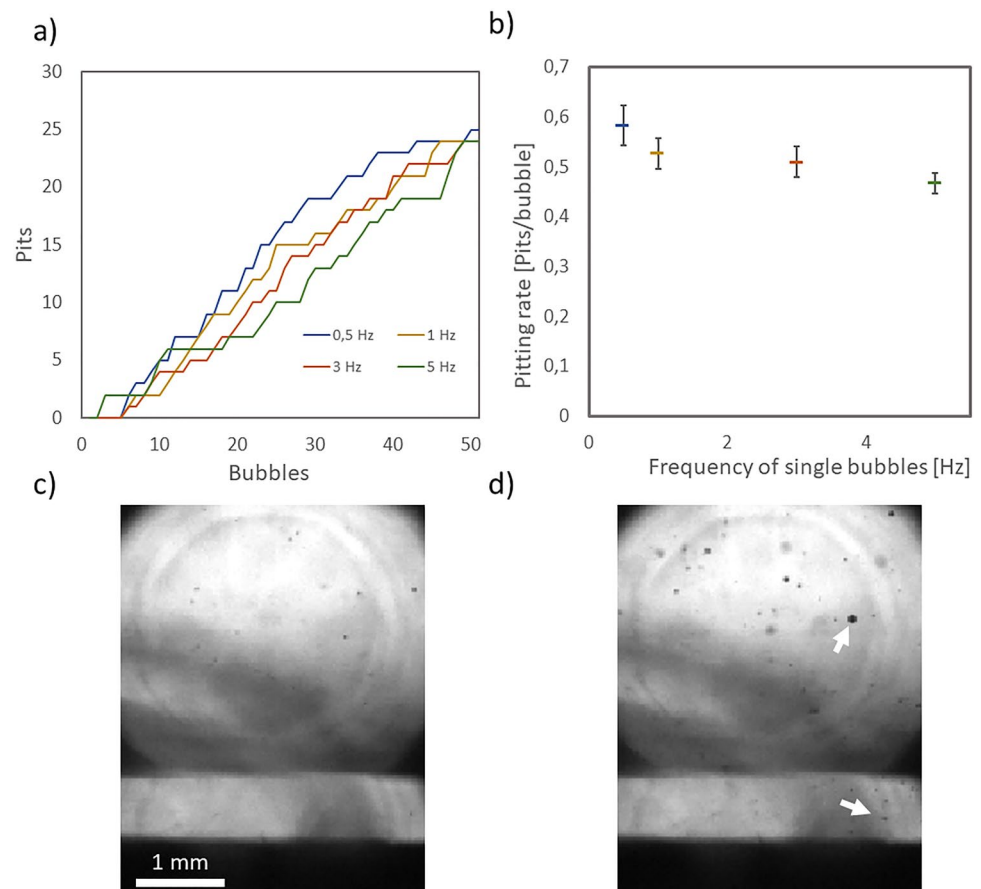
Figure 18a shows the pit count at four different bubble repetition rates. After 50 bubbles, there are 25 or 26 pits at all repetition rates. Figure 18b shows the pitting rate calculated from Fig. 18a. The errors bars represent the uncertainty of the linear fit. All four measurements are quite close. At the highest repetition rate of 5 Hz, the rate slightly decreases. However, the average bubble radius was also slightly lower for this measurement. This may be due to the fact that more dissolved gas bubbles refract part of the laser beam which can result in smaller bubbles. We conclude that within the range relevant for our experiment, the repetition rate has no significant effect on the pitting rate.

These measurements allow further conclusions regarding the influence of the experimental conditions on pit formation. Figure 18c, d show example images of the sample in water a few microseconds before the plasma breakdown at a repetition rate of 1 Hz and at 3 Hz. In the latter case, more dissolved gas bubbles are seen in the bulk liquid and also directly on the surface (white arrows) than in the former case. However, the pitting rate is the same. Thus, more dissolved gas bubbles, which is the main effect of higher frequencies, do not seem to have a significant effect on pitting.

Fig. 18 a Pit count for 50 bubbles at different frequencies, **b** repetition rates dependence of the pitting rate, and **c, d** liquid in the region where the bubble is induced just before the plasma breakdown at a bubble repetition rate of 1 Hz and 3 Hz, respectively. Arrows mark two of many gas bubbles in the liquid

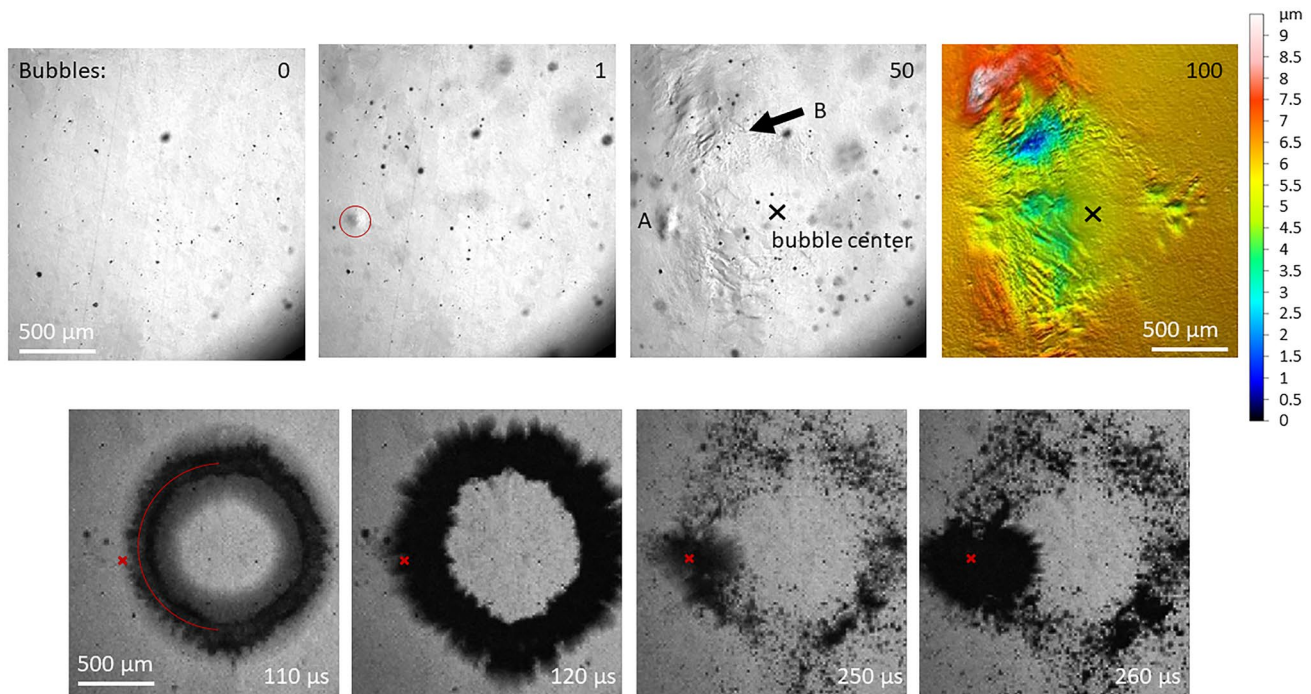
Figure 19 shows the damage to an aluminum sample and the first and second collapse of a bubble at $\gamma=0.5$. The first bubble caused a pit (red circle). After 50 bubbles, more pits can be observed in this region (A), but there are also surface changes that do not look like the previously described pits (B). This change looks more like a large-scale displacement of material that builds up over the whole area at once. The images of the first collapse (Fig. 19 110 μ s, 120 μ s) and the

second collapse (Fig. 19 250 μ s, 260 μ s) show that the first collapse is not responsible for the pit. In the second collapse, however, there is a SCA that can be associated with the pit. In addition, it can be seen that the damaged region (B) lies on the first collapse (red semicircle). In contrast to the technical materials, there is a surface change here that is not in the form of pits and is caused by a wide area of the collapse.

Finally, Fig. 19 also shows a confocal microscope image of the damage after 100 individual bubbles. The material displacement can be seen very well. The center of the bubble collapse is marked with a black X. This is where the liquid jet hits the sample surface. It can be seen that despite the small stand-off distance, no surface change occurred in this area. This shows the limitations of aluminum as a model

Fig. 19 Aluminum surface after 0, 1, and 50 bubbles in situ recorded and a confocal recording after 100 bubbles at $\gamma=0.5$ and $r=1.3$. Additionally, the first and second collapse of the first bubble are

shown. The red x marks the location of the pit found after this bubble (Color figure online)
