Application of supersonic particle deposition to enhance the structural integrity of aircraft structures

Matthews N.^{1*}, Jones R.² & Sih G.C.³

Aircraft metal components and structures are susceptible to environmental degradation throughout their original design life and in many cases their extended lives. This paper summarizes the results of an experimental program to evaluate the ability of Supersonic Particle Deposition (SPD), also known as cold spray, to extend the limit of validity (LOV) of aircraft structural components and to restore the structural integrity of corroded panels. In this study the potential for the SPD to seal the mechanically fastened joints and for this seal to remain intact even in the presence of multi-site damage (MSD) has been evaluated. By sealing the joint the onset of corrosion damage in the joint can be significantly retarded, possibly even eliminated, thereby dramatically extending the LOV of mechanically fastened joints. The study also shows that SPD can dramatically increase the damage tolerance of badly corroded wing skins.

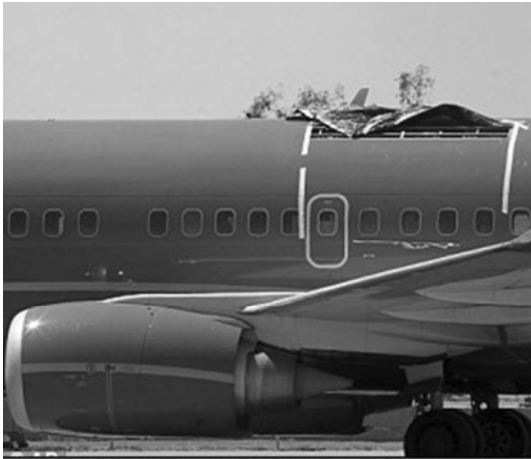
Figure 2 Tarpaulin covering the five-foot-hole that ripped open roof, from ref. [12].

The extent of the problems associated with fuselage lap joints is aptly illustrated by the April 2011 incident whereby cracking in the fuselage lap joint in a Southwest Airlines Boeing 737-300 aircraft resulted in a large 5 foot (1.524 m) hole in the roof (see Figure 2). This incident led to the grounding of 79 of its older Boeing 737 aircraft [12] and to the cancellation of almost 700 flights. Subsequent inspections, which found cracks in a total of four Southwest aircraft [12], led to the US FAA mandating the inspection of 175 Boeing 737 aircraft that had seen more than 35000 cycles. The problem of cracking in fuselage lap joints is not confined to Boeing 737 and 727 aircraft. On 26th October 2010 an American Airlines 757-200 aircraft was forced to land at Miami International Airport due to a sudden decompression arising from cracking in a fuselage joint [13]. This aircraft had experienced less than 23000 cycles. This led to

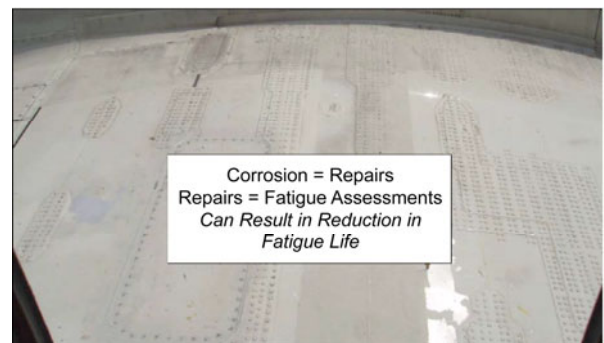
Figure 12 Multiple corrosion repairs on a RAAF P3C aircraft. This slide is by courtesy of Sqn Ldr Dorman RAAF DGTA.

The Aloha accident also highlighted the problem of multiple interacting repairs, (see Figure 1) which reveals that despite the presence of MSD in the fuselage lap joint the failure ran from corrosion repair to corrosion repair. Indeed, for Boeing 727 aircraft [16,17] there are numerous instances when there was no crack growth until after a corrosion repair had been installed. The problem of multiple interacting repairs to corrosion damage is not confined to corrosion in fuselage lap joints (see Figure 12). The common approach to corrosion damage in operational aircraft is to cut out the corrosion and rivet a mechanical doubler over the region (see Figures 1 and 12). Unfortunately if the aircraft is operated in an aggressive environment, then corrosion is likely to occur over a (relatively) broad area and this can lead to a number of mechanical repairs that lie in relatively close proximity, (see Figures 1 and 12). This repair process
