# Transverse and z-Direction CVN Impact Tests of X65 Line Pipe Steels of Two Centerline Segregation Ratings

LIHONG SU, HUIJUN LI, CHENG LU, JINTAO LI, LEIGH FLETCHER,  
IAN SIMPSON, FRANK BARBARO, LEI ZHENG, MINGZHUO BAI,  
JIANLAN SHEN, and XIANYONG QU

Centerline segregation occurs as a positive concentration of alloying elements in the mid-thickness region of continuously cast slab. Depending upon its severity, it may affect mechanical properties and potentially downstream processing such as weldability, particularly for high-strength line pipe. The segregation fraction in continuously cast slabs and corresponding hot-rolled strips was assessed on API 5L grade X65 line pipe steels with different levels of segregation, rated as Mannesmann 2.0 and 1.4. The results showed that the segregation fraction in hot-rolled strip samples was in accordance with that assessed in the cast slabs, and the segregated regions in hot-rolled strip samples were found to be discontinuous. Transverse and z-direction CVN impact tests were conducted on the two strips and the results showed that centerline segregation does have an influence on the Charpy impact properties of line pipe steel. Specimens lo

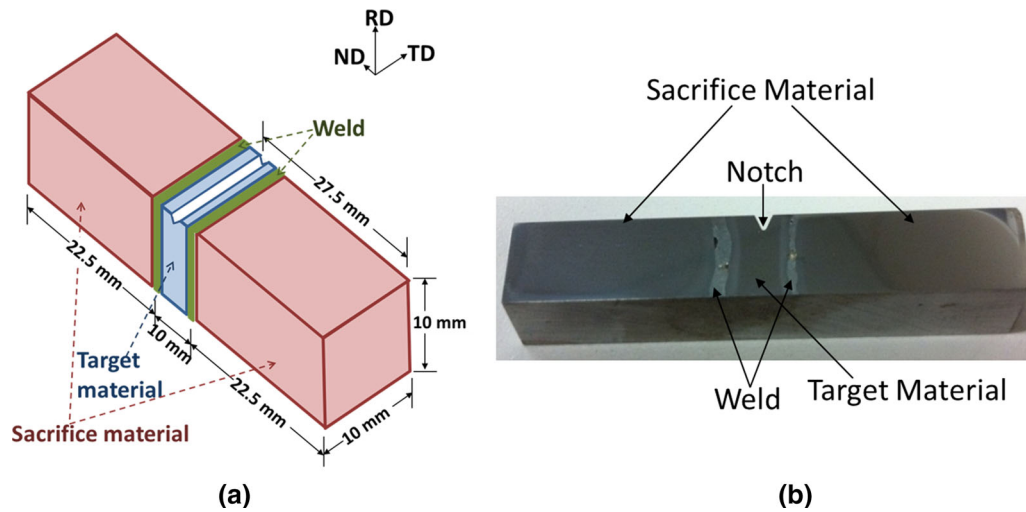
Fig. 1—(a) Schematic illustration and (b) real photo of *z*-direction Charpy specimen prepared by stud welding.

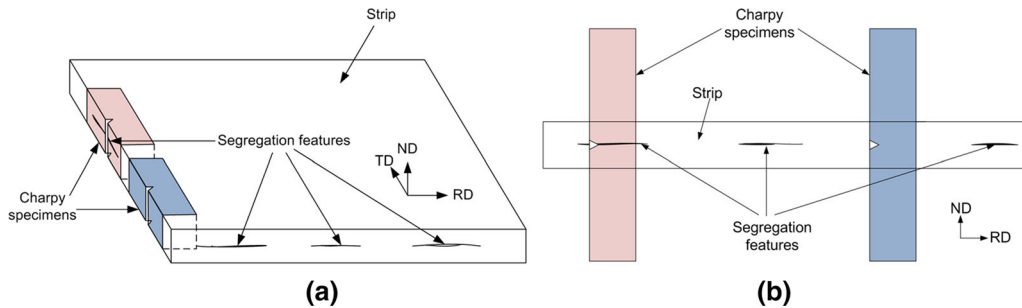
Fig. 2—Schematic illustration of (a) transverse and (b) *z*-direction Charpy specimens with and without segregation features inside.

Figure 6 shows the detailed analysis of the fracture surface for sample T1. It can be seen in Figure 6(a) that the fracture surface has a line in the middle of the surface. Referring to the specimen geometry illustrated in Figure 2(a), it can be seen that the position of the line in the fracture surface is in the same plane as the position of the segregation line in the rolled strip. Further, it can be inferred that the line in the fracture surface is caused by centerline segregation. Figure 6(b) shows an enlarged image at the middle of the fracture surface and it can be seen that the morphology of the midline appears to be different compared to the surrounding regions and the material is elongated toward both sides due to greatly elongated dimples. Figure 6(c) shows a higher magnified view of the midline where broken inclusions can be observed. EDS mapping of the inclusions indicates that these are MnS inclusions. Figure 6(d) shows the optical micrographs of the cross-sectional area beneath fracture surface obtained by cutting the fractured specimen in the midplane perpendicular to segregation line. A shallow

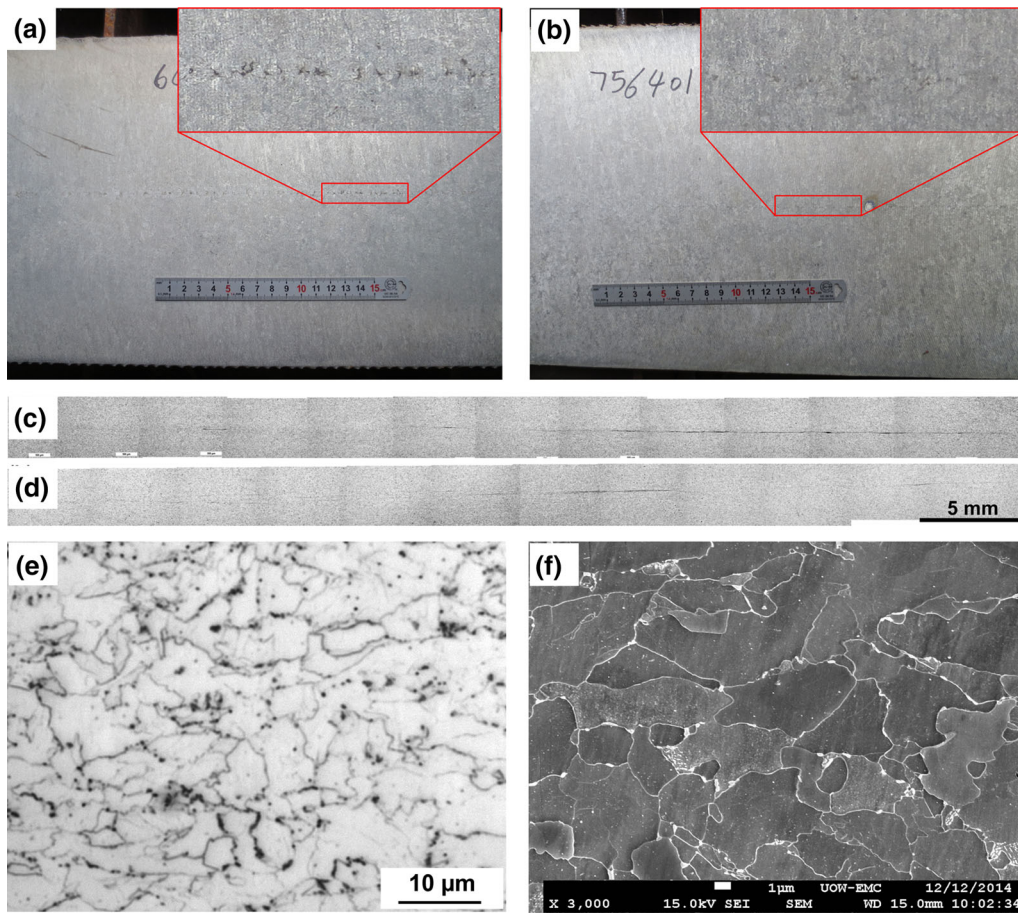
Figures 3(a) and (b) show the macro-etched slab images of steels #1 and #2, respectively. It can be seen that there are larger and more severe segregated features in slab #1 compared to that of #2, supporting the higher segregation rating of slab #1. In addition, the percentages of segregated features were calculated by dividing the total accumulated length of the segregated features by the image length. The values for slabs #1 and #2 were 25 and 13 pct, respectively, as listed in Table II. The percentage of segregated features for the standard Mannesmann level 2 image was measured to be 24 pct, which is quite close to the percentage of slab #1, indicating that our assessment method is reliable.

strip images are shown in Figures 3(c) and (d). It can be seen from these two images that the stringers in strip #1 were longer compared to those in #2. The sizes of these stringers were measured and the percentage of segregated features for the strips was calculated by the same method as that for the slabs and it was 21 and 10 pct for strips #1 and #2, respectively. It is worth emphasizing that the segregation features are discontinuous in the hot-rolled strips.

The microstructure of the base metal has been taken from strip #1 and it consists of mainly polygonal ferrite with small fractions of pearlite, as can be seen in the optical micrograph and the SEM image presented in Figures 3(e) and (f), respectively. The base metal microstructure of strip #2 is the same as that of #1.

Fig. 3—Macro-etched slab images of samples (a) #1 and (b) #2, selected low-magnification images of etched strips of samples (c) #1 and (d) #2, and high-magnification (e) OM and (f) SEM images of base metal.

In the current work, centerline segregation appears as many individual pockets along the centerline for both investigated slabs, as can be seen in Figure 3(a). The difference between the two slabs is that the pockets are

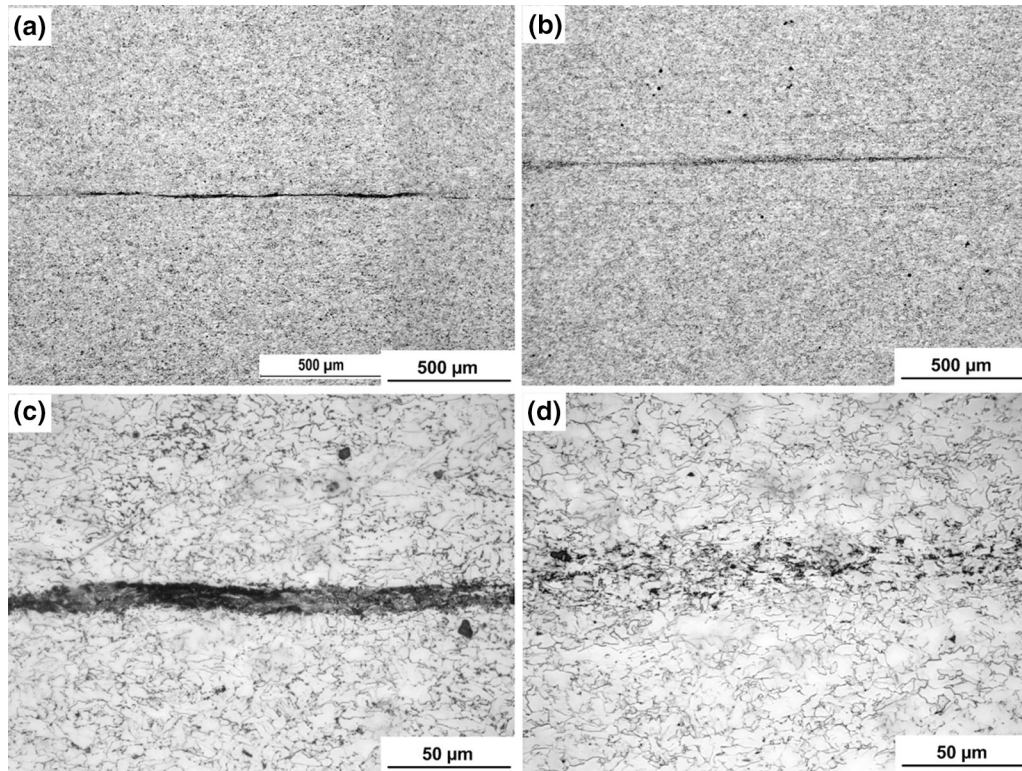
Figures 4(a), (c) and (b), (d) show the optical micrographs of the most segregated regions of the strips #1 and #2, respectively. It can be seen that the segregation band in strip #1 is a thick solid black line, while that in strip #2 is lighter in color and is not solid. The black-colored features are pearlite structures. It can be concluded from the micrographs that strip #1 is more severely segregated.

Fig. 4—Optical micrographs of the most segregated regions of the etched strips of (a) and (c) sample #1, and (b) and (d) sample #2.

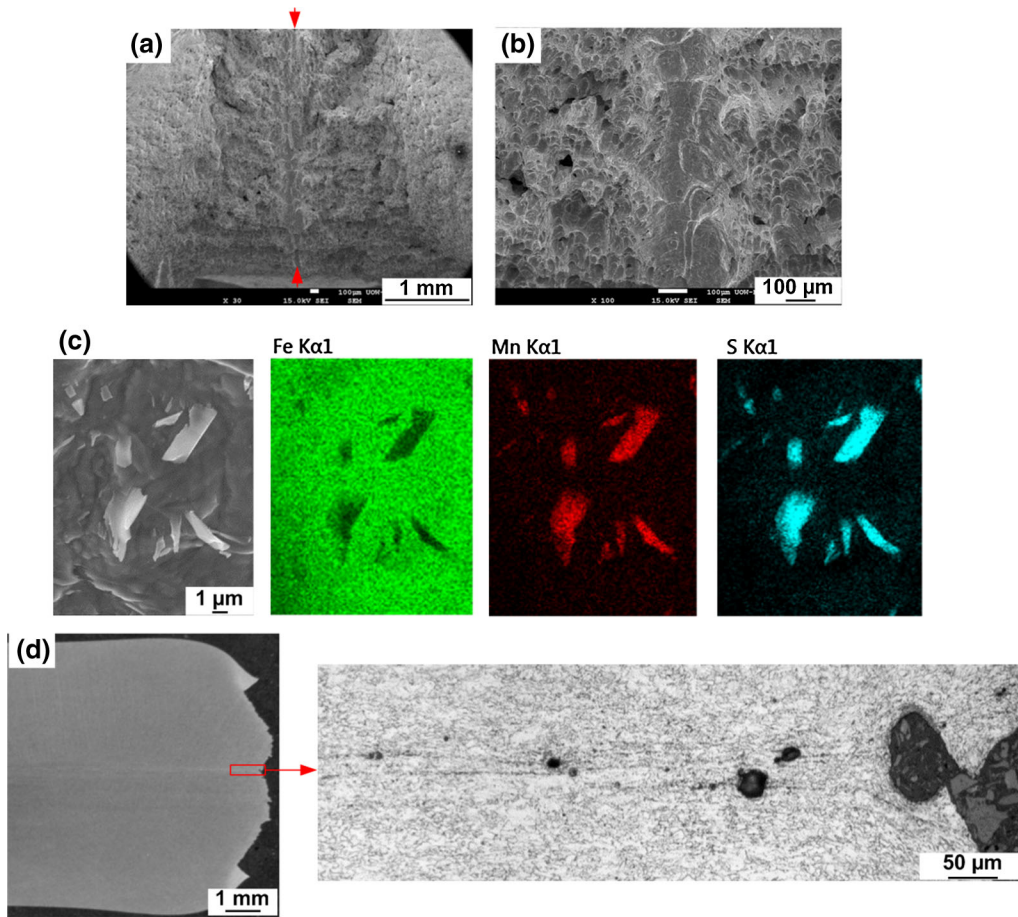
valley is observed at the position of the line shown in Figure 6(a). An enlarged image close to the center region of the fracture surface shows lines of pearlite structure. It confirms the speculation above that the centerline segregation is the reason for the line in the fracture surface.

Fig. 6—(a) SEM fractographs of fracture surfaces of sample T1, (b) enlarged view of the center region, (c) EDS mapping of the center region at high magnification, and (d) optical micrographs of the cross-sectional area beneath the fracture surface.

appears as broken rod pieces in Figure 6 and long rod shaped in Figures 12 through 14.

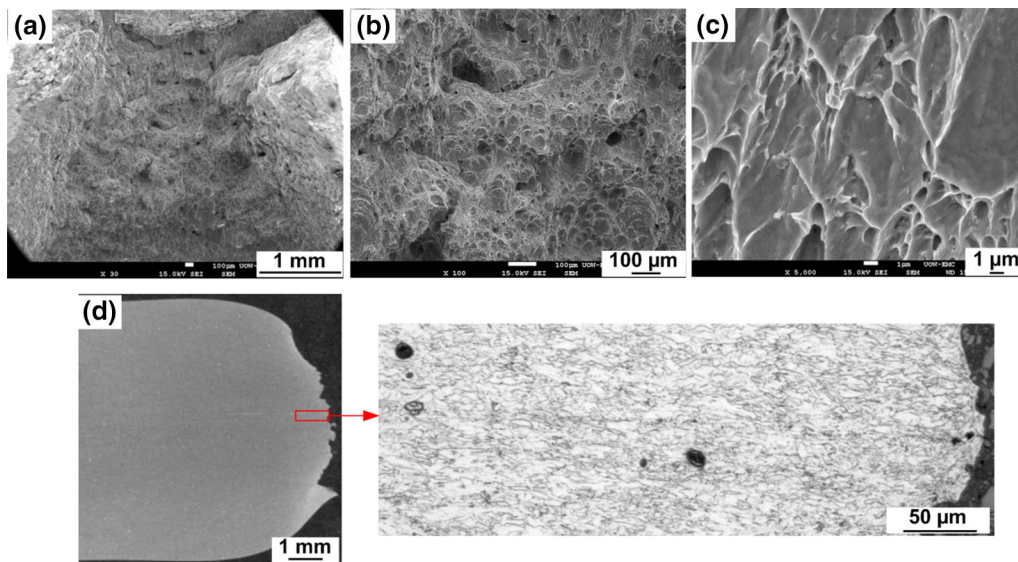
Figure 7 shows the analysis of the fracture surface for sample T2. Figure 7(a) presents the general appearance of the fracture surface which is ductile fracture and without any line in the sample compared to that of sample T1. An enlarged micrograph in the middle of the fracture surface (Figures 7(b) and (c)) only shows large

and small dimples which are typical of ductile fracture, but without any inclusions like in Figure 6(c). The cross-sectional image (Figure 7(c)) does not show any pearlite structure band in the mid-thickness line.

Fig. 7—(a) SEM fractographs of fracture surfaces of sample T2, (b) and (c) enlarged view of the center region, and (d) optical micrographs of the cross-sectional area beneath the fracture surface.

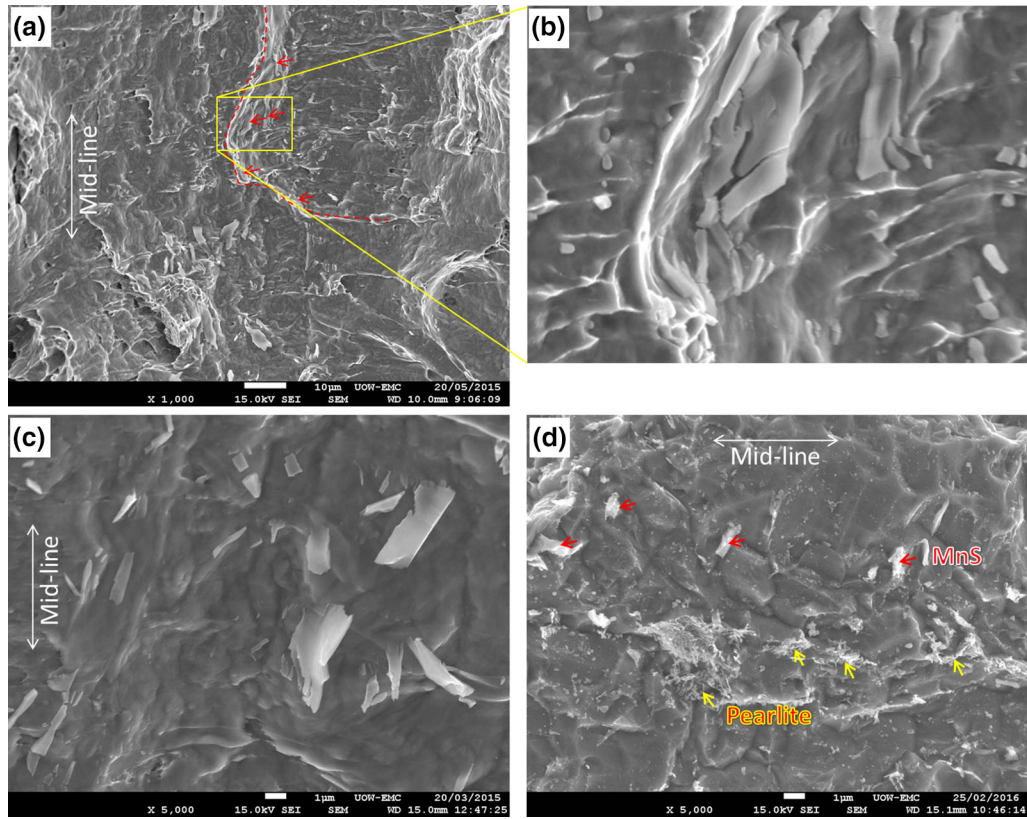
Figure 8 presents more detailed views at the midline of the transverse fracture surfaces from strip #1. Figure 8(a) shows a large but shallow elongated dimple that nucleated at the center and elongated toward the right of the image. There can be seen many fragmented MnS inclusions at the bottom of the shallow dimple (Figure 8(b) shows the MnS inclusions at a larger magnification). It can be inferred that void nucleated at these MnS inclusions and then grew toward both sides to form these elongated dimples. Even at a higher magnification view, brittle fracture was not identified at the midline, as can be seen in Figure 8(c). After etching the fracture surface using 2.5 pct nital for 100 seconds, most of the pearlite structure at the midline has been removed and brittle fracture patterns appear like intergranular fracture at the midline has been revealed, as can be seen in Figure 8(d).

Fig. 8—SEM fractographs at the midline of the fracture surfaces from strip #1, (a through c) as-Charpy fractured, and (d) after etching by 2.5 pct nital for 100 s. Note that the direction of the midline for (d) is different from (a through c).

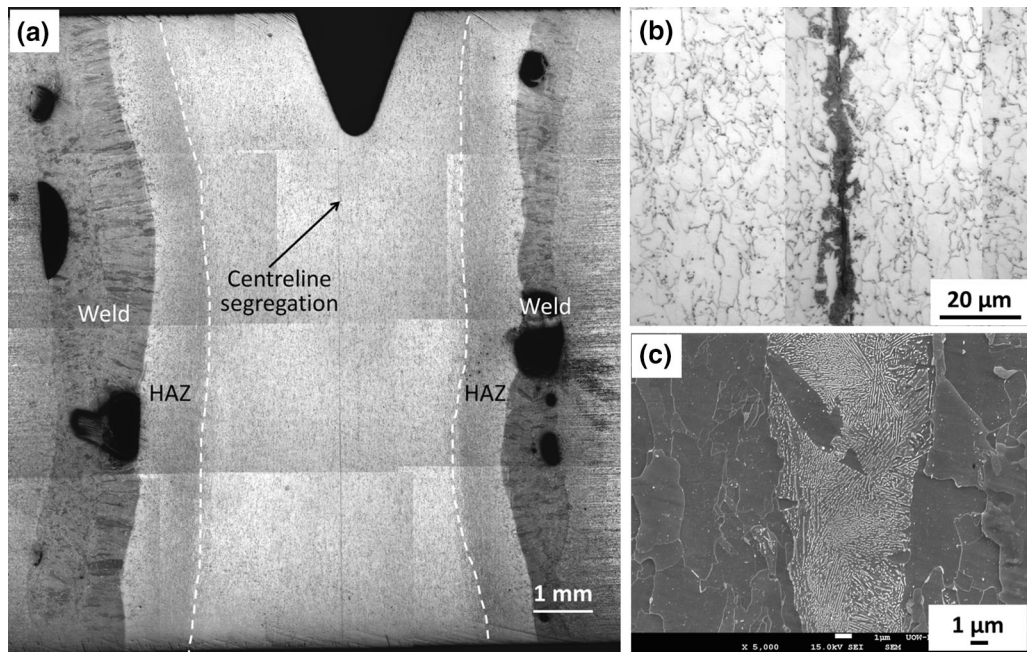
Figure 9 shows an example of the prepared z-direction Charpy specimen from strip #1 with centerline segregation in the specimen. It can be seen in Figure 9(a) that there are some voids in the welds. This is because the welding heat input was restricted to ensure that there is sufficient distance between the weld heat-affected zone (HAZ) and the centerline of the specimen to ensure that

the stud welding procedure did not change the microstructure at the center of the strip. Close examination of the centerline segregation shows a thick

pearlite structure as can be seen in Figures 9(b) and (c). The hardness in the pearlite band is  $HV\ 235 \pm 10$  and in the ferrite matrix is  $HV\ 170 \pm 4$ . It is assumed

Fig. 9—An example of the prepared z-direction Charpy V-notch impact specimen with segregation line close to notch tip: (a) overall view and (b) and (c) enlarged view at the center region of (a).

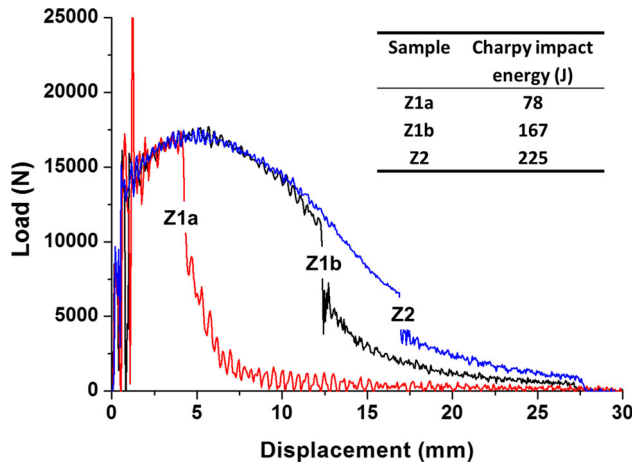
The instrumented load–displacement curves of samples Z1a, Z1b, and Z2 are shown in Figure 11. It can be seen that the three curves coincide with one another before the displacement reaches ~4 mm, where sample Z1a experienced a sharp jump which appeared to be the same as brittle crack jump described in Reference 17. The sharp jump phenomenon occurred at a later stage for sample Z1b (~12 mm displacement) after a certain distance of ductile crack propagation. For sample Z2, the sharp jump was also observed, but at a much later

stage (~17 mm displacement) the magnitude was much smaller than samples Z1a and Z1b. After the sharp jump, a consequent ductile final rupture was observed for all three samples. All load values became 0 at displacement of 28 mm. The areas under the curves increase from sample Z1a to Z1b to Z2, indicating the increasing toughness. As indicated in the embedded table in Figure 11, the Charpy impact toughness for Z1a, Z1b, and Z2 is 78 J, 167 J, and 225 J, respectively.

Fig. 11—Load–displacement curves of three selected *z*-direction Charpy specimens Z1a, Z1b, and Z2.

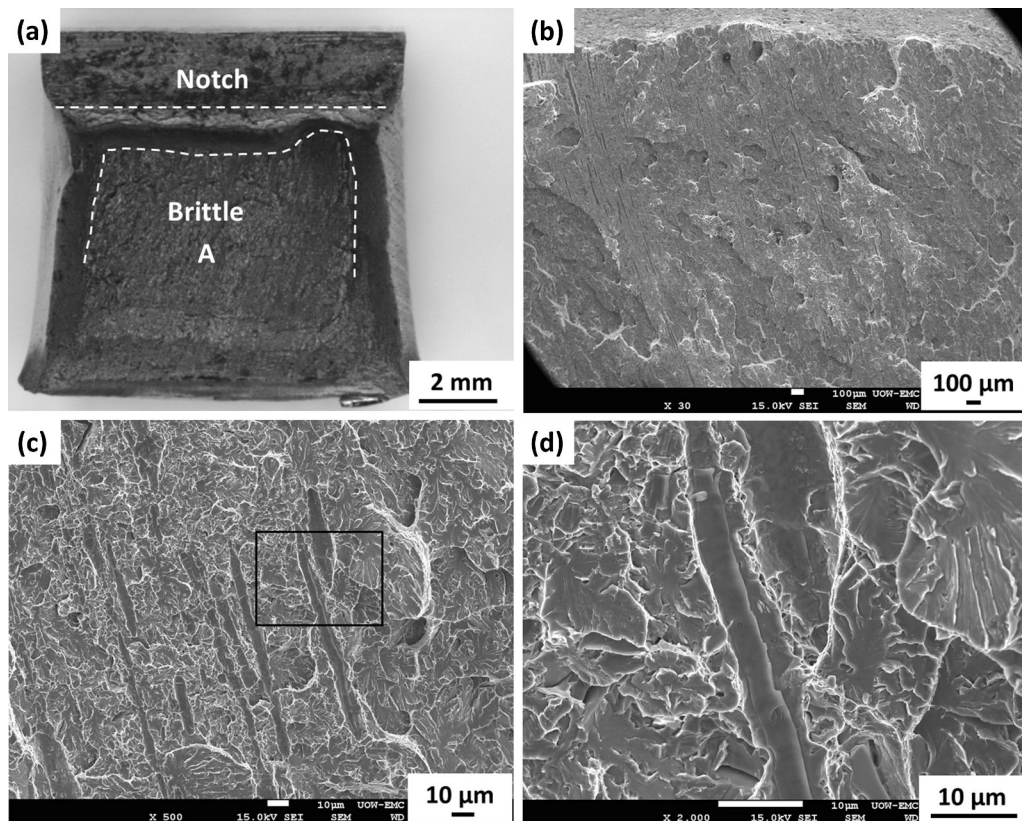
The fractographs of samples Z1a, Z1b, and Z2 are shown in Figures 12 through 15. It can be seen from the figures that the fracture surfaces of the three samples are quite different from one another. Figure 12 shows the fractographs of sample Z1a which appear as a brittle cleavage fracture surface with minimum necking and is overall flat. Closer examination of the fracture surface reveals three types of structures: cleavage facets containing river markings, ductile tearing ridges between the facets and long, rod-shaped features. EDS mapping of the fracture surface confirmed that the rod-shaped features were MnS inclusions, as indicated in Figure 13.

Fig. 12—Fractographs of fracture surfaces of sample Z1a: (a) overall view, (b) SEM at low magnification, (c) enlarged view at position A in (a), and (d) enlarged view of the frame in (c).

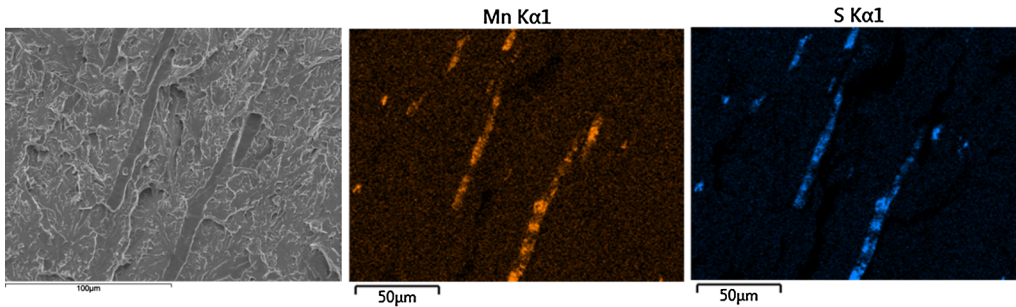
Fig. 13—EDS mapping at the fracture surface of sample Z1a.

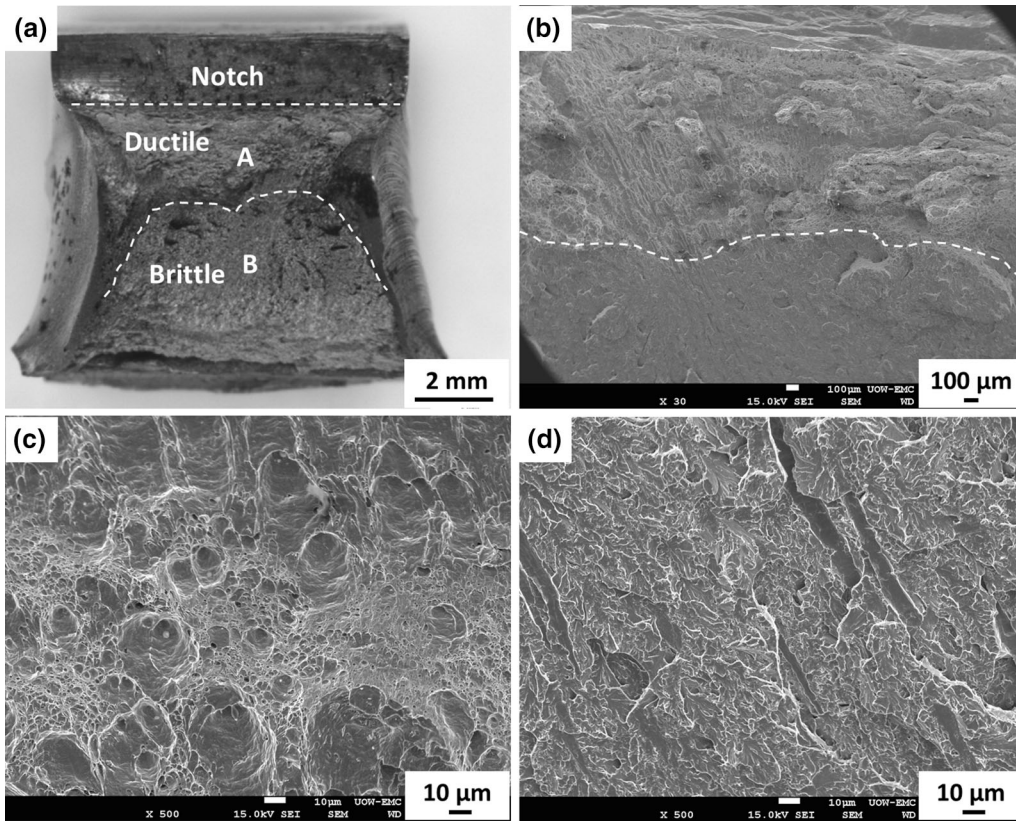
Figure 14 shows the fracture surfaces of sample Z1b. It can be seen that the fracture surface can be separated into two regions: ductile fracture region on top close to the original notch and brittle fracture region on the bottom. The brittle fracture region is slightly larger than the ductile fracture region. The brittle fracture region is also flat, the same as the fracture surface of sample Z1a. There can be seen apparent necking and the shear lip areas are larger than sample Z1a. Closer examination of the fracture surface reveals large and small shearing dimples and microvoids in the ductile region, as can be seen in Figure 14(c). The brittle fracture region shows a similar appearance as sample Z1a with cleavage facets, shear ridges, and MnS inclusions, as can be seen in Figure 14(d).

Fig. 14—Fractographs of fracture surfaces of sample Z1b: (a) overall view, (b) low-magnification SEM at center region, (c) enlarged view at position A in (a), and (d) enlarged view at position B in (a).

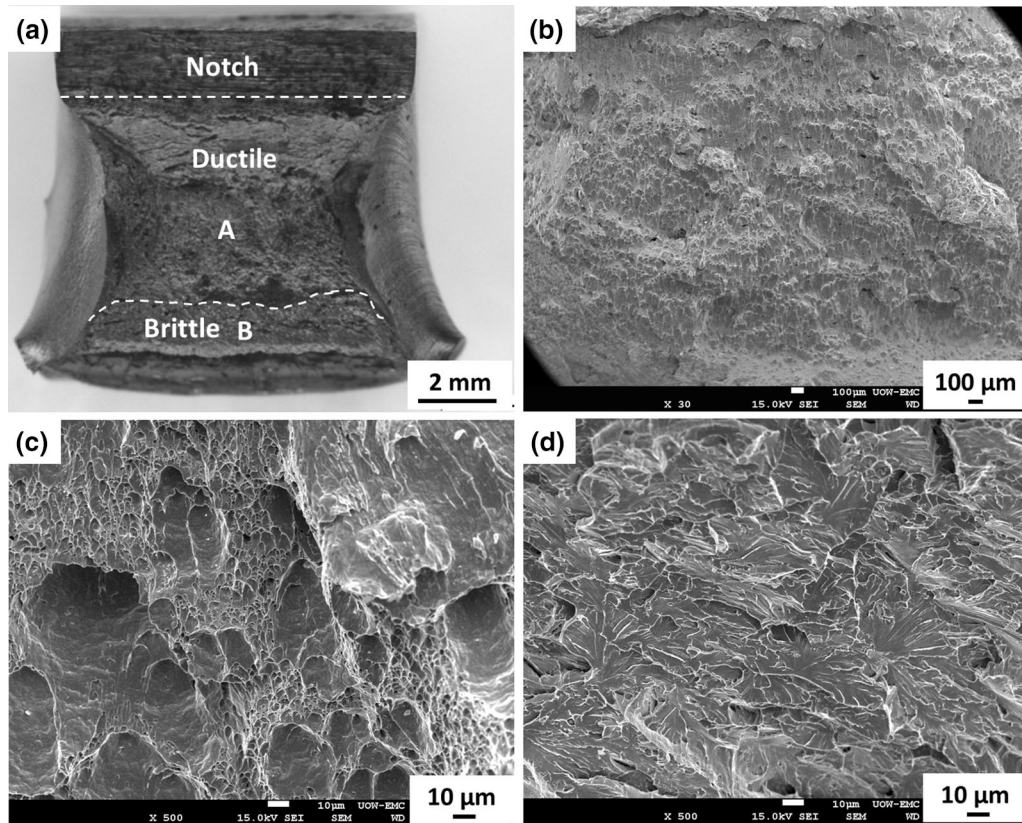
Figure 15 shows the fracture surfaces of sample Z2. It can be seen that the fracture surface is rough in

appearance and the amount of necking is maximum among the three samples. It can also be separated into two regions similar as in sample Z1b, but the brittle fracture region is much smaller in area. Closer examination of the ductile region reveals large and small shearing dimples and microvoids similar as in the ductile fracture region of Z1b, as can be seen in Figure 15(c). The brittle fracture region shows only cleavage facets, as can be seen in Figure 15(d).

Fig. 15—Fractographs of fracture surfaces of sample Z2: (a) overall view, (b) low-magnification SEM at center region, (c) enlarged view at position A in (a), and (d) enlarged view at position B in (a).

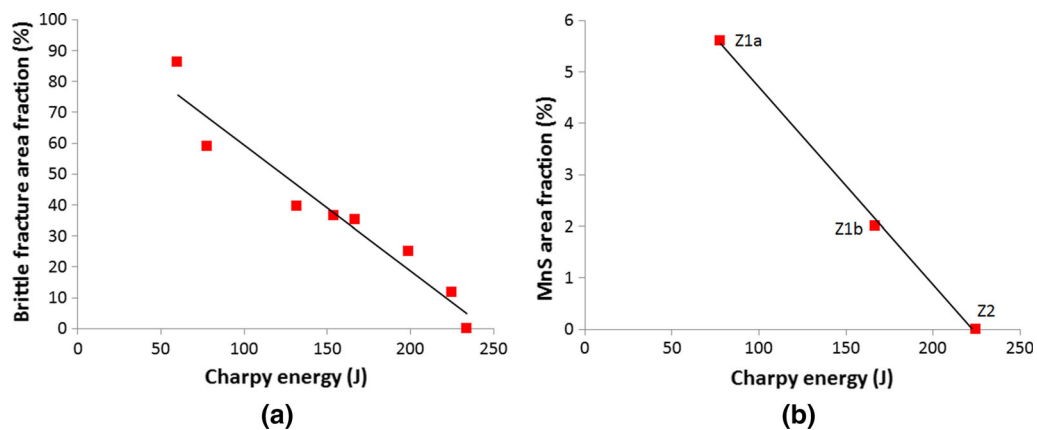
Figure 16(a) presents the relationship between the area fraction of brittle fracture and Charpy impact energy of  $z$ -direction Charpy test results. The data points are from all the specimens of strip #1 and specimen Z2. It can be seen that with decreasing Charpy impact energy, the brittle fracture area fraction

Fig. 16—Relationship between (a) brittle fracture area fraction and (b) MnS area fraction and Charpy impact energy.
