Microstructure Changes in Sn-3.5Ag Solder Alloy during Creep

V.I. IGOSHEV,¹ J.I. KLEIMAN,¹ D. SHANGGUAN,² C. LOCK,³ S. WONG,³
and M. WISEMAN³

Experimental data on behavior of the Sn-3.5Ag solder alloy microstructure during tensile creep deformation and subsequent failure is described. Depending upon applied stress, the nucleation and further development of grain boundary defects that start at an earlier stage in the deformation process was revealed. A discussion is presented on possible micromechanisms of the crack formation process.

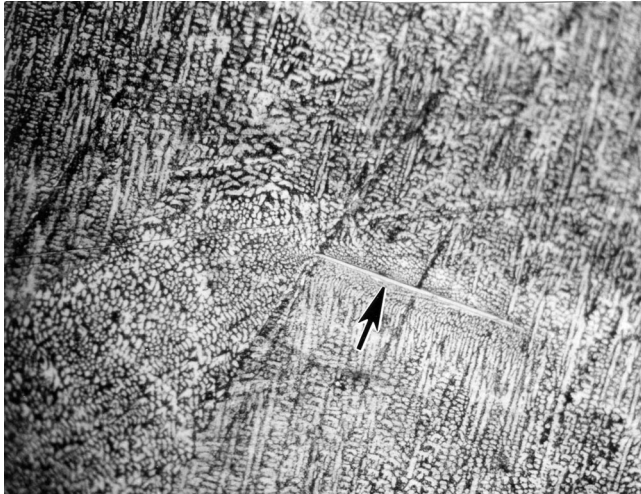
Fig. 1. Rod-like intermetallics of Ag_3Sn in the matrix of Sn. Annealing for 100 h at 373K. Optical microscopy, x160.

The cooling rate for specimens after molding was expected to be low due to the large mass of the mold and the chosen method of cooling in air. Low cooling rates should cause formation of rod-like Ag_3Sn intermetallics in an essentially pure Sn matrix, while high cooling rates lead to formation of small ($\sim 1 \mu m$) intermetallic particles dispersed in a Sn matrix.³⁻⁵ Figure 1 shows a typical microstructure for the molded and aged specimens. This type of microstructure is in accord with the reported data for low cooling rates.⁴ The microhardness value of $HV = 13.8 \pm 0.4$, measured for one of the samples, was found to correspond closely to the value of $HV = 13-14$ reported for the same type of microstructure.⁴ It should be noted, however, that microstructures obtained in our experiments with low cooling rates contained not only rod-like, but also finely dispersed particles of Ag_3Sn intermetallics in the Sn matrix as well (Fig. 2).
