Characterization of Atmospheric Corrosion of 2A12 Aluminum Alloy in Tropical Marine Environment

In this work, corrosion product formed on 2A12 aluminum (Al) alloy after 3 months of natural exposure in South China Sea atmosphere was characterized by various surface analysis techniques, including scanning electron microscopy, energy-dispersive x-ray analysis, x-ray photoelectron spectroscopy, and x-ray diffraction. The atmospheric corrosion mechanism of Al alloy in marine environment was derived. Results demonstrated that Al alloy specimen experiences serious general corrosion and pitting corrosion. Al and O are enriched in the product film, and Ca and Cl are also found in the film and corrosion pits in Al alloy substrate. The main component compounds existing in the film include Al_2O_3 , $\text{Al}(\text{OH})_3$, and AlOOH while AlCl_3 and CaCO_3 are also identified. Al alloy encounters corrosion under tropical marine atmosphere. Although somewhat protective, the formed surface film on Al alloy specimen is attacked by chloride ions, resulting in significant pitting corrosion of Al alloy.

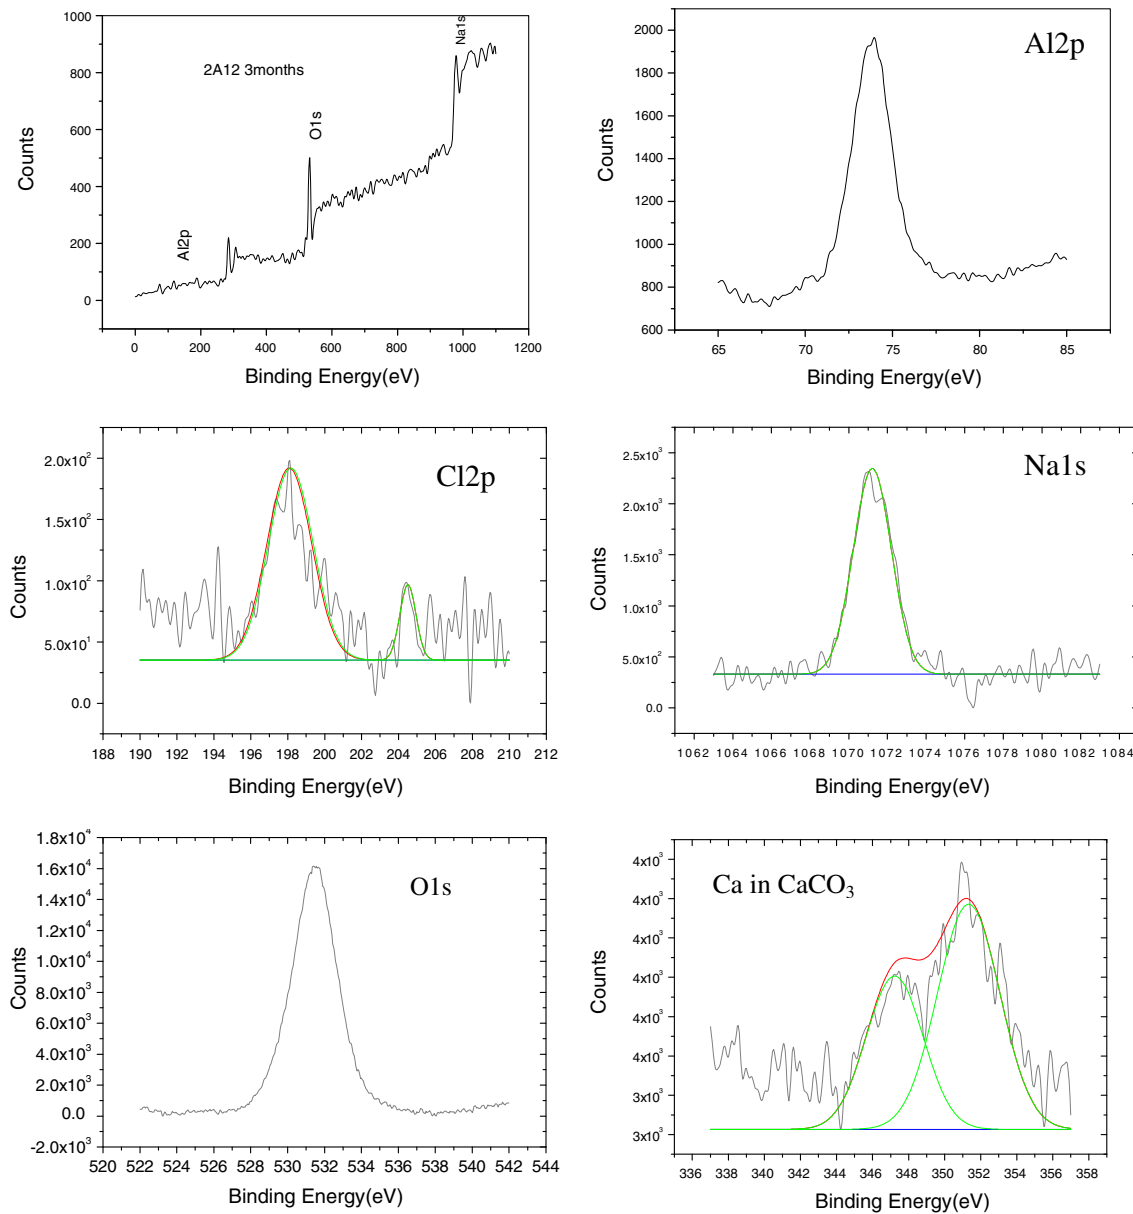
Figure 8 exhibits XPS results of corrosion product formed on Al alloy surface after 3 months of atmospheric exposure. It is seen that spectra of Al2P and O1s showed distinct peaks at about 74 and 531 eV, respectively. The peak of Na1s was observed at 1071.2 eV, which was mainly from NaCl since the reference spectrum energy was 1072.1 eV. Moreover, the weak peaks of Cl2p_{1/2}, Cl2p_{3/2}, Ca2p_{1/2}, and Ca2p_{3/2} were found at 198.66, 202.61, 351.33, and 347.22 eV, respectively. From XPS and EDXA results, it is expected that the corrosion product on Al alloy specimen possibly consisted of [Al(OH)₃] (bayerite), Al₂O₃, AlOOH, and chloride-containing product such as AlCl₃, CaCO₃, etc.

Fig. 8 XPS spectra measured on corrosion product formed on Al alloy specimen after 3 months of exposure in Xi-Sha Islands atmosphere
