Solid-State Repair of Casting Defects in ZL210 Aluminum Alloy

Zan Lv, Song Han, Wei Hu, Zhibo Dong, Ruofei Huang, and Kang Yang

Casting defects in the ZL210 aluminum alloys were repaired via a solid-state welding method named active-passive filling friction stir repairing (A-PFFSR). Effects of plunge speed on microstructures and mechanical properties of repaired joints were investigated based on a six-spiral-groove pinless tool. Casting defects were firstly machined into a tapered hole by a tapered and threaded pin. Then, the keyhole was successfully repaired by the materials surrounding the keyhole and an extra filler via the A-PFFSR. The lower plunge speed was propitious to improving frictional heat and material flow, which improved joint integrity containing surface appearance and interface joining behaviors. The maximum tensile strength of the repaired joint was approximately equivalent to that of base ZL210 alloys, realizing the quasi-repairing of the ZL210 aluminum alloys.

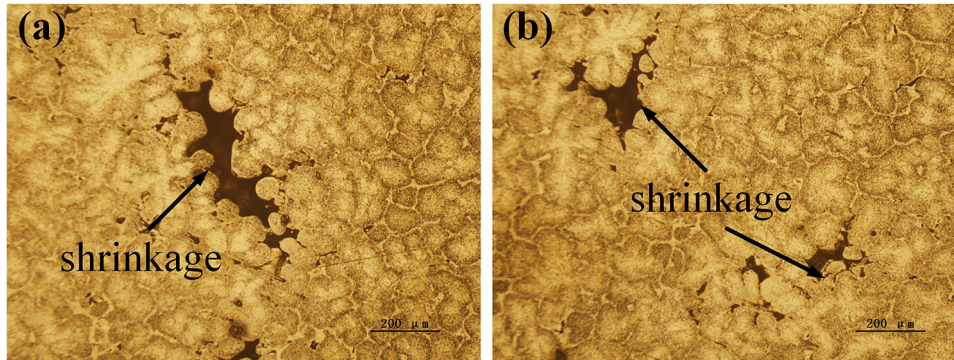
Fig. 1 Casting defects in the ZL210 alloy

The BM was ZL210 aluminum alloy with a T5 temper in this experiment, whose dimension was $200 \times 100 \times 6 \text{ mm}^3$. The casting defects are shown in Fig. 1. A series of tools containing the six-spiral-flute shoulder were employed, which were beneficial to improving the material flow and then enhancing the solid-state bonding. Schematic of the A-PFFSR is exhibited in Fig. 2. Before the repairing process, the casting

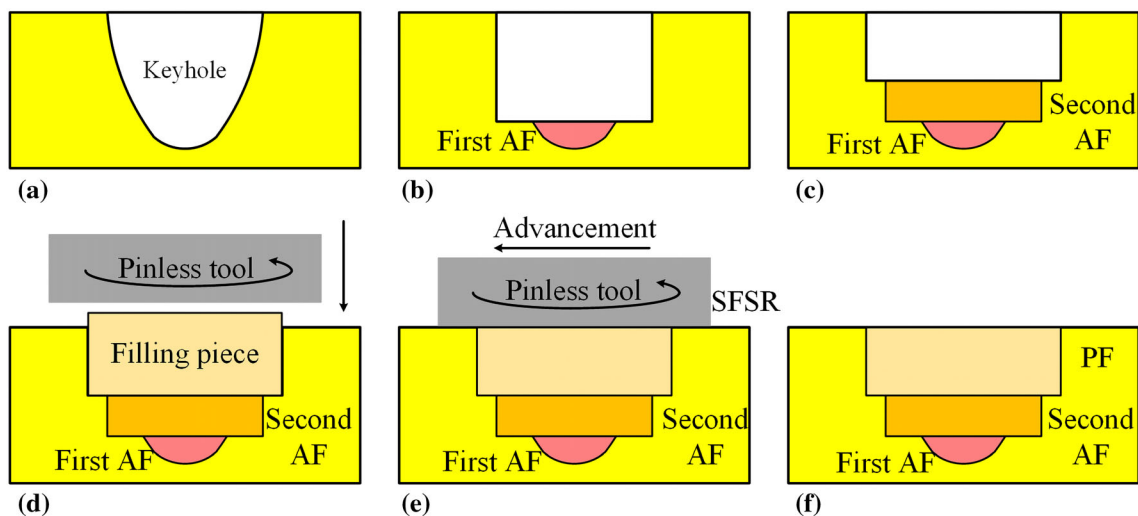
Fig. 2 Schematics of the A-PFFSR: (a) keyhole, (b) first active filling, (c) second active filling, (d) addition of filling piece, (e) SFSR and (f) completion of A-PFFSR

defects were firstly machined into a tapered hole by a tool with a threaded pin. The A-PFFSR process was divided into active filling (AF) and passive filling (PF) stages. During the AF stage, the rotating tool without pin plunges into the taper hole and then returns. The materials surrounding the keyhole were continuously squeezed into the keyhole by a pinless tool and then filling the keyhole to a certain depth. For the PF stage, an extra filler was put into the enlarged keyhole with a relatively small depth produced by the AF stage, and then, the filler was softened and transferred under the high temperature and

material flow produced by the rotation of the pinless tool. Finally, a surface friction stir repairing (SFSR) stage was performed, which was the rotational tool moved straightly for 15 mm after dwelling for 5 s. Consequently, the volume defects, such as the keyhole, could be completely repaired. In this study, the keyhole was produced by the tool with a 4 mm pin, so the two AF stages which were named, respectively, first AF and second AF stages were used. The shoulder diameters for the first and second AF stages were, respectively, 6 mm and 10 mm, and the corresponding repairing depths were 1 mm and 1.5 mm. Meanwhile, the shoulder with a 14 mm diameter was used during the PF stage and its repairing depth was 1.5 mm. The repairing pinless tools used in this study are shown in Fig. 3, and these pinless tools rotated clockwise (Ref 26). The height of the extra filler used in the PF stage was 2 mm. The rotating velocity was 1600 rpm. A tilting angle relative to the Z-axis was 2.5°. The investigated plunge speeds were 1, 2, 4 and 6 mm/min, respectively.

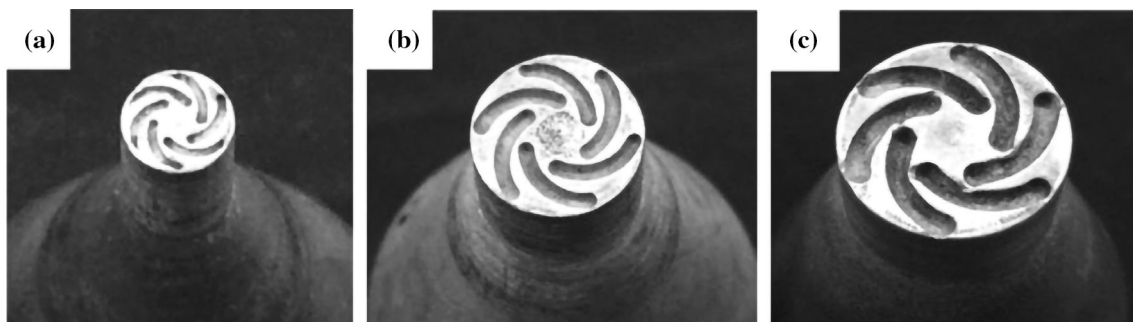
Fig. 3 Pinless tools with different shoulder diameters in the repairing process: (a) 6 mm, (b) 10 mm and (c) 14 mm

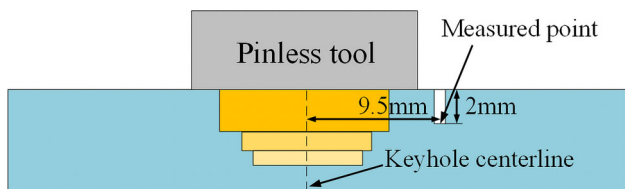
Fig. 4 Schematic of thermocouple locations during temperature measurement

In order to better analyze thermal cycle of filling zone (FZ) during the A-PFFSR process, the K-type thermocouples were used to measure temperature profile. The schematic diagram of the K-type thermocouples locations is shown in Fig. 4. Although the distance from the measured point to the center of the repairing zone is 9.5 mm, the temperature variation trend of measured point can reflect that of FZ. This is because the heat is conducted from FZ to the thermocouples location. A digital data logger was applied to record the temperature history of each location at a frequency of 1 Hz.

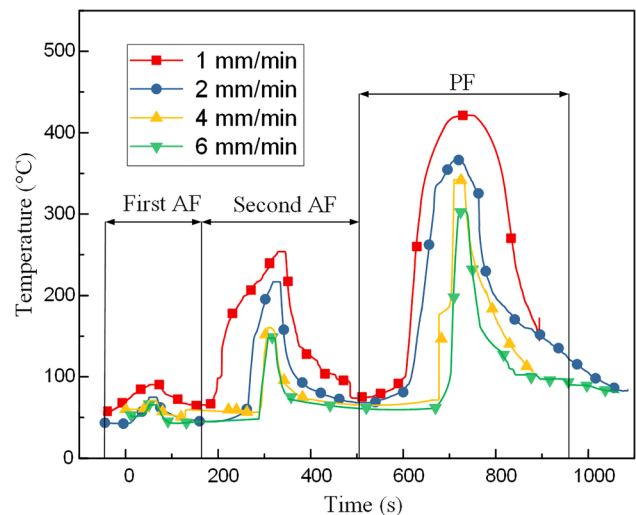
Fig. 5 Temperature profiles of repaired processes by different plunge speeds

Table 1 shows the surface morphologies of the repaired joints by different plunge speeds. In order to analyze the influence of plunge speed on surface formation, the temperatures during the repairing processes were measured, and the temperature profiles are indicated in Fig. 5. From Fig. 5, it is known that with the increase in plunge speed, the peak temperature in the FZ is decreased, and then, the insufficient material flow is obtained (Ref 28). When the plunge speed is 1 mm/min, the surface appearance is relatively smooth and few flashes are formed. This is because the low plunge speed can preheat the repaired materials for long time and then improve the material transfer behaviors, achieving the satisfactory surface integrity. With increasing plunge speed to 2 mm/min, the joint surface appearance similar to that of 1 mm/min is

attained due to the sufficient frictional heat and material flow. However, when the plunge speed is 4 mm/min, the frictional heat is significantly decreased. The insufficient heat input resulting from higher plunge speed is difficult to reduce the flow stress and increase material flow, which causes that the plasticized materials are difficult to be transferred from the edge to the center of shoulder, producing the wave shape morphology.

Compared with 4 mm/min, the bigger flashes appear at 6 mm/min due to the lower temperature. The extremely reduced heat input is hard to soften the repaired materials, and then, these materials are difficult to be transferred and exert a lower counterforce on the pinless tool, producing the big flashes. It can be concluded that a relatively lower plunge speed produces more heat input and is suitable to the surface integrity of the repaired joint.

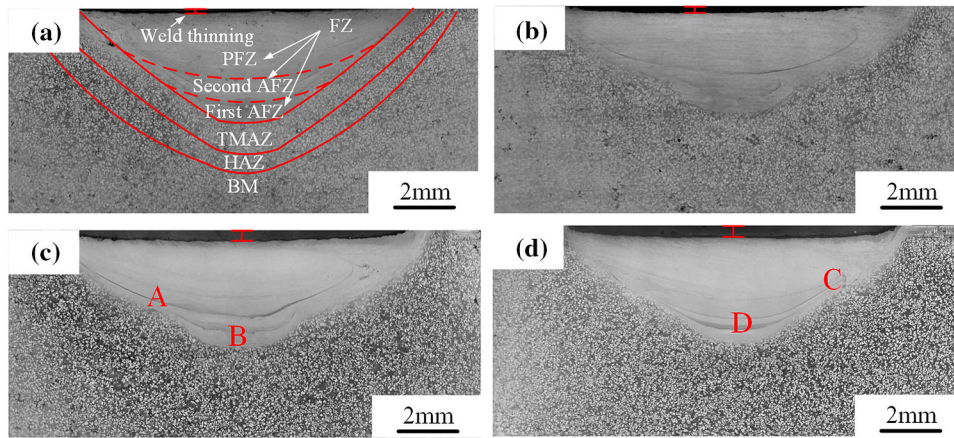
Fig. 6 Macrostructures of repaired joints by different plunge speeds: (a) 1 mm/min, (b) 2 mm/min, (c) 4 mm/min and (d) 6 mm/min

Figure 6 displays the macrostructures in cross sections of repaired joints by different plunge speeds. The interfacial characteristics between the repairing interfaces directly determine the repaired quality (Ref 29). The A-PFFSR joint is divided into four typical zones, namely BM, thermo-mechanically affected zone (TMAZ), heat-affected zone (HAZ) and FZ. The FZ consists of active filling zone (AFZ) and passive filling zone (PFZ). Moreover, the AFZ includes first active filling zone (first AFZ) and second active filling zone (second AFZ).

speed, the tensile strengths of the repaired joints gradually decrease due to the weld thinning and interfacial defects. At the plunge speed of 1 mm/min, the maximum tensile strength of the repaired joint is quasi-equivalent to BM due to the reduction of weld thinning and elimination of interfacial defects induced by the improved frictional heat (Fig. 5) and material flow, and the tensile fracture does not locate at the FZ (Fig. 10b). For the relatively higher plunge speed, the insufficient frictional heat and material flow result in the interfacial defects (Fig. 7) and the weld thinning (Fig. 6c and d). These two phenomena,

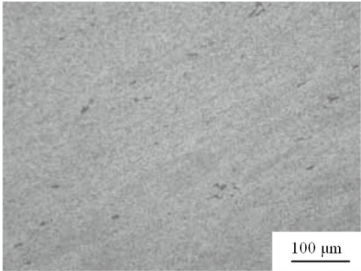
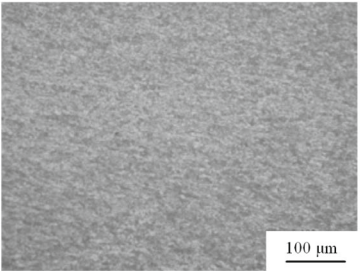
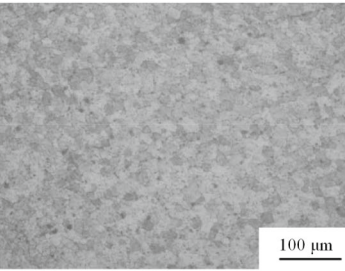
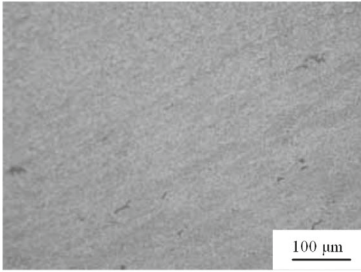
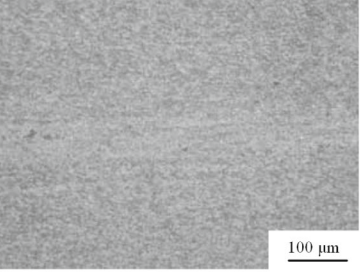
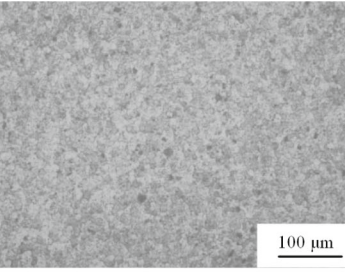
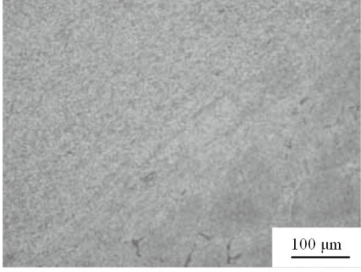
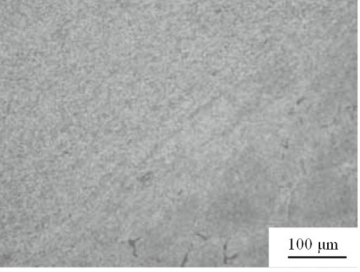
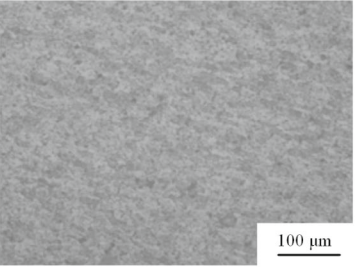
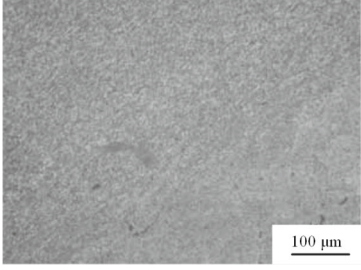
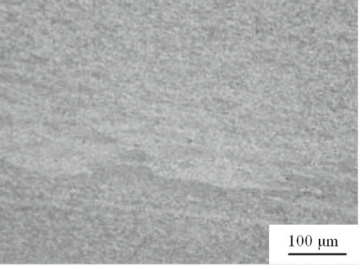
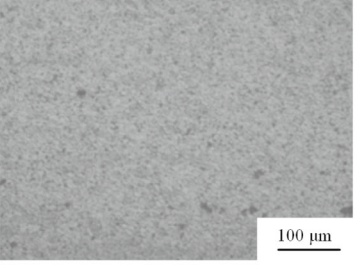
Table 2 Interfacial microstructures of the repaired joints by different plunge speeds

ω	TMAZ	Interface between PFZ and second AFZ	PFZ
1 mm/min

As listed in Table 2, there are no defects appear at the TMAZ and the PFZ of the joints by the plunge speeds of 1 mm/min and 2 mm/min, indicating the good metallurgical bonding, which results from the sufficient solid-state diffusion due to the relatively higher frictional heat (Fig. 5) and sufficient material flow. Moreover, lower weld thinning is formed at the surface of the repaired joint by the lower plunge speeds (Fig. 6a and b). As exhibited in Fig. 7, the defects are formed at the joining interfaces, which results from that the insufficient frictional heat and material flow induced by higher plunge speed. The defect

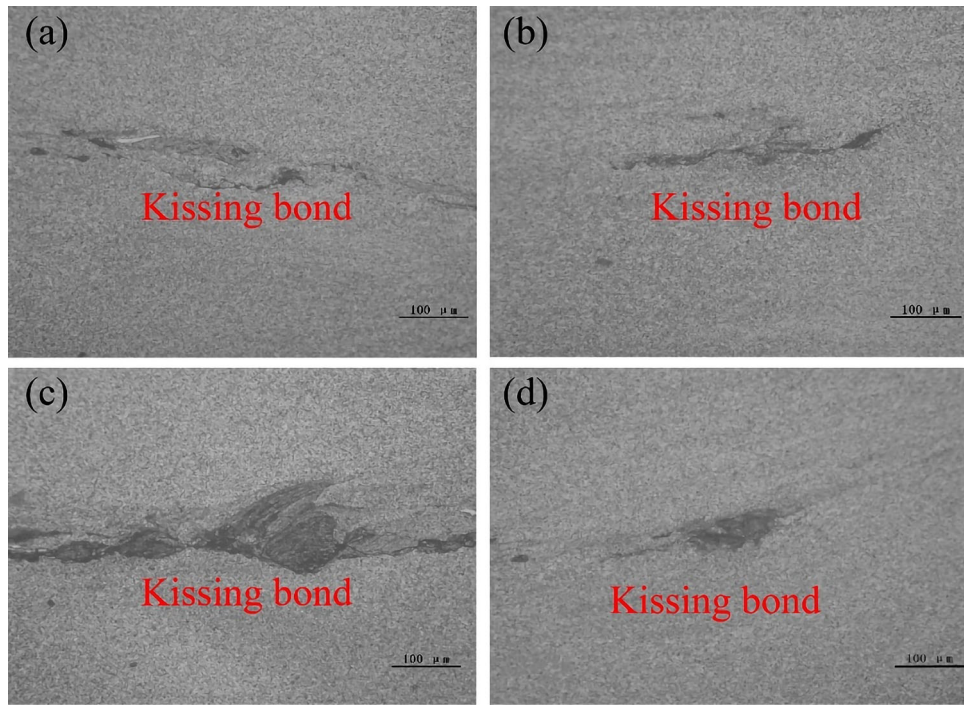
Fig. 7 Interfacial defects in the repaired joints: (a) and (b) A and B marked in Fig. 6(c), (c) and (d) C and D marked in Fig. 6(d)

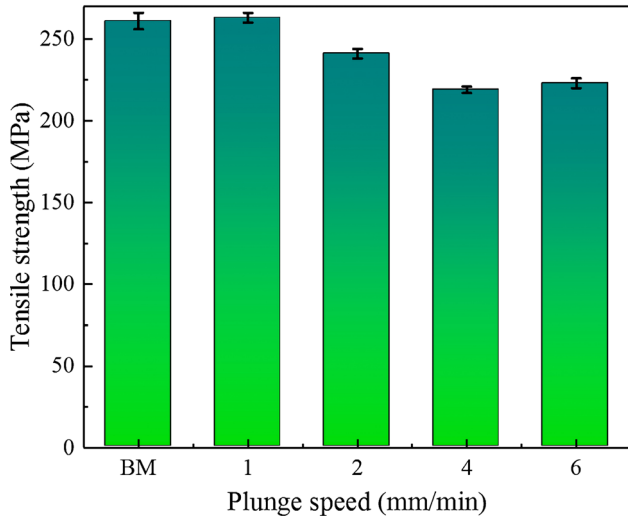
Fig. 9 Tensile strengths of the BM and repaired joints by different plunge speeds

Figure 9 and 10 displays tensile results of the repaired joints at different plunge speeds. With the increase in the plunge

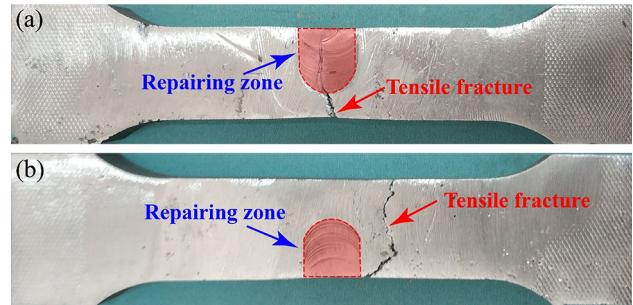
Fig. 10 Fracture locations of the repaired joints by different plunge speeds: (a) 1 mm/min and (b) 6 mm/min

respectively, produce the stress concentration and reduce the bearing area of the repaired joint, which greatly decreases the tensile properties and leads to the fracture located at the FZ (Fig. 10a).

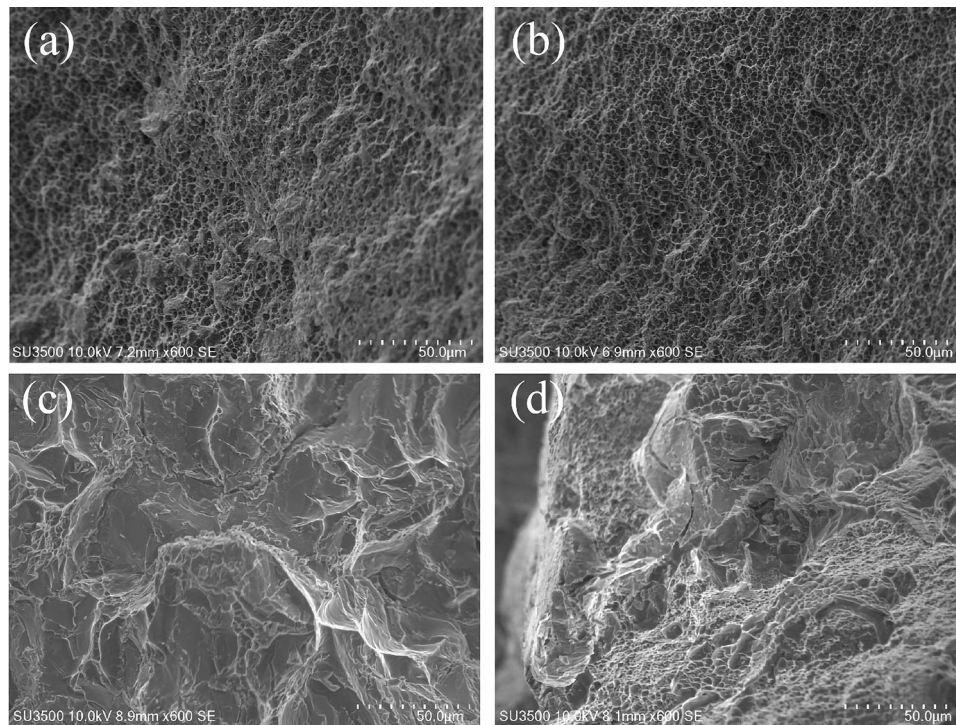
Fig. 11 Fracture surface morphologies of the repaired joints at different plunge speeds: (a) and (b) 1 mm/min, (c) and (d) 6 mm/min

Figure 11 shows the fracture surface morphologies which are obtained with an SEM of the repaired joints owning the lower and higher tensile strengths. For the repaired joint with higher tensile strength at the plunge speed of 1 mm/min, various dimples are observed on the fracture surface, as exhibited in Fig. 11(a) and (b). This indicates the typical ductile

fracture, which corresponds to the fracture location in the BM. For the repaired joint with the lower tensile strength at the plunge speed of 6 mm/min, some cleavage morphologies (Fig. 11c) are presented on the fracture surfaces, which results from the interfacial defect in the FZ. Meanwhile, few dimples appear on the fracture surface locating at the repairing interfaces, as shown in Fig. 11(d), which indicates the good

interfacial joining is still formed at the repairing interfaces. From the macrostructures, microstructures and mechanical properties mentioned above, it can be concluded that the lower plunge speed is beneficial to eliminating the interfacial defects and then improving the tensile strength of the repaired joint for cast aluminum alloy.
