Hot Corrosion Performance of Plasma-Sprayed Multiwalled Carbon Nanotube–Al₂O₃ Composite Coatings in a Coal-Fired Boiler at 900 °C

Rakesh Goyal, Buta Singh Sidhu, and Vikas Chawla

The present study investigates the high-temperature corrosion behavior of plasma-coated boiler steel for 1000 h in a 110-MW water tube boiler, which had encountered severe corrosion and the tube failure. The coating was carried out by alumina and MWCNTs (multiwalled carbon nanotubes)-reinforced alumina composite powders. The uncoated and coated steel substrates were hung at a platen superheater at 900 °C. After the exposure, thermogravimetric analysis was carried out to evaluate the kinetics of corrosion. XRD, SEM, TEM and EDS analysis was carried out to evaluate the corrosion products at the end of the cyclic high-temperature corrosion. The present research work concludes that CNT-reinforced alumina coatings (4.0 wt.% CNT + Al₂O₃ coating) have decreased the corrosion rate to 30.72 mpy, which was 113.53 mpy for conventional alumina coatings and 376.96 mpy for bare T11 boiler steel in the boiler environment. This manuscript submits the failure of tube at the platen superheater, exposure conditions and the

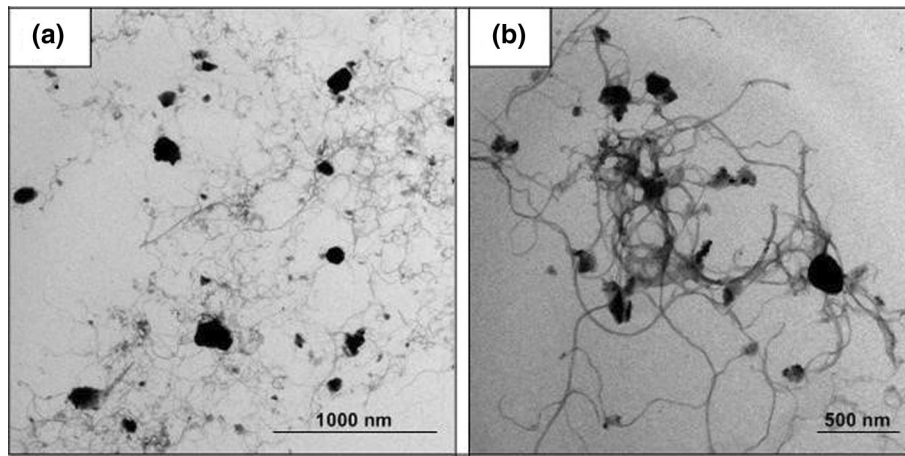
Fig. 1 (a-b) TEM images showing dispersed CNTs in alumina alloy powder in $4\text{CAI}_2\text{O}_3$.

The maximum resistance to the degradation has been shown by 4CAI₂O₃-coated specimens. This might be attributed to the less porous coating after CNT reinforcement into the alumina matrix. The TEM images for 4CAI₂O₃-coated steel at different magnifications clearly indicated the presence of CNTs in the alumina matrix. The presence of CNTs in alumina matrix might have resulted in a decrease in porosity of alumina coatings. The coating has higher corrosion resistance if it is more compact and of lesser porosity (Ref 48). The nickel- and chromium-rich layer might have been a reason for lower corrosion rate of this coated steel. Comparatively superior corrosion resistance of 4CAI₂O₃-coated T11 might be due to higher percentage of CNTs. XRD graphs indicated the peaks of Al_2O_3 and SiO_2 along with C in the scale. Ahmad et al. (Ref 31) have observed similar peaks during studies on CNT-reinforced alumina composites. SiO_2 may be due to the ash particles present on the surface of specimen. The formation of these compounds has been further validated by EDS as shown in Fig. 7(c), (d) and (e).

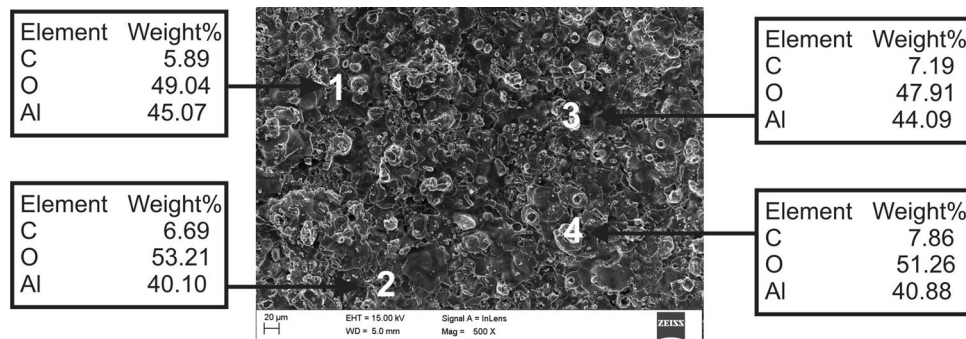
Fig. 2 FE-SEM and EDS analysis for $4\text{CAI}_2\text{O}_3$ -coated T11 steel.

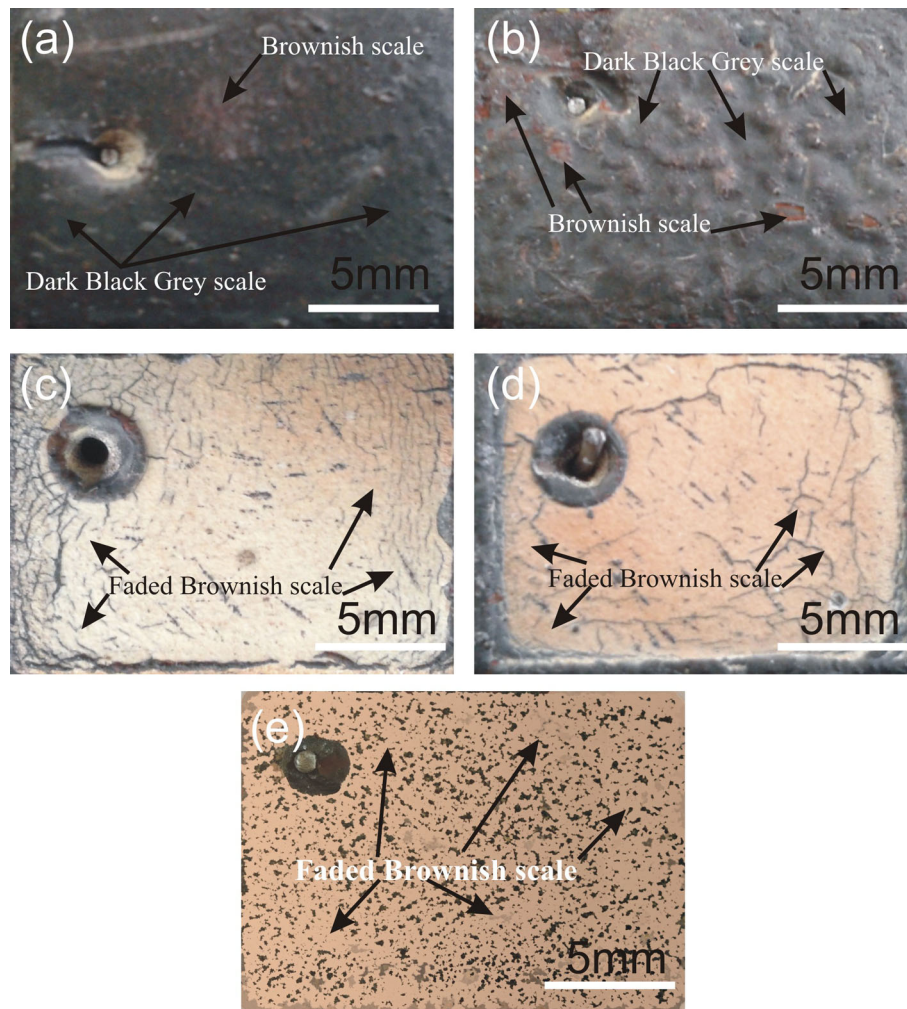
Fig. 3 Macrographs of (a) bare T11 steel, (b) $0\text{Al}_2\text{O}_3$ coating, (c) $1.5\text{Al}_2\text{O}_3$ coating, (d) $2\text{Al}_2\text{O}_3$ coating, (e) $4\text{Al}_2\text{O}_3$ coating after exposure to thermal environment.

After every cycle, each specimen was visually examined for variation in color, luster and development of cracks in the oxide scale. After the completion of ten cycles, the specimens were finally examined and their macrographs were taken. The macrographs for uncoated and coated specimens after exposure

to boiler environment at $900\text{ }^\circ\text{C}$ for 1000 h are shown in Fig. 3(a), (b), (c), (d) and (e).

For the uncoated boiler steel substrate, from the first cycle onward, a scale appeared on the surface, which is dark black gray in color. Ash has been deposited on the sample just after the completion of the first cycle. The sample showed spalling when it is exposed in the boiler environment. Severe spalling and ash deposition of the bare T11 steel were continued until the last cycle. The ash has been removed from the sample by washing it with acetone. The weight of the specimens was recorded after the completion of each cycle. After the completion of the 1000-h cyclic study, ash deposited with fragile scale indicating severe spalling and dark gray-colored surface appearance on the surface and brownish-colored scale in the middle was observed (Fig. 3a). For the alumina-coated T11 boiler steel, blackish gray-colored oxide scale was seen at the last of the study. Top scale spalling was also detected at some brownish-colored areas, as shown in Fig. 3(b). Ash deposition was seen just after the first cycle and until the end. Macrographs of CNT- Al_2O_3 -coated T11 steels after exposure of 1000 h at about $900\text{ }^\circ\text{C}$ are shown in Fig. 3(c), (d) and (e). For all the CNT- Al_2O_3 -coated steels, the color of scale was noticed to be brown after the first cycle of 100 h. After that, the fading of brown color has been initiated but it remained until the end of the cyclic study. No spalling was observed, and the scale was intact even after 1000 h of exposure. The dark gray patches on the scale may be due to ash deposition.

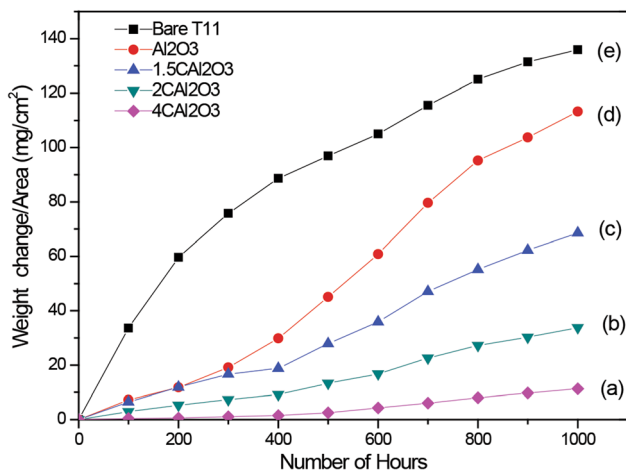
Fig. 4 Cumulative weight gain per unit area for (a) bare T11 steel, (b) $0\text{Al}_2\text{O}_3$ coating, (c) $1.5\text{Al}_2\text{O}_3$ coating, (d) $2\text{Al}_2\text{O}_3$ coating, (e) $4\text{Al}_2\text{O}_3$ coating.

Figure 4 indicates the cumulative weight gain/unit area (mg/cm^2) for all the specimens after for 1000-h cyclic examination. The net weight gain represents the resulting effect of weight gain due to oxide-scale formation and weight loss because of spalling of scale. The overall weight gain by the bare steel has come out to be $135.96\text{ mg}/\text{cm}^2$. This higher weight gain, for uncoated steel as compared to coated steels, has been due to the formation of thick oxide scale. The weight gain of conventional Al_2O_3 -coated T11 steel has been found to be $113.27\text{ mg}/\text{cm}^2$. The overall weight gain of $1.5\text{CAI}_2\text{O}_3$ -coated, $2\text{CAI}_2\text{O}_3$ -coated and $4\text{CAI}_2\text{O}_3$ -coated T11 steel was determined to be 68.59, 33.82 and $11.27\text{ mg}/\text{cm}^2$, respectively. It shows that with the addition of CNTs content in the Al_2O_3 , the weight gain of coated steel decreases. $4\text{CAI}_2\text{O}_3$ -coated T11 steel exhibited minimum overall weight gain among all types of coatings.

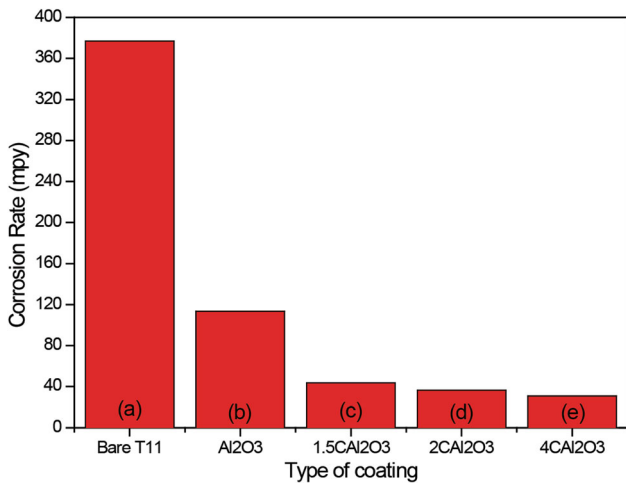
Fig. 5 Corrosion rate in mils per year (mpy) for (a) Bare T11 steel, (b) 0Al₂O₃ coating, (c) 1.5Al₂O₃ coating, (d) 2Al₂O₃ coating, (e) 4Al₂O₃ coating.

The loss of thickness of the bare steel after exposure has been measured as 1.093 mm as observed in cross-sectional view. Thus, corrosion rate comes out to be 376.96 mpy

after conversion in mils/year (mpy). Further, on the basis of thickness loss data recorded, the corrosion rates of the coatings were measured as 113.53, 43.63, 36.51 and 30.72 mpy for $0\text{Al}_2\text{O}_3$ -coated, $1.5\text{Al}_2\text{O}_3$ -coated, $2\text{Al}_2\text{O}_3$ -coated and $4\text{Al}_2\text{O}_3$ -coated steel, respectively, and are shown in Fig. 5.

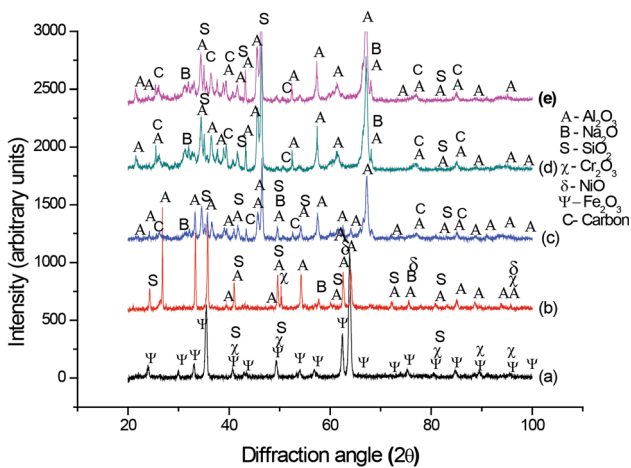
Fig. 6 XRD pattern for the (a) bare, (b) 0Al₂O₃-coated, (c) 1.5Al₂O₃-coated, (d) 1.5Al₂O₃-coated, (e) 4Al₂O₃-coated T11 steel after exposure.

X-ray peaks for the uncoated, $0\text{Al}_2\text{O}_3$ -, $1.5\text{Al}_2\text{O}_3$ -, $2\text{Al}_2\text{O}_3$ - and $4\text{Al}_2\text{O}_3$ -coated steels after exposure are shown in Fig. 6(a), (b), (c), (d) and (e), respectively. The formation of oxides of Fe could be identified in the case of uncoated steel. The prominent phase noticed for this steel is Fe_2O_3 (JCPDS No. 00-002-1047) and SiO_2 (JCPDS No. 00-001-0649) and Cr_2O_3 (JCPDS No. 00-001-1294) as minor phase (Fig. 6a). Al_2O_3 -coated T11 steel uncovered to the boiler surroundings has indicated the formation of Al_2O_3 (JCPDS No. 10-173) as the main phase along with Na_2O (JCPDS No. 00-003-1074), SiO_2 , NiO (JCPDS No. 00-022-1189) and Cr_2O_3 (Fig. 6b). In the cases of $1.5\text{Al}_2\text{O}_3$ -, $2\text{Al}_2\text{O}_3$ - and $4\text{Al}_2\text{O}_3$ -coated T11 steels (Fig. 6c, d and e), Al_2O_3 was the major phase and C (JCPDS No. 00-0010640), Na_2O and SiO_2 have been observed as the minor XRD phases.

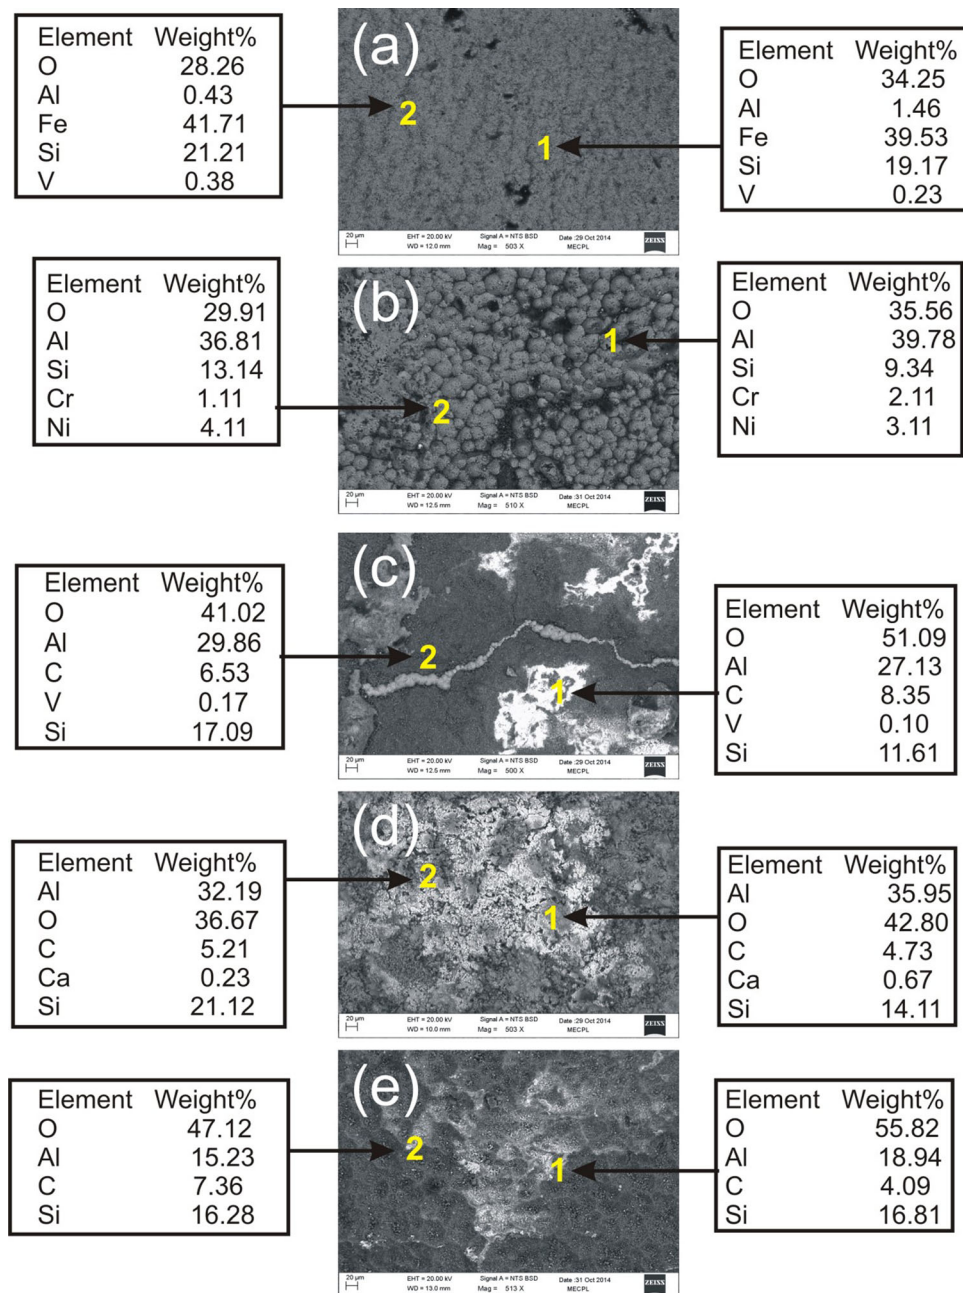
Fig. 7 FE-SEM and EDS analysis for (a) bare T11 steel, (b) 0CaAl₂O₃ coating, (c) 1.5CaAl₂O₃ coating, (d) 2CaAl₂O₃ coating, (e) 4CaAl₂O₃ coating after exposure to boiler.

FE-SEM and EDS analysis for uncoated and plasma spray-coated T11 samples after exposure is presented in Fig. 7. The surface morphology of bare T11 steel indicated the granular scale as presented in Fig. 7(a). The micrograph indicates the scale developed with blackish gray and white regions. Also the surface shows the signs of erosion. Excessive corrosion could be experienced on the surface of specimen. The EDS analysis of uncoated T11 steel substrates at points 1 and 2 in the micrograph shows the presence of Si, Al and O along with Fe. This may be because of the ash contents present on the specimen. This clearly indicates the formation of Fe₂O₃ mainly and some amounts of SiO₂. The micrograph of the Al₂O₃-coated corroded specimen (Fig. 7b) points the presence of mainly Al, Ni, Cr, Si and O element at points 1 and 2, which may be oxide layer of alumina and ash. The scale consists of white and dark gray regions.

The micrograph of 1.5Al₂O₃-coated T11 steel (Fig. 7c) indicates a higher amount of O than Al in the composition and

minor percentage of C is also visible in the scale, at both the points. The EDS analysis for the scale of 2Al₂O₃-coated T11 steel indicated in Fig. 7(d) shows the presence of Al, O and C. The FE-SEM micrograph of 4Al₂O₃-coated T11 steel is shown in Fig. 7(e). The presence of O, Al and C can be clearly seen in the scale after hot corrosion in actual boiler environment. Ash particles such as Al, Si, V and Ca can also be seen imbedded in scale as white color nodules.

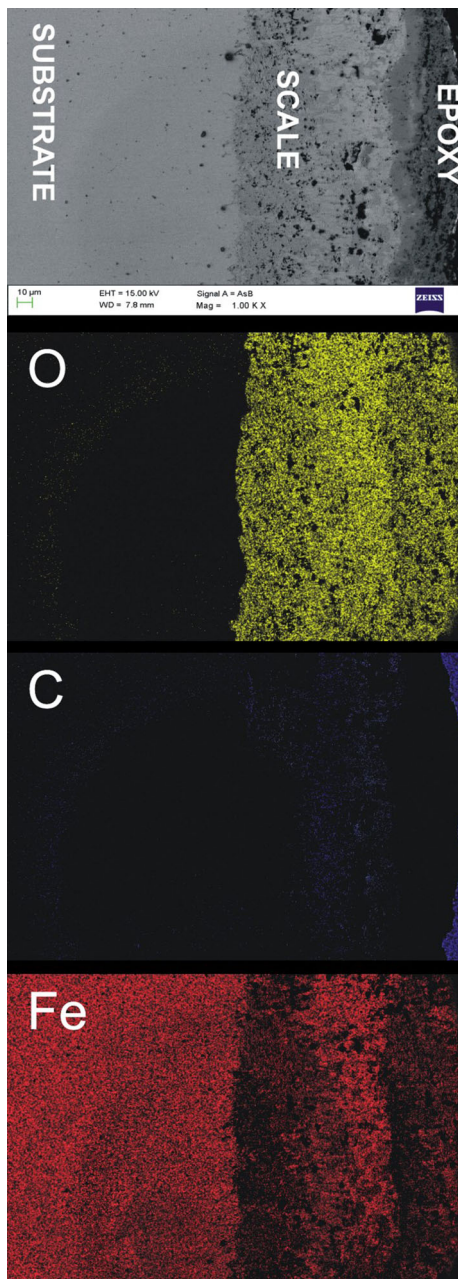
Fig. 9 Composition image and x-ray mappings across the cross section of the T11 steel after exposure.

X-ray mappings for a section of oxide scale of uncoated as well as coated specimens are presented in Fig. 9-11. The micrograph of bare T11 steel (Fig. 9) depicts significant corrosion along scale-substrate interface and the formation of dense oxide scale. Mainly, the scale of iron oxide has been composed. The O has been seen penetrating deep into the substrate, as pointed by x-ray mapping.

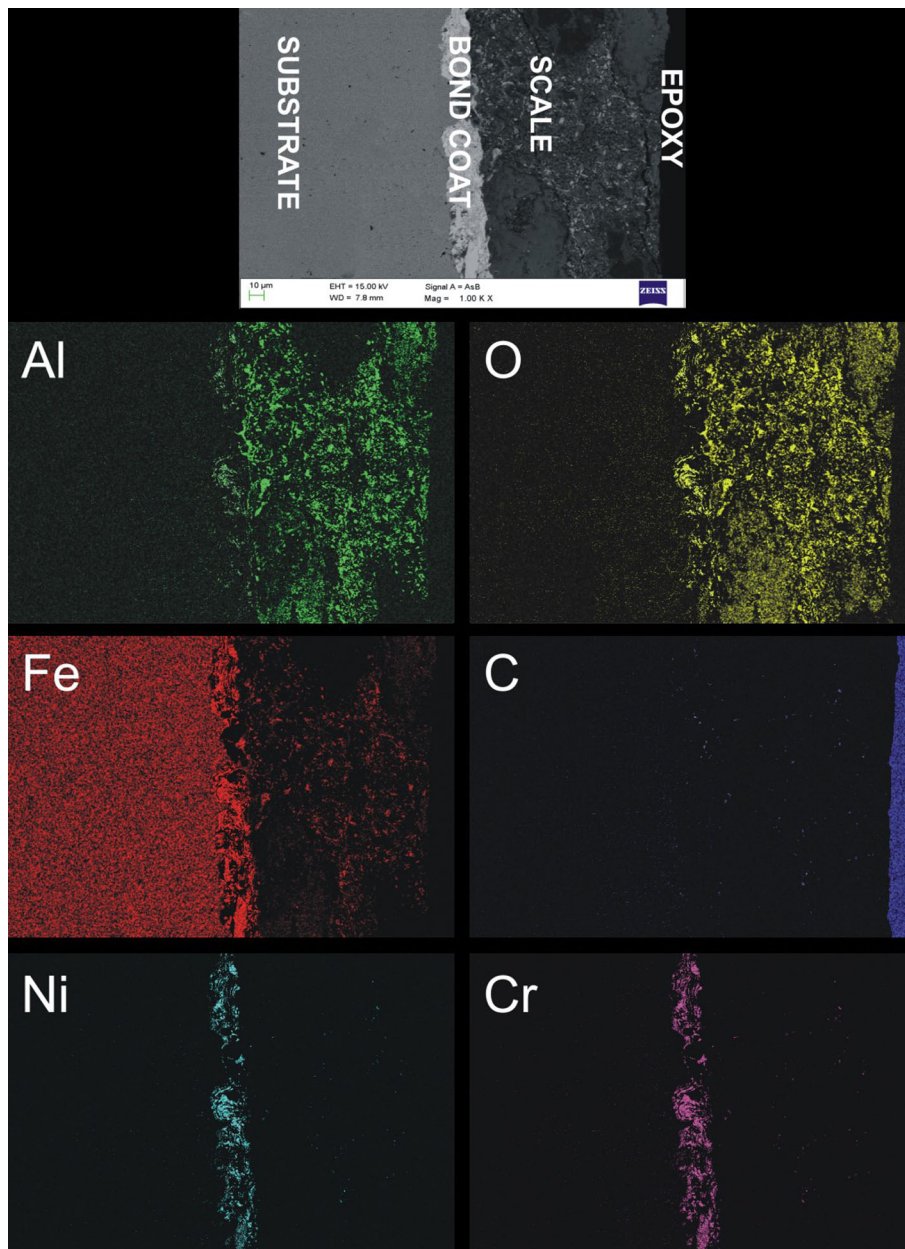
Fig. 10 Composition image and x-ray mappings across the cross section of the plasma-sprayed 0CaAl₂O₃-coated T11 steel after exposure.

The x-ray mapping for Al₂O₃-coated T11 boiler steel points the presence of Al, Fe and O throughout the scale along with Ni and Cr near the interface (Fig. 10). For 1.5Al₂O₃-coated T11 boiler steel, the BSEI and x-ray mappings are shown in Fig. 11. The x-ray mapping indicates the presence of Al and O along with minor traces of C throughout the scale. Similar x-ray mapping results were observed for 2Al₂O₃- and 4Al₂O₃-coated T11 boiler steel. But, the traces of C become more significant, with the increase of CNTs (from 1.5 to 4%) in the composite coating. The x-ray mappings indicate that the interface between coating and substrate is plentiful in Ni and Cr. This evinces the presence of bond coat at the interface.

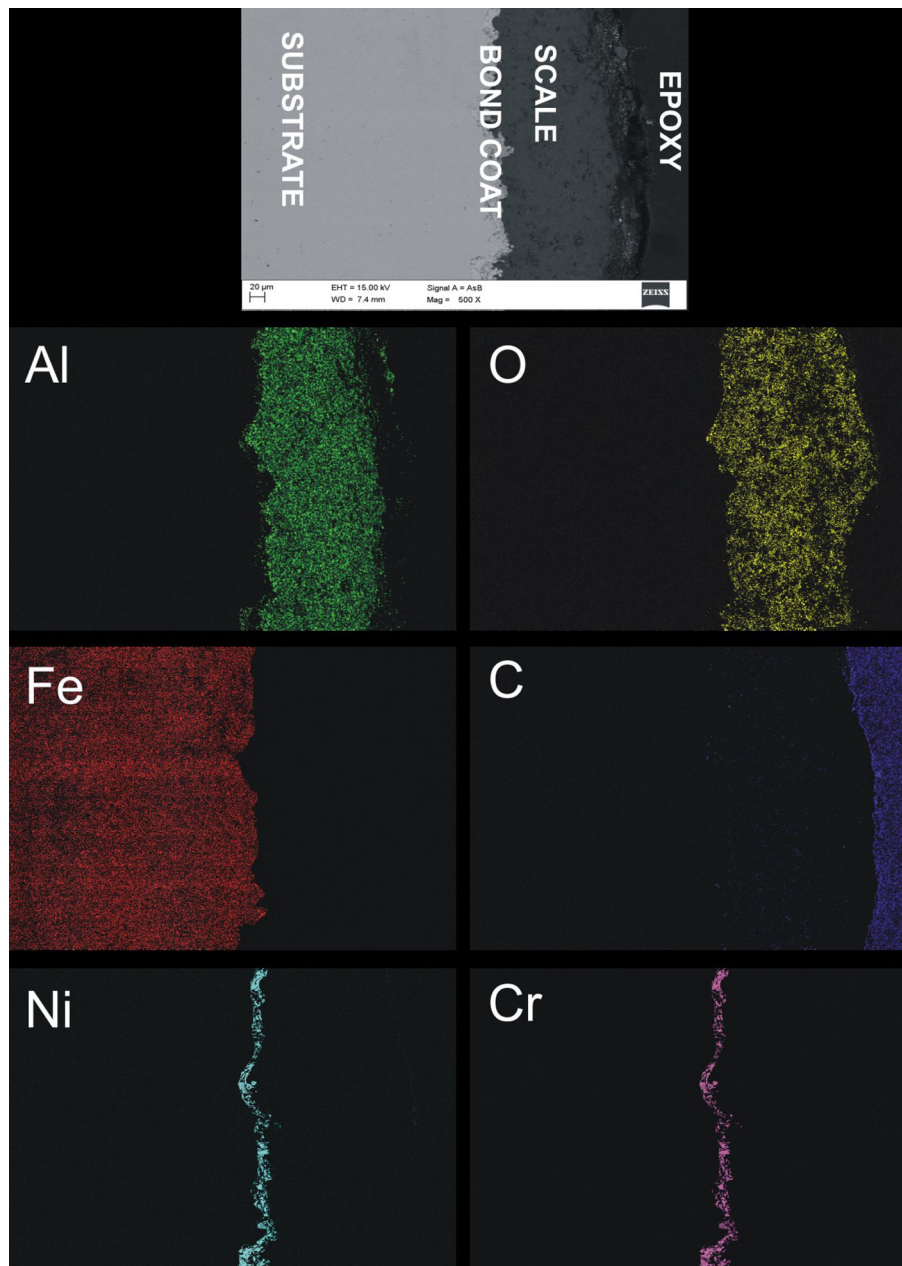
Fig. 11 Composition image and x-ray mappings across the cross section of the plasma-sprayed 1.5CAI₂O₃-coated T11 steel after exposure.
