Effect of Spray Particle Velocity on Cavitation Erosion Resistance Characteristics of HVOF and HVOF Processed 86WC-10Co4Cr Hydro Turbine Coatings

R.K. Kumar, M. Kamaraj, S. Seetharamu, T. Pramod, and P. Sampathkumaran

Keywords cavitation erosion, HVOF/HVOF coating, porosity, surface topography

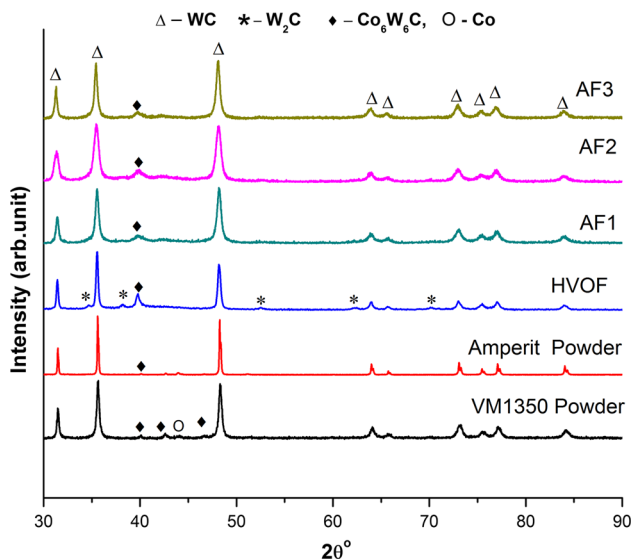
Fig. 4 XRD spectra of the powder material used for HVOF and HVAF coatings

The morphology of the feedstock powder used in HVAF coatings (Amperit 558.059) has shown comparatively higher spherical in shape than the powder used for the HVOF coating (VM 1350), (Fig. 1). The XRD spectra of both the powders and coatings have shown predominantly WC peaks. The absence of W_2C peak in the VM 1350 feedstock powder and the occurrence of prominent crystalline peaks of W_2C in the HVOF coating imply that decarburization of WC has taken place during the spray process (Fig. 4). However, the incidence of W_2C peak was absent in HVAF coatings. It is widely reported that the

The evidence of matrix undergoing deformation preferentially was ascertained through Backscattered Electron imaging (BSE) of both the matrix region (gray colored) and the WC grain regions (bright) along with compositional analysis by EDS, and the results are shown in Fig. 10. The composition in the matrix region of AF1 coating shows primarily Cr and Co with minor amounts of W content. However, the corresponding region of the HVOF coating is rich in W, Co, and Cr. The prominent $\text{W}_6\text{Co}_6\text{C}$ and W_2C peaks observed in the XRD spectra of HVOF coating (Fig. 4), lend support to this in view.

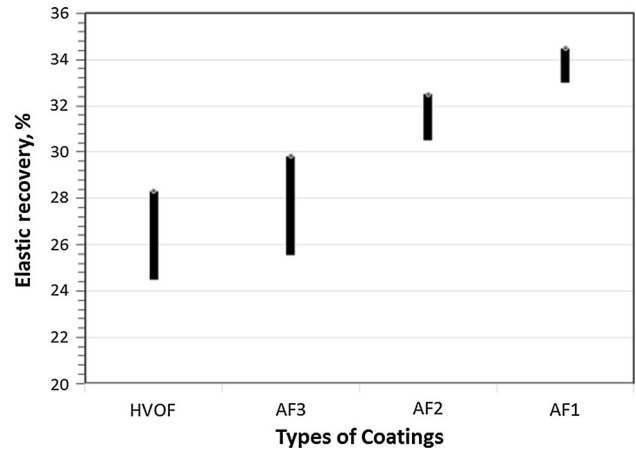
Fig. 15 Percent elastic recovery during nano-indentation of different coatings

the unloading curve. The total deformation energy is considered equal to the area under the loading curve. Four indentations were made on the surface of the coating, and the range of elastic strain energy observed in all coatings is shown in Fig. 15. In general, the observed elastic strain energy was higher in HVAF coatings compared to HVOF coating and that a maximum increase in the elastic recovery of 40.2% was observed at a maximum spray velocity of 1010 m/s. This appears possibly due to the combined effect of increased hardness and surface compressive residual stress in these coatings.

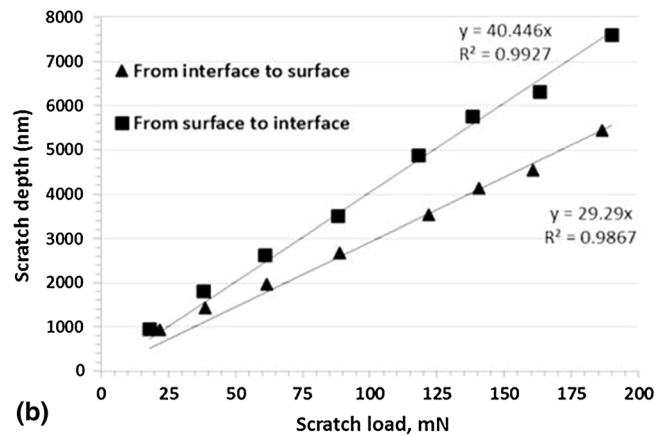
Fig. 14 Variation of depth into the coating surface during scratch loading in two scratch directions AF1 (a) and HVOF (b)
