Influence of Bondcoat Spray Process on Lifetime of Suspension Plasma-Sprayed Thermal Barrier Coatings

Abstract Development of thermal barrier coatings (TBCs) manufactured by suspension plasma spraying (SPS) is of high commercial interest as SPS has been shown capable of producing highly porous columnar microstructures similar to the conventionally used electron beam–physical vapor deposition. However, lifetime of SPS coatings needs to be improved further to be used in commercial applications. The bondcoat microstructure as well as topcoat–bondcoat interface topography affects the TBC lifetime significantly. The objective of this work was to investigate the influence of different bondcoat deposition processes for SPS topcoats. In this work, a NiCoCrAlY bondcoat deposited by high velocity air fuel (HVOF) was compared to commercial vacuum plasma-sprayed NiCoCrAlY and PtAl diffusion bondcoats. All bondcoat variations were prepared with and without grit blasting the bondcoat surface. SPS was used to deposit the topcoats on all samples using the same spray parameters. Lifetime of these samples was examined by thermal cyclic fatigue testing. Isothermal heat treatment was performed to stu

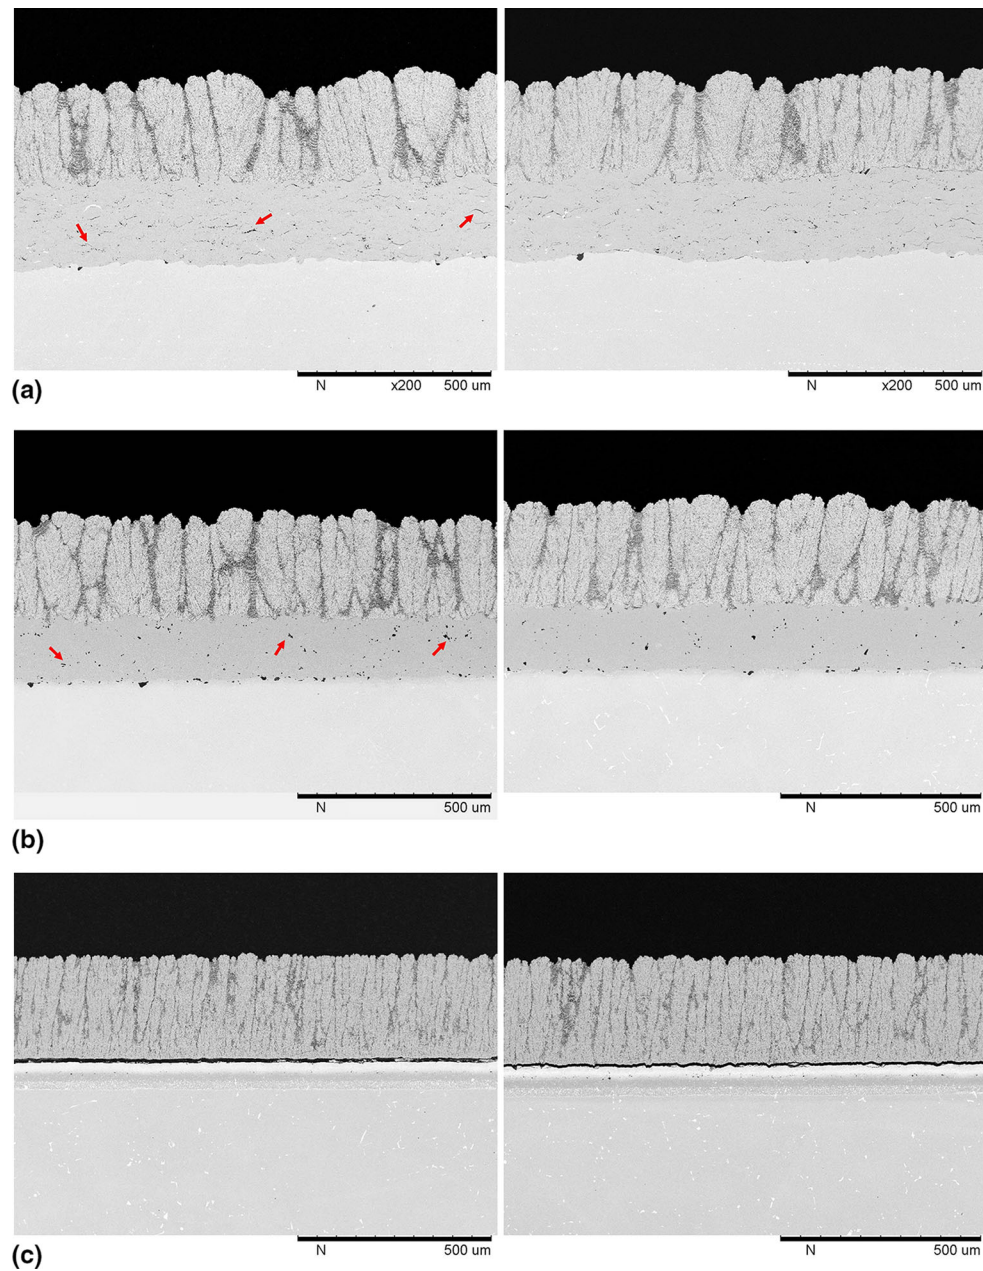
Fig. 2 Microstructure cross-sectional images of samples in as-sprayed condition with non-grit-blasted (left) and grit-blasted (right) bondcoats (a) HVOF, (b) VPS, and (c) diffusion

in all samples as observed in Fig. 2, perhaps due to insufficient change in the surface roughness after grit blasting as compared to the initial surface roughness.

to the other two samples even though all topcoats were sprayed with the same spray parameters. The reason for this difference can be attributed directly to the initial bondcoat surface roughness which controls the column size and structure in the SPS topcoat microstructure due to differences in the number of initiation peaks for column formation (Ref 13, 14). These differences in the topcoat microstructures correlate well with the observations in Fig. 2.

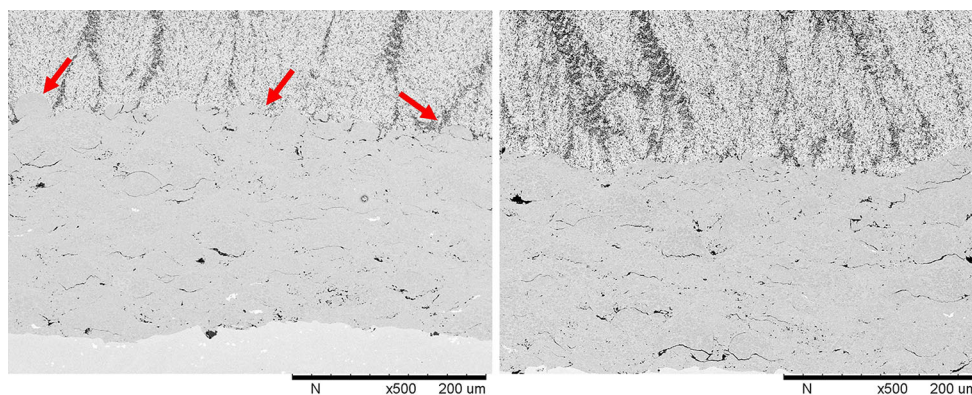
Fig. 3 Microstructure cross-sectional images of HVAF samples in as-sprayed condition with non-grit-blasted (left) and grit-blasted (right) bondcoats

Figure 3 shows the microstructure images of the HVOF samples in as-sprayed condition with non-grit-blasted (left) and grit-blasted (right) bondcoats. It can be observed in the figure that before grit blasting, some semi-molten particles creating a hemispherical hill can be found at the bondcoat interface close to topcoat as also indicated by the arrows. These particles were also observed in the bondcoat surface profile before grit blasting shown in Fig. 1(a). However, as it can be observed in Fig. 3, these hemispherical hills cannot be found after grit blasting of the bondcoat surface, indicating that the grit blasting step was successful in removing at least most of these particles over the HVOF bondcoat surface as desired. This observation was also suggested by the lower Ra roughness achieved after grit blasting as shown in Table 1. However, the grit blasting step did not affect the topcoat microstructure significantly

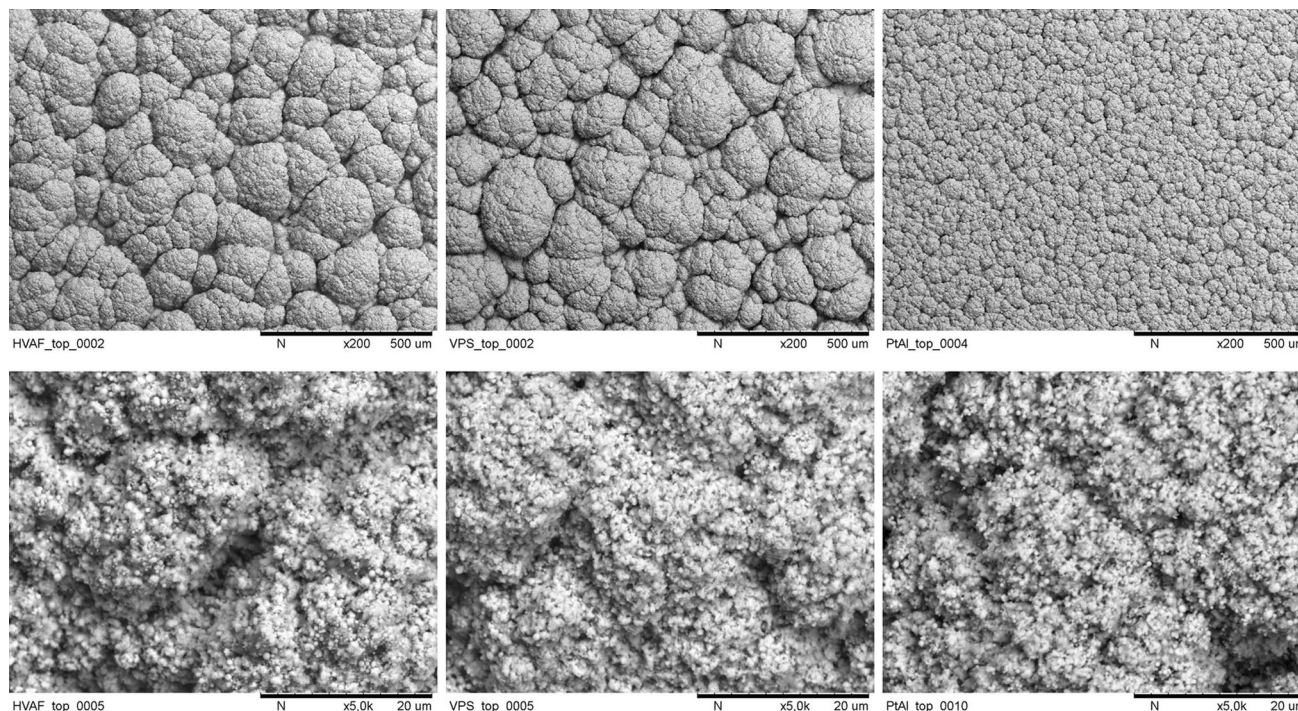
Fig. 4 SEM images of the top view of samples in as-sprayed condition (left) HVAF, (middle) VPS, and (right) diffusion with non-grit-blasted bondcoats. The top row shows the images at low magnification, while the bottom row shows the images at high magnification

Figure 4 shows the SEM images of the top view of the TBC samples in as-sprayed condition with (left) HVOF, (middle) VPS, and (right) diffusion bondcoats. In the top row images shown at low magnification, it can be observed that all topcoats had a typical cauliflower structure exhibited by SPS coatings. However, while the HVOF and VPS samples had similar column sizes and structures, the diffusion sample had much smaller column sizes as compared

The bottom row in Fig. 4 shows the top view images at high magnification. These images were captured at the

center of randomly selected columns covering only a fraction of the column top surface due to the high magnification, thus avoiding the intercolumnar region. The columns in all three topcoats showed a very similar microstructure with similar porosity and particle sizes at high magnification even though the low magnification images showed significantly different column sizes. This result was somehow expected as same spray parameters were used for all topcoats using the same suspension feedstock resulting in similar droplet sizes, temperatures, and velocities. The results in Fig. 4 imply that for a given suspension, although the column size and structure in the topcoat microstructure are extensively influenced by the

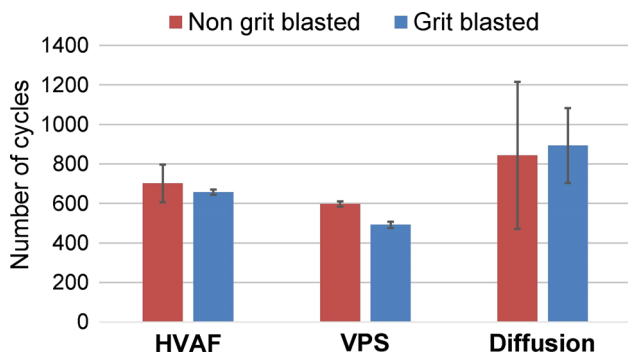
Fig. 5 Thermal cyclic fatigue lifetime results

The results from TCF testing are shown in Fig. 5. All tested samples showed good TCF lifetimes, fulfilling the industrial requirements for this type of test. Between the HVAF and VPS samples that were sprayed with the same feedstock material, HVAF bondcoat showed around 20%

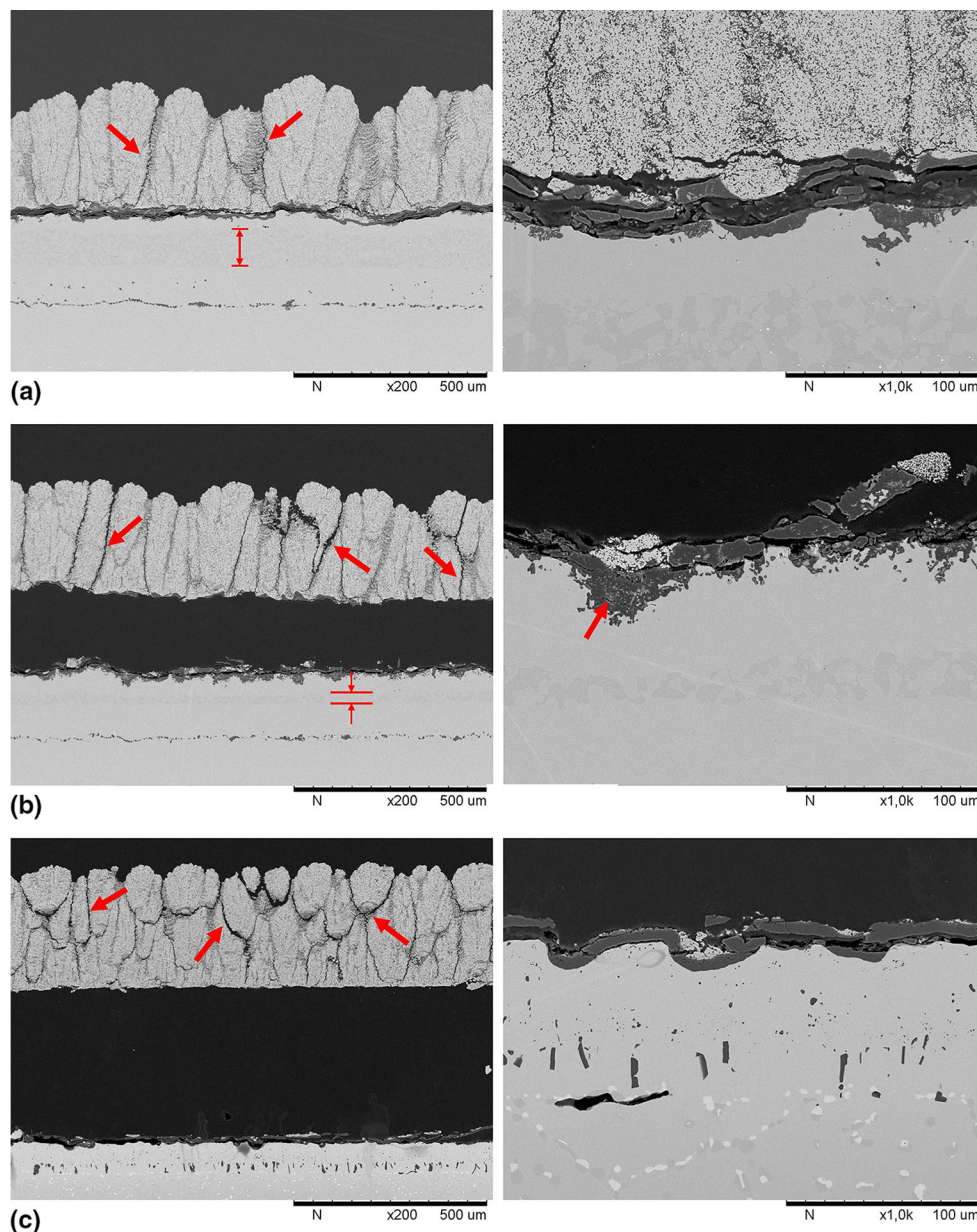
Fig. 6 Microstructure cross-sectional images of the samples after failure in TCF testing (a) HVOF, (b) VPS, and (c) diffusion with grit-blasted bondcoats. Images on the left show overview of the TBCs, while images on the right show TGO at a higher magnification

Figure 6 shows the microstructure cross-sectional images of the samples after failure in TCF testing. It can be clearly observed that in all samples, failure occurred due to complete spallation of the topcoat due to cracking, mainly at the topcoat–TGO interface along with cracking within the TGO as well as at the TGO–bondcoat interface. This type of failure is understood to occur mainly due to the swelling of TGO and thermal mismatch stresses close to the topcoat–bondcoat interface during thermal cycling (Ref 19, 20). Opening up of the column gaps (indicated by the arrows in the topcoat layer in the images on the left) can be also be observed in all cases. This phenomenon is understood to occur due to sintering of the topcoat

It can be observed in Fig. 6(a) that the HVAF sample had a thin and uniform layer of TGO consisting of mainly alumina seen as the dark gray layer at the topcoat–bondcoat interface without a significant presence of mixed oxides that could be typically seen by their light gray color. On the other hand, the VPS bondcoat showed some internal oxidation close to the topcoat–bondcoat interface resulting in an uneven layer of TGO with mainly alumina, but also some mixed oxides as indicated by the arrow in the image on the right in Fig. 6(b). It can also be observed in Fig. 6(a) and (b) that the beta-phase was still present in both bondcoats after failure in TCF testing, showing that there was still an aluminum reservoir left in the bondcoat (though smaller in the VPS bondcoat) and failure did not occur due to chemical failure of the bondcoat (Ref 10). This result indicates that the lower thickness of the VPS bondcoat as compared to the HVAF bondcoat did not have an influence on the TCF lifetime as the failure did not occur due to depletion of aluminum reservoir. These results show that HVAF could be a suitable alternative to VPS for bondcoat deposition in SPS TBCs.

In case of the diffusion sample after TCF testing shown in Fig. 6(c), it can be observed that a thin and uniform layer of pure alumina shown by the dark gray layer was formed. The reason for high TCF lifetime of diffusion bondcoats is deemed to be due to the different chemical composition of the bondcoat which results in a uniform and slow growing pure alumina layer without any detrimental oxides such as chromia, spinel, nickel oxide, as well as the high strain tolerance of the topcoat microstructure with very thin columns similar to a EB-PVD topcoat.

deeper into the bondcoat thickness (Ref 25, 26). This type of oxidation is of course not desired as it creates a thicker and uneven TGO layer which could cause additional stresses in the topcoat. These oxide pegs were also observed after TCF testing as shown in Fig. 6(b) which could have contributed to earlier failure of the VPS samples as compared to the HVOF samples. The oxide pegs could perhaps be diminished by optimizing the bondcoat surface roughness or chemical composition.

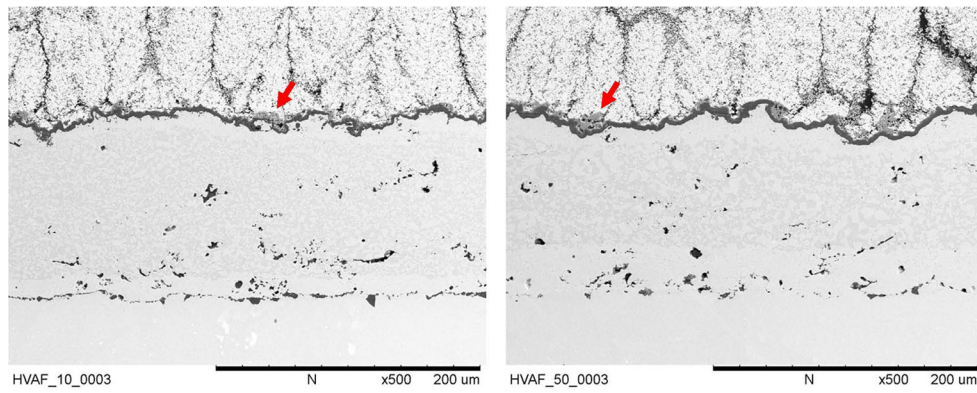
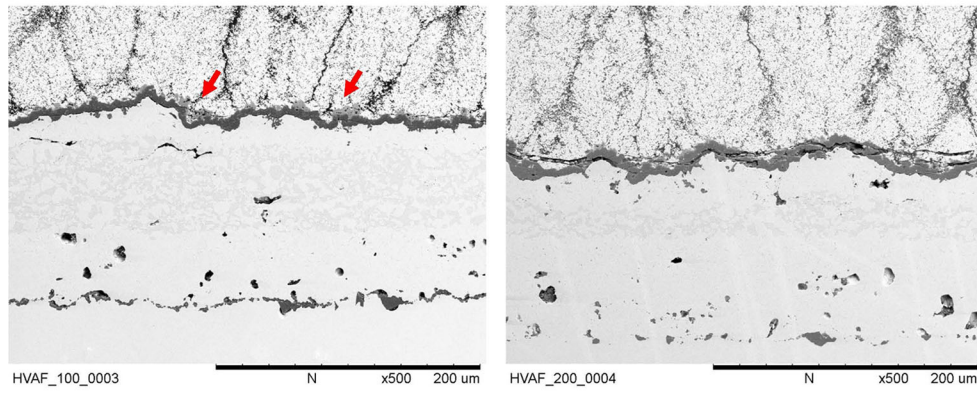
Fig. 7 Microstructure cross-sectional images of the samples after isothermal heat treatment at 1100 °C for (top left) 10 h, (top right) 50 h, (bottom left) 100 h, and (bottom right) 200 h (a) HVAF, (b) VPS, and (c) diffusion with non-grit-blasted bondcoats

It can be observed in Fig. 7(a) that the HVAF bondcoat oxidized gradually as expected over time. A dense and

uniform dark gray layer of alumina can be clearly seen without any cracks except after 200 h where cracking was observed after metallography preparation. A few light gray regions of mixed oxides can also be observed at all stages as also indicated by the arrows in the figure. It is well known that mixed oxides can form at an early stage during exposure to high temperatures known as the ‘transient stage’ of oxidation (Ref 18). The beta-phase layer can still be observed in the bondcoat after 200 h indicating the presence of aluminum reservoir for further growth of the protective alumina layer. The thickness of the TGO layer after 200 h was about 8–10 μm. It can be concluded from these observations that a dense and uniform layer of alumina without any cracks was produced in the HVAF bondcoat which is typically desired as it could prevent the bondcoat from detrimental oxidation. Due to limited number of samples, another set of HVAF bondcoats sprayed with same parameters, but lower bondcoat thickness were used for isothermal heat treatment study. However, since the beta-phase was still present after 200 h, the lower bondcoat thickness should not have affected the results in this case.

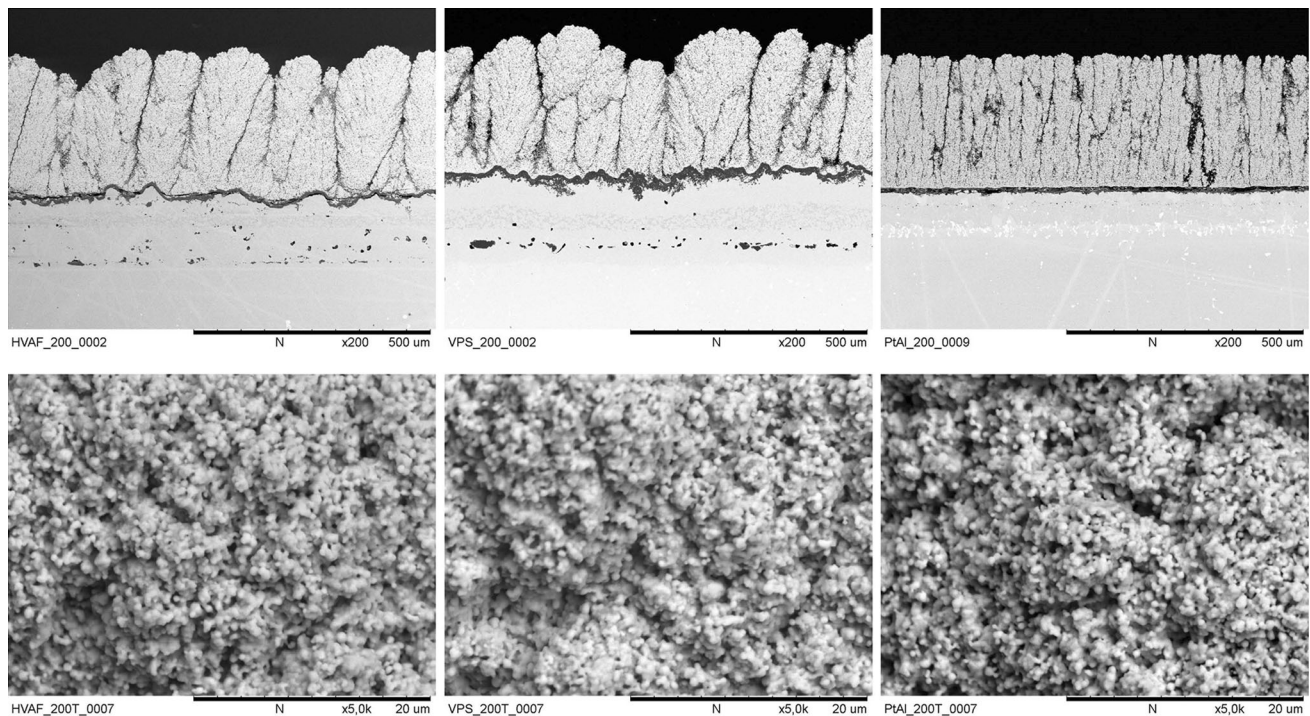
Fig. 8 Microstructure cross-sectional images (top row) and top view (bottom row) of the samples after isothermal heat treatment at 1100 °C (left) HVAF, (middle) VPS, and (right) diffusion with non-grit-blasted bondcoats

Figure 8 shows the microstructure cross-sectional images (top row) and top view images (bottom row) of the

topcoats after heat treatment for 200 h. Opening up of the column gaps due to sintering of the topcoat can be observed in all cases shown in the top row similar to the observations after TCF testing shown in Fig. 6. Merging of some columns can also be observed in the diffusion sample. These observations indicate that sintering had a major contribution to the changes in topcoat microstructure after TCF testing apart from the effect of expansion and contraction of the topcoat due to thermal cycling. The top view images shown in the bottom row in Fig. 8 were captured at the center of randomly selected columns. Again, very similar microstructures with similar porosity and particle sizes can be observed in all cases which was expected due to the similarity found in the as-sprayed condition as shown in Fig. 4. Significant sintering of the topcoat can be noted in all cases as the microstructure seems to be better cohered than in the as-sprayed condition with larger particles. The individual spherical-shaped particles present in the as-sprayed condition seemed to have fuse together and are not distinctly visible any longer. These changes in the topcoat microstructure after sintering were observed in previous work as well (Ref 20). These results show that the effect of sintering within the columns was similar and only inter-columnar sintering was different, which was expected as
