Microstructure and Corrosion Behavior of Thermal-Sprayed Hydroxyapatite/Magnesium Composite Coating on the Surface of AZ91D Magnesium Alloy

Abstract To slow down the corrosion rate and increase the bioactivity of magnesium alloys, biodegradable hydroxyapatite/magnesium (HA/Mg) composite coating was deposited onto AZ91D alloy substrate by high-velocity suspension flame spray technique using nano-sized HA and micron-sized Mg powders. Microstructures and phase constitutions of HA/Mg composite coating were analyzed by scanning electron microscopy and x-ray diffraction. Corrosion resistance of composite coating was also evaluated by potentiodynamic polarization test and electrochemical impedance spectroscopy in Hanks' balanced salt solution (HBSS). The result shows that the HA/Mg composite coating mainly consisted of Mg and HA in addition to a few of MgO phases. The coating showed a rough surface morphology with homogeneous elemental distribution and a lamellar structure in cross section as well as well-bonded coating/substrate interface. Mg particles presented superior deposition during spraying due to their higher melting degree compared to HA particles. AZ91D alloy substrate was sig

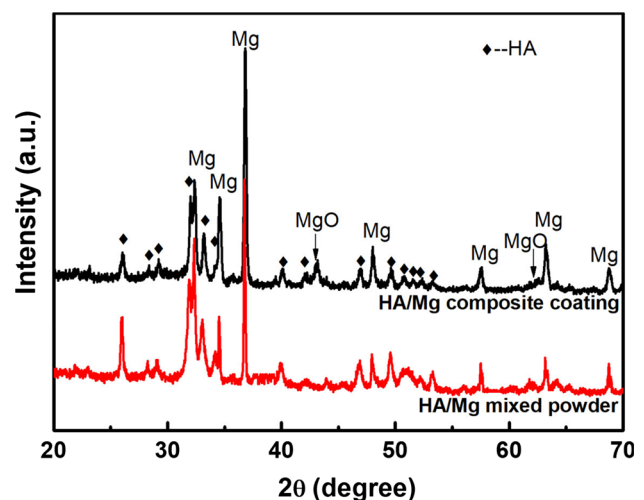
Fig. 2 XRD patterns of HA/Mg mixed powder and composite coating

Figure 2 shows the XRD patterns of HA/Mg mixed powder and composite coatings. The HA/Mg composite coating mainly consisted of HA and Mg in addition to a few of MgO phase. Consistent with our previous results (Ref 21, 22), the HA was not decomposed into other additional phases such as TCP, TTCP or CaO. Moreover, no mutual reaction of HA particles with Mg particles occurred. These facts indicate that the Mg and HA particles were largely preserved in the composite coating.

It is worth note that the HA/Mg composite coating contained only very few of MgO phase, although the Mg powders were subjected to the oxygen-propane flame with the temperature of higher than 1800 °C (Ref 21). Combustion of Mg particle usually has four stages: molten,

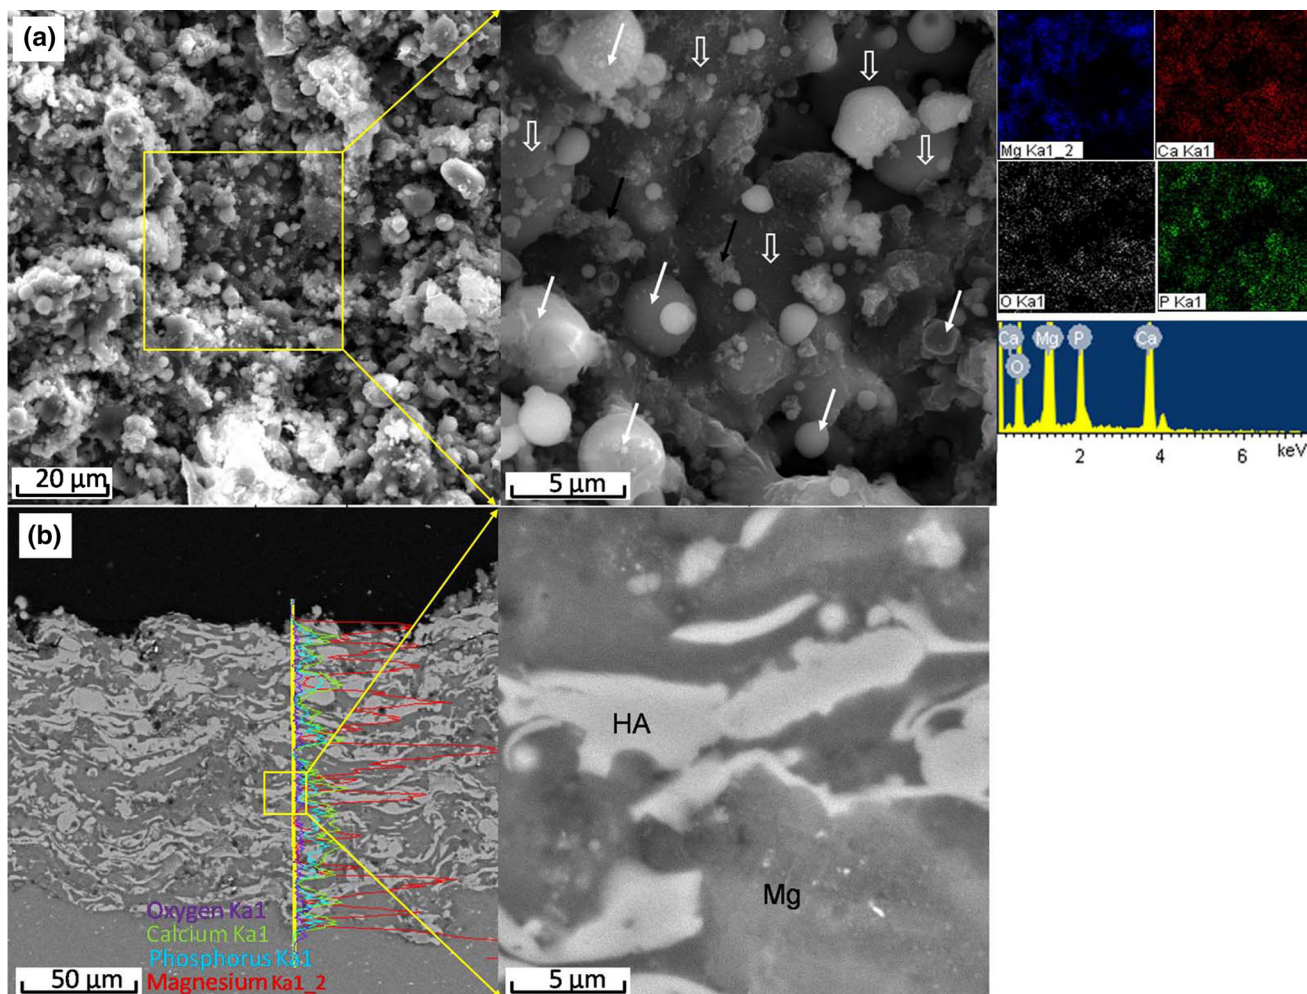
Fig. 4 Surface morphology (a) and cross-sectional microstructure (b) of HA/Mg composite coating. (In Fig. 4a, black arrows refer to nanoparticle agglomerates, white arrows refer to near-spherical splats, white hollow arrows refer to smooth surface splats)

Figure 4(a) shows that the HA/Mg composite coating presented a rough surface with different features, i.e., smooth surface splats, nanoparticle agglomerates and near-spherical droplets, which were the typical features of HA/metal composite coatings deposited by HVSFS, as described in our previous study (Ref 22). The smooth splats and near-spherical droplets are formed by melted Mg and HA particles. In contrast, the nanoparticle agglomerates with unsmooth surface are formed by the un-melt HA particles. Those surface features were consistent with the HA/Mg splats as shown in Fig. 3. EDS analysis shows that Mg, Ca,

P, and O elements were homogeneously dispersed on the coating surface (see inset in Fig. 4a). Compared to the original Mg powder, no micron-sized spherical Mg splats were observed on the coating surface. This phenomenon indicates that the Mg particles were melted, dispersed and deformed during the coating deposition.

The cross-sectional morphology of the HA/Mg composite coating exhibits a typical lamellar structure at the BSE mode (see Fig. 4b) and exists alternatively distributed lamella with different grayscale. Moreover, the coating was well-bonded to the substrate without any obvious coating/substrate interface. According to the elemental content, the dark lamellae were rich in Mg and the gray lamellae were rich in HA. It is difficult to identify the MgO phase from the cross-sectional image due to its limited content. Conventionally, the TEC of HA is around $11\text{--}13 \times 10^{-6}/\text{K}$ (Ref 25) and the TEC of AZ91D alloy is around $28 \times 10^{-6}/\text{K}$ (Ref 26). This significant difference in TEC between HA and AZ91D alloy is liable to induce cracking

in the coating during thermal spraying. However, from Fig. 4(b), there were not any obvious cracks in the HA/Mg composite coating and on coating/substrate interface. According to the tensile strength test, the bond strength of the HA/Mg composite coating was 26.7 ± 5.6 MPa. This bond strength was comparable to that of HVFS HA/TiO₂ multilayer coating (Ref 21). This phenomenon can be ascribed to the match of thermal expansion coefficient (TEC) between the AZ91D substrate and HA/Mg composite coating. In addition, the HA/Mg composite coating was dense with some small isolated pores. This dense microstructure is benefit to prevent the corrosion electrolyte from penetrating into the coating/substrate interface.

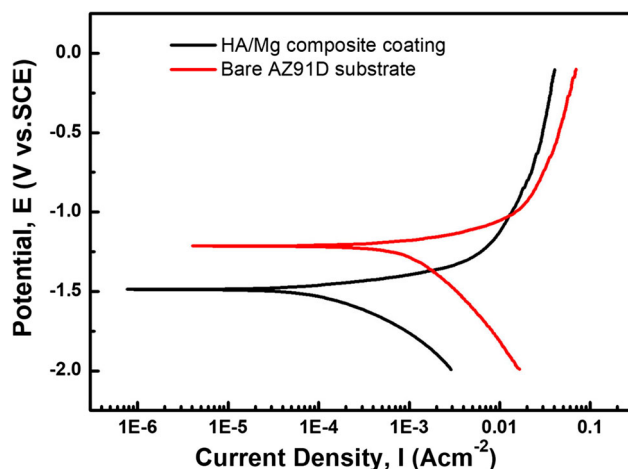
Fig. 5 Potentiodynamic polarization curves for HA/Mg coating and bare AZ91D substrate

Corrosion resistance performance of Mg alloys in simulated body fluid (SBF) is usually weak (Ref 28), resulting in the rapid failure of Mg-based implants before the expected period. Preparations of coatings on Mg-based implants are the main method to improve their corrosion resistance properties (Ref 2, 10). Figure 5 shows that the HA/Mg composite coating had a lower corrosion current than the bare AZ91D substrate. Based on the potentiodynamic polarization curves, the electrochemical parameters are listed in Table 2. Compared with the bare substrate, the corrosion current of HA/Mg composite coating was decreased by ~ 7 -fold from 570.5 ± 79.5 to $81.8 \pm 15.2 \mu\text{A}/\text{cm}^2$, and the corrosion resistance was increased by ~ 7 -fold from 45.7 ± 12.5 to $331.9 \pm 65.9 \text{ Ohms}/\text{cm}^2$ resulting in the decrease in corrosion rate by ~ 7 -fold from 264.2 ± 56.9 to $37.4 \pm 7.7 \text{ MPY}$. The corrosion potential was slightly decreased from -1.215 ± 0.012 to $-1.482 \pm 0.007 \text{ V}$.

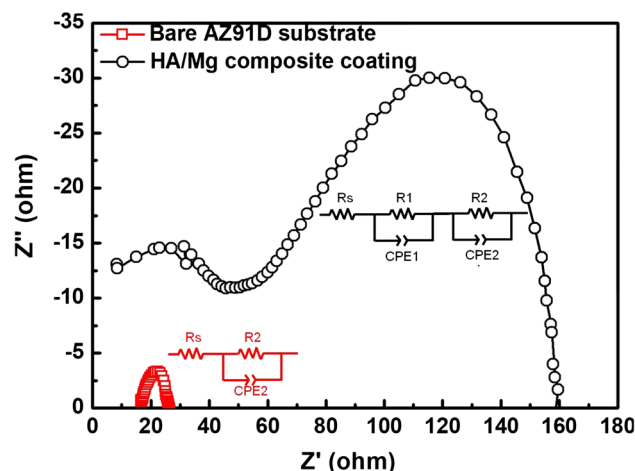
Fig. 6 EIS and equivalent circuits for HA/Mg coating and bare AZ91D substrate

According to our previous study (Ref 22), two semi-circles of the HA/Mg composite coating in EIS as shown in Fig. 6 refer to charge transfer resistance for the composite coating and coating/substrate or substrate/electrolyte interface, respectively. Thus, in the equivalent circuit (Ref 22) (see the insert in Fig. 6), R1 and CPE1 represent the charge transfer resistance and capacitive characteristics of HA/Mg composite coatings, respectively; R2 and CPE2 represent the charge transfer resistance and electrical double layer capacitance of the coating/substrate or substrate/electrolyte interface, respectively. Compared to the bare AZ91D substrate, the HA/Mg composite coating showed higher charge transfer resistance (as shown in Fig. 6 and Table 3), which was consistent with the above potentiodynamic polarization measurements. Similarly, many studies also report that HA/Mg composites or coatings on Mg substrates can show high corrosion resistances compared to the bare Mg alloys, such as HA/Mg composites (Ref 29, 30), pulsed laser-deposited HA/Mg coatings (Ref 31), and plasma-sprayed HA coatings (Ref 32). These results indicate that the HVFSFS HA/Mg composite coating can also protect the AZ91D substrate against corrosion in HBSS.

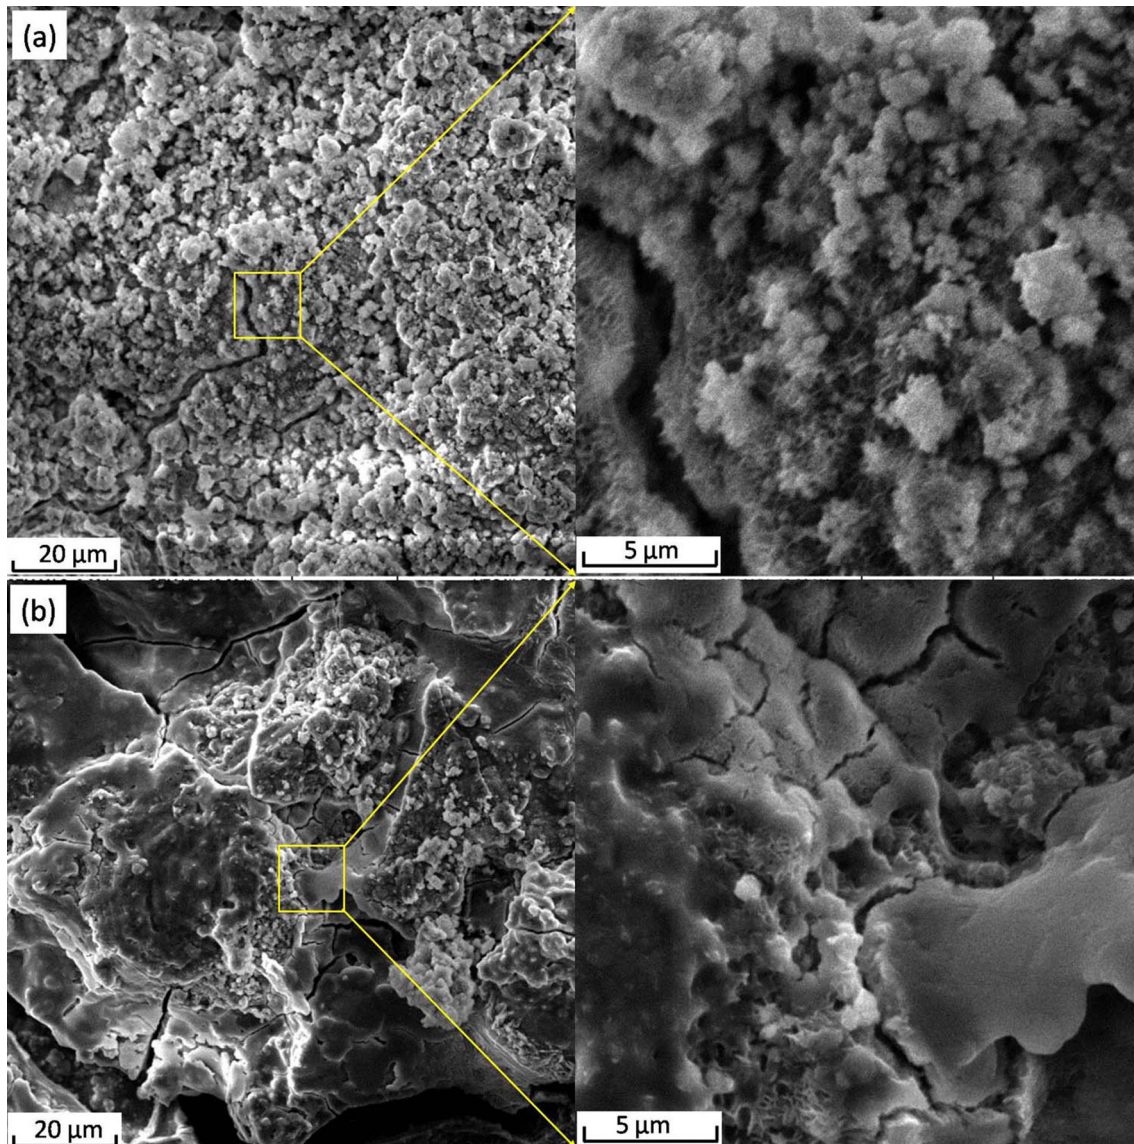
**Fig. 7** Surface morphologies of both the HA/Mg composite coating (a) and bare AZ91D substrate (b) after the polarization tests

Figure 7 shows the surface morphologies of both the HA/Mg composite coating and bare AZ91D substrate after the polarization tests. Compared with the as-sprayed coating, some microcracks and nanoparticles agglomerates appeared on the surface of HA/Mg composite coating (see Fig. 7a). Those microcracks resulted from the dissolution

of Mg metal in HBSS during the polarization test (Ref 13). In contrast, on the surface of sand-blasted AZ91D after the polarization tests, there appeared some microcracks and smooth precipitation. The abrasive feature caused by sand-blasted disappeared (see Fig. 7b) indicating the dissolution of AZ91D substrate. To identify the formation of precipitations, the XRD analysis was performed on the surface of HA/Mg composite coating and bare AZ91D substrate after
