# Fracture Surface Morphology of Delamination Failure of Polymer Fiber Composites Under Different Failure Modes

Pasa Yayla

**Abstract** The delamination of fiber reinforced polymer composites is one of the most common failures encountered in industrial applications. The most unique macroscopic and microscopic fracture surface features of the delaminations under different failure modes are of interests not only for practical failure analysis investigations but also it helps to reveal the physics behind the delamination phenomenon. In this work, fracture surface morphology of the delaminated carbon fiber polymer composites under mode I, mode II, and mixed-mode I/II loading conditions is investigated mainly with scanning electron microscopy. The unique fractographic features are identified and discussed. The results on ductile and brittle matrix composites have shown their own features, and most important of all the alignment angle of fibrils in the resin-rich ductile matrix could be correlated with the delamination mode.

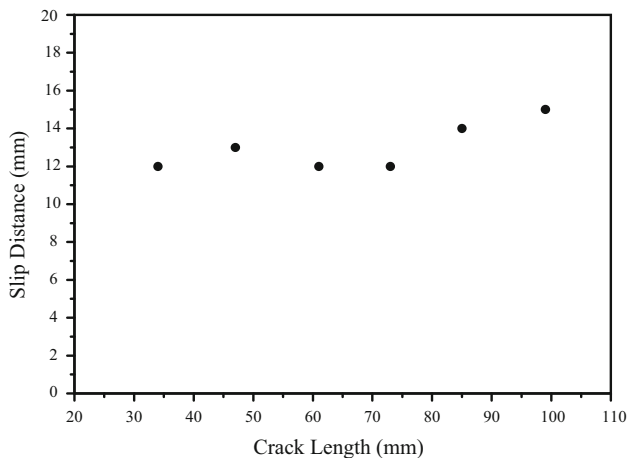
**Fig. 13** Variation of slip distance as a function of the crack length in PEEK composite delaminated in Mod I for ram velocity of 0.5 m/s
