Integration of Fire Safety Barriers in the Probabilistic Analysis of Accident Scenarios Triggered by Lightning Strike on Atmospheric Storage Tanks

Bilal Benkaouha · Zakarya Chiremsel · Djamel Bellala

Keywords Accident analysis · Fire safety barriers · Atmospheric storage tanks · Bayesian network · Fault and event trees · Sensitivity analysis

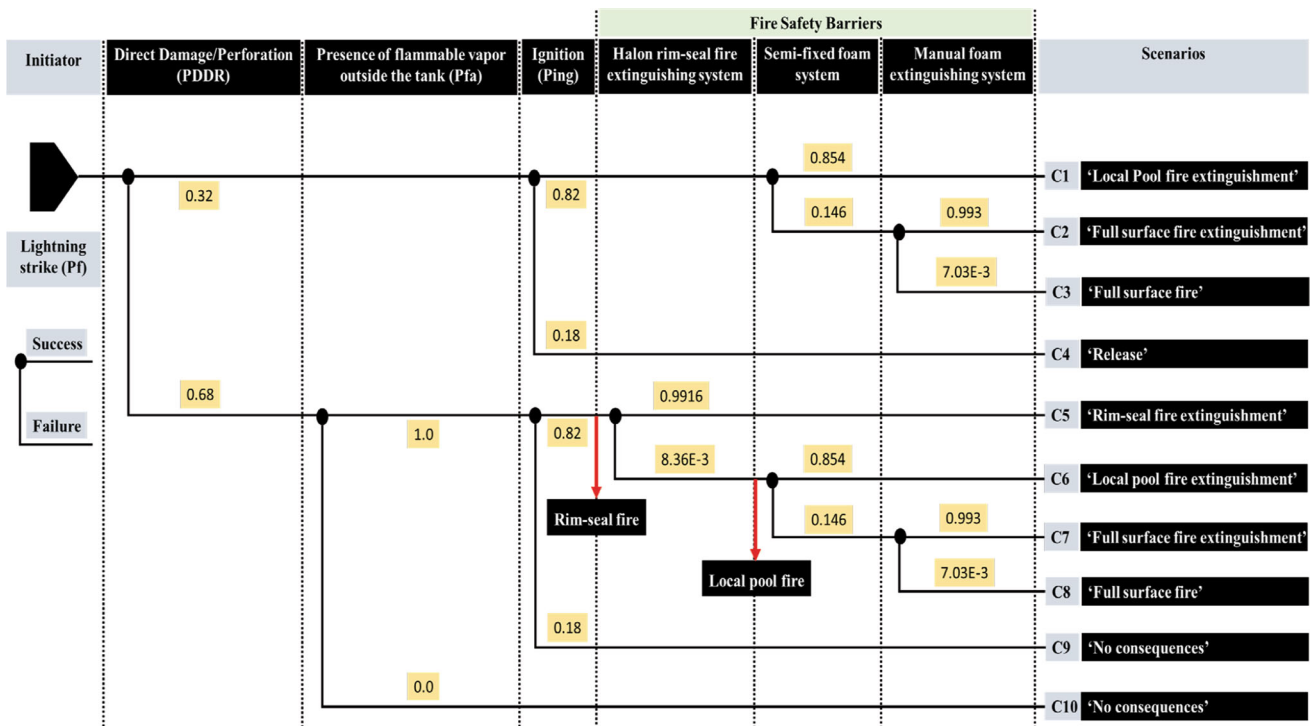
Fig. 3 Event tree following the direct lightning impact on the tank roof of external floating roof tanks

Based on the tank type, three different ET models were generated considering the role of safety barriers installed in the storage tank of interest. Two models are obtained for EFRT considering two different cases. The first one, where the direct lightning strike is supposed to affect the tank shell, while in the second case direct lightning strike is supposed to affect the floating roof (see Fig. 2 and Fig. 3). The ET obtained for FRT is reported in Fig. 4.

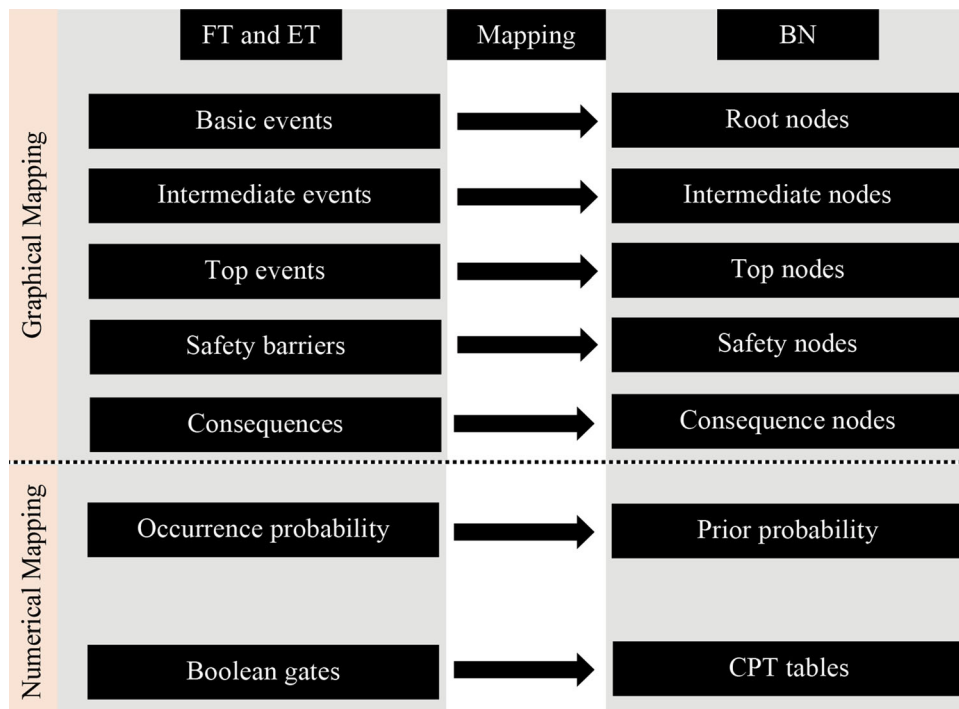
et al. [26] as shown in Fig. 7. This mapping algorithm includes graphical and numerical tasks. In graphical mapping, the basic, intermediate, and top events in FT are represented as root, intermediate, and top nodes in the BN model. Besides, safety barriers and consequences in ET are considered as safety and consequence nodes in the BN model. In numerical mapping, the occurrence probabilities of the basic events are inserted as prior probabilities for the root nodes, and a conditional probability table (CPT) is assigned for each intermediate and top node according to the type of the gate [22].

Fig. 7 Mapping algorithm from FT and ET into equivalent BN

In order to overcome the limitations of ET and FT and to perform a sensitivity analysis, the fault trees of fire safety barriers and the ET related to the first case (see Fig. 2) were converted into an equivalent BN model (see Fig. 9) following the mapping algorithm presented in Fig. 7, and using GeNIe software [35]. For the sake of brevity, this model is constructed only for the first case where lightning strike is supposed to affect the tank shell.

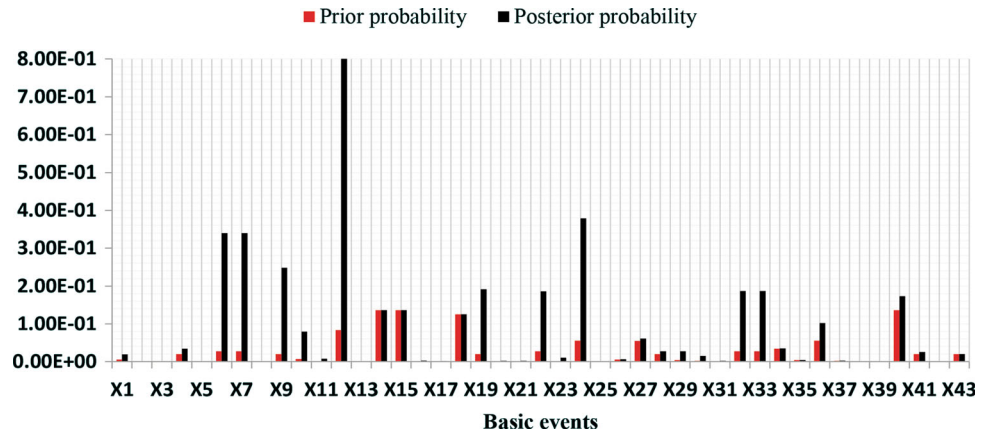
Fig. 11 Difference between prior and posterior probabilities of basic events

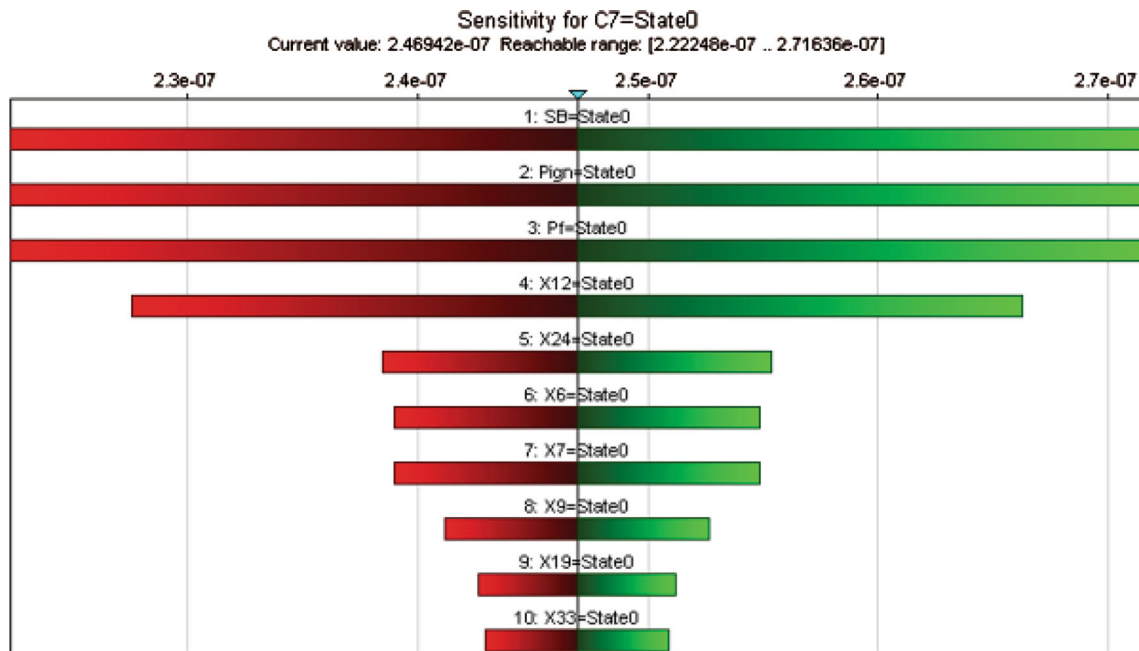
Fig. 12 Tornado diagram of the most critical basic events

Based on the Tornado diagram given by GeNIe software, X12, X24, X6, X7, X9, X19, X33 were considered as the most critical basic events, as shown in Fig. 12. Besides these events, three other events are appeared (P_{ign} , P_f , and SB) in this diagram. However, these events are not considered as critical since they are out of the scope of sensitivity analysis.
