Progressive Damage Analysis of Carbon Fabric-reinforced Polymer Composites under Three-point Bending

Kang-ning Han, Wei Zhou*, Reng Qin, Sa Yang, and Lian-Hua Ma*

College of Quality and Technical Supervision, Hebei University, Baoding 071002, China

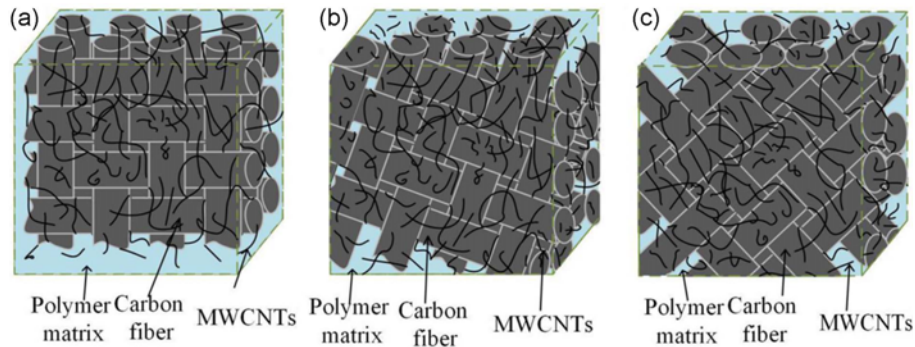
Figure 2. Architectures of specimens with different axial angles; (a) specimen A (0°), (b) specimen B (30°), and (c) specimen C (45°).

After roasting for 6 h at 130 °C and cooling down to room temperature, CFRP laminates was cut into standard specimens with different axial angles by Water-jet cutting method. The axial angles of Specimen A, B and C are 0 °, 30 ° and 45 °, respectively. The architectures of specimens with different axial angles are shown in Figure 2. The size of standard specimen is 60 mm×20 mm. Figure 3 shows the morphology features of Specimen A, B and C. There are three specimens in each class of composite materials.

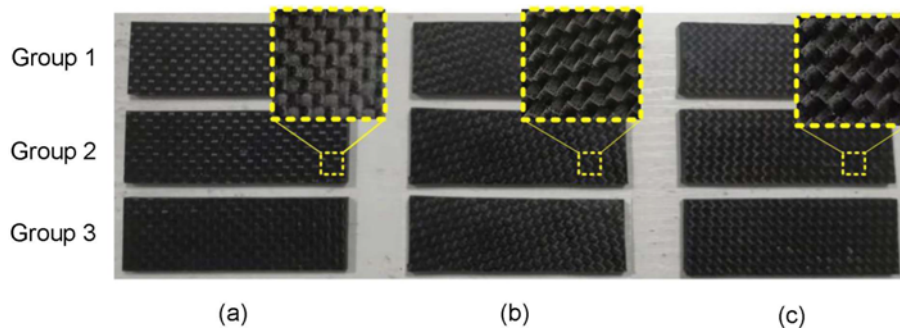
Figure 3. Three types of CFRP laminate specimens; (a) specimen A (0°), (b) specimen B (30°), and (c) specimen C (45°).

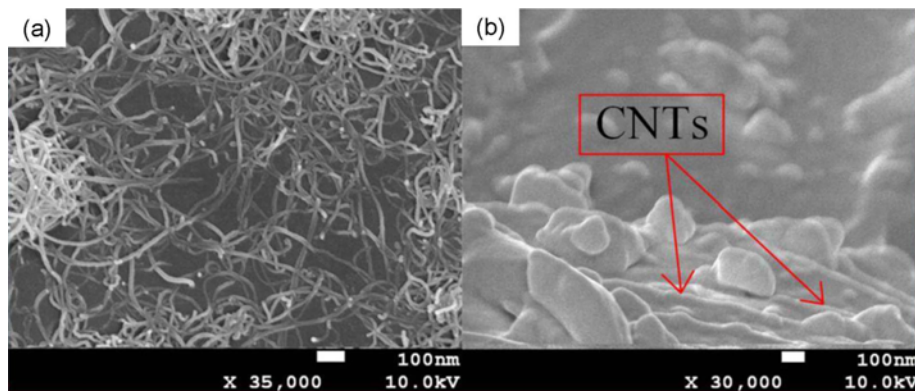
Figure 4. Microstructure characterization of CNTs; (a) morphology of CNTs and (b) morphology of CNTs in epoxy.

Based on the information of supplier, the length of CNTs is about 7 μm and the CNTs have a diameter ranging 5-15 nm. The purity of CNTs is about 95 wt%. Figure 4(a) shows the morphology features of CNTs and Figure 4(b)

shows the morphology of CNTs in epoxy. The CNTs have the tube-shaped materials form and tend to create the agglomerations under the function of Van der Waals forces [25]. The microscopic mechanisms of CFRP laminates can be observed by SEM (JSM-7500F) which coated by gold before observation.

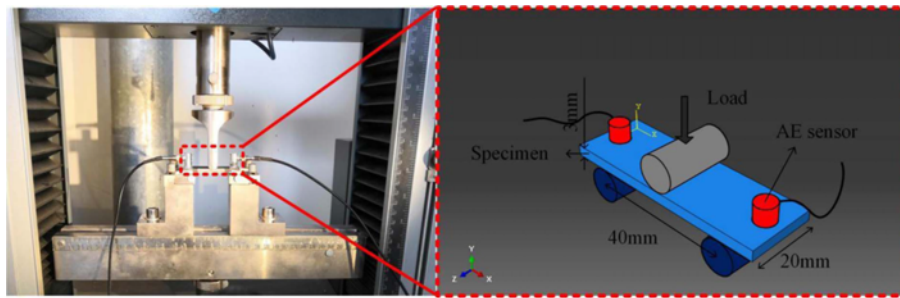
Figure 5. Three-point bending mechanical testing system.

Three-point bending mechanical testing system is shown in Figure 5. According to ASTM D790, the three-point bending tests of CFRP laminate specimens were carried out on LD24 machine. The displacement loading rate was set as

2 mm/min. The distance of two supporting rollers was kept at 40 mm. An upper roller was located at the middle of composites to apply bending load. Acoustic emission instrument (DS2-8A) was used to acquire the acoustic emission signals during the process of three-point bending tests. Meanwhile, the peak definition time (PDT) was determined to be 30 μs, the hit definition time (HDT) was set to 150 μs and hit lock out time (HLT) to 300 μs. Two RS-54A acoustic emission sensors were installed on laminate specimens being 50 mm apart. The bandwidth of sensors is 100-900 kHz and the preamplifier is 40 dB. The sampling frequency and threshold were set as 3 MHz and 10 mV,

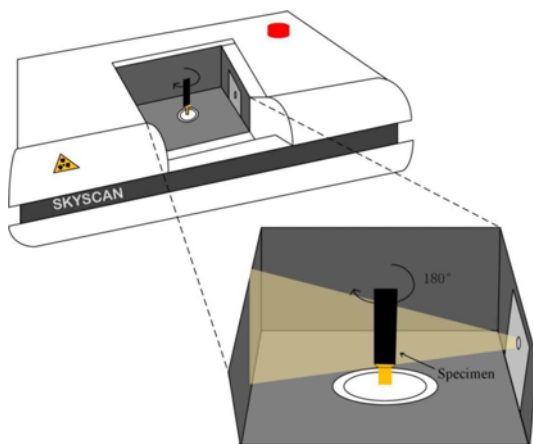
Figure 6. Measurement principle and apparatus of Micro-CT.

The laminate specimens were scanned by Skyscan 1172 X-ray. Measurement principle and apparatus of Micro-CT are shown in Figure 6. 2D images were obtained with 180° of tomographic rotation (0.2 rotation step). For given size of the laminates and the distance between the laminate and X-ray source, high resolution image data with voxel size of $6.8 \mu\text{m}$ was generated. The X-ray tube voltage and beam current were set to 78 kV and $132 \mu\text{A}$, respectively. The distance had been adjusted to ensure a specific region of interest of specimen on the detector screen. Each sample may use about 2 hours to acquire the images. The reconstruction was performed by NRecon based on Feldkamp algorithm. CT-vox software was utilized for 3D reconstruction model of the specimens. The components of the laminates were distinguishable based on the differences in the absorption of the X-ray radiation.

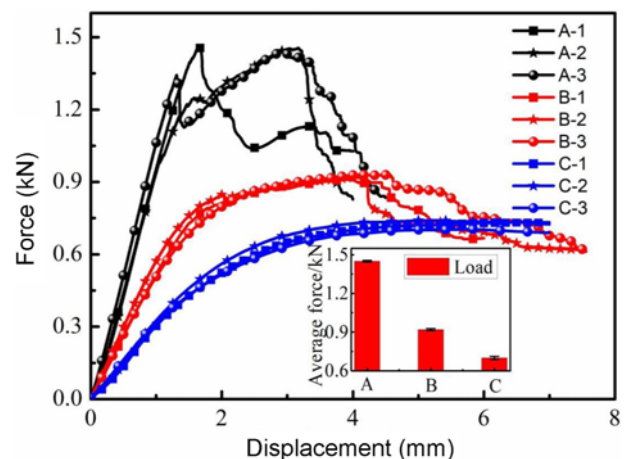
Figure 7. Bending load-displacement curves of laminates with various off-axial angles.

Figure 7 exhibits the bending load-displacement curves of laminates with various off-axial angles. The failure loads of laminates with various off-axial angles are shown in Table 1. The average maximum loads of Specimen A, B and C are 1.45, 0.92 and 0.72 kN, respectively. The average bending strengths of Specimen A, B and C which calculated by equation (1) are 483.33, 306.67 and 240.00 MPa, respectively. The load-displacement curves exhibit good repeatability. Every curve can fully describe the initiation and growth of damage and the change of specimen stiffness. All curves

show a linear growth trend at the beginning. However, the trend of curves of three laminates is significantly different with the bending load increasing, which indicates that the off-axis angles have an obvious impact on the failure mechanism. For both 0° and 30° specimens, a sudden drop is obtained when the first peak achieved. This phenomenon may be caused by the failure of the critical structure [26]. There is no sudden drop for 45° specimen owing to the matrix plasticity and alignment of tows along the loading directions which called fiber trellising [11]. With the increase of off-axis angle, the maximum load of the laminates decreases and the bending deflection increases. At the same time, the stiffness of laminates decreases with the increase of off-axis angle. The reason for this phenomenon may be that the fibers play an important supporting role

According to the Figure 7, three key points are selected to investigate progressive damage. In the linear stage, selecting the Point A (the linear growth point) to detect whether

has the largest failure load as shown in Figure 7. It can be obtained from the figure that the off-axis angle has significant influence on the damage evolution. With the decrease of the off-axis angle, the damage increases more and more severely. Unlike the characterization of Specimen A, the fiber breakage at the top and the delamination at the bottom are the main damages in Specimen B. No continuous cracks are found in these specimens. The fibers will slide when the fiber/matrix interface can not bear the shear stress which can result in the fiber/matrix cracking. For Specimen C, only a few fiber breakage and delamination appear at the top, which explains why the acoustic emission signals are shorter than those of Specimen A and B as shown in Figure 10. Moreover, the deformation and the load on matrix of Specimen C are larger. As a result, the bending strength of Specimen C is lower than that of others from a macroscopic level. In conclusion, Micro-CT can further verify the damage modes of laminates on the basis of acoustic emission technology. Acoustic emission technology can be utilized to monitor the damages inside the composites in real time. Micro-CT can analyze the damage modes in the process of progressive damage from the microscopic perspective. This complementary analysis method can provide a basis for health monitoring of CFRP laminates.

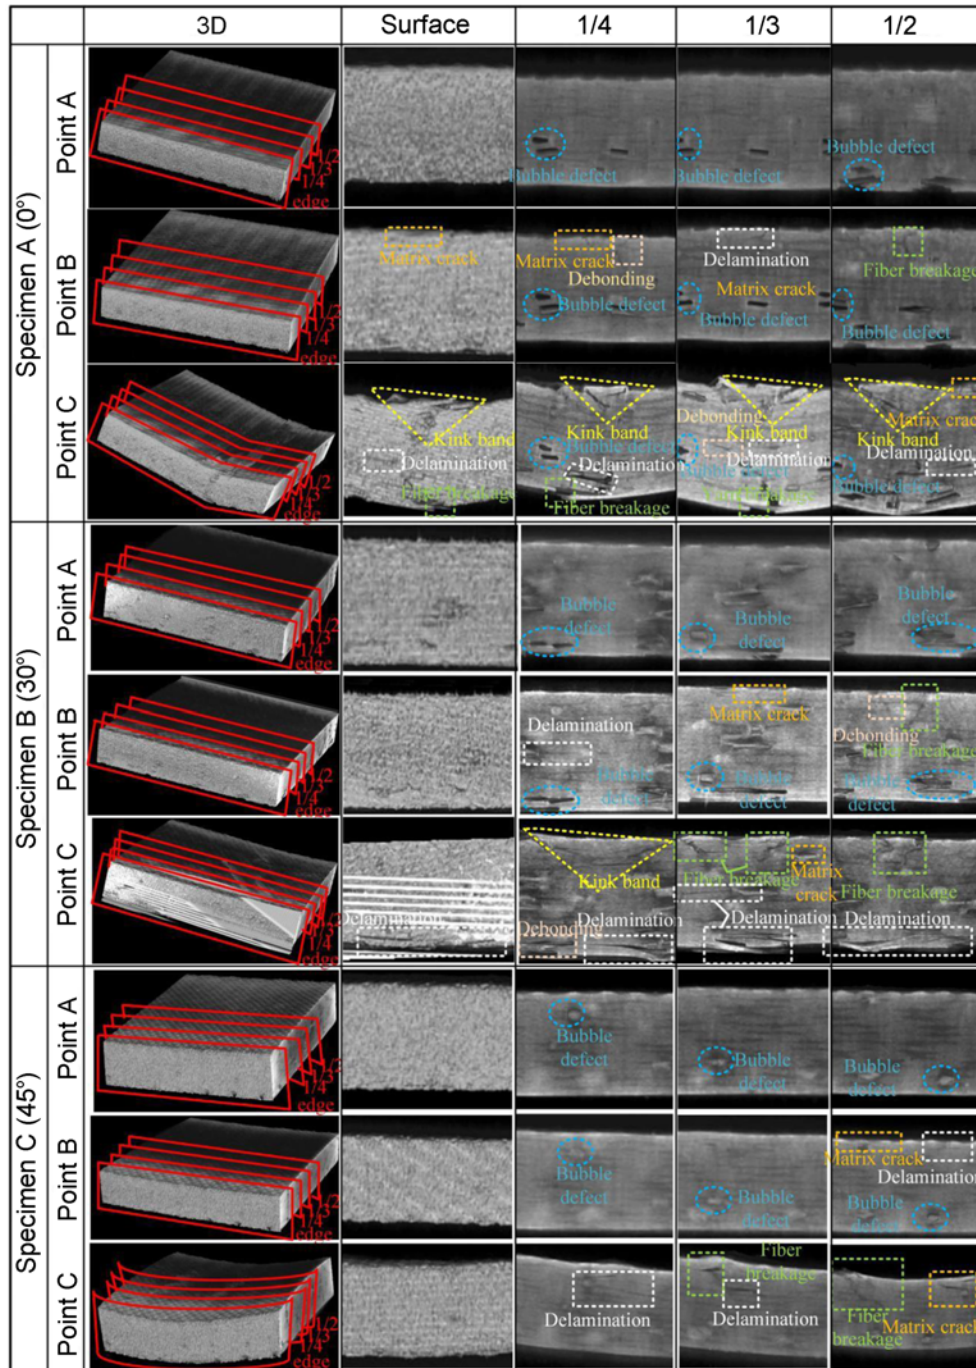
Figure 11. Tomographic sections of the damage mechanism at different stages with various off-axis angles.

Micro-CT can monitor various damage modes of CFRP laminates at the micro-structure level [10]. The middle part of laminates is recorded due to the limitation of view field and the information obtained can be used to investigate the progressive failure process. Figure 11 demonstrates

tomographic sections of the damage mechanism at different stages with various off-axis angles. Higher-density materials have lighter colors, thus the light grey areas represent carbon fiber and dark grey areas represent cracks and damage [10, 26]. In Point A, the defects are mainly bubble defects which mainly come from the manufacture process and there is no obvious damage of three kinds of specimens. The damage initiation/evolution can be detected in the Stage 2. The load curve comes to Point B after the steep decline. In addition to bubble defect, the matrix crack, delamination and debonding almost occur in three kinds of specimens. The fiber breakage is found in Specimen A and B, which is consistent with the result of the cluster analysis of the acoustic emission signals as shown in Figure 9. However, the extent of damage decreases with the increase of off-axis angles apart from the similar damage modes. Micro-CT scan is carried out at Point C to obtain ultimate failure modes. In this point, the damage becomes more and more seriously. Damage to the matrix continues damaging the fibers through the coalescence of diffuse pores at the early period [2]. The elastoplastic matrix shares more loads with the increase of off-axis angles, thus bending occurs first which can enhance the fracture toughness and suppress damage. Because the damage is further deteriorated, the count and energy of signals increase as shown in Figure 8. For Specimen C, the fiber fracture is not as catastrophic as Specimen A and B due to plasticity. At the same time, the AE signals of Specimen C are less than

those of other specimens. Hence, it is evident that pseudo-ductility in Specimen C leads to the inhibition of damage under dynamic loading [11]. The damage from cross-section surface to 1/2 exhibits slight difference. Compared with the surface of the specimen, the middle part of the specimen has more comprehensive and severe damage. Hence, it can be reasonably inferred that damage initiation/evolution can be utilized by using the damage modes of 1/2 section rather than the damage modes of the whole specimen.

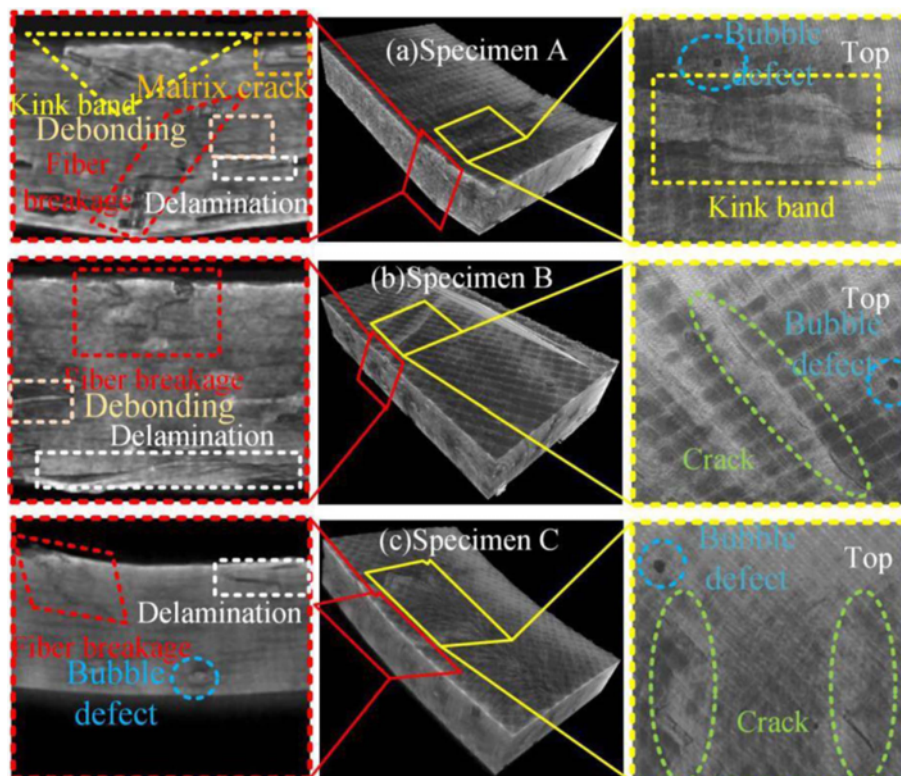
Figure 12. Damage modes in the 1/2 section of Point C of specimens with different off-axis angles.

The details of the damage modes in the 1/2 section of specimens with different off-axis angles are shown in Figure 12. For Specimen A, the detailed failure modes mainly include kink band, fiber breakage, matrix crack, debonding and delamination. The fracture section is perpendicular to the fiber direction and the fiber damage penetrates the entire specimen with some fibers pulled out. The fracture occurs in a remarkably short period of time and leads to a sudden decreasing of load. Specifically, the kink band results in the high shear strain near the loading head due to fiber misalignment and matrix degradation [26]. Subsequently, cracks begin to appear in the matrix and fibers around the kink zone and the cracks propagate across the boundary toward another weft along the thickness direction. During this process, inter-tows cracks and debonding occur at warp and weft. Fibers are the dominant parts to bear the load which proves that the axial yarn have a supporting and reinforcing effect on the laminates. Therefore, Specimen A
