Nanoclay Addition and Core Materials Effect on Impact and Damage Tolerance Capability of Glass Fiber Skin Sandwich Laminates

Abstract This study explores the effects of modified (OMMT) nanoclay and core material on low velocity impact behavior and damage tolerance capability of glass fiber reinforced (FRP) polyester resin – polystyrene foam (PS) sandwich laminates. The FRP and sandwich laminates are prepared by a compression molding technique for investigation. Low velocity impacts are carried out on all the fabricated laminates by using a instrumented drop weight impact tower with the energy level of 30 J and load–energy–time plots were recorded using data acquisition software. Post impact flexural tests have been conducted to evaluate the damage tolerance capability of the fabricated composite laminates. X-ray Diffraction (XRD) results have been obtained for the samples, where the nanoclay has indicated that intergallery spacing of the layered clay increases with the matrix. Scanning Electron Microscopy (SEM) has given the morphological picture of the nanoclay dispersion in the polymer fracture samples. The results of the study show that the impact properties and damage toleranc

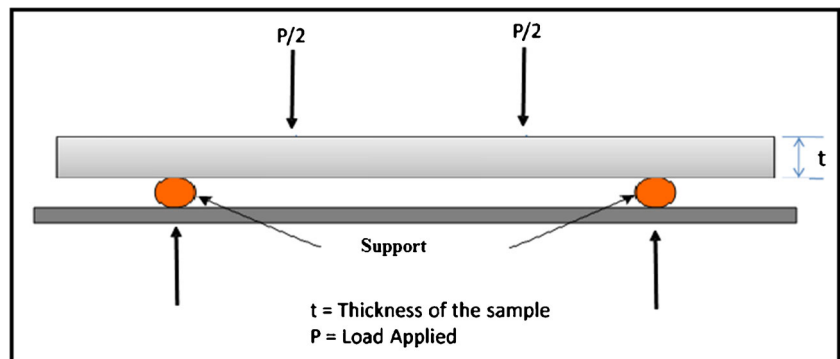
Fig. 2 Four point bending load arrangement for FRP and sandwich sample

configuration of four-point bending is shown in Fig. 2. A span-to-depth ratio of 16:1 and a cross-head speed of 2.5 mm/min were used. The samples for post-impact flexural tests were cut from the squared impacted samples to a size of (125 × 15) mm, such that the damage zone is oriented at the center of the flexural test samples, as shown in Fig. 3. Note that the damage extension developed by an impact energy of 30 J does not exceed the sample width as considered per the ASTM standard.

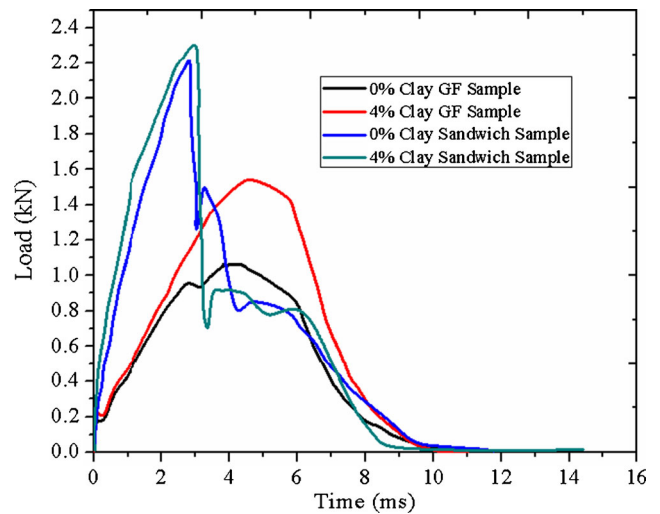
Fig. 4 Typical load vs. time response curves of various samples

Figures 4 and 5 show the typical load and energy versus time responses for all six kinds of samples at an incidental

Table 1 summarizes low velocity impact test results of FRP and sandwich laminates. The first sudden load drop in the load vs. time plot is a sign of internal delamination beginning or fiber-matrix interface failure in the laminates close to the back surface of the impacted laminates [18]. This load point is called the incipient damage point and has an insignificant effect on the load carrying ability of the laminates. The equivalent energy is called incipient energy. However, as the impact continues, there are noticeably different trends for different composite laminates (see Fig. 4). The load decreased suddenly after reaching the peak level.

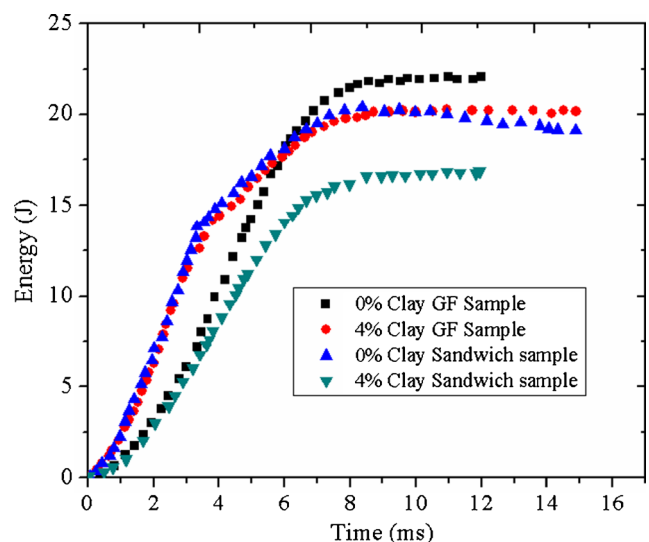
Fig. 5 Typical energy vs. time response curves of various samples

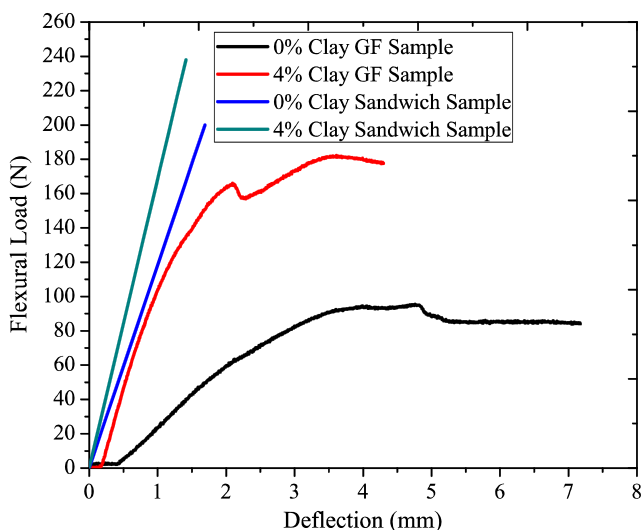
Fig. 12 Typical flexural load – deflection curve of non-impacted FRP and sandwich laminate samples

The evaluation of the residual strength of a damaged structure is of practical importance for an effective damage tolerant design. It is well known that impact-damaged laminates experience significant strength reductions when subjected to bending load, compared with undamaged samples due to the local instabilities arising from the existing damage. Table 2 summarizes flexural properties of undamaged and impact damaged composites laminates while Figs. 12 and 13 show the comparison of the typical flexural load - deflection responses of undamaged and impact-damaged composite laminate samples respectively.

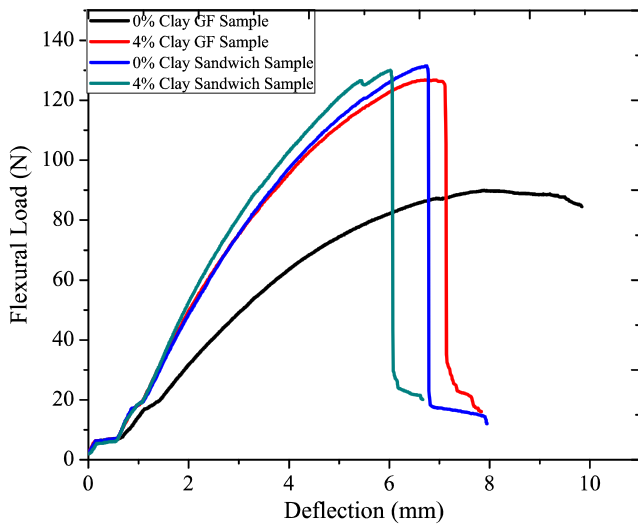
Fig. 13 Typical flexural load – deflection curve of impacted FRP and sandwich laminate samples

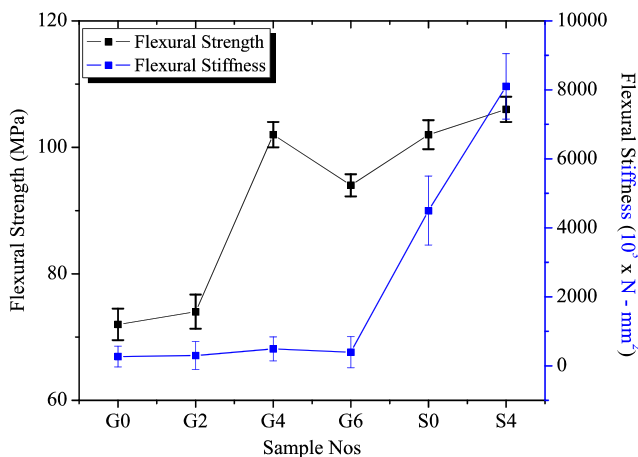
Fig. 14 Flexural properties of various impacted laminate samples

Figures 14 and 15 show flexural properties (flexural strength and flexural stiffness), of impacted and non-impacted samples respectively. It is observed from both impacted and non-impacted samples that the flexural properties such as flexural strength and flexural stiffness

increased with increase of nanoclay loading up to 4%. Further, addition of nanoclay (6%) leads to reduction of flexural properties due to agglomeration of nanoclay in the resin. Increase in stiffness is obtained by reinforcement of nanoclay and moment of inertia of laminates by placing a soft core between GFRP skins. For better evaluation of the influence on impact damage on the residual properties, the normalized flexural properties of each sample have been calculated as the ratio between the mean flexural properties of the impacted samples and the mean flexural properties of the undamaged samples and are represented in Fig. 16 for different laminates. Further, flexural stiffness ratios for non-impacted and impacted samples have been evaluated and are presented in Fig. 17. As expected, samples with larger damaged area are matched by a reduction in normalized residual flexural properties for all laminates studied. Similar to the above observation in that the laminates containing nanoclay resulted in a smaller damaged area as indicated by the photo image measurements (Fig. 10a–h), nanoclay also gave rise to higher normalized residual flexural properties than the laminates made from neat polyester. Increase in the normalized residual flexural strength and stiffness for the 4% nanoclay sandwich sample (S4) is found to be 23 and 40% respectively, when compared with the 0% nanoclay sample (G0).

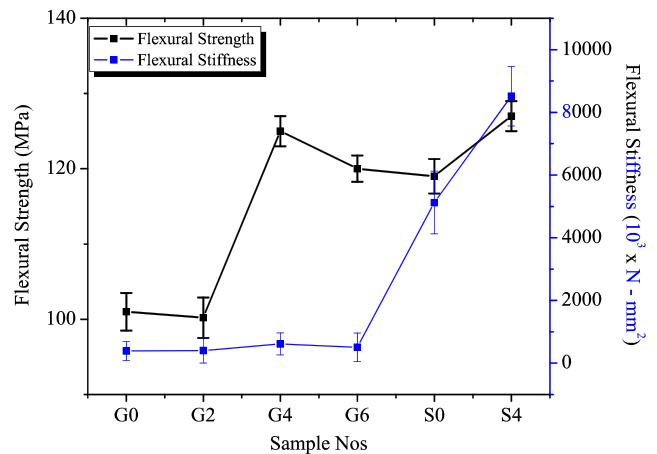
Fig. 15 Flexural properties of various non-impacted laminate samples

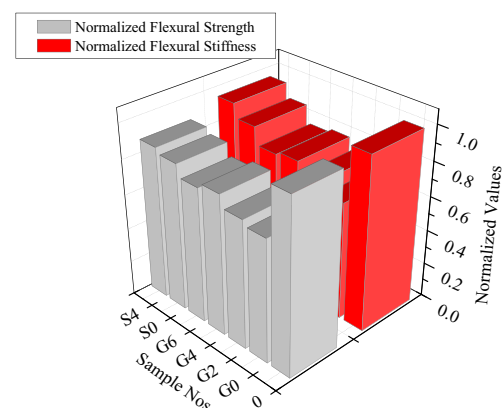
Fig. 16 Normalized flexural properties of various laminate samples

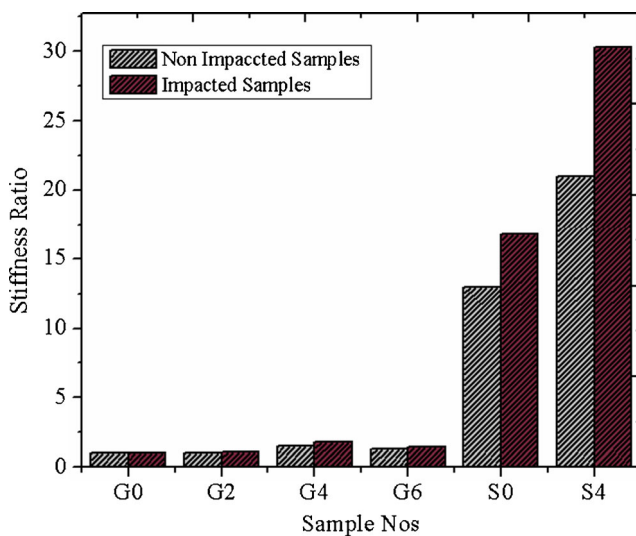
Fig. 17 Flexural stiffness ratio of various laminate samples

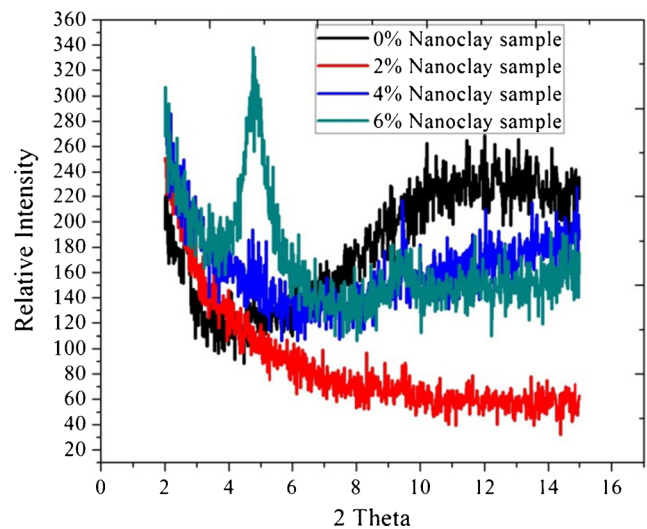
Fig. 18 X-ray diffractograms of laminate with respect to different samples

The results of the x-ray diffraction study are shown in Fig. 18 in which up to 4% nanoclay the results obtained are almost similar [20]. Samples with nanoclay particles have a d-spacing of 18.77 Å, while the d-spacing of the

natural nanoclay particle is 11.7 Å. This 51% increase in the gallery spacing of the nanoclay is a clear indication of intercalation. The polyester resin molecules have penetrated between the clay sheets and have resulted in the expansion in gallery spacing. The disappearance of a peak indicates the separation of clay layers and the formation of an exfoliated nanocomposite. For the organoclay content of 6% nanoclay sample there is a broad peak at 2θ value of 4.5° and the corresponding intergallery spacing is 24.22 Å. This indicates the formation of an intercalated nanocomposite.
