Effect of Damage on Natural Vibration Characteristics of Large Semi-cushion Spiral Case Structure

Abstract

Keywords Large semi-cushion spiral case structure · Natural vibration characteristic · Concrete damage · Resonance checking · Four-parameter damage model · Finite element method

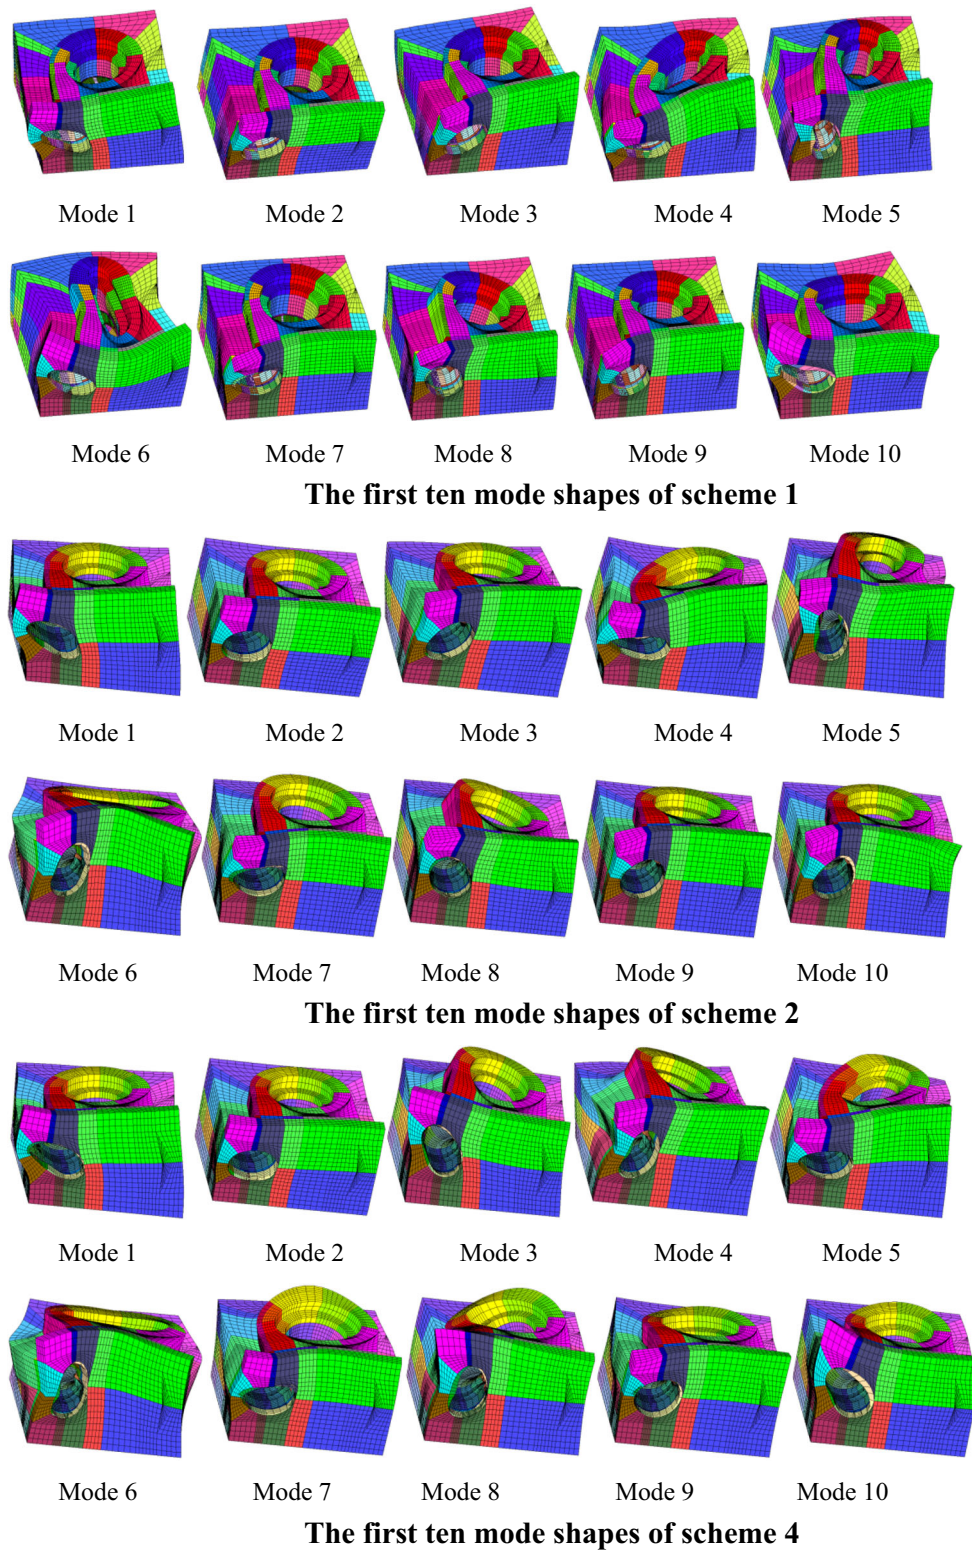
Fig. 8 The first ten mode shapes of the machine pier structure under various schemes

natural frequencies under various schemes. Figure 8 shows the first ten mode shapes of schemes 1, 2, and 4.

(3) Comparing the mode shapes before and after the damage in concrete shows that the mode shapes are all complex

and twisted vibrations of structure. However, after considering damage, the amplitude is generally large.
