Nondestructive Evaluation of Hidden Damages in Glass Fiber Reinforced Plastic by Using the Terahertz Spectroscopy

KEYWORDS: Non-destructive evaluation, Glass fiber reinforced plastic, Delamination, Failure modes

In this work, the terahertz (THz) spectroscopy system was used for the detecting and evaluation of hidden damages in a glass fiber reinforced plastic (GFRP). The interaction between THz and the GFRP was analyzed including the effects of reflecting, scattering and absorption of THz radiations with respect to the type of hidden damage. Both the transmission and reflective configurations were used to investigate the hidden damages including the delamination, fiber fracture and moisture absorption. Finally, the hidden damages inside of the composite laminates were successfully imaged simultaneously based on the time-domain spectroscopy of THz radiation. Additionally, the moisture absorption damage in the GFRP could be detected by analyzing of the frequency domain spectrum. It is expected that the developed THz nondestructive evaluation (NDE) technique can be widely used to evaluate the health of the composite structures.

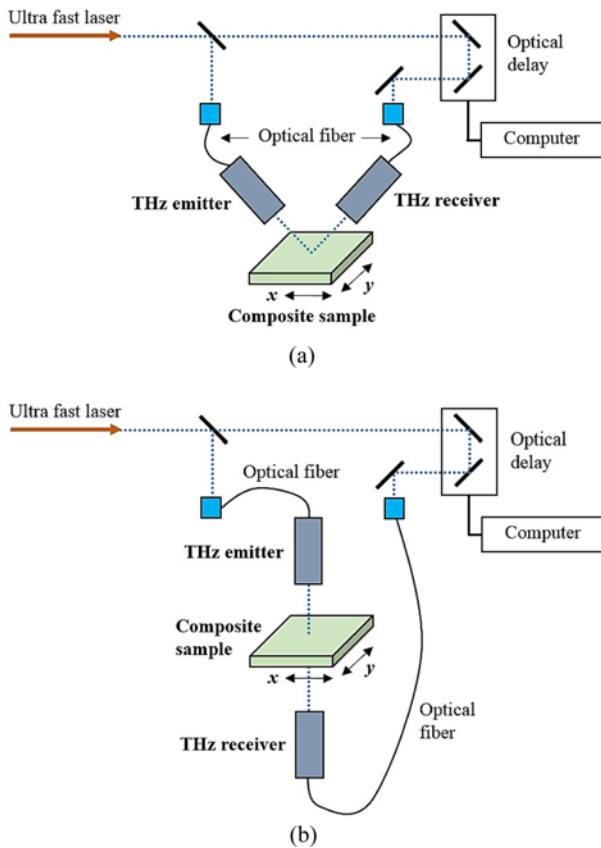
Fig. 2 A schematic diagram of THz spectroscopy system: (a) Reflective mode, (b) Transmission mode

different refractive indices inside of sample. Then, the impulses gathered by a set of mirrors and fall onto the detector. The position and types of the hidden defects can be investigated based on the different wave response between reflected or transmitted signals of the THz waves for the determining of medium properties.²⁰ During the inspection, the repeatability could be achieved by installation of system which taking two consecutive data sets and normalizing their frequency spectra. This normalization gives about 99% data repeatability after 100 scans averaging for each data set in less than 1 second.

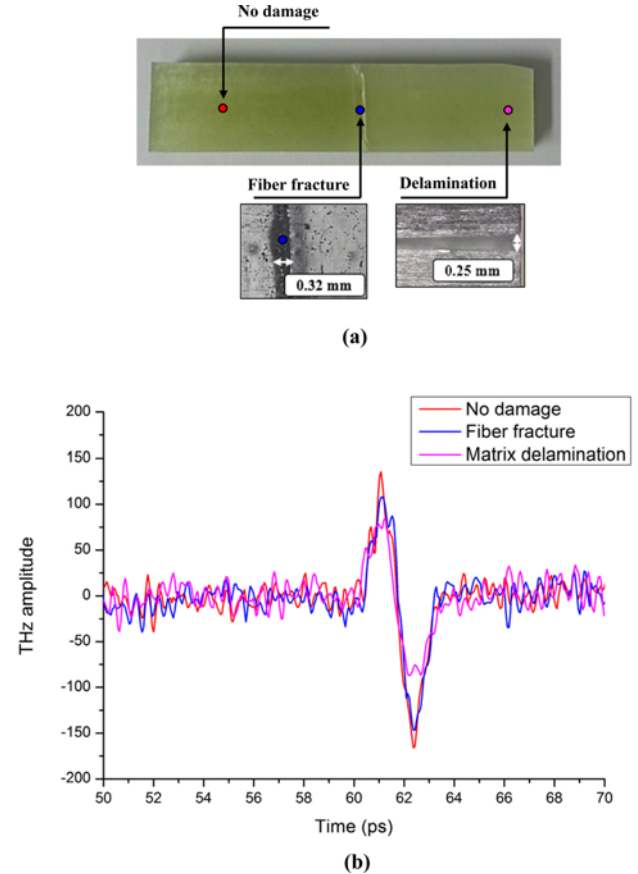
Fig. 5 THz inspection results of 3.5 mm thickness GFRP with respect to the failure position: (a) Position of inspection, (b) Change of THz amplitude

Fig. 5(b) shows the THz inspection results of 3.5 mm thickness GFRP with respect to the failure position as shown in Fig. 5(a). It was found that the amplitude of THz wave was reduced at the damaged region. It is noteworthy that the THz amplitude was more decreased at the delamination area compared to that of the fiber fracture. The THz inspection was also performed from the inside to outside direction that the gap of delamination is increased as shown in Fig. 6(a). It could be known that the THz amplitude was much reduced from the delamination region, and also it was slightly decreased as the gap of delamination increases (Fig. 6(b)).

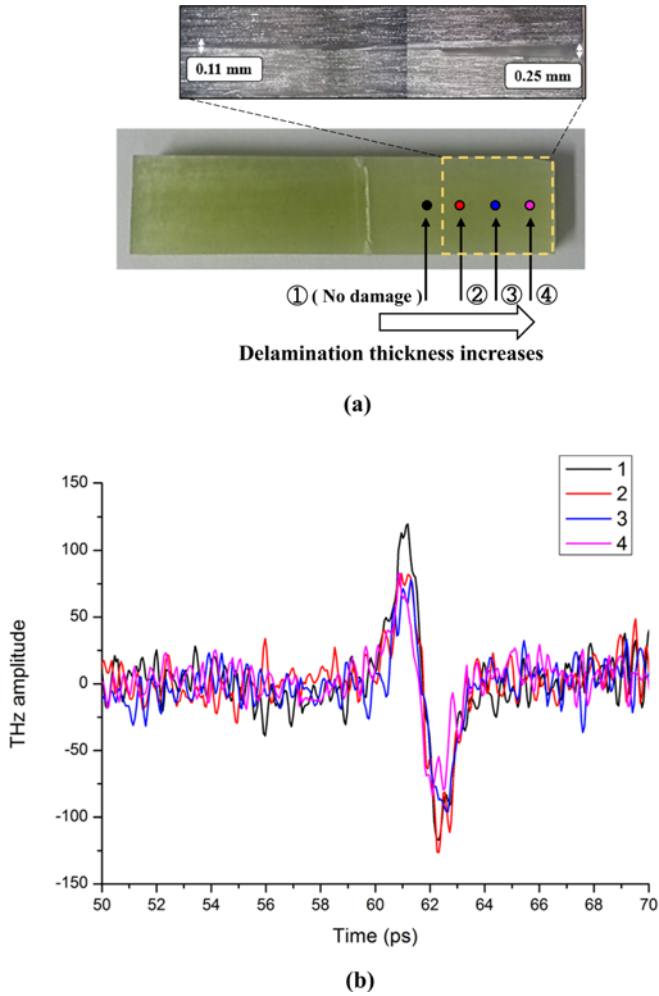
Fig. 6 THz inspection results of 3.5 mm thickness GFRP with respect to the delaminated thickness: (a) Position of inspection, (b) Change of THz amplitude

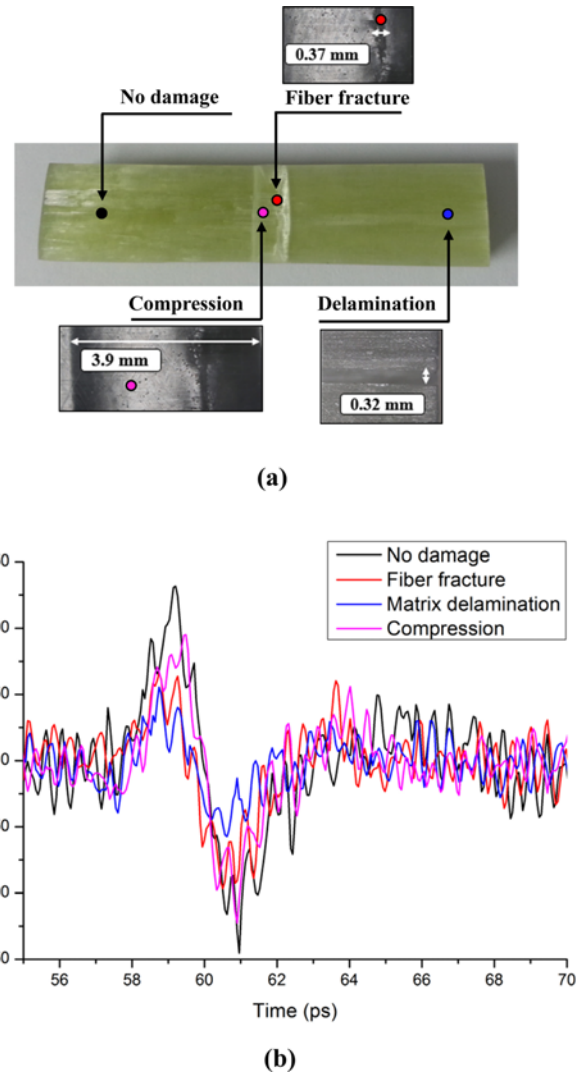
Fig. 7 THz inspection results of 6.2 mm thickness GFRP with respect to the failure position: (a) Position of inspection, (b) Change of THz amplitude

Fig. 7(a) shows the THz response from 6.2 mm thickness of GFRP with respect to the failure position as shown in Fig. 7(b). Similar to the results of 3.2 mm specimen, it was found that the THz amplitude was reduced in the damage regions. Additionally, the THz amplitude was decreased also at the region of compression damage. From these results, it can be concluded that the THz amplitude is reduced when it passes through the damaged region, and also that of reducing ratio is depending on its failure mode. It comes from the fact that the various optical effects of THz wave occurred when it passed through the damage region.¹³ As shown in Fig. 8, if there are no defects in the material, two reflections (air/GFRP and GFRP/air) and one absorption

from separated bottom part of GFRP due to the delamination (Fig. 8). By using above equations, the reduced THz amplitude in the delamination region was calculated to be about 78% of the amplitude in the no damage region. However, the amplitude should be more decreased because the surfaces between delamination are not a flat clean surfaces which lead to the scattering of THz wave. Additionally, the amplitude was more reduced as the gap of delamination increases due to the extended distance of diffusion or re-scattered radiations between two scattering surfaces.²³ These are the reason that the THz amplitude was more decreased as the gap of delamination is increased (Figs. 5(b), 6(b) and 7(b)). In the case of compression damage, the amplitude was slightly reduced compared to the no damage region. It may come from the fact that the scattering of THz wave occurred due to the micro cracks in inside of GFRP which generated under the compression load (Fig. 7(b)).

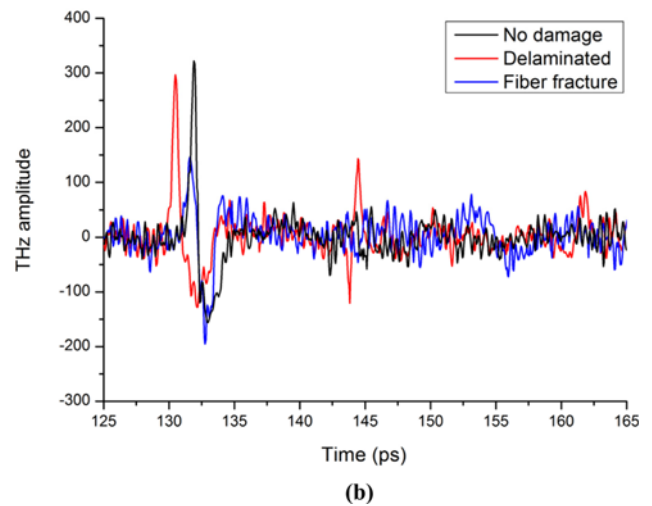
Fig. 10 THz inspection results of 3.5 mm thickness GFRP using reflective mode with respect to the failure position: (a) Position of inspection, (b) Change of THz amplitude

Fig. 10(b) shows the THz response from 3.5 mm thickness of short-beam tested specimen in reflective configuration with respect to the failure position (Fig. 10(a)). It was found that the different THz responses were obtained as the types of hidden damage. First of all, the front peak was obtained which reflected from the surface of specimen (130 - 135 ps). It could be known that the all of front peaks showed reversed phase compared to the transmitted THz wave (Fig. 5(b)), because the fixed reflection occurred from the low density medium (air) to the high density medium (GFRP). For this case, the relative permittivity can be obtained by using the following equation from the refractive index of the GFRP:

travel distance of THz wave from the emitter to detector was slightly reduced due to the lifted surface of specimen as shown in microscopic image of delamination (Fig. 10(a)). Also, it is noteworthy that another reflected peak was detected at 145 ps from the delamination region. It was come from the fact that the additional reflection occurred due to the fractured interfaces of matrix delamination. The schematic of detailed THz spectroscopy in the reflective mode was depicted in Fig. 11. The earlier front reflection occurred due to the lifted surface and the additional reflection occurred from the surface of delamination (GFRP/air). Also, the reversed phase of delamination peak compared to the front peak showed the fact that the THz wave was reflected from the upper interface of delamination, because the free reflection occurred when the THz wave passes from the high density medium (GFRP) to the low density medium (air). In the case of fiber fracture, the amplitude of front peak was much reduced (Fig 10(b)). As shown in Fig. 11, it is because the THz wave lost much energy during reflection due to the scattering effect at the rough surface of fracture, compared to that of no damage region. Based on these results, the hidden

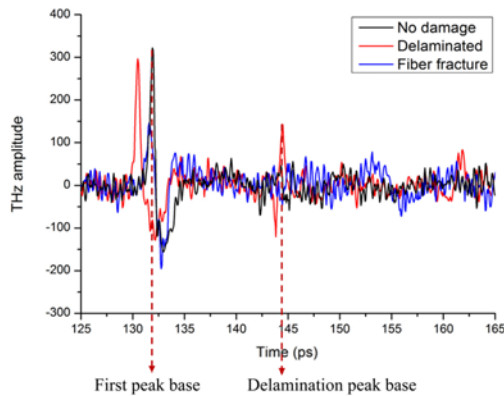
Fig. 12 Damage detecting of 3.5 mm thickness GFRP specimen based on the results of THz spectroscopy using reflective mode: (a) Imaging basis, (b) Images

damages in specimen could be imaged as shown in Fig. 12. Based on these results, the THz imaging was performed based on the both of different respond of first peak (132 ps) and delamination peak (144 ps), respectively. It was found that the fiber fracture and matrix delamination could be detected successfully by using the THz inspection system with reflective mode.
