# Third-Rail Insulator Failure Causes and Mitigating Practices: A Comparative Study of Multiple Case Studies in the U.S.

**Abstract** Rail transit systems are one of the most important and popular types of transit systems used daily in metropolitan areas all around the world. The third rail is one of the providers of traction power in electrified rail systems, but it faces several issues, such as insulator failures. The purpose of this study is to investigate the causes of insulator failures, which have not been comprehensively studied and presented in the literature. To accomplish this objective, eight transit systems with third rails were selected to (1) investigate the characteristics of third-rail systems, (2) determine the causes of insulator failures, (3) analyze the costs associated with insulator failures, and (4) determine mitigating practices to reduce the number and cost of insulator failures. After a thorough literature review, details of eight case studies were collected from different transit agencies, and their subject matter experts were asked to complete a survey and provide input. The results revealed that a build-up of dirt was the major cause of the 17 identifi

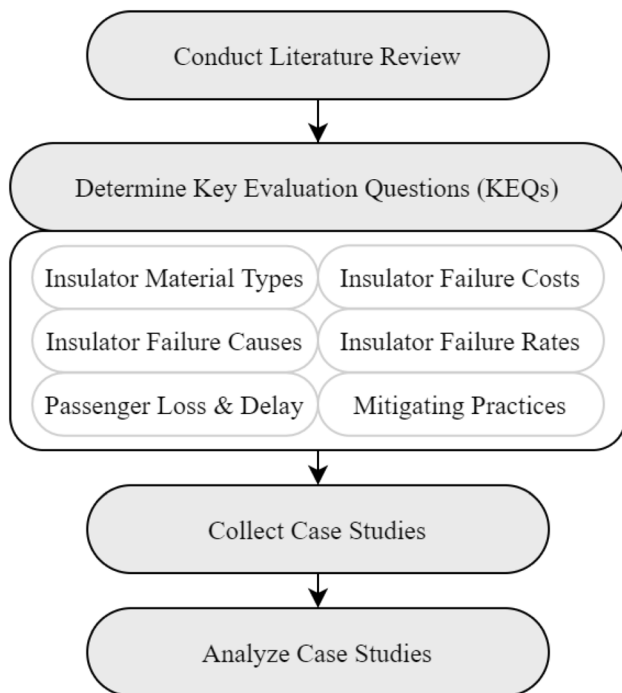
**Fig. 1** Research methodology

A four-step methodology, shown in Fig. 1, was developed to accomplish the objectives of this study. In the first step, literature relating to the failure causes and mitigating practices of third-rail insulators was collected and studied. In the second step, the key evaluation questions (KEQs) for data collection were determined. In step three, based on the KEQs, the data from selected case studies was collected and categorized by (1) transit system characteristics, (2) features of insulators, (3) insulator failure causes, (4) insulator failure costs, and (5) insulator failure mitigating practices. Subject matter experts (SMEs) from eight active transit agencies with third-rail systems were asked to

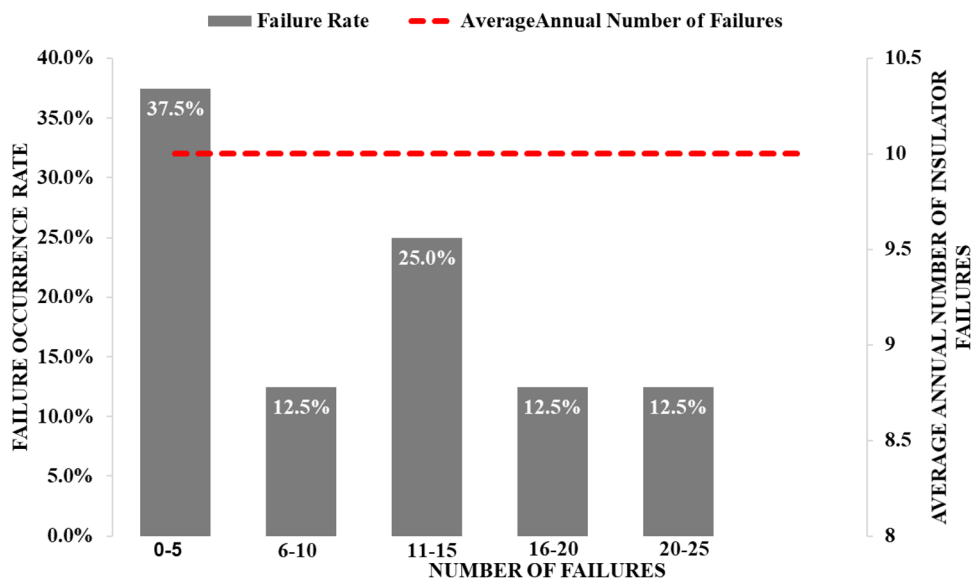
**Fig. 2** Rate of insulator failures per year in case studies

When the failure rate of insulators is high, new materials and/or installment methods can be implemented to reduce them. The average annual number of insulator failures of each transit system was investigated during this study, and Fig. 2 shows the distribution of the average rate of insulator failures occurring across all of the case studies. As shown, 37.5% of the transit systems have less than five insulator failures per year, and an average of ten insulator failures occur annually in all of the transit system case studies.

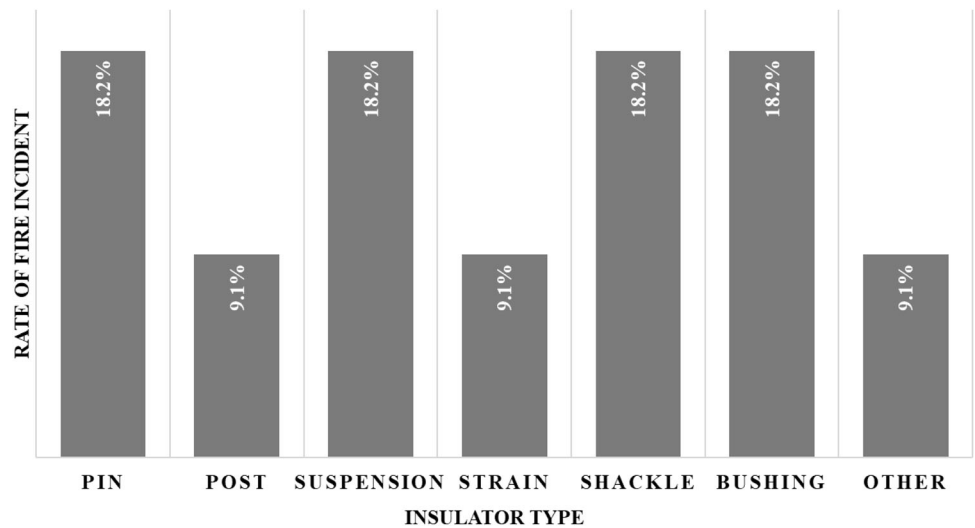
**Fig. 3** Rate of fire incident occurrences in various insulators

major fires: pin, post, suspension, strain, shackle, and bushing. According to the responses, summarized in Fig. 3, fire incidents were less likely to occur in post and strain insulators, both of which had a 9.1% rate of occurrence. The rest of the insulators each had a fire incident rate of 18.2%. Being aware of the insulators more prone to fires helps practitioners prevent or at least lessen the number of fire incidents in their transit systems.

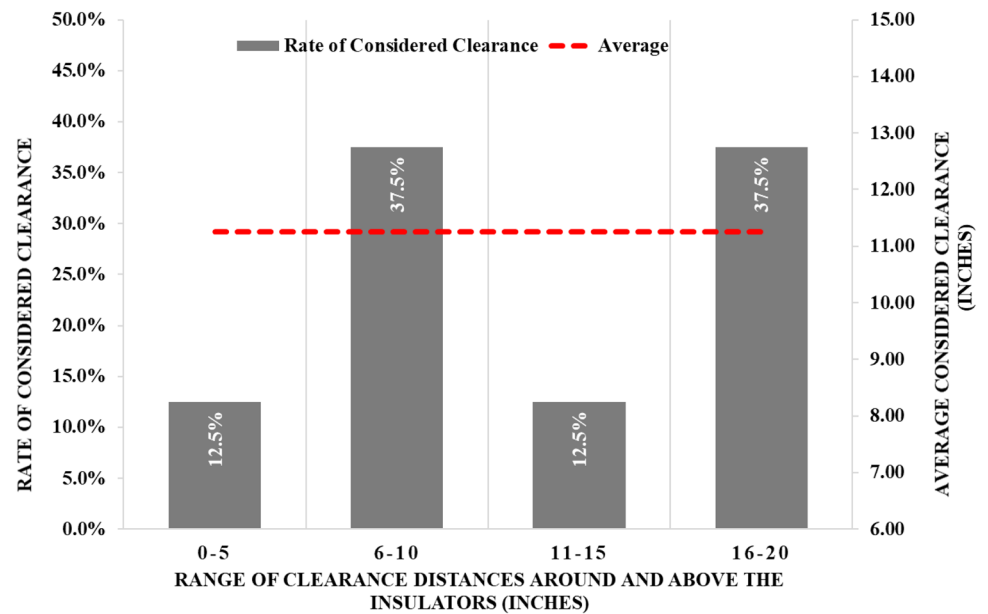
**Fig. 4** Range of clearance spaces around insulators

A clearance space is required in the space above and around each installed insulator off third-rail systems to provide good access. Each transit agency determines its own clearance space requirement due to several different criteria and limitations, such as safety considerations. If sufficient clearance space is not provided, access is limited, and cleaning the insulators is either prevented or marginalized. Figure 4 shows a comparison of the clearance space provided around insulators by the studied transit agencies. The highest implemented clearance space is 20 inches, while an average of 11.25 inches of clearance space is implemented by the third-rail systems.

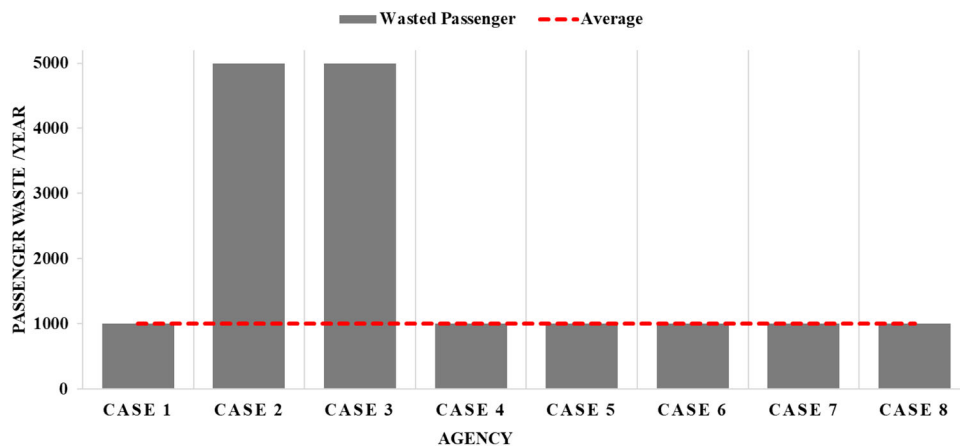
**Fig. 5** Range of annual lost passengers for each case study

Due to insulator failures and the corresponding shut-down of the system for a while, some of the passengers switch to another transit system, which means a loss of passengers. The SMEs were asked to determine the range of annual passenger loss due to insulator failures, and their estimated ranges are summarized for each agency in Fig. 5. As demonstrated, cases 2 and 3 experience the biggest losses, with 1000–5000 passengers who switch to another system.

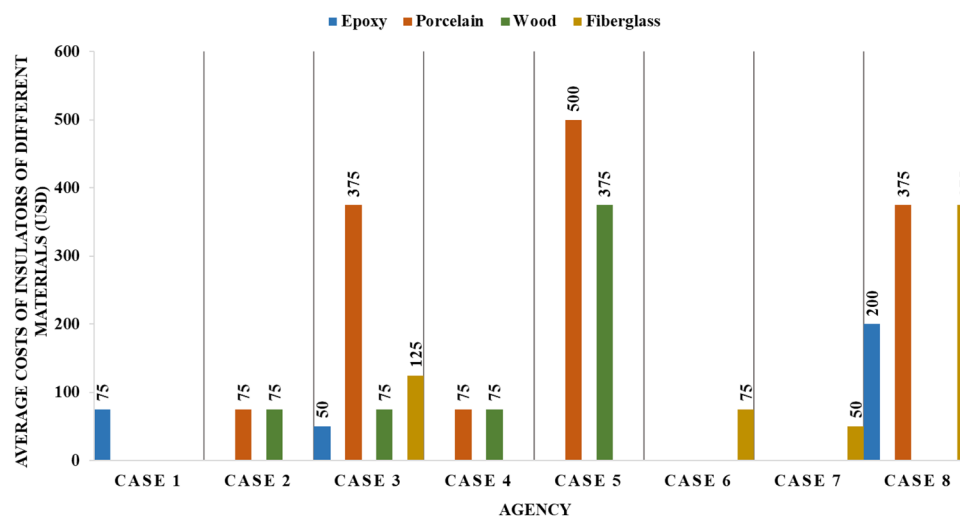
**Fig. 6** Average costs of insulators made of different materials

The cost of insulators varies with the type of material and according to the regular inspection intervals in each agency. The insulator materials for which the SMEs provided the corresponding costs included epoxy, porcelain, wood, and fiberglass, as shown in Fig. 6. Porcelain insulators are, on average, the most expensive insulators with an average declared cost of \$256 and maximum cost of \$500. Epoxy insulators, at \$108, seem to be the least

expensive; however, that may be somewhat misleading because their use often results in leakage currents and flashovers. The SMEs indicated that an average of \$15,000–\$20,000 is imposed annually on the case study transit agencies due to leakage currents. It must be added that the costs include the average cost of an insulator and the cost of regular inspection of the entire transit system due to the failure of the insulators.

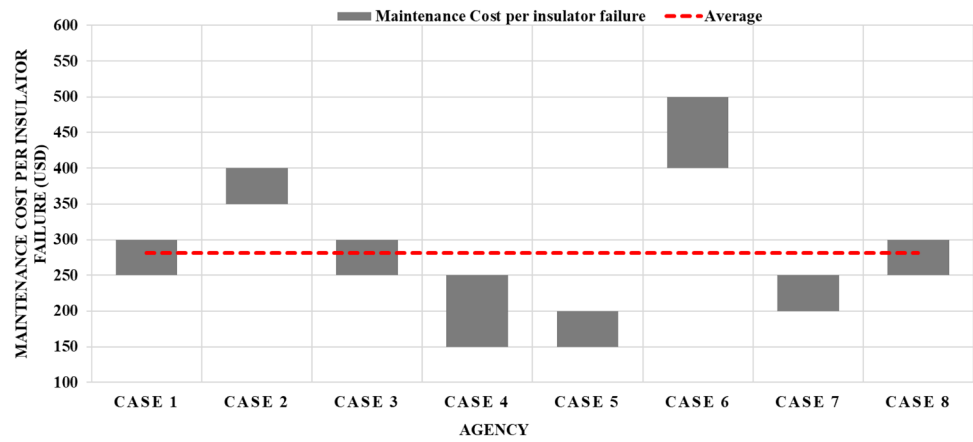
**Fig. 7** Range of operational costs per insulator per case study

In addition to the cost of replacing a failed insulator, the transit company also realizes an increase in its operating costs, which vary for different third-rail systems. The SMEs determined the range of costs attributed to operational activities that are depicted in Fig. 7. As is shown, the highest operational cost (\$400–\$500) belongs to case 6, and the lowest belongs to case 5 (\$400–\$500). The average operational cost per insulator (excluding the cost of the insulator itself) among all of the case studies was estimated

as \$281.25, as shown in Fig. 7. According to the experts, the average cost of replacing an insulator of any type and material is much less than \$281.25; therefore, it can be concluded that it is more economical to replace the insulators that are likely to fail before failure occurs. The development of a failure prediction model and/or conducting regular inspections and maintenance practices can help transit agencies reduce their operating costs that have been impacted by insulator failures.

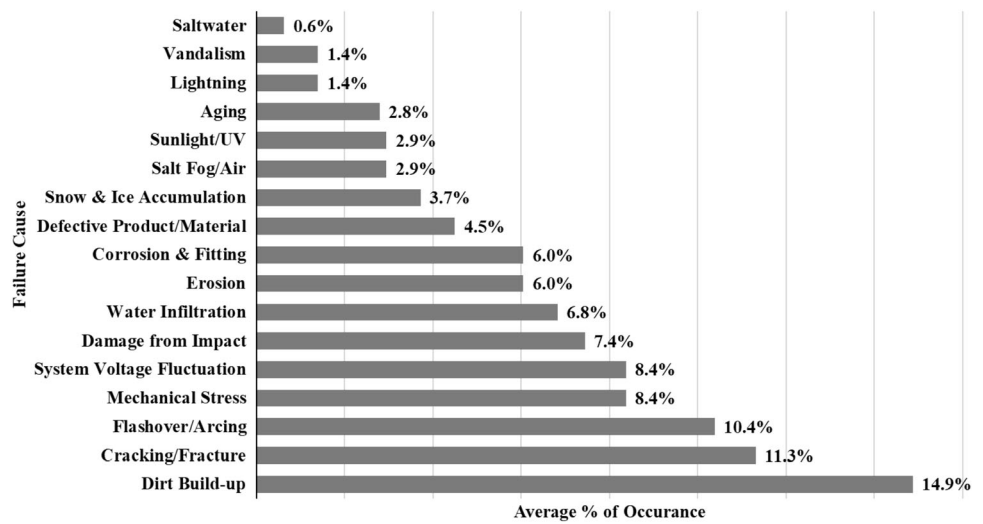
**Fig. 8** Average frequency of insulator failure causes in the transit agencies studied

As shown in Table 1 in the literature section, the existing literature identifies 17 causes of insulator failure. Figure 8 shows that dirt build-up, cracks/fractures, and flashovers/ arcing are the top three most frequent causes of failure, with rates of 14.9%, 11.3%, and 10.4%, respectively. The least frequent causes are saltwater penetration, vandalism, and lightning, with rates of occurrence of 0.6%, 1.4%, and 1.4%, respectively.

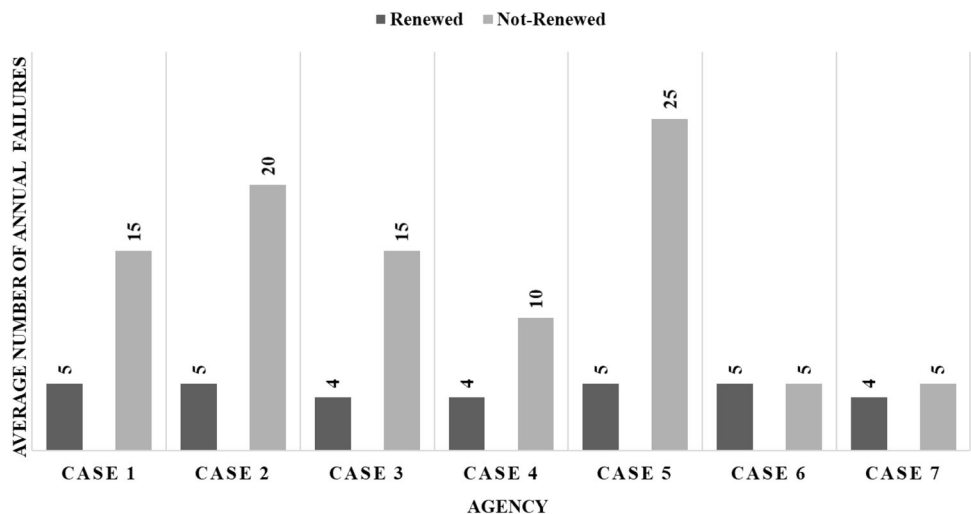
**Fig. 9** Comparison of average number of annual failures of newer/replaced track systems with not-renewed track systems

One of the strategies that can be employed to reduce the number of failures in a transit system is to improve the system by replacing the aged track sections with new segments. The rate of failure of newer/replaced track systems was investigated, and the average annual number of failures of renewed segments in every agency was compared with the average annual number of failures of track segments that had not been replaced. Figure 9 shows that the rate of failure in renewed segments decreased, but in case 7, the same number of failures was observed for the renewed and not-renewed segments. In case 6, where the largest failure rate reduction occurred, a 400% reduction in the number of failures was observed. Therefore, it can be concluded that regular replacement of aged track systems helps transit agencies significantly reduce their rates of failures.

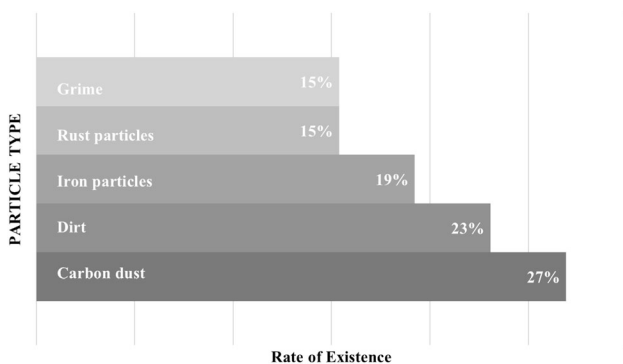
**Fig. 10** Rate of particle types leading to insulator failures

Dirt build-up was the most frequently cited cause of insulator failure in the case studies; therefore, identifying the particles that lead to failure can help transit managers prevent the build-up by implementing appropriate strategies. As shown in Fig. 10, five particle types leading to insulator failures were identified, with carbon dust (27%) and dirt (23%) found the most often in third-rail systems. Grime and rust particles were the least observed particles, averaging 15% each.

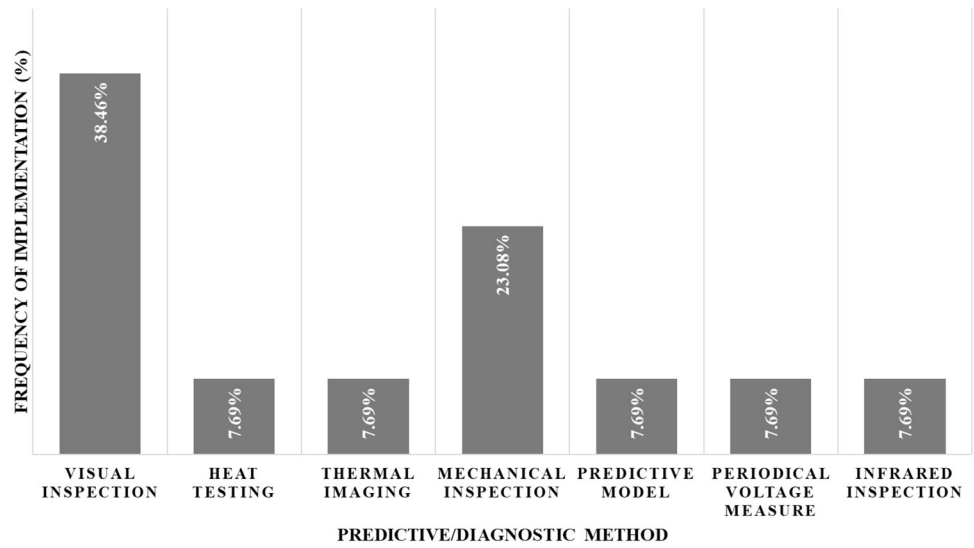
**Fig. 11** Frequency of implementation of predictive/diagnostic methods

Failure predictive/diagnostic methods for insulators were studied for each of the represented transit systems. Seven methods were used by all of the case-study agencies, among which visual inspection was the most frequently adopted (38.4%). As shown in Fig. 11, the second most frequently adopted method was mechanical inspection, with an implementation rate of 23.08%, while the rest of the methods were implemented at the rate of 7.69% each. The main reason that the visual inspection is the most frequently used method is that it is the least costly and the easiest to implement. It is not able to help with the diagnosis of every type of flaw in insulators, however, so

several technologies and tests, such as thermal imaging and heat testing, can be implemented to achieve more reliable results (see Fig. 11). It is highly recommended that new methods be implemented by the transit agency decision-makers.

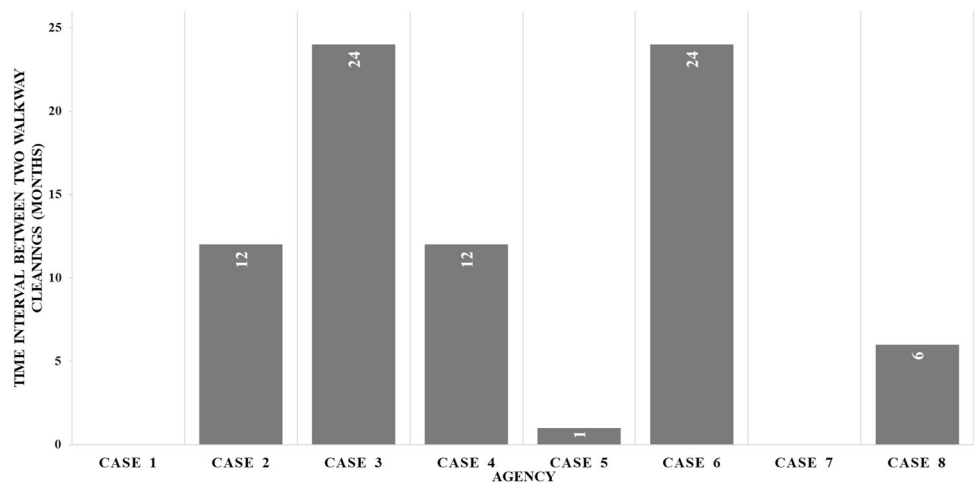
**Fig. 12** Time interval between two cleaning practices

Cleaning the tunnel walkways and insulators is a preventive practice that prevents dirt from building up on insulators and possibly causing failures. The SMEs were asked to how often the tunnel walkways and insulators of the third rails were cleaned at their transit agencies, and while all except case 1 and case 7 responded that they clean them, the frequency varied from once every month (case 5) to once every 24 months (cases 3 and 6). The average time interval between the cleanings was 13 months (see Fig. 12).

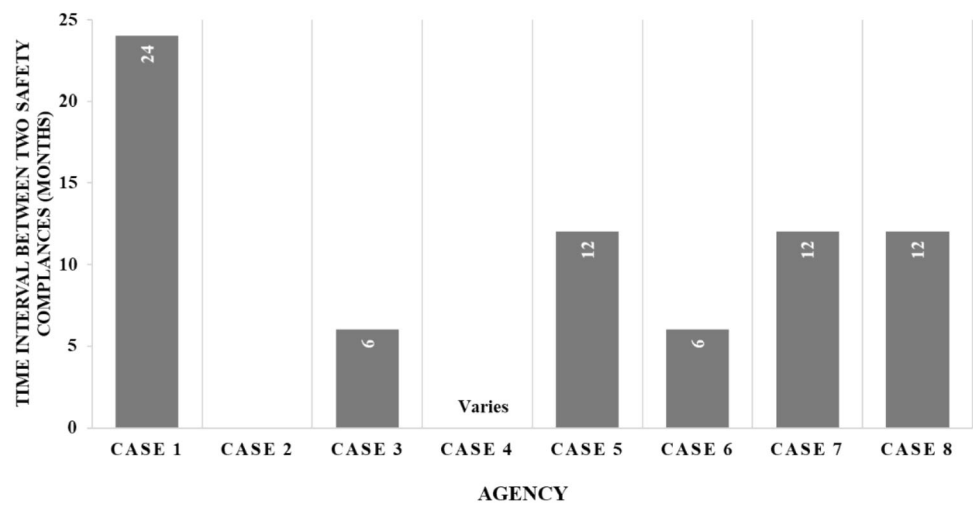
**Fig. 13** Time intervals between two safety compliance inspections

The SMEs were also asked to specify how frequently they conduct safety compliance inspections. Case 2 reported that they never conduct safety compliance inspections, and the SMEs of case 3 and case 6 reported that they perform safety compliance inspections every 6 months, which is the shortest interval reported. Case 1 indicated that it takes them 24 months to conduct a safety compliance inspection which is the longest interval reported. The remaining transit systems reported that they perform the safety compliance inspection every year; however, case 4 does not conduct the compliance on a regular basis. Figure 13 shows the time intervals between safety compliance inspections for the studied transit agencies.
