# Development of Strategies to Prevent Third Rail Insulator Failures in Transit Systems

**Abstract** Failures of third rail insulators, which often impose problems that affect the serviceability of transit systems, rarely have been investigated. This study examines various aspects of third rail systems, identifies causes of insulator failures, and develops and categorizes preventive strategies. To accomplish the goals, the existing literature was reviewed and analyzed to identify various characteristics of third rails and insulators. Then, five transit case studies were analyzed to determine the characteristics of third rails, identify the causes of insulator failures, and evaluate the preventive strategies adopted by transit agencies. The results revealed that local environmental conditions cause degradation of insulators, with dirt build-up being the biggest contributor to failure. Performing maintenance and inspections of insulators at predetermined intervals was also shown to be very effective for preventing failure. The preventive strategies were classified into three categories: regular inspections; preventive maintenance programs; and regulation and safety, with regular ins

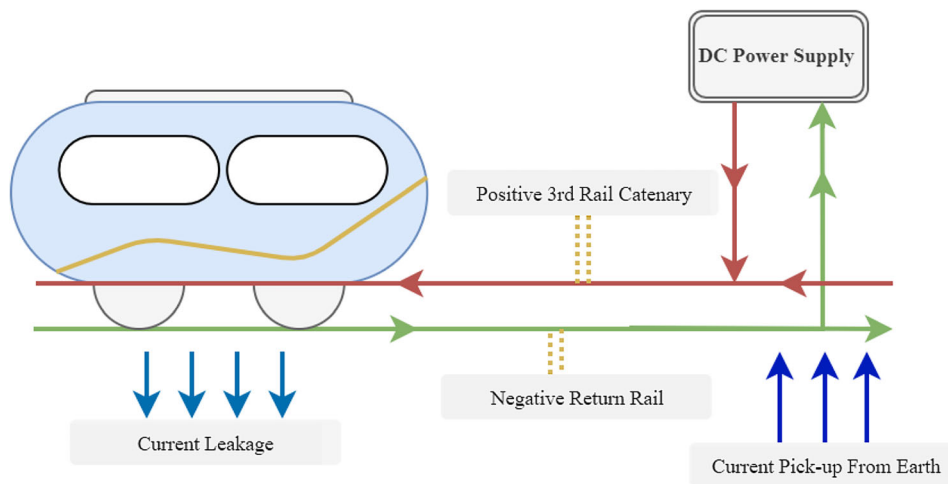
**Fig. 2** Schematic sections of a third rail

collected by a shoe that is mounted on a beam and located on its side. In Fig. 2, a third rail system is demonstrated schematically.

Third rails can be of several different shapes and can be placed either outside the rails or between them to transmit current to the moving train. The current is transmitted to the train by a sliding connection that is composed of springs and pistons, and a shoe gear. The material used for the shoe gear varies according to the material of the third rail [12].

To minimize resistance in the electric circuit, the running rails are usually connected by wire bonds or other tools. The contact position between the train and the rail varies. A top contact was used in the earliest transit systems, but a side or bottom contact was used in transit systems that were developed later [13]. Both the side contact and bottom contact cover the conductor rail, protect track workers, and protect the conductor rail from dirt, snow, ice, etc. Contact shoes can be positioned anywhere around the third rail, depending on the third rail type [13].

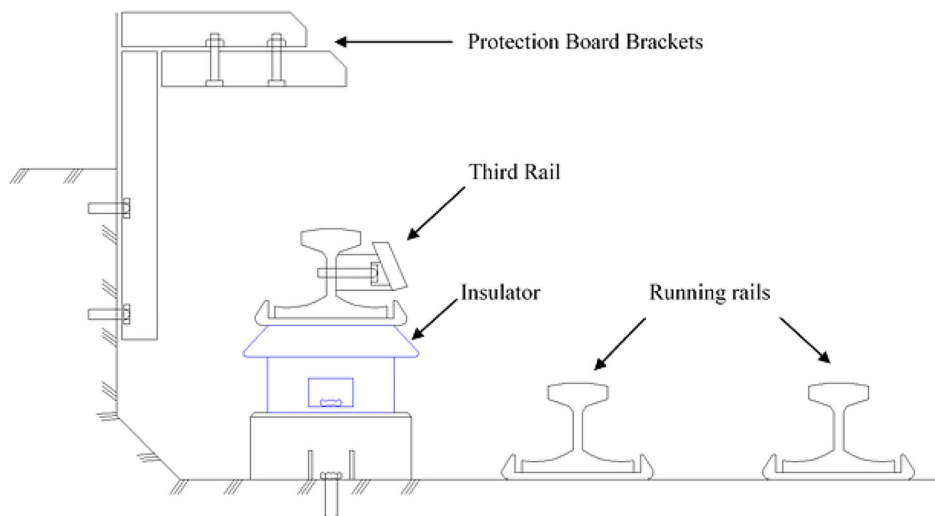
**Fig. 3** Third rail position in the railway system and other relative equipment

Third rails consist of running rails, insulators, protection boards, protection board brackets, and shoe contacts. Fig. 3 shows the placement of these sections.

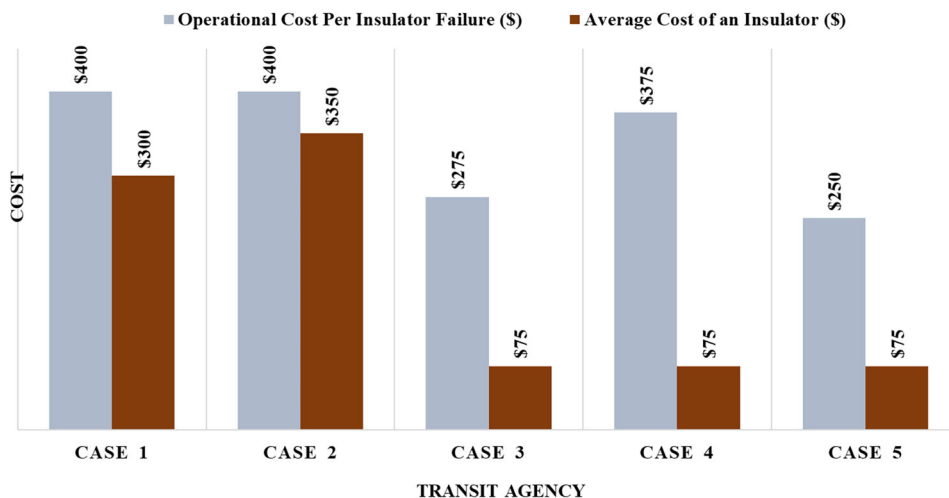
**Fig. 4** Comparison of rate of operational cost of each insulator failure and average insulator renewal cost in the five case studies

Dirt build-up, erosion, and cracks/fractures were the most frequent contributors to insulator failures in all of the case studies. Many of the causes were weather-related, and appropriate strategies can resolve these issues and reduce the number of failures, delays, and additional costs. It is important for the agency to decide whether insulators are to be renewed or replaced before failure. Figure 4 shows a comparison of how the agencies in the case studies make that decision, based on the rate of operational cost of each insulator failure and the average renewal cost. As is shown, the operational cost per insulator failure is higher than average cost of the insulator itself for all of the third rail systems, but the differences vary.

In cases 1 and 2, the cost differences were 12.5% and 25%, respectively, and in cases 3, 4, and 5, the differences were 72%, 80%, and 70%, respectively. The variations occurred because of the different types of insulators used in each transit system, as well as differences in the economy, geographic location, etc. Overall, it can be concluded that renewal of the insulators before failure is the most cost-effective choice than paying for operational costs after insulator failure.
