Effect of Curing Cycle on Fatigue Life of Cracked AA7075-T6 Aircraft Sheet Repaired with a Boron/Epoxy Composite Patch

Malika Khodja^{1,2} · Hamida Fekirini¹ · Gonasagren Govender² · Belabbes Bachir Bouiadjra¹

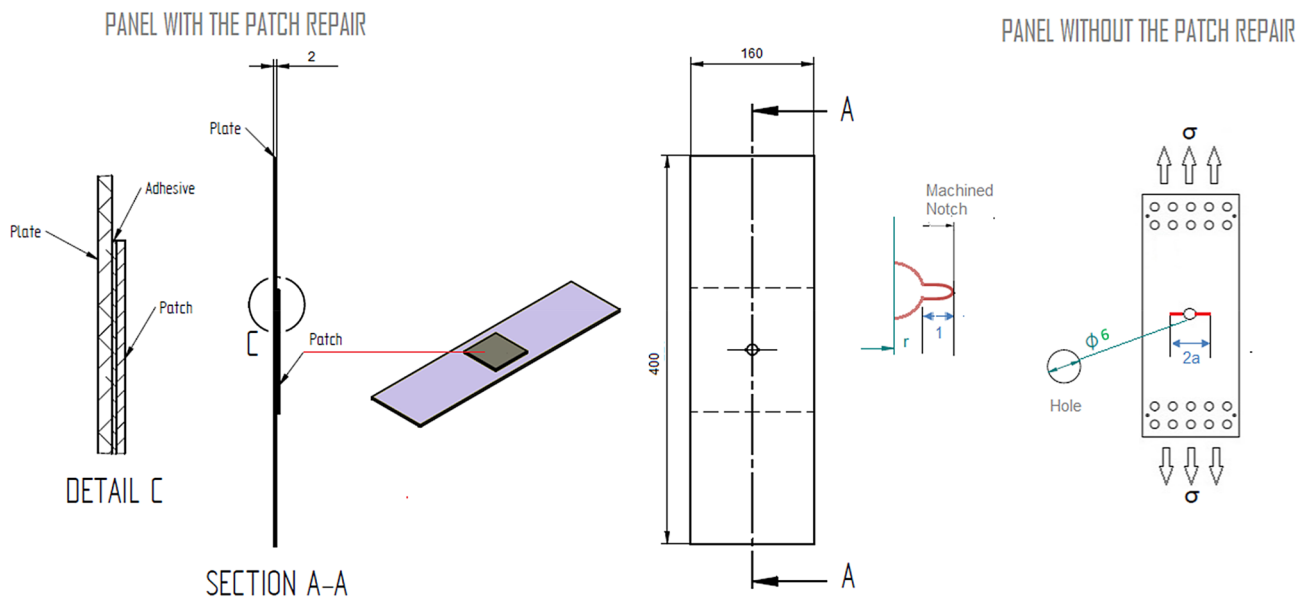
Fig. 1 Geometry of the plate and composite repair patch

Three panels were made for each cure condition. The layers per panel were: an aluminium AA7075-T6 plate, an adhesive layer and a structural composite layer. The dimension of the AA7075-T6 aluminium plate was 400 mm × 160 mm × 2 mm and contained a 6 mm size rivet hole with a wire-cut notch of 1 mm length perpendicular to the length of the plate emanating from the hole's edge. Figure 1 illustrates the geometry of the plate and composite repair patch. Cytec/Solvay FM73 (Cytec Engineered Materials 2011) knitted epoxy film of 0.25 mm thick was used as an adhesive between the aluminium and the boron/epoxy patch. The structural composite layer was composed of six plies, 5.2-mil thick, of type B4/5521 unidirectional 4-mil Boron/epoxy prepreg tape from Specialty Materials, Inc. (Boron 5521 Prepreg Tape

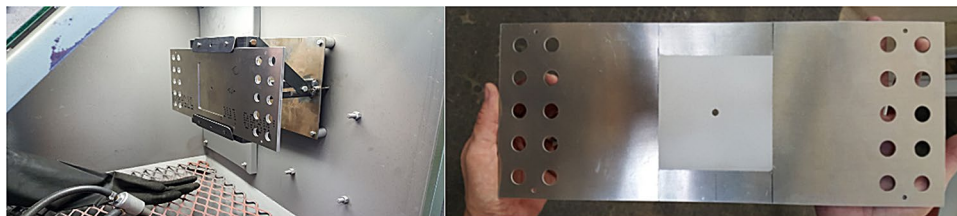
Fig. 2 Surface preparation by grit blasting

An important factor influencing the strength of the bonded joint is the surface preparation of the metal. Many studies have been done on the influence of surface treatment on the mechanical behaviour of bonded assemblies (Kinloch 1987; Adams and Wake 1984; Emami Mehr et al. 2019). To prepare the bonded area, the metal surface was subjected to mechanical abrasion (grit blasting) with uniform alumina grit. The process employed 210 μm alumina grit at a pressure of 300 kPa and a working distance of 10–15 cm to obtain the required surface roughness without inducing compressive stresses. The surface was then cleaned with trichloroethylene to remove impurities. Figure 2 shows the bare prepared aluminium panel.

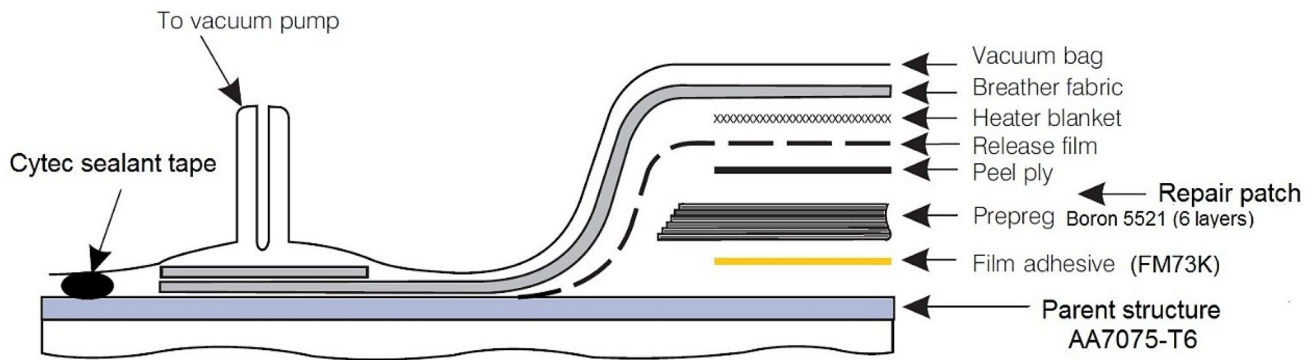
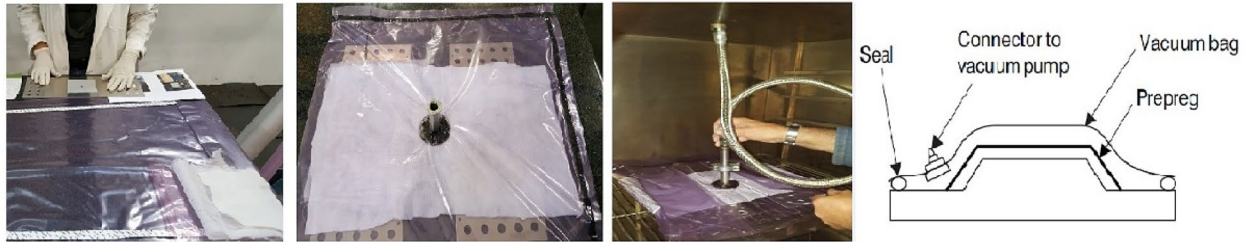
Fig. 3 Detail of vacuum bag lay-up

The lay-up is shown schematically in Fig. 3 and it shows the sequence that was employed. The AA7075-T6 aluminium was the base plate; it was bonded with the FM73 adhesive to six layers, Type B4/5521 unidirectional prepreg tape. In the case when the crack position is perpendicular to the loading, the best stacking layup is with the fibres in the unidirectional

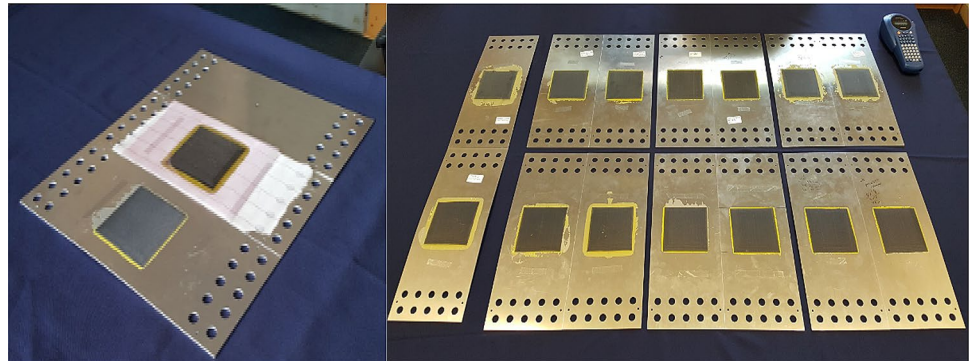
Fig. 4 The steps to the final patched test panel

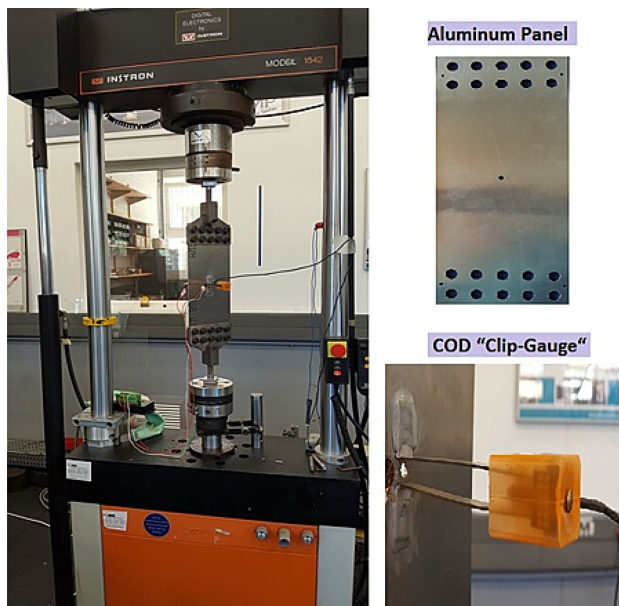
Fig. 5 AA7075-T6 Aluminium Panel fitted with COD “Clip-Gauge”

Fatigue crack growth tests of repaired and unrepaired structures were performed on an Instron 1342-H1314 servo-hydraulic system with a dynamic capacity of 25 kN following the ASTM E647 standard (ASTM International 2013). Samples dimensions were chosen to closely match dimensions where the width of the panels is wider to comply with the spacing in stiffened structures of aeroplane skin. The test panel setup is illustrated in Fig. 5. All fatigue tests were conducted at cyclic constant-load amplitude, frequency of 10 Hz and stress ratio of 0.1. Crack length data and number of cycles were logged on a computer. Panels were fatigued until crack lengths approached the edge of the patch.

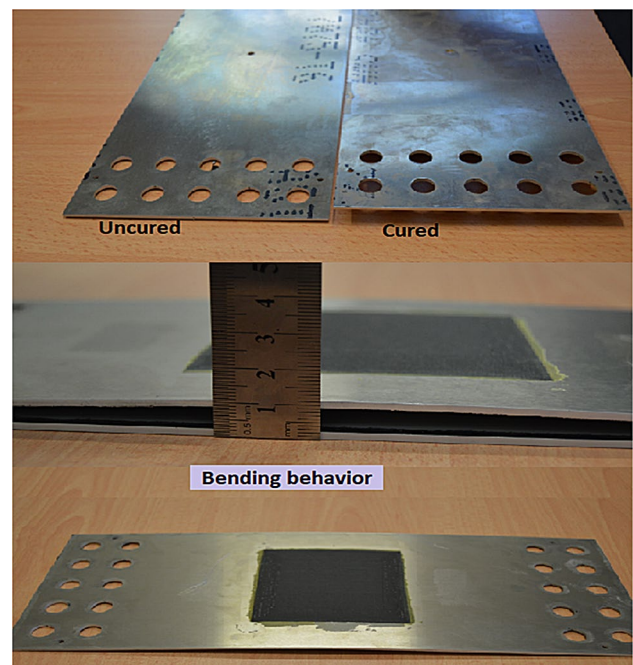
Fig. 6 Curvature of panels results in bending due to the curing process

All plates showed distortion after curing. Distortion culminated in warping along the length of the plate. Figure 6 shows an example of a warped plate and it can be seen that the warp curvature is towards the aluminium’s side.

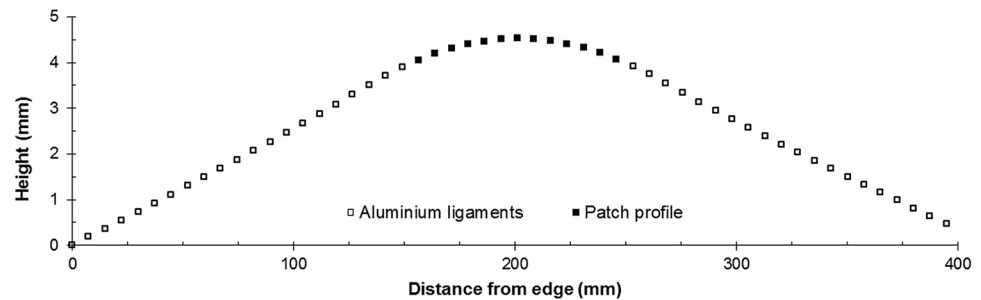
Fig. 7 Bending profile from the data for curing condition A

An inverted plot of the profile from the data for curing condition A, as an example, is shown in Fig. 7. It can be seen from Fig. 7 that the profile is symmetrically around the apex, which is the centre of the patch by way of the lay-up geometry. The distortion is significant but it should be noted that the distortion between the apex and any baseline is exaggerated due to the aspect ratio scaling between the physical plate and the graph. The aluminium ligaments up to both sides of the patch baseline are straight as expected, because they were unconstrained during cooling and their contraction must be linear. The two linear-fit trend lines reinforce this fact. The distortion of the plate is given as the distance from the ligament baseline to the apex. Table 2 represents the measured distortion of bonded repaired samples in different curing conditions.

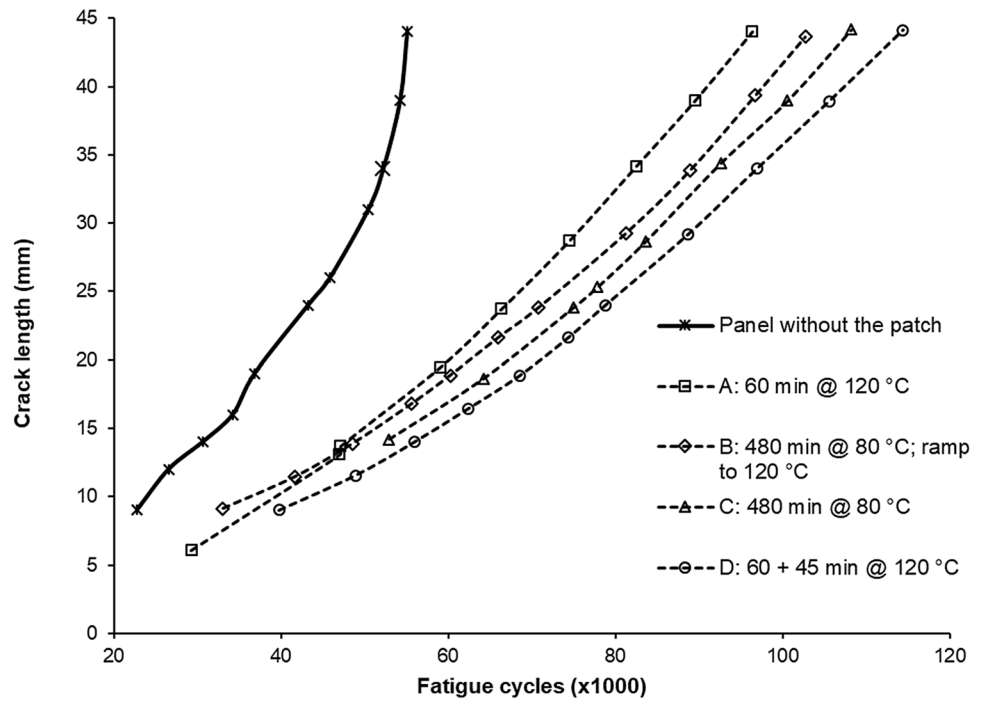
Fig. 8 Effect of curing condition on crack propagation in the repaired panels

The panel is symmetrical along its length with respect to the hole and notch. The crack length starts at 4 mm, which is the 3 mm radius of the hole plus 1 mm for the machined notch. The crack length measurement is calibrated at the start of each test and measurement data were automatically logged. The fatigue propagation curves terminate at 44 mm which was chosen and defines fatigue life, in the case of the repaired panels to prevent the crack from growing past the edge of the half-patch at 50 mm. The fatigue crack growth curves for unrepaired and repaired panels are presented in Fig. 8.

Results from fatigue tests to determine the effect of different cure parameters on the repair efficiency and fatigue life of the structure showed that the fatigue life of the unrepaired structure according is decreased compared to the repaired structure. The general trend in Fig. 8 is uneventful with a gradual stabilisation of the crack growth rate. The final order of fatigue life cycles for cure condition is $A < B < C < D$.

The use of a composite patch offers advantages for repaired cracks to increase the service life as shown in Fig. 8.

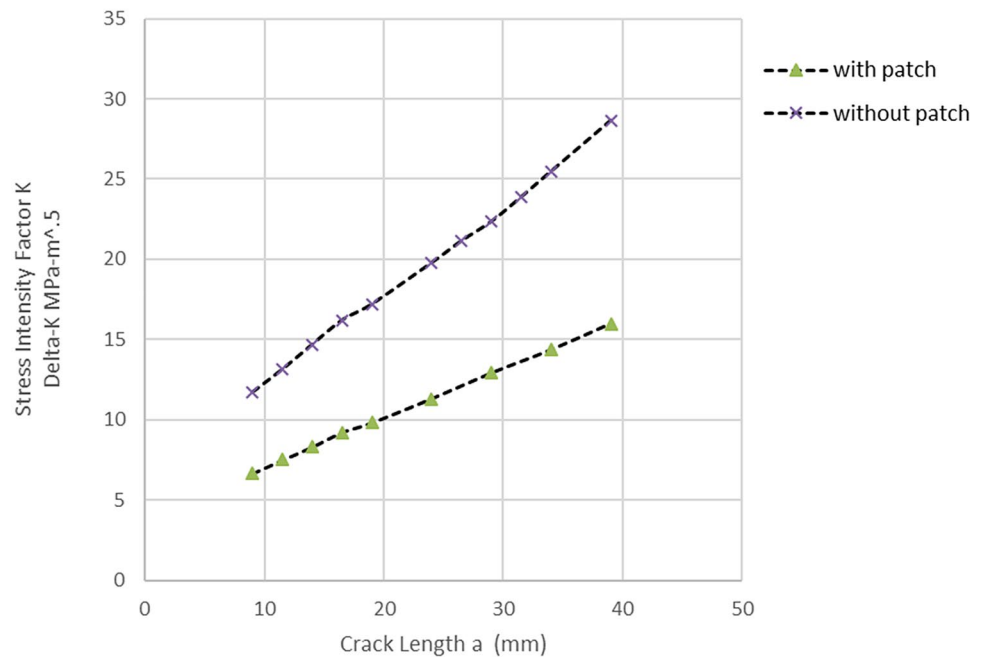
Reduction in Stress Intensity Factor with Repair

Fig. 9 Reduction in stress intensity factor with repair (Curing condition A)

The increase in the fatigue life performance from unrepaired to repaired is due to the decrease in stress intensity factor due to the boron/epoxy patch bridging the crack. This is confirmed in Fig. 9 representing the reduction in

stress intensity factor (SIF) between panels with and without patch. Figure 9 shows that the stress intensity factor increases as the crack length increases both in panels with and without patch, this due to higher stress concentration at the crack tip. The stress intensity factor was determined experimentally during the fatigue test from the data by

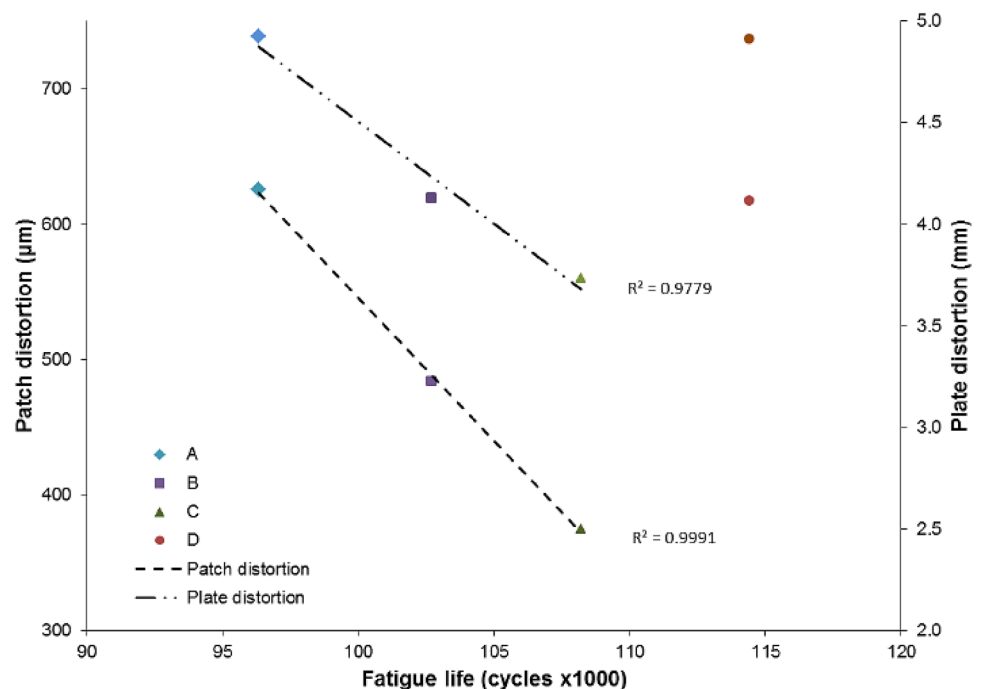
Fig. 10 The relationships between fatigue life and plate distortion

Figure 10 shows the relationship between plate and patch distortion and fatigue life. It is expected that increasing distortion would reduce fatigue life, presumably due to induced bending stresses that could contribute to the crack growth. It can be seen that fatigue life decreases as the plate distortion increases, that is, for cure conditions A, B, and C. The exception is cure condition D, which has the largest plate distortions, but the longest fatigue life.

The fatigue life follows a straight-line relationship with the plate distortion (for cure conditions A, B and C), and the curve fitting coefficient has an $R^2 = 0.9779$, which indicates a strong correlation. The fatigue life in the case of the patch distortion also follows a linear relationship with an $R^2 = 0.9991$, which indicates even a stronger relationship. Cure condition D does not follow the straight-line relationship in Fig. 10, and the possible reason for its unique behaviour is the use of the elevated curing temperatures for

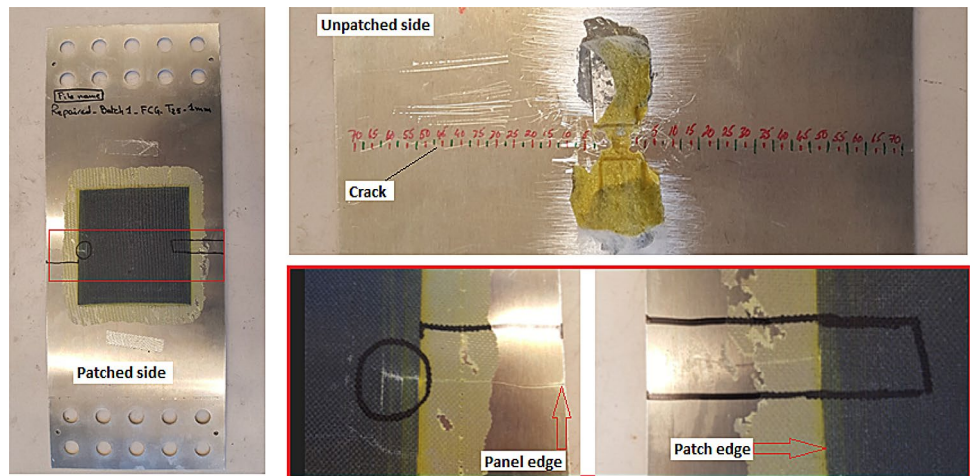
Fig. 11 Crack growth behaviour in the repaired plate

During the fatigue test of the patched plates, the crack growth exceeds the patch edge. The crack continues growing towards the end of the aluminium plate as shown in Fig. 11; in other words, the crack had propagated across the entire width of the specimen without any sign of detachment of the patches from the plate after long time cycling. While kept under continuous cycling loading

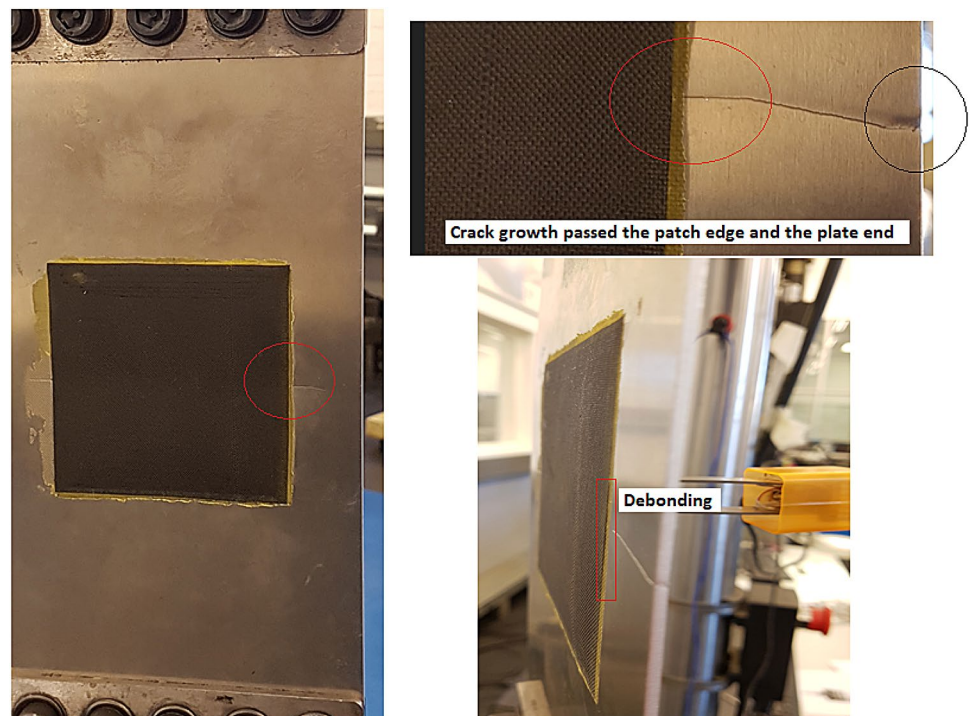
Fig. 12 Effect of patch strength after plate failure

after the crack passed the edge of the plate, a debonding line between the patch and plate was observed as seen in Fig. 12. The fatigue test was first completed by growing the crack inside the patch zone, and then the panels were subsequently pulled apart. Specimens, namely unpatched and patched with boron composite patch in cure condition (A, B, C and D) were loaded to failure in tension in order to observe the failure mechanism of the damaged repair. For the purpose of comparison, it was done at the same crack length growth (70 mm) in order to analyse the effect of the strength of the assembly on the repair efficiency. Results observed explains that the strength of the assembly is highly increased with the composite patch

The observed debonding in Fig. 12 creates unbound interfaces. Such a defect can give rise to preferential sites at the initiation of rupture or detachment. Similarly, when the stress supports are not on the same plane a bending moment appears, thus creating in the joint area and the supports stress normal to the bonding, which is superimposed on the shear stresses. If the rigidity of the supports is low, the latter will flex under the action of bending moment, which increases the normal stresses at the ends of the bond line and risks endangering the bonded area by initiating the separation. Stresses in the adhesive bond layer are increased due to the mismatch between the patch and plate that can lead to possible peel and cleavage stresses. Tension on the repair system creates shear stress in the bond line. The composite fibre breakage in a sliding failure along a plane that is parallel to the loading direction can be seen in Fig. 13.

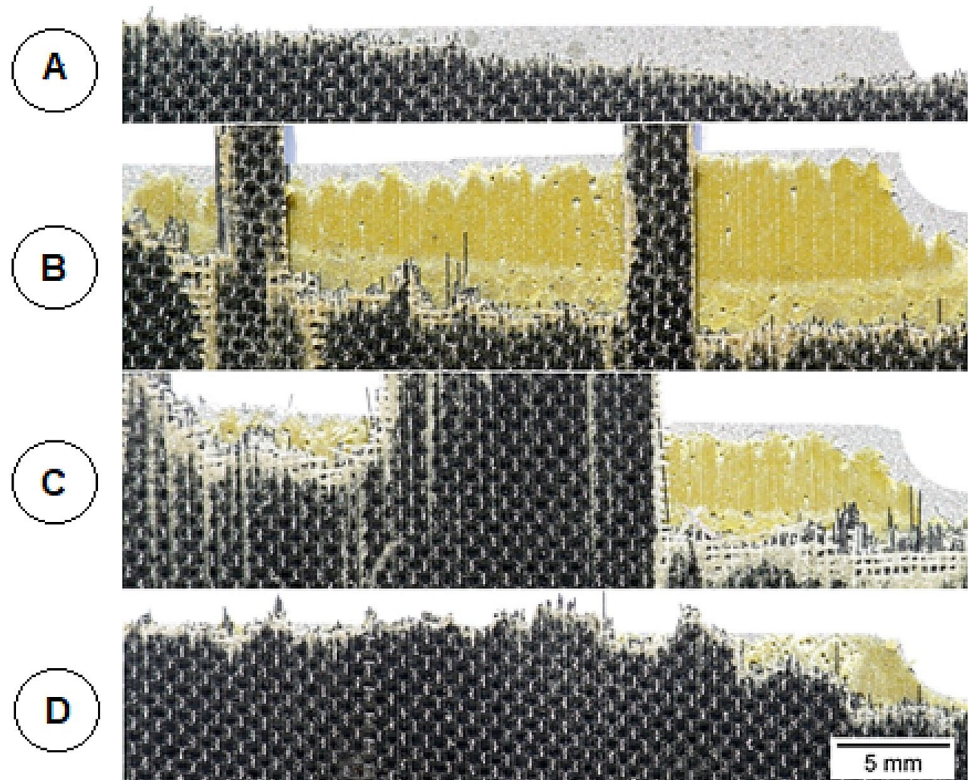
Fig. 13 Fractured samples in shear mode after tension test

Figure 13 shows the fractured panels after the tension test. At first, it can be seen that debonding between the aluminium base plate and the adhesive happened in cases for cure condition A, B, and C. The same type of debonding was not evident for cure condition D. Furthermore, it can be seen from the area around the fatigue crack that the yellow adhesive is visible underneath the boron/epoxy layer, meaning that there also was debonding at the adhesive-boron/epoxy interface. The increased fatigue life of cure condition D is
