Effects of service environment and pre-deformation on the fatigue behaviour of 2524 aluminium alloy

Abstract

Keywords 2524 alloy · Service environment · Pre-deformation · Fatigue crack propagation

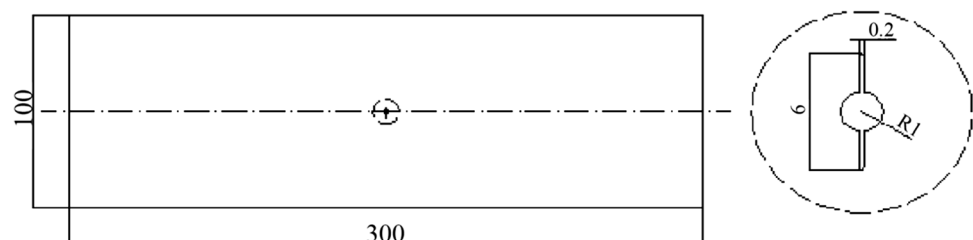
Fig. 1 The fatigue crack propagation test specimen (all dimensions, mm)

The raw material used in this study was a 2.2 mm cold-rolled 2524 alloy plate, with the nominal chemical composition of Al–4.21 Cu–1.41 Mg–0.58 Mn–0.08 Fe–0.06 Si (wt%). The plate was cut into 400 mm × 120 mm pieces which were subjected to solution treatment at 500 °C for 30 min followed by quenching. Immediately, different degrees (0% (T4 temper), 2%, and 5%) of stretching could be applied to these plates using an MTS-Landmark hydraulic servo-controlled test machine. The plate then underwent natural ageing at room temperature for at least 96 h. Then, standard middle-tension M (T) specimens measuring 2.2 mm × 100 mm × 300 mm were produced from the centre of the plate in the L–T orientation (Fig. 1).

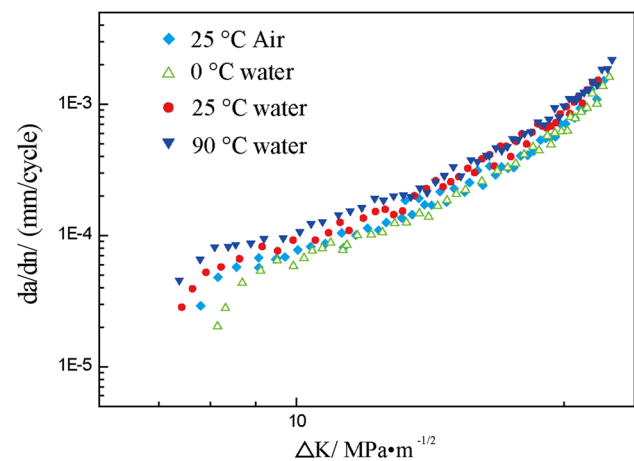
Fig. 3 The da/dn curves of 2524-T4 alloy in air and different water environments

Figure 3 demonstrates the da/dn curves of 2524-T4 alloy (unpredeformed) in air and water environments at different temperatures. It can be seen that, at the same ΔK , the FCGR of the alloy decreases monotonically with temperature in water. This indicates that a low temperature can delay crack propagation. In the four environments, at the same ΔK , the FCGR of alloy is the largest at 90 °C in water and it is the lowest at 0 °C in water. Besides, at the same temperature of 25 °C, the FCGR of this alloy is higher in water than in air, which suggests that a water environment aids crack

propagation, while, when the temperature is only reduced by 25 °C, the FCGR of alloy in water at 0 °C is lower than that in air. A previous study by Burns et al. [25] found that, when the temperature was changed from 23 to -50 °C, the FCGR of a 7075 aluminium alloy is decreased by nearly an order of magnitude. Our study also supported the fact that the FCGR of alloy is sensitive to temperature and a low-temperature environment can delay crack propagation.

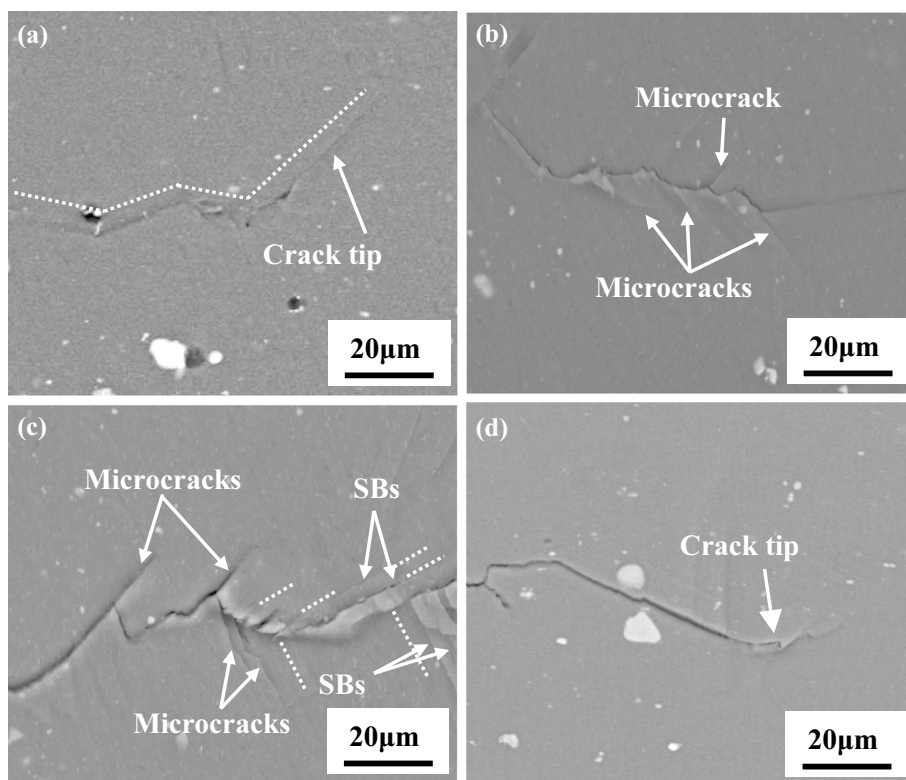
Fig. 5 SEM images of the crack tip region of 2524 alloy fatigue loaded under air and different water temperature conditions at $\Delta K \approx 15 \text{ MPa m}^{1/2}$ **a** 0 °C water; **b** 25 °C water; **c** 90 °C water; **d** 25 °C air

Figure 5 shows the SEM images of the crack tip region of the alloy loaded under air and different water temperature conditions at $\Delta K \approx 15 \text{ MPa m}^{1/2}$. As shown in Fig. 5a, the crevice at 0 °C in water is quite narrow and the crack is relatively obscure, which implies that only a small plastic deformation occurs. Different from the crack at 0 °C in water, many microcracks are distributed around the tip region of the crack at 25 °C in water (Fig. 5b) and these microcracks increase in number and extent for alloy specimens loaded at 90 °C in water (Fig. 5c). These results indicate that the embrittlement effect on the crack tip region increases with temperature. As is shown in Fig. 5d, the crack formed at 25 °C in air is also tortuous, but it is neither like that at 0 °C in water which shows apparently zigzag characteristics nor

like those at 25 °C and 90 °C in water which have many microcracks therein.

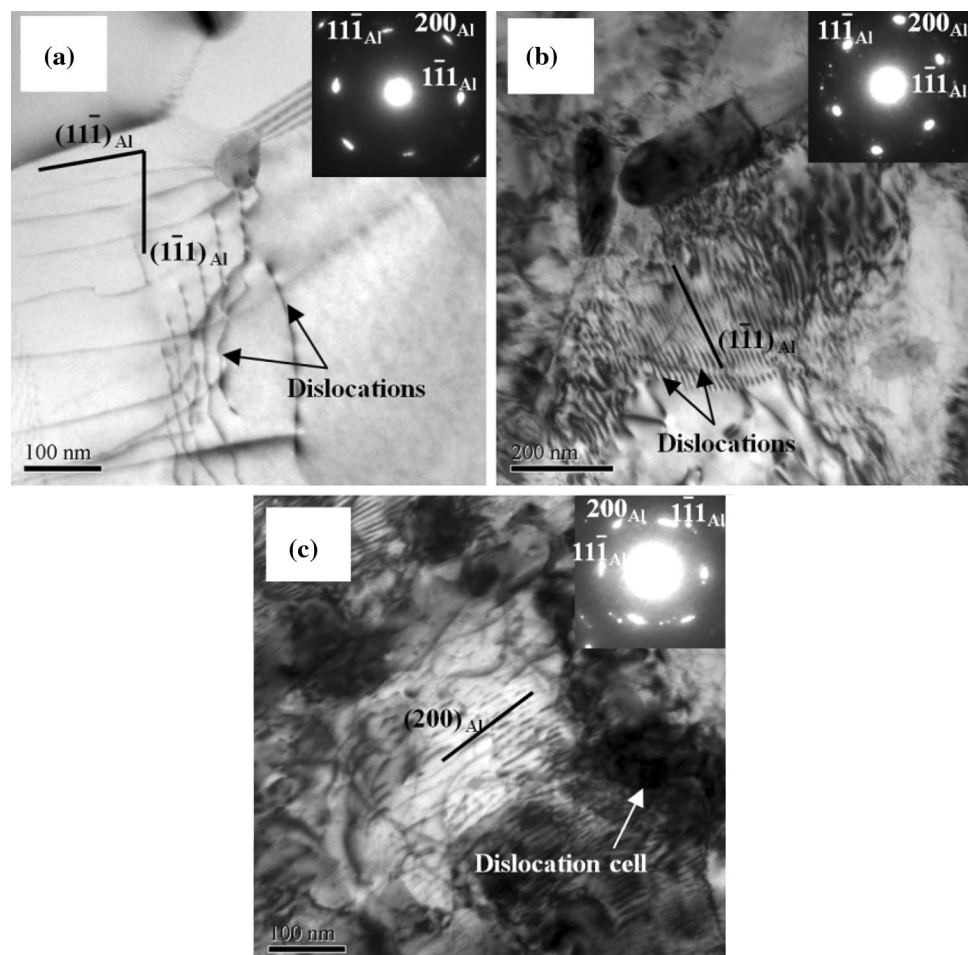
Fig. 6 TEM images of 2524-T4 alloy at the crack tip regions ($\Delta K \approx 15 \text{ MPa m}^{1/2}$) fatigue loaded at different water temperatures **a** 0 °C; **b** 25 °C; **c** 90 °C

Figure 6 shows the TEM images of the near-fracture-surface-region of alloy loaded in water at different temperatures. As shown in Fig. 6a, when loaded in water at 0 °C, the dislocation density of alloy is quite low. These dislocations are generally parallel to the $\{111\}_{Al}$ planes which sometimes inter-tangled. When loaded in water at 25 °C, the dislocation density of alloy increases significantly. As can be seen in Fig. 6b, a mass of dislocations piled up on the second-phase/matrix interface are still found to be parallel to the $\{111\}_{Al}$ planes, i.e., the main slip planes for aluminium alloys. This phenomenon indicates that, although the dislocation density increases when the temperature increases from 0 to 25 °C, the main slip systems of the alloy do not change. When loaded in water at 90 °C (Fig. 6c), the dislocation density of the alloy further increases and some dislocations are found to lie near the direction of the $\{200\}_{Al}$ planes, which indicates that more slip systems are activated at this elevated temperature.

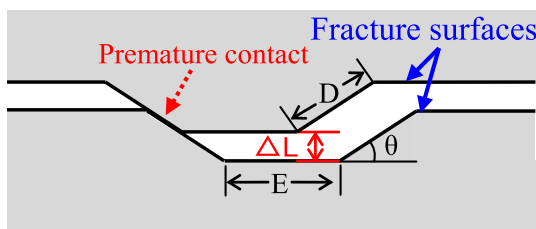
Fig. 7 Schematic representations of crack deflection

where D is the extended distance of tilted crack along the kink (as illustrated in Fig. 7), and E represents the extended

distance of the crack on the propagated plane and normal to the loading direction. θ is the kink angle, $(da/dn)_L$ is the FCGR for a straight crack.

The decreases in da/dn value, caused by the extra length during deflection, were calculated to be only 7.3–9.4% for the crack at 0 °C in water ($\theta=22^\circ\text{--}25^\circ$) and 1.2–1.5% for the crack at 25 °C in water ($\theta=9^\circ\text{--}10^\circ$) according to Eq. (3), but the practical differences between the FCGRs at different water temperatures were measured to be as large as four times those at $\Delta K=8.2 \text{ MPa m}^{1/2}$ and around 70% of those at $\Delta K=15.2 \text{ MPa m}^{1/2}$ (Table 2). This means that the delay for the crack propagated in water at low temperature should not be mainly attributed to the extra length caused by crack deflection but can be mainly attributed to the decrease in hydrogen embrittlement or roughness-induced crack closure (RICC) [28]. As is known, RICC always results in a reduced ΔK value at the crack tip which is caused by the premature contact between mating fracture surfaces in a zigzag-shaped cracks (Fig. 7).

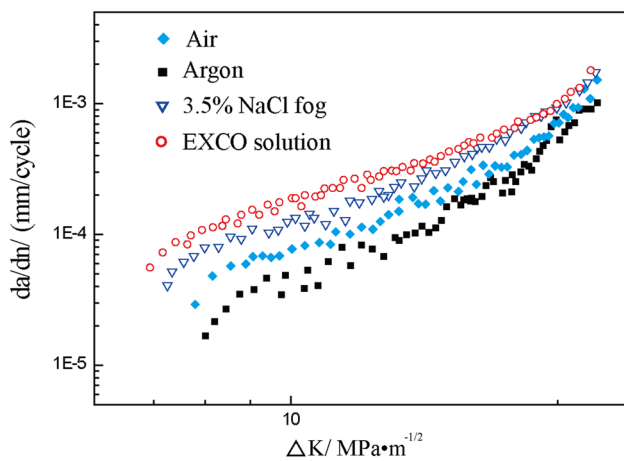
Fig. 8 The da/dn curves of 2524-T4 alloy in different environments

Figure 8 shows the da/dn curves of 2524-T4 alloy in air, argon, 3.5% NaCl fog, and EXCO solution environments, respectively. Compared with the traditional 2024 alloy [29], the 2524-T4 alloy exhibits an approximately 30% smaller FCGR in the early stage of crack propagation when loaded in air. This difference increases with ΔK and finally reaches over two times its original value at $\Delta K > 20 \text{ MPa m}^{1/2}$. As shown in Fig. 8, there are large differences between the FCGRs of 2524-T4 alloy in different environments, especially in the early stage of crack propagation (i.e., low ΔK). When $\Delta K \approx 8 \text{ MPa m}^{1/2}$, the da/dn value of alloy in EXCO solution environment is about $1.1 \times 10^{-4} \text{ mm/cycle}$, which is 46.7% greater than that in 3.5% NaCl fog, two times greater than that in air, and nearly nine times greater than that in argon. With the increase of ΔK , these differences tend

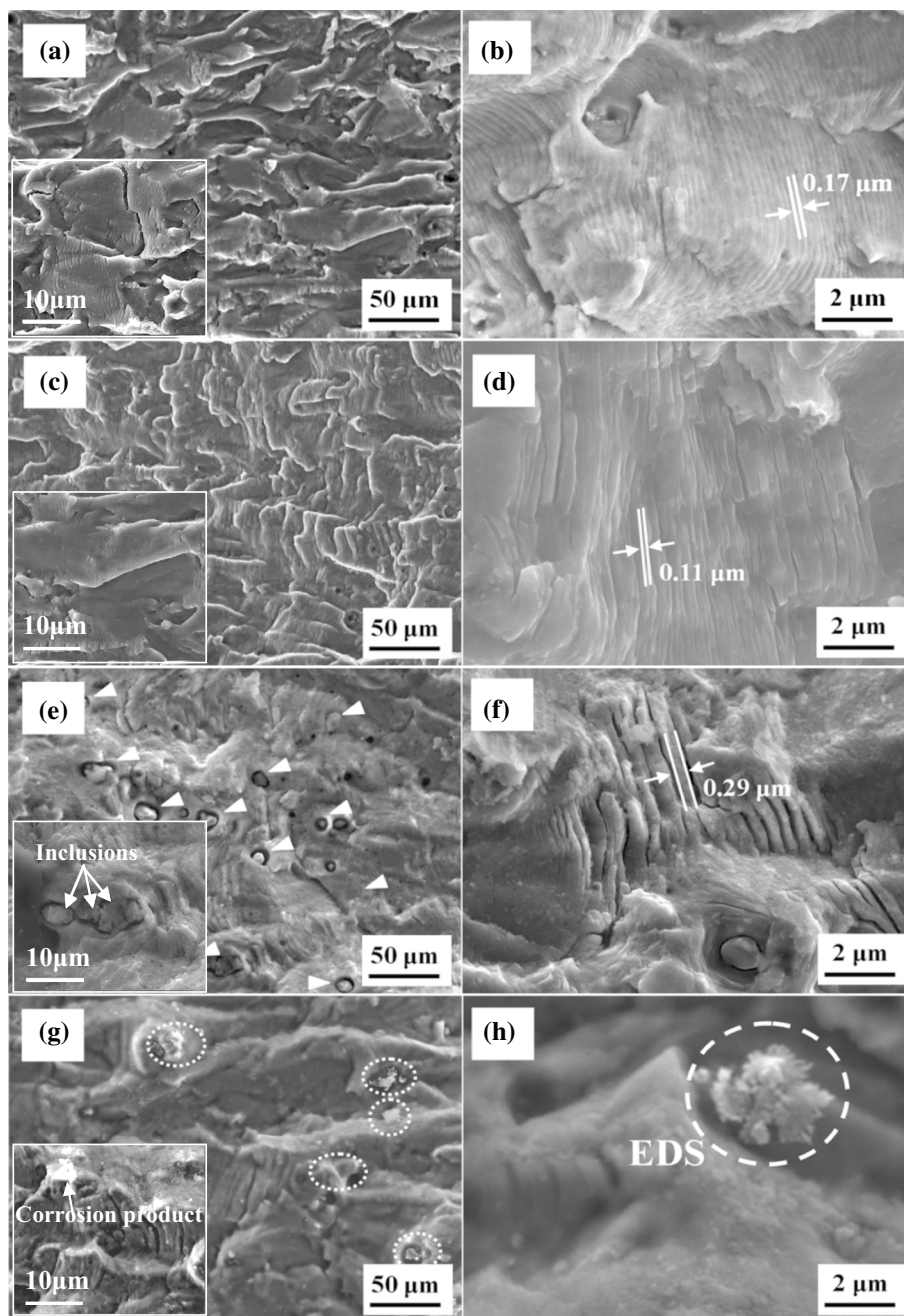
Fig. 9 SEM images of the fatigue fracture surface of 2524-T4 alloy in different environments at $\Delta K \approx 15 \text{ MPa m}^{1/2}$ **a** fracture surface in air shows a rough fractograph, **b** fatigue striation in air, **c** fracture surface in argon indicates a relatively smooth fractograph, **d** fatigue striation in argon, **e** many corrosion pits distributed on the fracture surface in 3.5% NaCl fog, **f** fatigue striation in 3.5% NaCl fog, **g** many corrosion products dispersed over the fracture surface in EXCO solution, **h** fatigue striation in EXCO solution

Figure 9 shows the fatigue fracture morphologies of 2524-T4 alloy in different environments at $\Delta K \approx 15$ MPa m^{1/2}. As shown in Fig. 9a, the fracture morphology of the alloy in air shows apparent crystallographical characteristics in which some small tearing ribs can be observed. In Fig. 9b, the fatigue striations on the alloy are clear, and their width is about 0.17 μ m. The fatigue fracture of alloy in an argon environment shown in Fig. 9c is flatter and smoother compared with that in Fig. 9a which presents a wave-like pattern. The fatigue striations have a width of about 0.11 μ m (Fig. 9d), while not being as evident as those formed in air. This might be due to the more efficient slip reversal in inert environment which impedes the formation of “sharp trenches” at the

fracture surface according to Wanhill [31]. Differing from the fracture morphologies in argon and air environments, a large number of corrosion pits are present on the fatigue fracture surface of the alloy in a 3.5% NaCl fog environment (indicated by white arrows in Fig. 9e). In the inset magnified image, spherical inclusions can be seen just inside the corrosion pits. The width of fatigue striations in Fig. 9f is about 0.29 μ m. Figure 9g shows the fatigue fracture surface of the alloy in EXCO solution. This fracture surface is covered by a thick oxidation film which appears to be obscure. The striations on this surface are indistinguishable; in addition, many quasi-crystalline corrosion products are dispersed over the fracture surface, as indicated by white dashed circles. Table 4 lists the results of EDS analysis on the corrosion product shown in Fig. 9h, which suggests the corrosion products consist of a certain amount of N, Cl, and O.

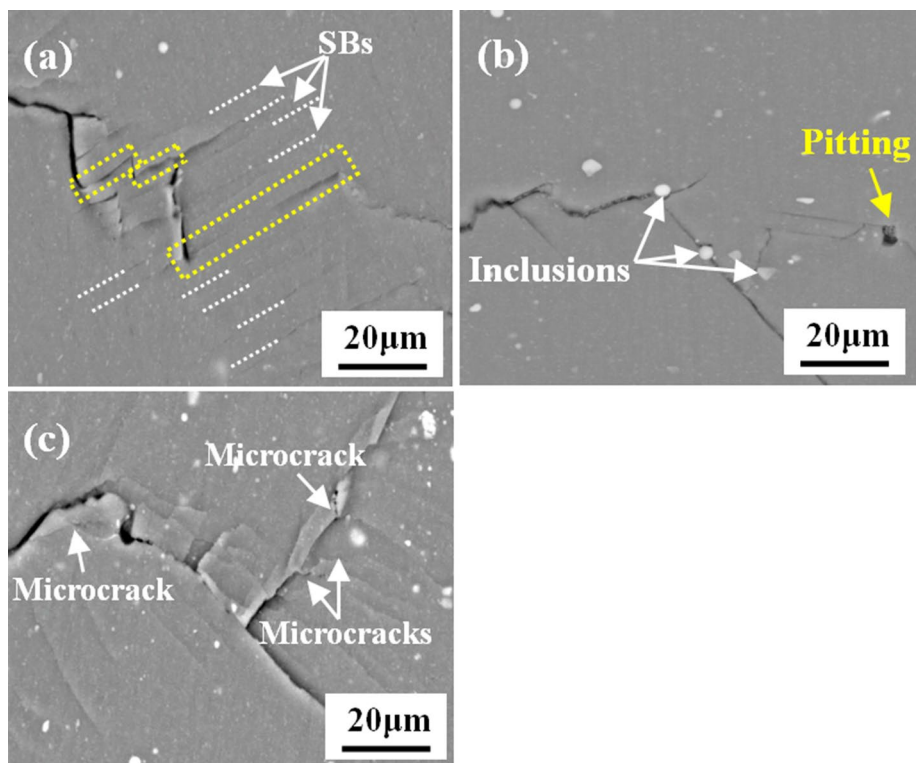
Fig. 11 SEM images of the crack tip region of 2524 alloy fatigue loaded in different environments at $\Delta K \approx 15 \text{ MPa m}^{1/2}$ **a** argon, **b** 3.5% NaCl fog, **c** EXCO solution

Figure 11 shows typical SEM images of the crack tip region of 2524 alloy loaded in argon, 3.5% NaCl fog, and EXCO solution. In argon (Fig. 11a), a mass of parallel straight, and uniformly spaced SBs are presented at the crack tip region and some sections of the main crack extend along these SBs (as indicated by dotted box). This indicates that slip plays a dominant role in determining the crack propagation behaviour of this alloy in argon. Besides, due to the strong effect of slip on crack propagation, microscopically, the crack in argon exhibits a zigzag characteristic which makes the crack path more tortuous than that in air (Fig. 5d). In 3.5% NaCl fog (Fig. 11b), the crack shows greater tendency to deflect than in air at 25 °C (Fig. 5d). In addition, many inclusions and corrosion pits can be found distributed on the deflected crack-growth route; this implies that this crack is sensitive to not only the corrosion pit but also the inclusion in front of its path. In EXCO solution (Fig. 11c), the crack displays brittle characteristics namely plentiful microcracks distributed around the crack tip region.

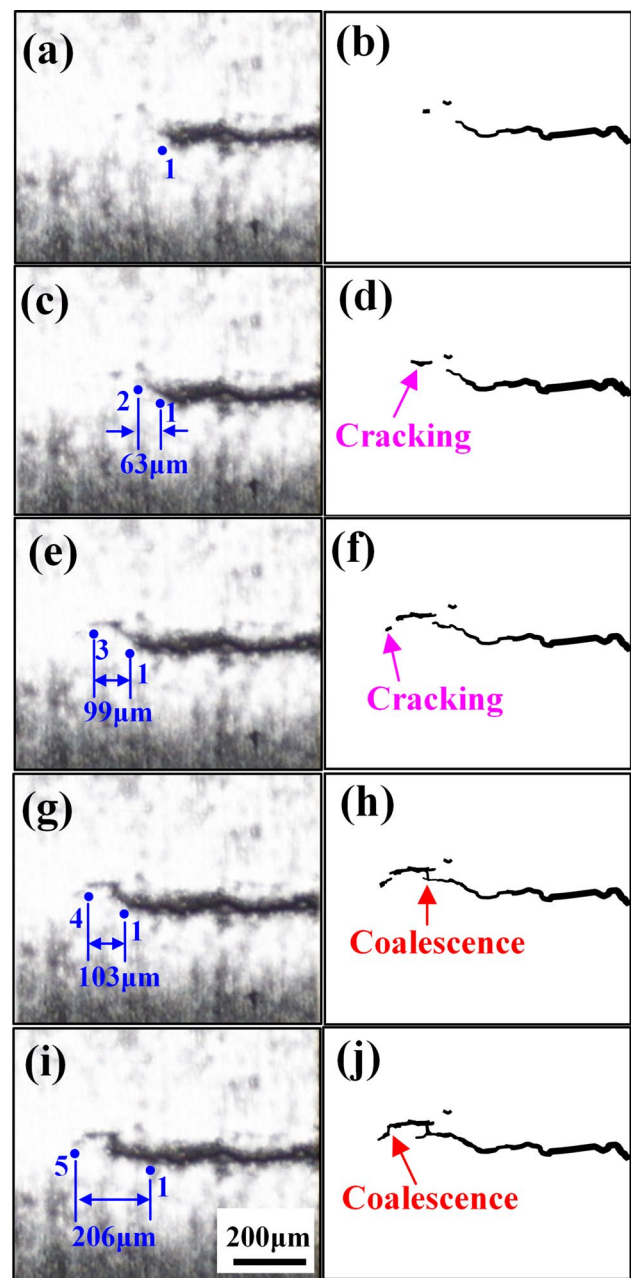
Fig. 12 In situ observation using the CCD camera on the crack ($\Delta K \approx 15 \text{ MPa m}^{1/2}$) in 3.5% NaCl fog environment: **a** no cycles, **b** schematic diagram of **a**, **c** 826 cycles, **d** schematic diagram of **c**, **e** 983 cycles, **f** schematic diagram of **e**, **g** 1263 cycles, **h** schematic diagram of **g**, **i** 1534 cycles, **j** schematic diagram of **i**

The 2524 alloy in 3.5% NaCl fog has a higher FCGR than that in air at the same ΔK . This is in agreement with results from other studies [4, 7]. To investigate the accelerating mechanism of NaCl fog on the FCGRs of aluminium alloy, an in situ observation on the propagation behaviour of the crack in 3.5% NaCl fog was carried out (Fig. 12) where both the number of loading cycles and crack length were zeroed. The image in Fig. 12a shows that two large defects (inclusions or corrosion pits) are present, ahead of the crack tip, as indicated by triangles in Fig. 12a. Under cyclic loading, the one in the front induces a microcrack forming at this defect-containing region (Fig. 12c). After 826 cycles, the main crack is propagating slowly towards this microcrack. Again, a new defect forms ahead of the crack tip and it becomes a new microcrack (Fig. 12e). Finally, through coalescence between the main crack and the microcracks, the crack truncates these defect-containing regions after 1263 cycles (Fig. 12g) and 1534 cycles (Fig. 12i), respectively. During these processes, its length suddenly increases to about $99 \mu\text{m}$ and $251 \mu\text{m}$, respectively, which indicates that the local FCGR of aluminium alloy in NaCl fog has a high dependence on the microcrack ahead of the crack tip. Besides, it can also be noticed that the crack propagation in the NaCl fog environment can be considered as an iterative process of microcrack formation and crack coalescence.

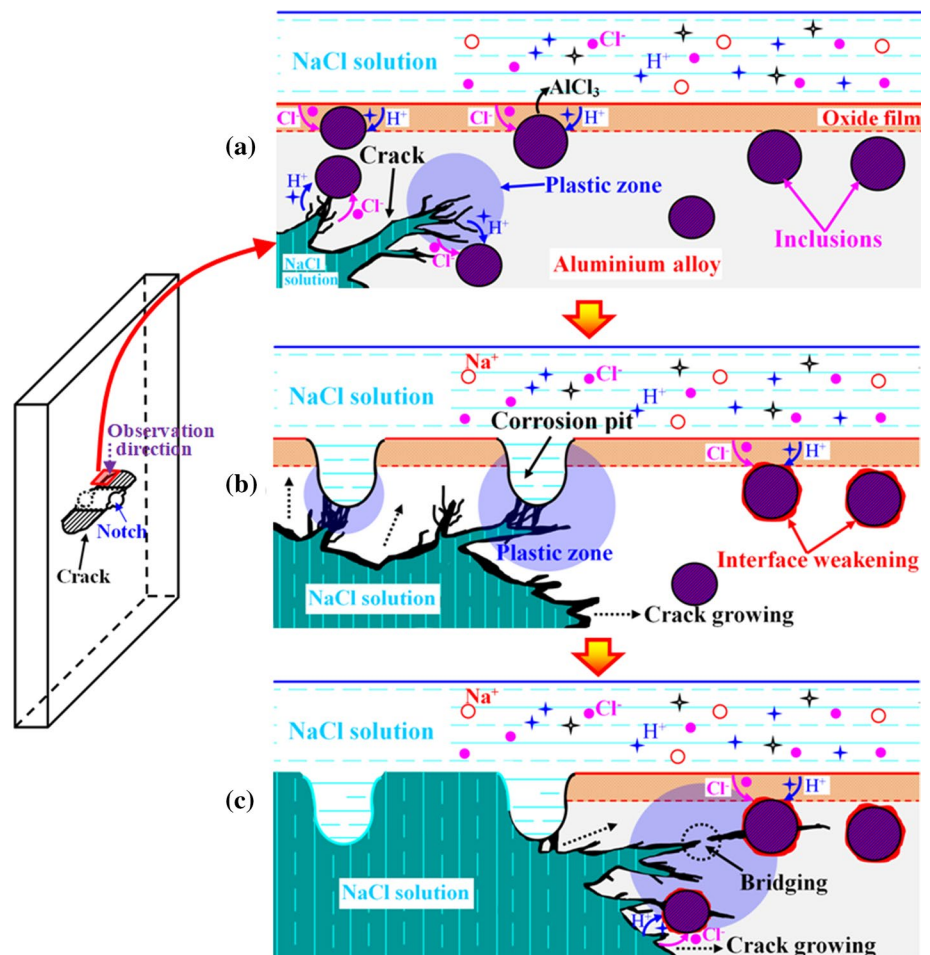
Fig. 13 Schematic diagram of the crack propagation in NaCl fog environment **a** the matrix dissolution surrounding the inclusion by the erosion of H^+ and Cl^- , **b** the interconnection between the crack and corrosion pits, **c** the interconnection between the crack and inclusions with weakly bonded interfaces

To depict the crack propagation mode in NaCl fog, a schematic illustration is provided (Fig. 13). It is generally believed that [4], in a NaCl fog environment, the oxide film forms first which covers the inclusions on the crack surface (Fig. 13a). Since the radii of H^+ and Cl^- are small [7], they can penetrate the oxide film and promote matrix dissolution around the inclusion through galvanic reactions; this leads to interfacial weakening and formation of corrosion pits (Fig. 13b). Previous work [22] shows that, these corrosion

in the process of changing into corrosion pits for which the interface with the matrix is weak due to the erosion of H^+ and Cl^- . Both corrosion pits and these inclusions can be regarded as defects which are prone to stress concentration [22]. Thus, during fatigue loading, as the crack tip plastic zone gradually encounters, and finally encompasses, these defects (corrosion pits and inclusions), the formation of microcracks would take place at the defect-containing region ahead of the crack tip. Then, the main crack bridges the microcracks ahead of the crack tip during which the FCGR is accelerated (Fig. 13c).

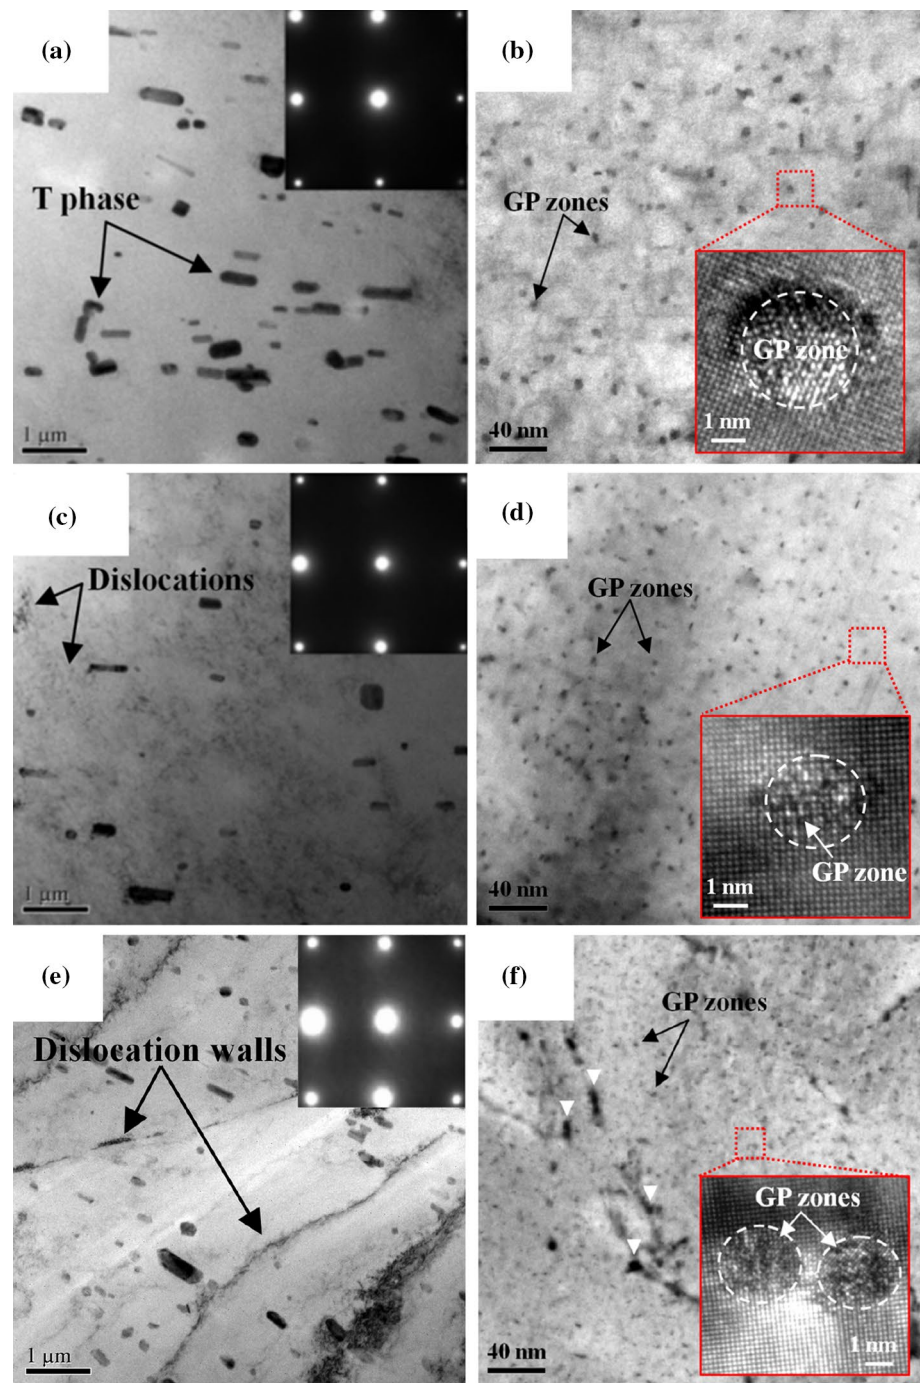
Fig. 16 TEM images, corresponding selected-area electron diffraction patterns (SAEDP) and HRTEM images of 2524 alloy after different pre-deformations viewed along the $\langle 010 \rangle_{Al}$ axis **a** the dislocation distribution and **b** GP zones of alloy specimens with 0% pre-deformation; **c** the dislocation distribution and **d** GP zones of alloy specimens with 2% pre-deformation; **e** the dislocation distribution and **f** GP zones of alloy specimens with 5% pre-deformation

Figure 16 shows the microstructure of 2524 alloy after different pre-deformations. It is found that there is no apparent precipitate in these alloys but a large number of short rod-shaped T-phase particles [34] exist within the matrix (Fig. 16a). These T-rods are known to be the main dispersoids in this type of alloy which are believed to be formed during the homogenisation process after casting [35]. For the unstretched specimen, the dislocation density is quite low (Fig. 16a) shows a large number of ellipsoidal GP zones [36, 37] with a mean average size of 3.52 ± 0.23 nm distributed homogeneously in the matrix (Fig. 16b). With the increase of pre-deformation to 2%, the dislocation density increases (Fig. 16c), and these dislocations are generally uniformly distributed in the matrix. Besides, the GP zone density of the specimen after 2% pre-deformation increases but their average size decreases to 3.08 ± 0.18 nm (Fig. 16d). When the pre-deformation increases to 5%, the distribution of dislocations becomes non-uniform, and some parallel dislocation walls (Fig. 16e) and abnormally grown GP zones (as shown by the white triangles in Fig. 16f) can be seen in the matrix.

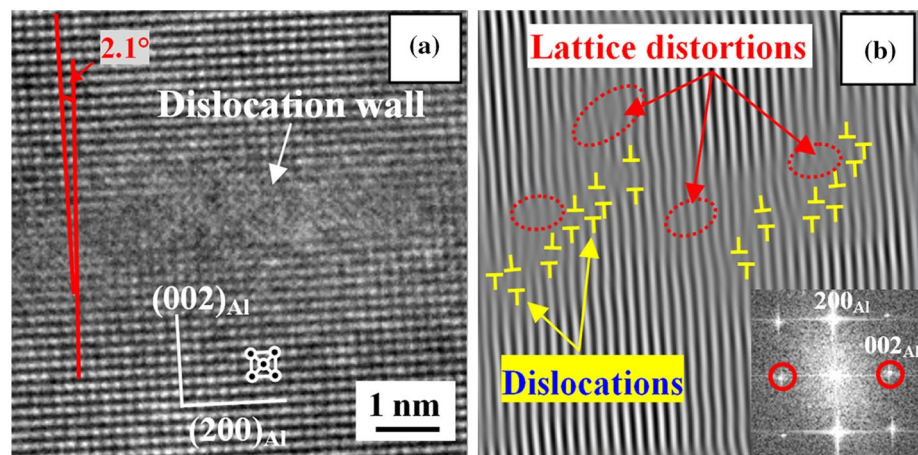
Fig. 17 **a** The typical HRTEM images of a dislocation wall in the specimen with 5% pre-deformation viewed along the $\langle 010 \rangle_{\text{Al}}$ axis, **b** inverse fast-Fourier-filtered (IFFT) image indicating that a large number of dislocations and significant lattice distortions are present in the dislocation wall region (the inset shows the corresponding fast-Fourier-filtered (FFT) image)

dislocation and lattice distortions can be seen in the matrix (Fig. 17). Wu et al. [42] investigated the pre-stretching effect on the microstructure of an artificial aged 2024 aluminium alloy, finding that, when the pre-stretch exceeds 2.0%, it can induce an uneven distribution of both dislocations and second-phase particles. Inhomogeneous deformation produced by 5% pre-deformation can be thought of as microscopic damage. It inevitably leads to a loss of ductility reflected in the significant decrease in δ (Table 5). As predicted, such microscopic damage can provide source loci for both crack
