Modification of Refractory Components in Russian Coke-Oven Linings

Abstract—To date, Giprokoks designs have been used for all Russian coke batteries. The condition of these coke batteries has been deteriorating from year to year. The mean life of Russian coke batteries is 32 years, with values of 35 years for OAO EVRAZ ZSMK, 40 years for OAO MMK, 33 years for OAO Altai Koks, and 30 years for PAO Severstal'. The condition of the coke ovens determines the stability of steel output. The Russian coke industry faces the challenge of renewing (modernizing) its worn-out coke batteries. Changes are proposed here in some refractory components used in coke-battery linings. These proposals may be of interest to coke-battery designers and to contractors preparing for the reconstruction (or construction) of coke batteries.

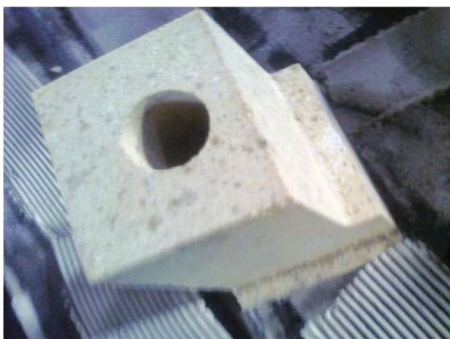
Fig. 4. Proposed burner design.

The proposed burner for coke batteries with bottom supply of coke-oven gas (Fig. 4) has a projection for positioning in the lining of the channel base. At present,
