SMALL URBAN RIVERS OF CHERNIVTSI: LEVEL OF ORGANIC POLLUTANTS CONTENT, MAIN SOURCES AND EFFECTIVE GREEN SOLUTIONS

Abstract. This paper provides results of systematic monitoring of the organic pollutants content in small urban rivers of Chernivtsi, Ukraine. It has been found that this content continuously exceeds maximum concentration limit for any weather conditions. We supposed that unorganized and spontaneous urban effluents provided main part of this pollution. One year long monitoring proved that organic pollutants level lowered significantly even after partial elimination of unorganized effluents of residential waste water (RWW). We suppose that further elimination of RWW effluents would bring organic pollutants content under maximum concentration limit even in the presence of the organized sources of urban rainwater and wastewater.

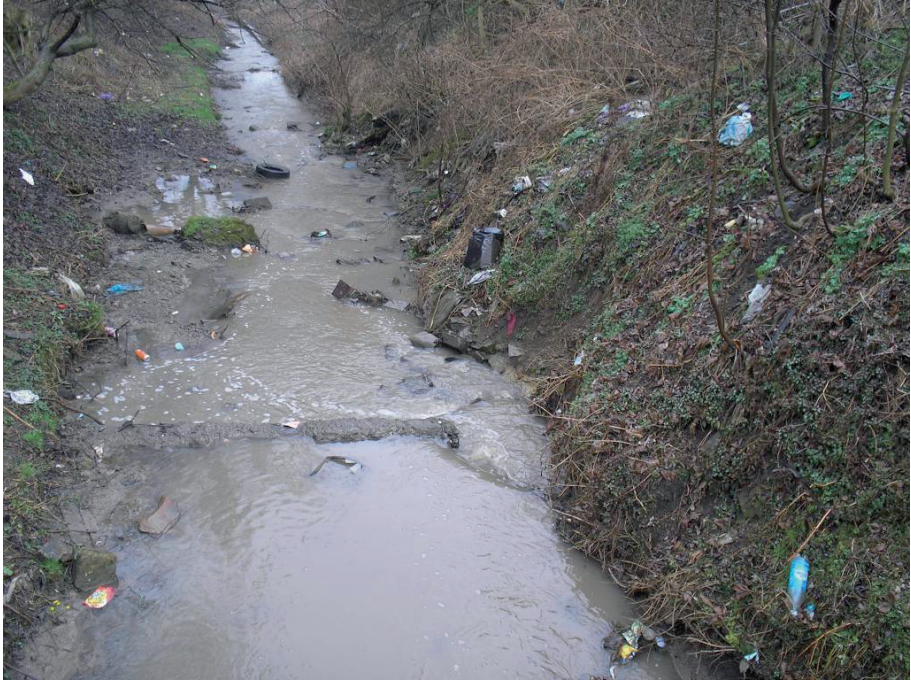
- Riverbanks are often littered within city limits with numerous unapproved scrap-heaps, which seriously pollute river water (see Figure 1);
- Old and poor city sewerage lines can cause small but numerous effluents of RWW, which finally get to the local small rivers;

Figure 1. Littered riverbanks of Molnitsa within the city of Chernivtsi, Ukraine
