Chapter 4

Effects of Shape and Surface Modification on the Corrosion of Nitinol Alloy Wires Exposed to Saline Solutions

F. Placido, A. McLean, A.A. Ogwu and W. Ademosu

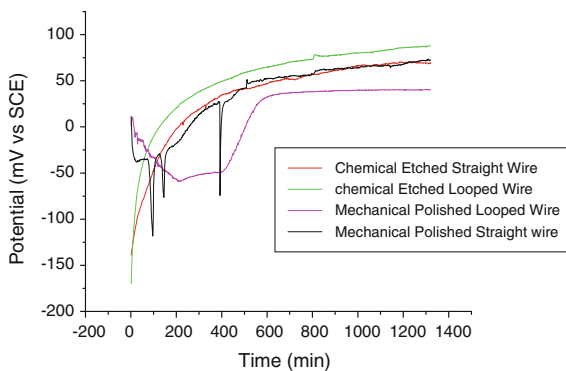
Fig. 4.1 OCP versus time curves for the stable potential determination of nitinol in 0.9 % saline solution

OCP is the thermodynamic measurement of how likely the surfaces are to corrode. The more positive an OCP the more stable is the oxide film on the surface and therefore the less reactive the surface. The OCP was measured to determine the stable corrosion potential (E_{corr}) of the nitinol alloy samples, i.e. the values obtained when the potential becomes constant (Fig. 4.1).

The OCP value for chemical etched wire in looped geometry proved to be the most positive value of OCP, the wire progressively becomes more anodic with time, the oxide layer film remains intact and the material stays stable in the passive state, and is therefore the least reactive surface in 0.9 % saline. The mechanically polished wire initially shifted towards more negative values before stabilising in more positive values after 22 h. Table 4.2 shows the OCP value table of the nitinol wires after 22 h.

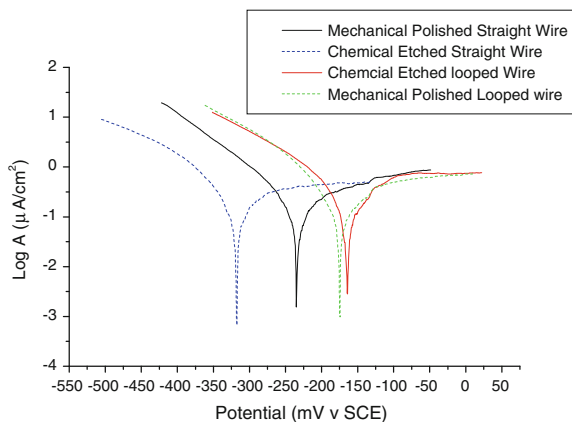
Fig. 4.2 Tafel plot of wires in 0.9 % saline solution

Tafel plots of the different surface treatments, shown in Fig. 4.2, are used to measure the corrosion current i_{CORR} which is then used to calculate the corrosion rate. The Tafel plot yields the Tafel constants β_A and β_C which is used with polarisation resistance (R_p) [8, 9] data to calculate corrosion rate as shown in Table 4.3. Results show chemical etched looped sample with the highest corrosion potential and the chemical etched straight wire with the lowest corrosion potential. The results indicate that the chemically etched looped wire is the most stable of the wires, with the highest corrosion potential, a low corrosion current and low corrosion rate as shown in Fig. 4.3.

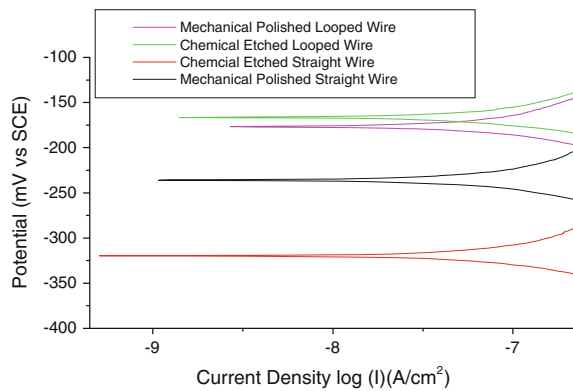
Fig. 4.3 Tafel curve looking at E_{corr} and i_{corr} saline solution

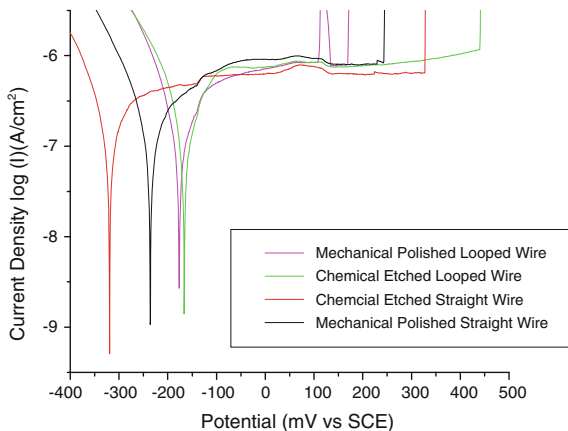
Fig. 4.4 Passivation region of potentiodynamic curve in 0.9 % saline

The potentiodynamic curves are as shown in Fig. 4.4. The potentiodynamic curves indicate the passivation tendencies of the wires in the passive region. Results from

Fig. 4.4 show that the chemically etched looped wire has the largest passivation region, i.e. (-0.78 to +448 mV) [9].

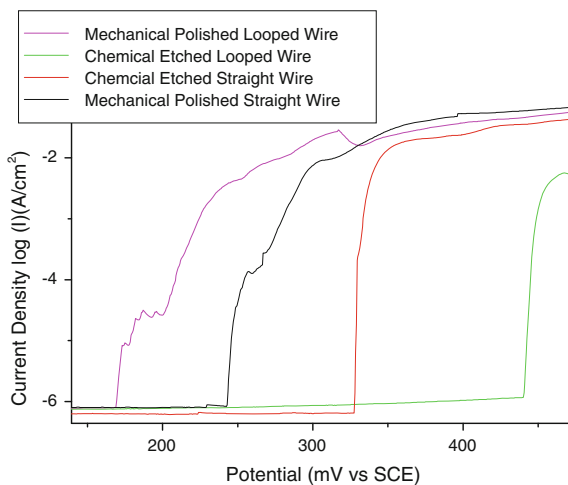
Fig. 4.5 Corrosive region (transpassive region) of the potentiodynamic curve in 0.9 % saline

Figure 4.5 shows the corrosive region of the different wires from the potentiodynamic curve, where there is a sudden increase in the current.

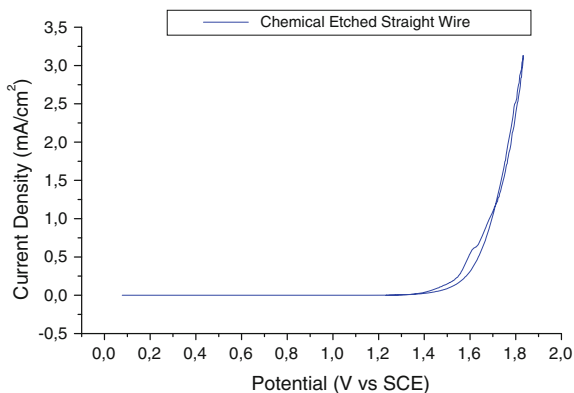
Fig. 4.6 Anodic polarisation of chemical etched straight wire in 0.9 % saline

Anodic polarisation curves reveal the pitting corrosion potential of the chemical etched straight wire at 1415 mV and the chemical etched looped wire at 1451 mV as

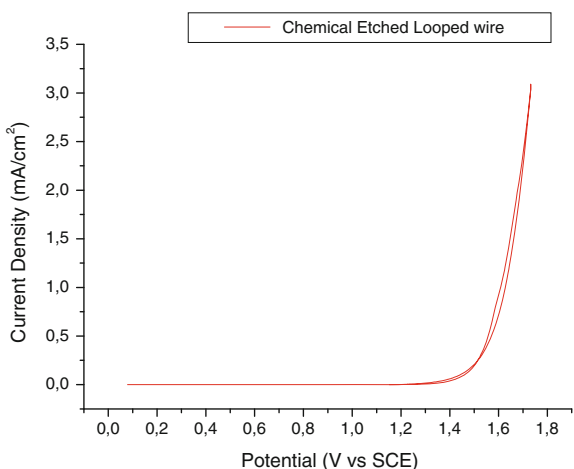
Fig. 4.7 Anodic polarisation of chemically etched looped wire in saline solution

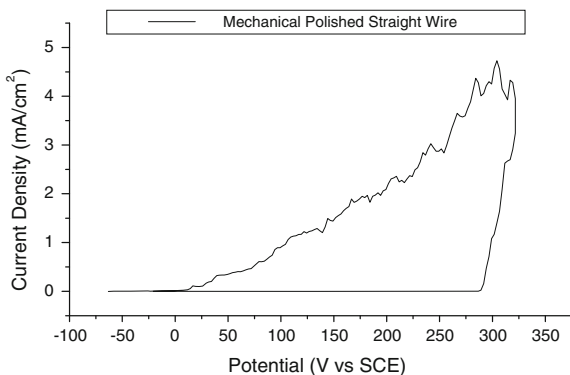
Fig. 4.8 Anodic polarisation of mechanically polished straight wire in 0.9 % saline

shown in Figs. 4.6 and 4.7 whilst the pitting in the mechanically polished straight wire is at 289 mV and the mechanical polished looped wire is at 233 mV as shown in Figs. 4.8 and 4.9. The protection potential also known as the repassivation potential is the potential at which the current becomes negligible on the reverse scan. For the mechanical polished wire, the repassivation potential is observed at 13.3 mV, whilst the repassivation for the chemical etched wire is observed at 1382 mV. The mechanical polished surfaces undergo early pitting below 300 mV as shown in Figs. 4.8 and 4.9 whilst the chemical etched surfaces remain stable for a while before pitting takes place above 1400 mV as shown in Figs. 4.6 and 4.7. Results also show pitting potential (E_{pitt}) and repassivation potential (E_{rep}) are rather close for the chemically etched surface samples. For the mechanically polished surfaces, the E_{pitt} and E_{rep} potentials are very far apart. Pitting potential and protection potential calculated from the pitting corrosion curves are shown in Table 4.5.

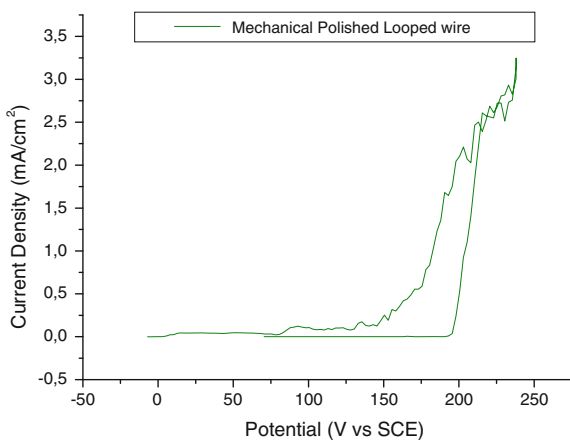
Fig. 4.9 Mechanically polished looped wire in Saline solution

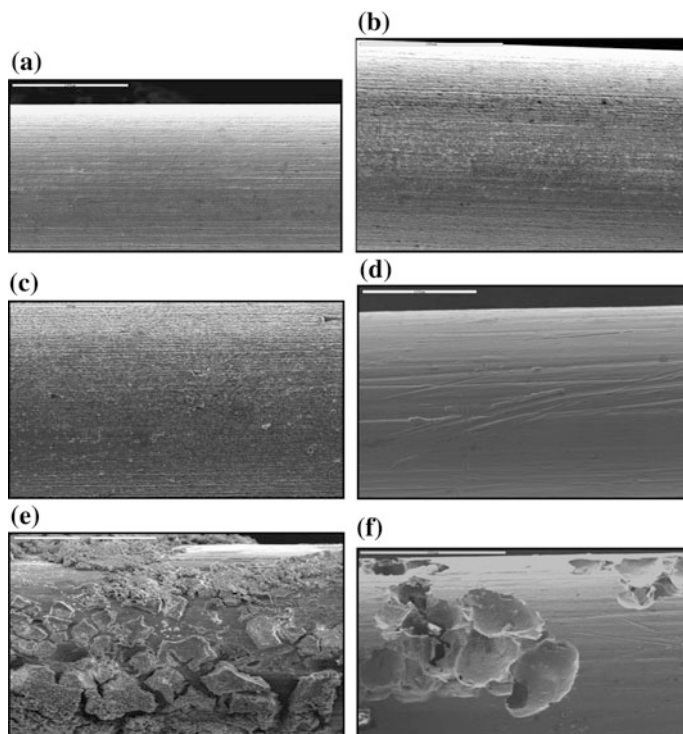
Fig. 4.10 **a** SEM image of chemical etched surface before corrosion (scale bar 100 μm). **b** SEM image of chemically etched straight surface after the potentiodynamic test (Magnification $\times 500$). **c** SEM image of chemically etched looped surface after potentiodynamic test (Magnification $\times 500$). **d** SEM image of mechanically polished wire before corrosion (scale bar 100 μm). **e** SEM image of mechanically polished straight wire after potentiodynamic test (+3500 mV) (scale bar magnification $\times 500$). **f** SEM image of mechanically polished looped wire after potentiodynamic test (+3500 mV) (scale bar magnification $\times 500$)

SEM images of chemical etched and mechanical polished wires before and after corrosion in 0.9 % saline are as shown in Fig. 4.10a–f.

The SEM images in Fig. 4.10b, c show the chemical etched wire after the pitting test. It is evident that no pitting or corrosion took place. The surface of the wire is

not as smooth as the as-received wire. There was no significant difference between the looped and the straight geometry. Both pitting and corrosion would seem to have taken place on the surface of the mechanically polished wires in Figs. 4.10e, f. The mechanically polished looped wire in Fig. 4.10f appears to have undergone excessive pitting. In certain areas on the surface, the pits have turned into cracks. Pitting is only observed on certain areas of the surface and other areas have been left untouched. The crumbling effect of the oxide layer on the mechanically polished straight wire can be observed in Fig. 4.10e. Also, it appears that the oxide layer has been broken into smaller parts so that another layer on the mechanical polished wire can be observed. EDX analysis of the chemical etched wire after potentiodynamic test of +3500 mV. Figure 4.11a showed reduced nickel content of less than 10cps on the surface; whilst nickel content of the mechanical polished wire had remained the same at around 70 cps as shown in Fig. 4.11b.

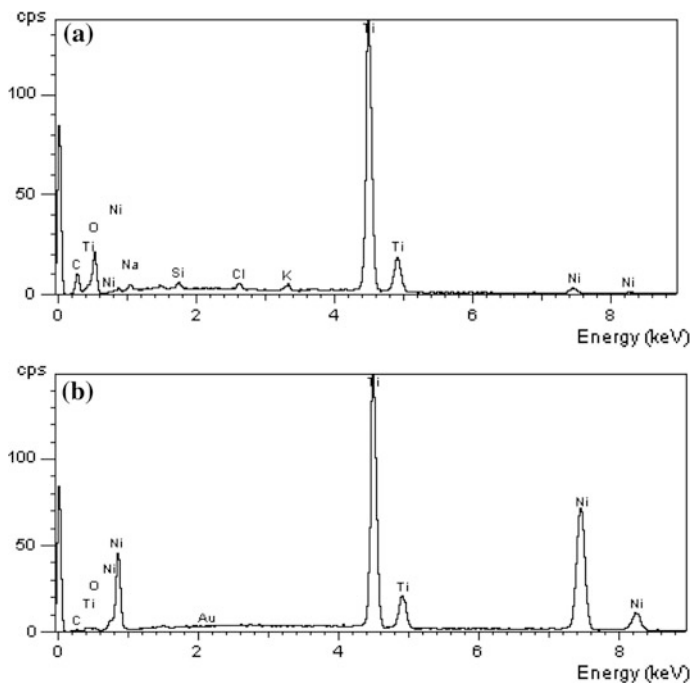
Fig. 4.11 **a** EDX analysis of chemically etched wire PD +3500 mV having very little nickel on its surface. **b** EDX analysis of mechanically polished wire PD +3500 mV
