Predicting Plant Metal Bioaccessibility at the Historic Wheal Maid Tailings Lagoons, Cornwall, UK

Abstract Abandoned mine sites with their metal-rich substrates pose significant challenges to naturally colonizing plants. In this study, the abandoned Sn-Cu tailings lagoons at Wheal Maid (Cornwall, UK) have been investigated to establish the bioaccessibility of metals and metalloids (As, Cd, Cu, Pb, Sb, Zn) in exposed tailings and wastes using a new plant bioaccessibility test. Four main substrate types were sampled: (1) mine waste used to construct the lagoons, a relatively uncontaminated material with variable particle size; (2) granular capping material used in the upper lagoon to cover the tailings and relatively uncontaminated; (3) grey tailings a fine to medium grained material with visible sulfides and white secondary salts, extremely high in near-total Zn concentrations; and (4) marbled tailings a fine grained brown/red/yellow material with extremely high near-total As concentrations. The analytical quality of results produced by a new plant bioaccessibility test was monitored using blanks, spiked solutions and repeat analyses. The grey tailings had the highest bioaccessible

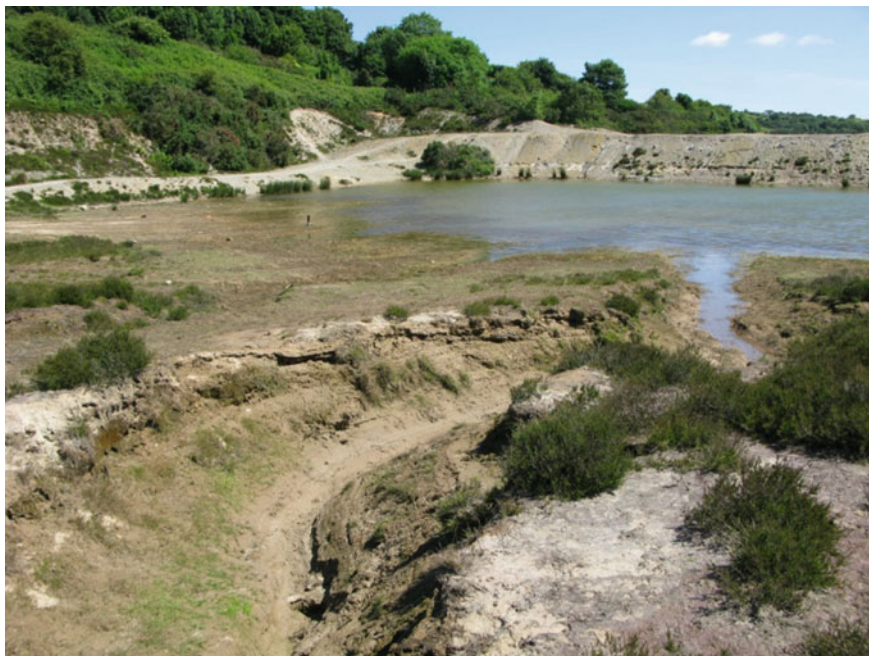
Fig. 1 Granular capping at the upper Wheal Maid tailings lagoon, with evidence of some re-vegetation (foreground) and mine waste used to construct the lagoons (beyond the standing water, middle distance) (color figure online)

Approximately 10 km northwest of Falmouth, the site has its center at 50°14' 14.61"N and 5°9'37.85"W. The site comprises two lagoons which are bordered by a path which runs around the perimeter of the site. The western lagoon is referred to as the upper lagoon and has some vegetation cover and some standing water (Fig. 1). The eastern lagoon is referred to as the lower lagoon, this has no vegetation and the standing water is a striking orange colour (Fig. 2) due to the Fe oxides present in the water.

1. Mine Waste (MW). This material was used in the construction of the dams and is located around the perimeter of the lagoons. It is a granular material with a variable particle size (Fig. 1).
2. Granular Capping (GC). This material was used in the upper lagoon to cover the tailings; some of it was subsequently seeded in an attempt to remediate the land (Fig. 2).
3. Marbled Tailings (MT). This material was located around the lower lagoon. It is a fine grained brown/red/yellow material (Fig. 2).
4. Grey Tailings (GT). This material was located at one end of the lower lagoon. It is a fine to medium grained material (Fig. 3). Grains of sulfide material can be seen by eye and there are white effervescent salts evident on the surface of the material in some places.

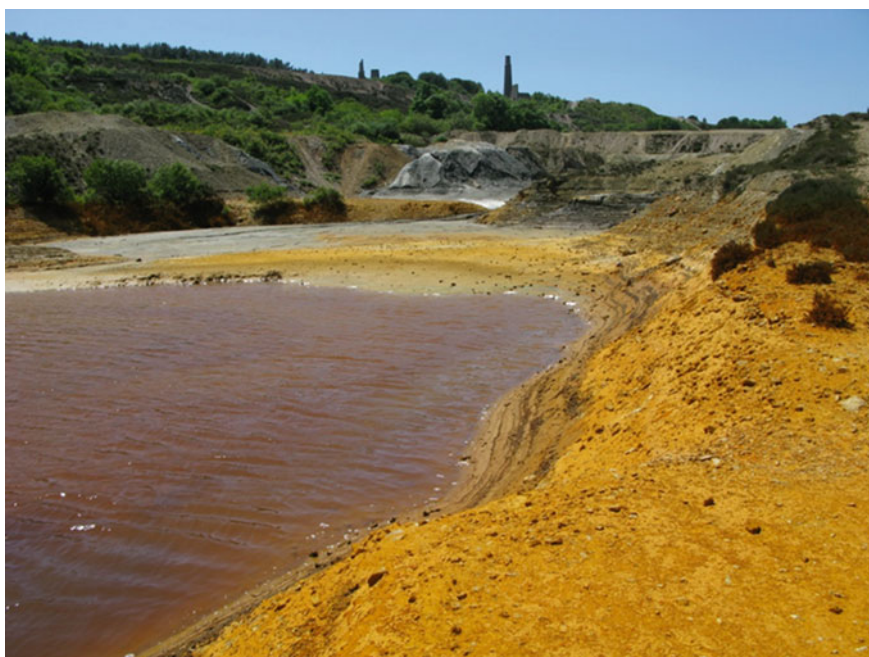
Fig. 2 Marbled tailings (foreground) and standing water at the lower Wheal Maid tailings lagoon (color figure online)

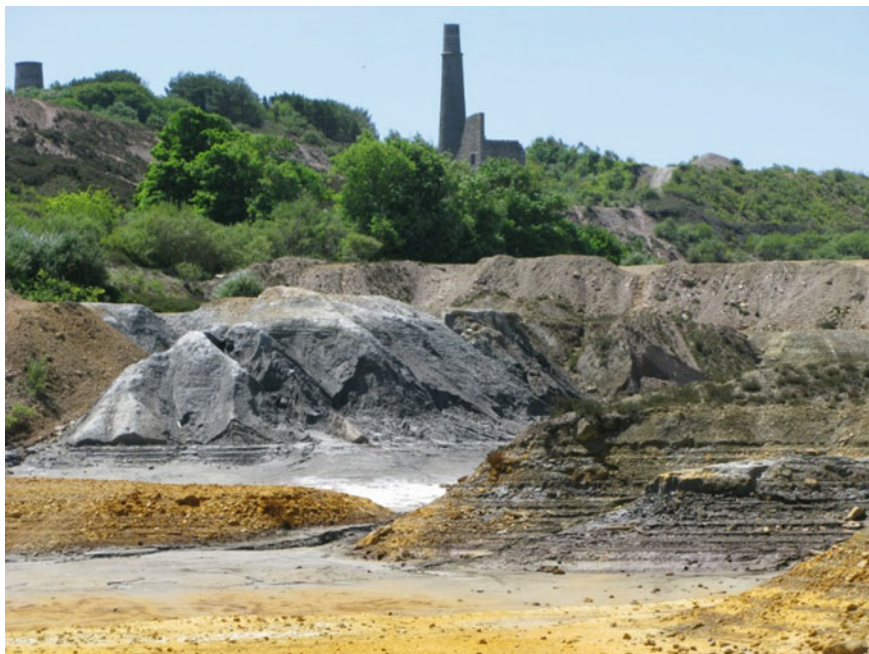
Fig. 3 Grey tailings at the lower Wheel Maid tailings lagoon (color figure online)
