Radiography Limitations and Pitfalls

Keynes T.A. Low and Wilfred C.G. Peh

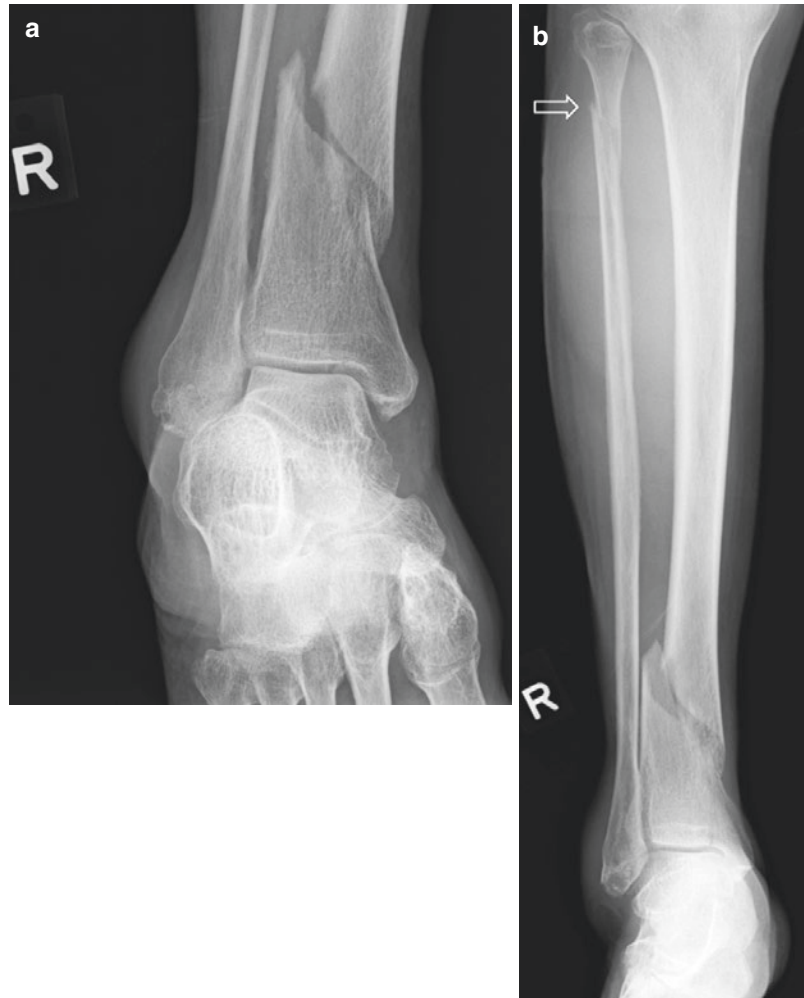
Fig. 1.2 An 87-year-old woman who presented with right ankle pain after a fall. **(a)** Frontal radiograph of the right ankle shows a spiral fracture of the distal tibia. **(b)** Frontal radiograph of the right leg shows a proximal fibular fracture (*arrow*). This Maisonneuve injury would have been missed if imaging coverage of the proximal leg was not performed

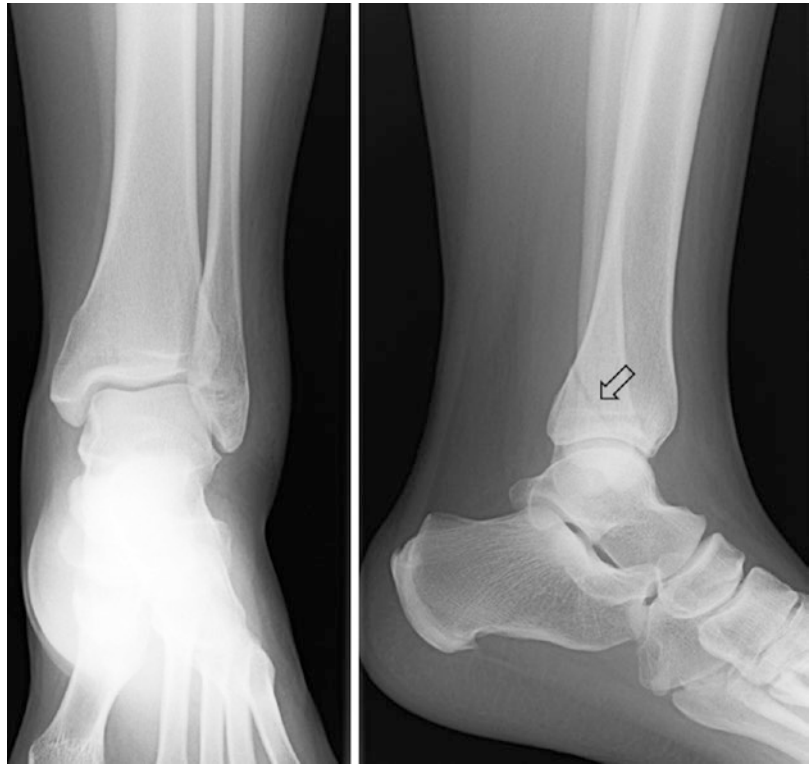
Fig. 1.3 A 31-year-old woman who presented with left lateral ankle pain. Frontal and lateral radiographs of the left ankle were obtained. A minimally displaced distal fibular fracture is seen as a lucent line only on the lateral radiograph (*arrow*). It is occult on the frontal radiograph. This common injury illustrates the importance of having sufficient radiographic views for proper evaluation

In general, orthogonal views are sufficient in the radiographic imaging of the axial and appendicular skeleton (Fig. 1.3). However, additional views may be required based on the complexity of the anatomy, especially if the structure of

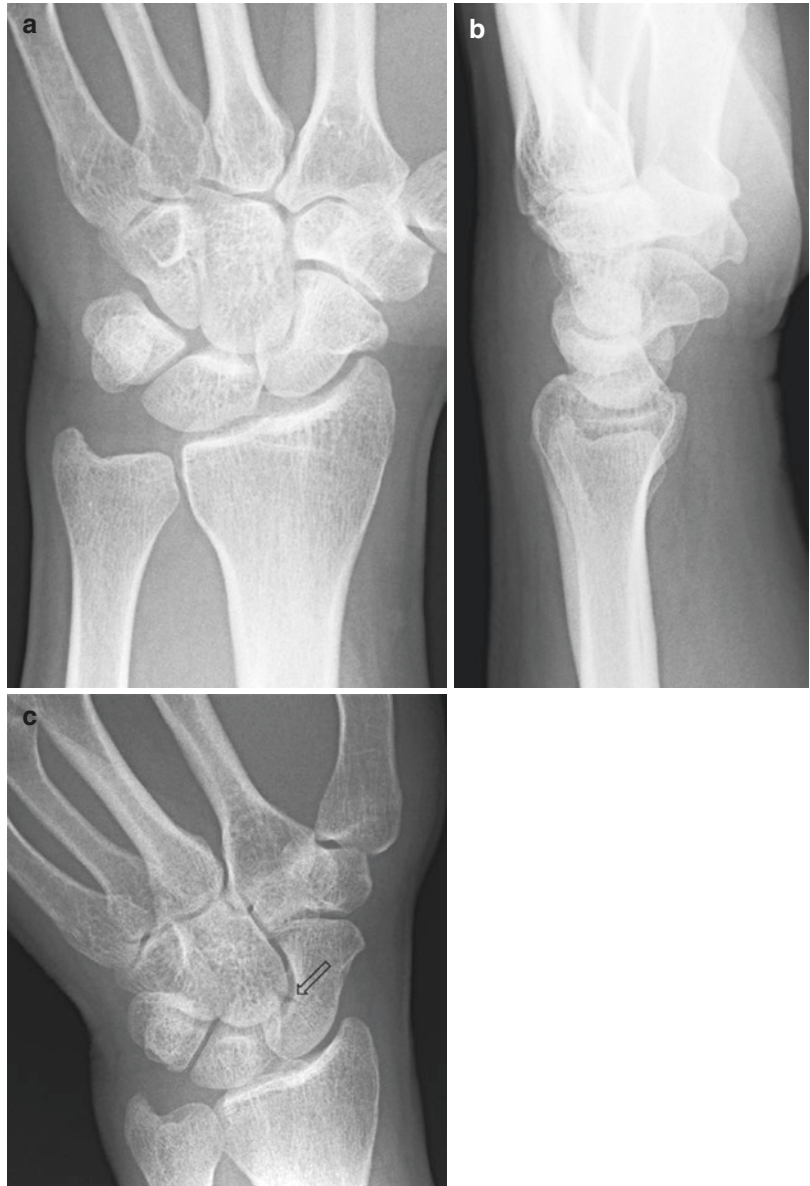
Fig. 1.5 A 40-year-old man who presented with left wrist pain after falling onto his outstretched left hand. (a) Frontal and (b) lateral radiographs of the left wrist show no fracture or dislocation. (c) Posteroanterior view of the left wrist taken in ulnar deviation and slight tube angulation, usually part of the scaphoid imaging series, shows an undisplaced fracture of the waist of the scaphoid (*arrow*)

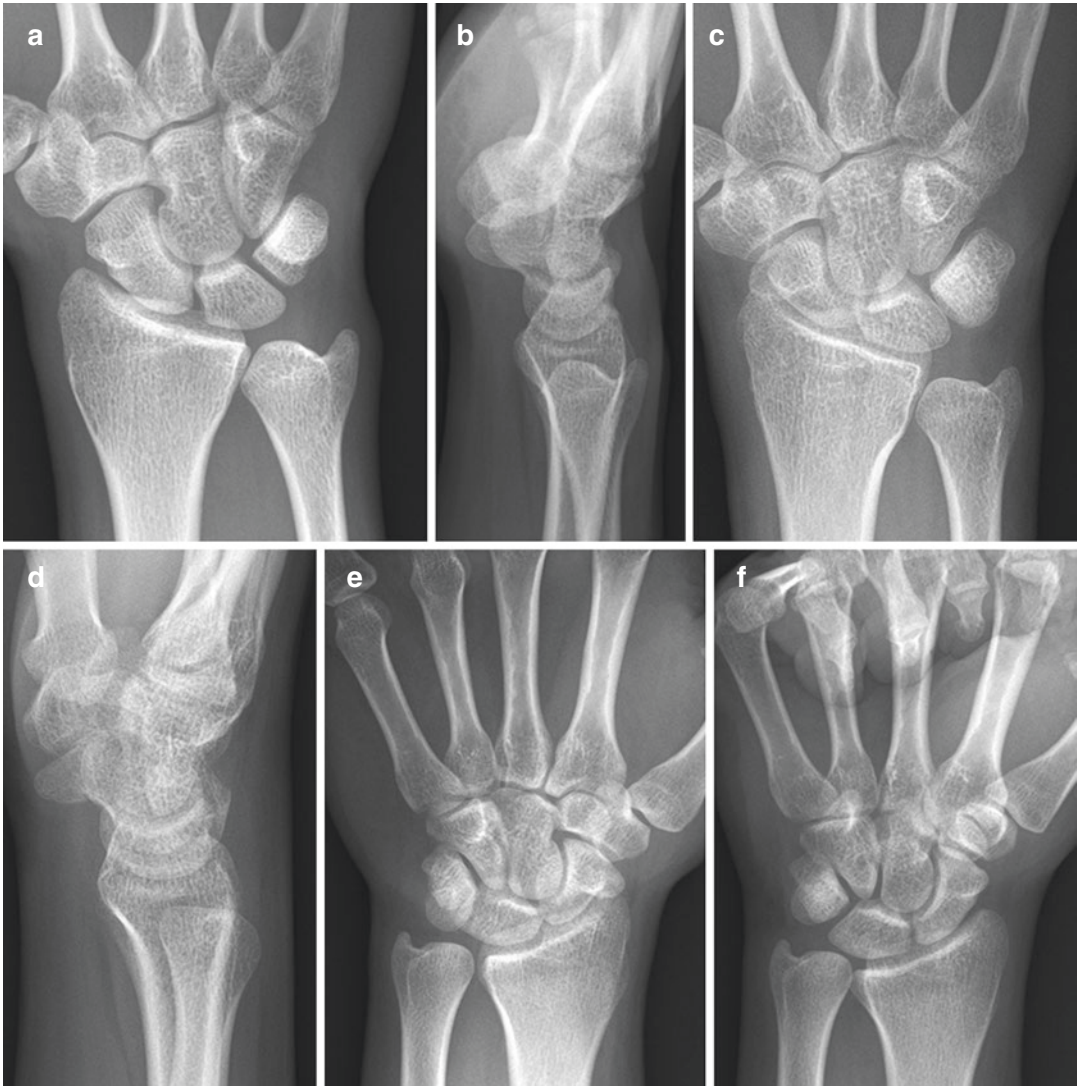
Fig. 1.7 Poor positioning affects the radiographic orthogonal views of the wrist in a 24-year-old man. (a) Posteroanterior and (b) lateral radiographs of the right wrist show inappropriate positioning of the wrist on the lateral view. After acquisition of the standard posteroanterior view, the wrist was left on the imaging plate with forearm supination performed for acquisition of the lateral view. Note the resultant identical appearances of the ulna on both images, making this a suboptimal radiographic study due to the lack of proper orthogonal views. (c) Posteroanterior and (d) lateral radiographs of the right wrist in another patient show

appropriate positioning of the wrist, which remains in neutral position on both views. The ulnar variance is also influenced by the position of the wrist, increasing on pronation and decreasing on supination. Ulnar variance is therefore only accurately assessed on the standardized posteroanterior view of the wrist in the neutral position. It is noteworthy that dynamic stress maneuvers can also alter bony alignment. For example, the (e) frontal and (f) clenched-fist stress radiographs of the left wrist of a 40-year-old woman show an increase in ulnar variance on the stress view, which is a normal finding

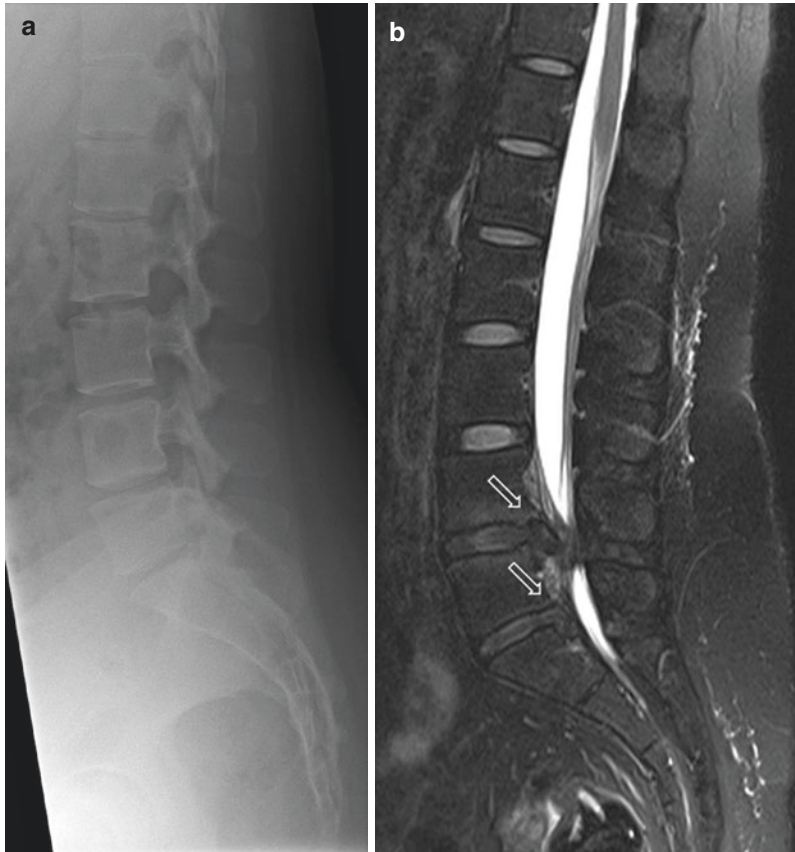
Fig. 1.19 A 25-year-old woman who presented with low back pain and bilateral lower limb numbness after lifting some heavy loads. **(a)** Lateral radiograph of the lumbar spine is essentially normal. **(b)** Sagittal fat-suppressed T2-W MR image of the lumbar spine shows posterior intervertebral disk extrusions at L4–L5 and L5–S1 levels (*arrows*), worse at the L4–L5 level where there is significant spinal canal stenosis with likely impingement of the

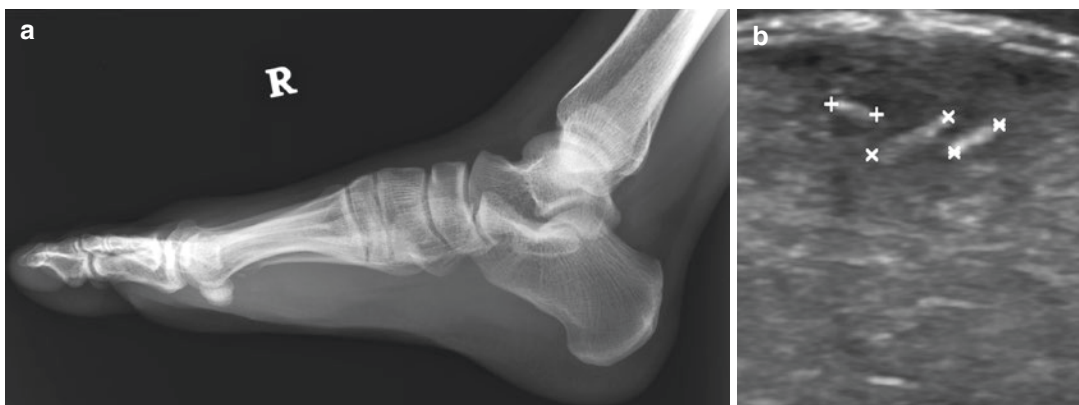
Fig. 1.23 A 34-year-old construction worker who presented with pain in the right foot after stepping barefoot onto unknown material at his work site. (a) Lateral radiograph of the right foot does not show any radiopaque foreign body. (b) US image shows a few small foreign bodies

tation of radiography is in the detection of foreign bodies which are weakly radiopaque, especially if the material of the foreign body has a density close to that of the surrounding soft tissue (e.g., wood). These weakly radiopaque foreign bodies will not be appreciated on the radiograph. This potential pitfall should be recognized by the clinician requesting the radiograph, and if necessary, an alternative imaging modality such as US imaging should be considered (Aras et al. 2010) (Fig. 1.23).

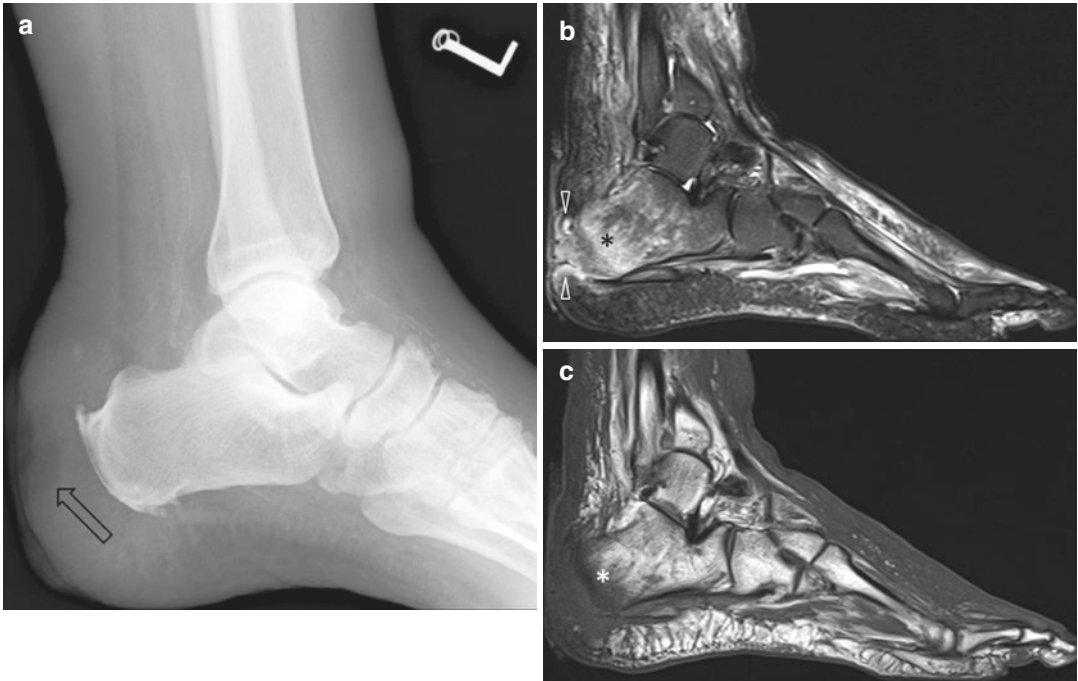
Fig. 1.25 A 62-year-old man with type 2 diabetes mellitus who presented with an infected ulcer at the left hind-foot. (a) Lateral radiograph of the left ankle shows a radiolucent area posterior to the calcaneum (arrow), corresponding to the known ulcer. No obvious radiographic sign of osteomyelitis (e.g., periosteal reaction and bone destruction) is discerned. (b) Sagittal TIRM MR image of

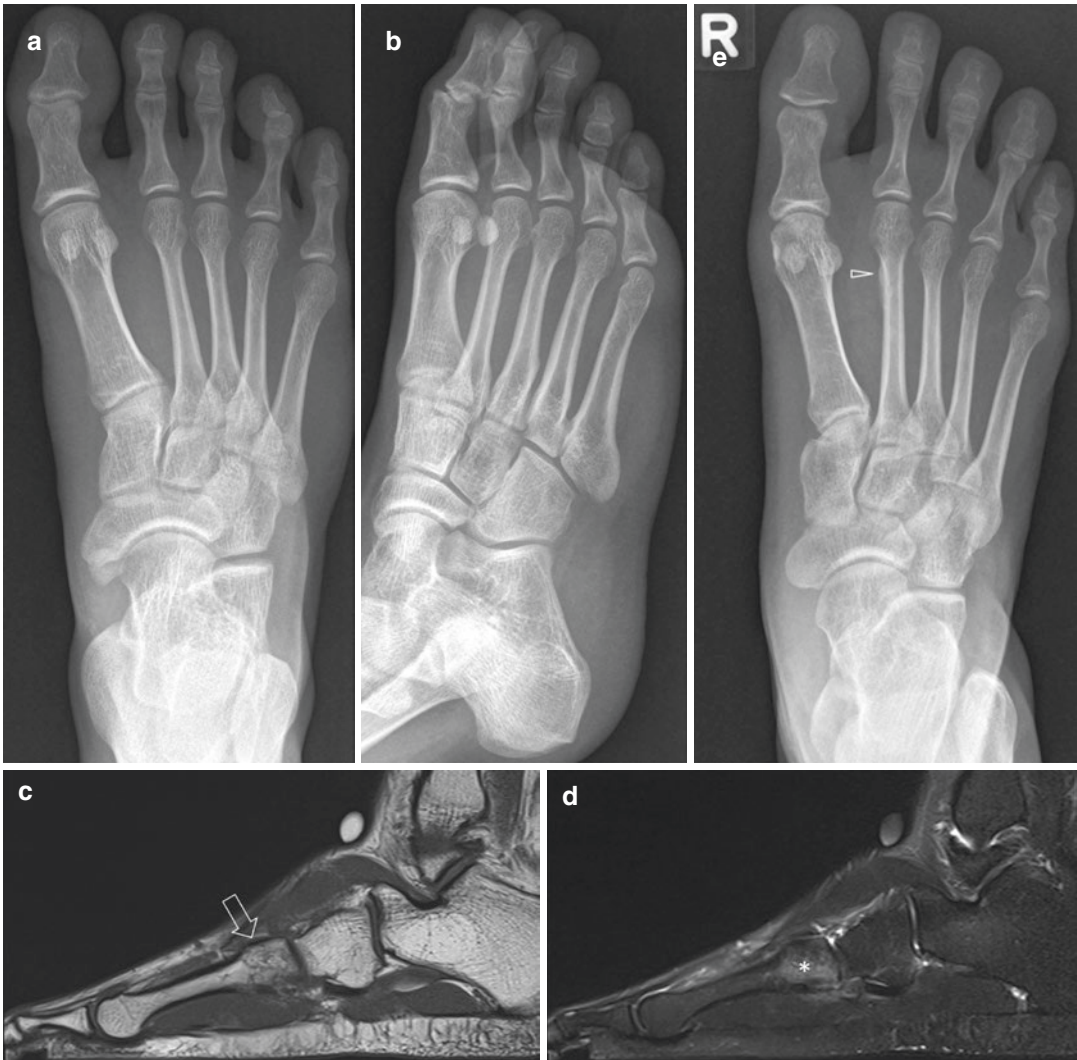
Fig. 1.29 A 24-year-old avid runner who presented with right foot pain. **(a)** Frontal and **(b)** oblique radiographs of the right foot show no significant abnormality. Incidental note is made of a type 2 os navicularis. **(c)** Sagittal T1-W MR image of the right foot shows curvilinear hypointense trabecular fracture lines in the base of the fourth metatarsal (*arrow*). **(d)** Sagittal fat-suppressed T2-W MR image of the right foot shows associated marrow edema (*asterisk*).

isk). With the presence of a concordant history, the findings were consistent with a stress injury. **(e)** Frontal radiograph of the right foot in another patient at a later stage in the natural progression of a stress injury shows typical periosteal reaction adjacent to the neck of the second metatarsal (*arrowhead*), indicating a healing stress fracture. This is the earliest radiographic feature of stress injury

cortical fracture. Formation of periosteal new bone is the earliest radiographic feature of stress fractures, and its appearance may be delayed up to 3 months from the initial injurious stimulus (Jarraya et al. 2013) (Fig. 1.29).
