Performance Evaluation of SWRO Desalination Plant at Skikda (Algeria)

One of these plants is investigated in this study. It is an SWRO desalination plant of Skikda, located in the east of Algeria, commissioned in 2009, with a capacity of $100,000 \text{ m}^3/\text{day}$.

The objective of this paper is to study the performance of the plant and identify the different shortcomings. The plant performance was established from the operation and maintenance data as well as from visits made to the plant.

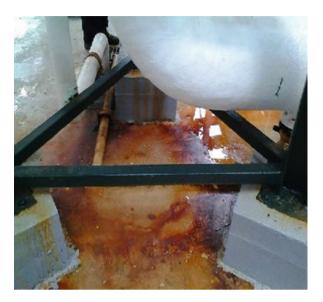
Fig. 2 Corrosion in the cartridge filters

Another problem encountered in the Skikda plant is material corrosion in pretreatment, especially in the cartridge filters and sand filters, as shown in Figs. 2 and 3.

This corrosion is due to the washing of sand and anthracite filters by the brine and the quality of the material chosen for the joints, fittings, and valves.

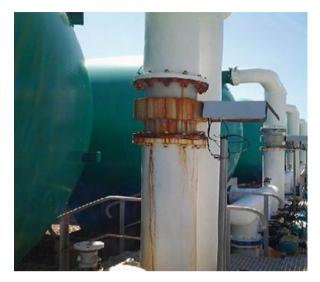
Fig. 3 Corrosion in sand filters
