SEISMIC RISK ASSESSMENT AND RETROFITTING

Seismic Risk Assessment and Retrofitting

With Special Emphasis on Existing
Low-Rise Structures

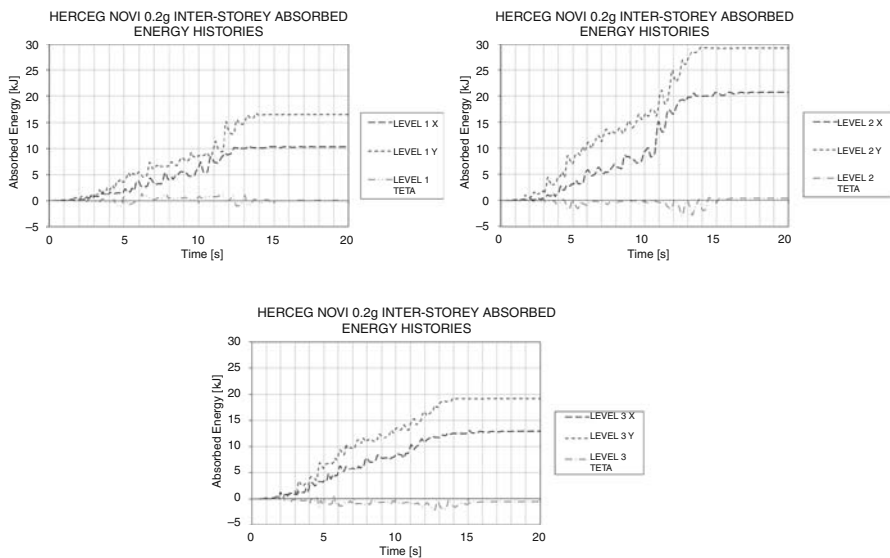
Fig. 3.13 Herceg-Novoi 0.2 g input: interstorey total absorbed energy histories

Meanwhile, the values of the total energy absorbed by the rotational mode were smaller in comparison to those absorbed by the translational DoFs, as can be seen in Fig. 3.13; moreover, in the last part of the response, it came out that when the rotation strongly increased and the torsional component became very important, it caused a shifting of the column drifts with respect to that of the CM and the strongest increase in the maximum values of the edge column drifts.

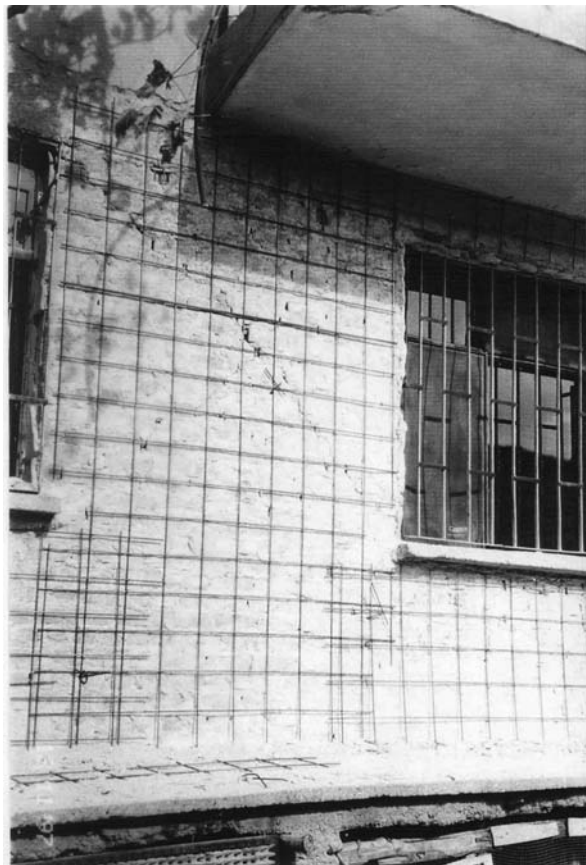
Fig. 8.24 Application of web reinforcement

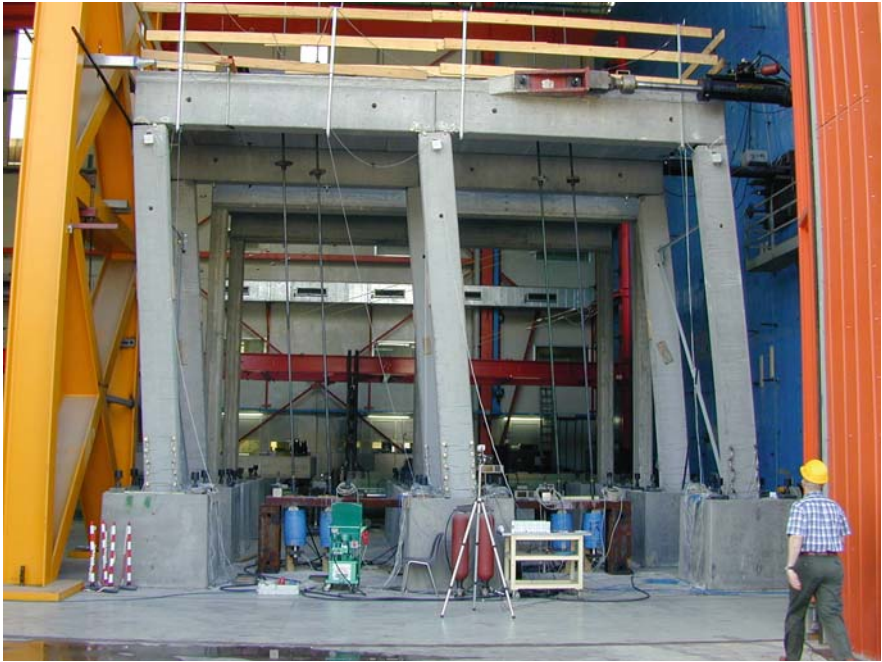
Fig. 10.12 Precast mock up for pseudodynamic testing designed and built for the “Ecoleader” research project

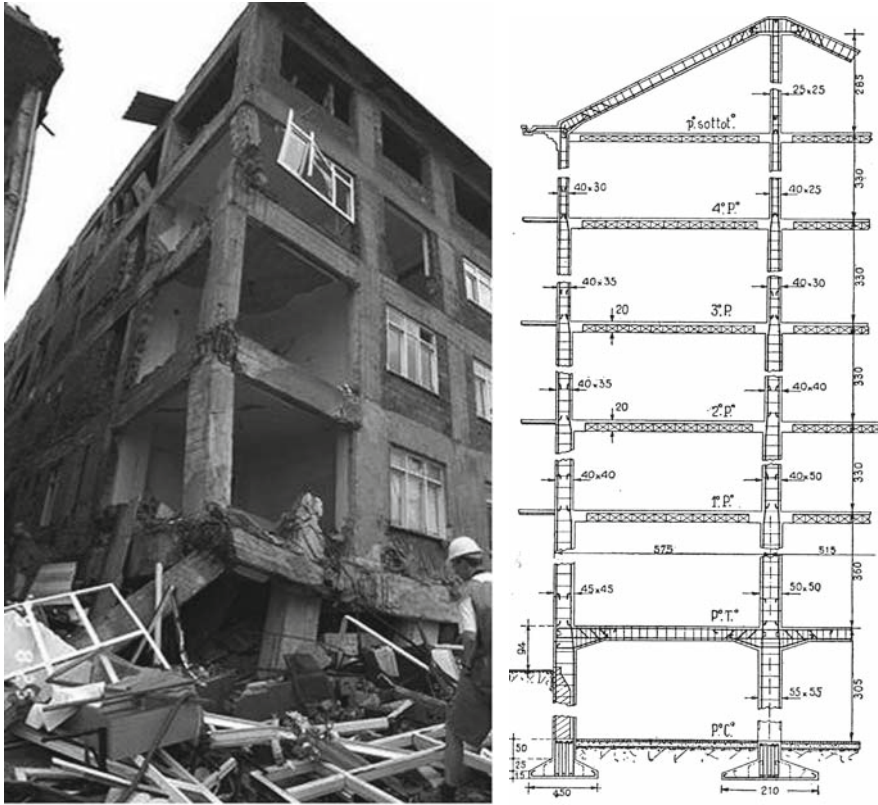
Fig. 13.2 *Left*: observed damage in a pre-1970s existing reinforced concrete frame buildings with masonry infills (Izmit-Kocaeli earthquake, 1999, courtesy of EERC Library, Berkeley, NISEE Image Collection). *Right*: typical section elevation of a RC frame building designed in Italy in the late 1950s (after [22])

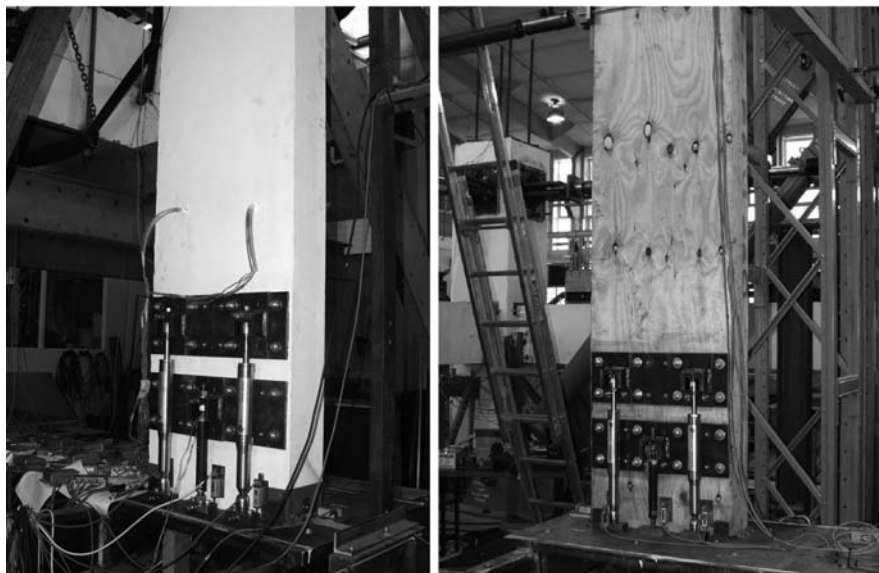
Fig. 13.16 Prototypes of post-tensioned rocking/dissipative concrete and timber walls under shake table tests (after [39])

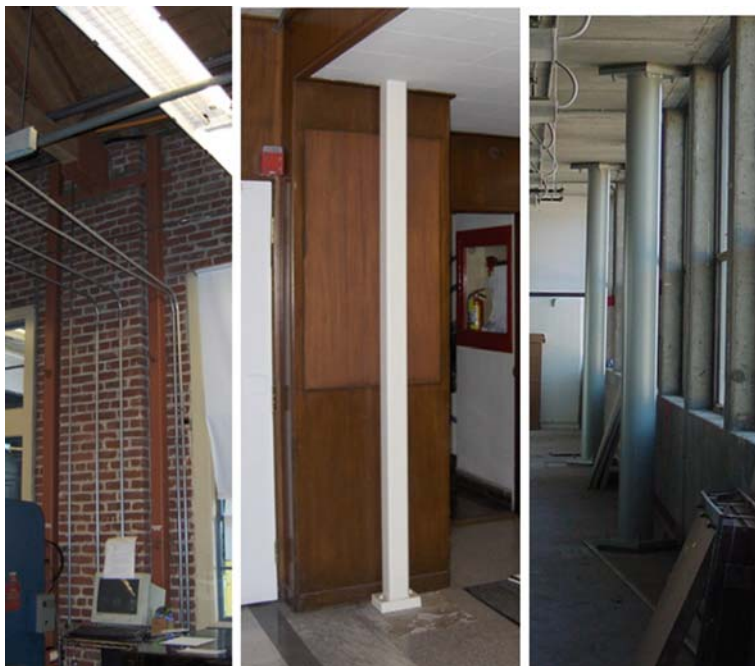
Fig. 16.3 Steel column “pre-shoring” examples from Stanford University and University of California, Berkeley (See also Plate 21 in Color Plate Section on page 468)

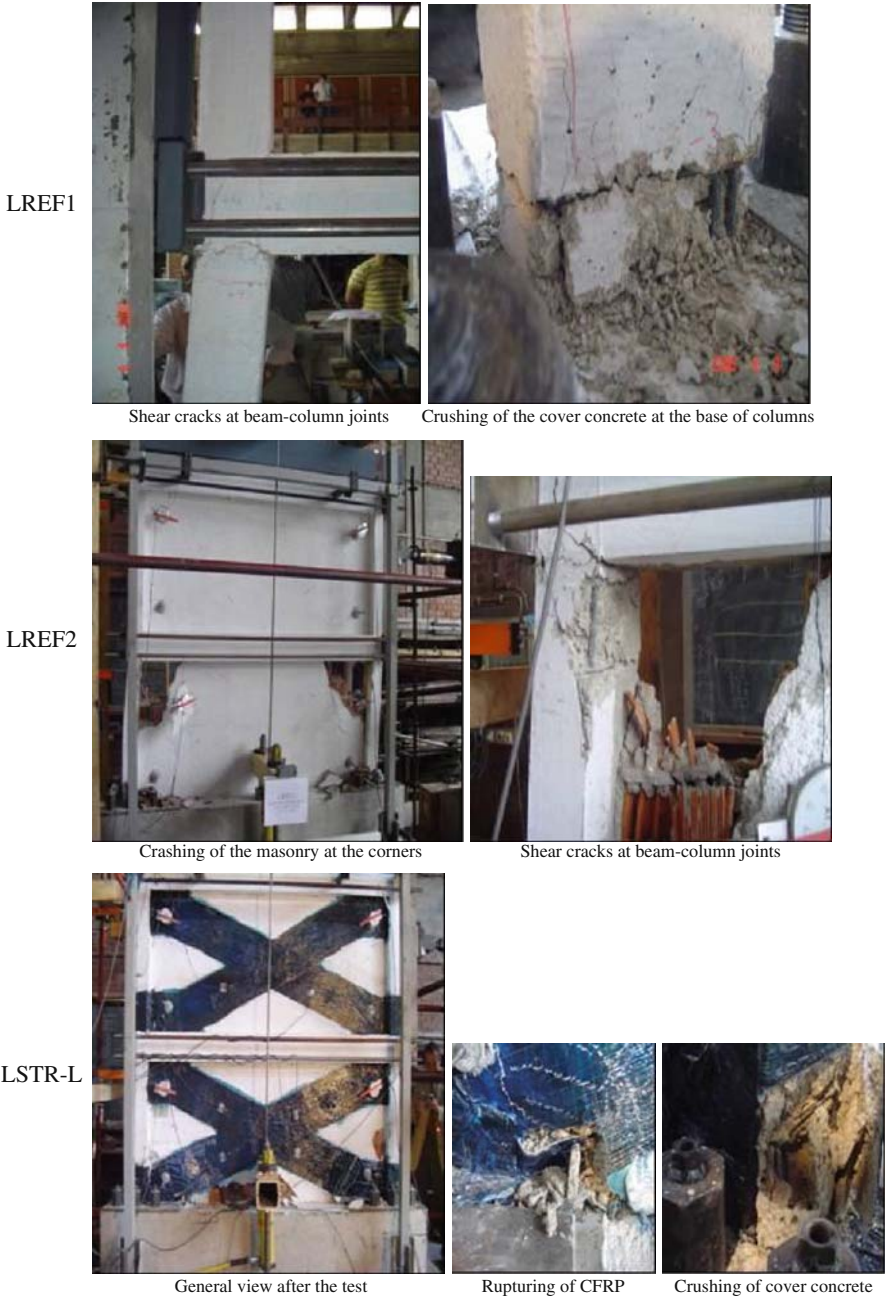
Fig. 18.5 Failure pattern of the test specimens

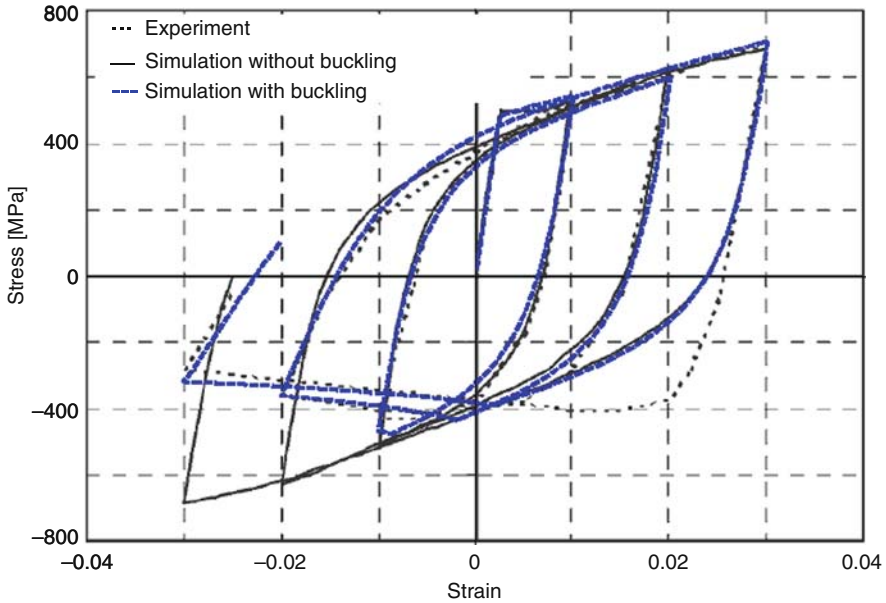
Fig. 20.10 Model simulations of bar-buckling experiments in [25] for length/diameter ratio = 11 (See also Plate 45 in Color Plate Section on page 479)
