Design and placement of a multi-species riparian buffer strip system*

Key words: filter strip, NPS pollution, constructed wetland, soil bioengineering, best management practice

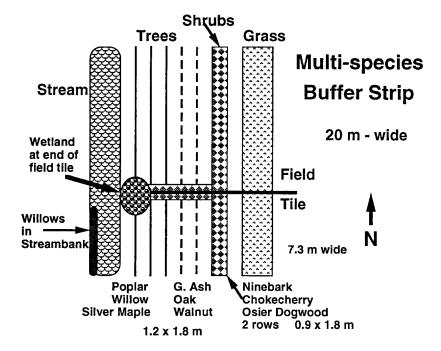
The following figure demonstrates the MSRBS design that is recommended by IStART. Figure 1 shows the general concept of a 20 m-wide filter strip. Starting at the stream, four or five rows of trees, two rows of shrubs and a 7 m-wide band of switchgrass (*Panicum virgatum*) are recommended. Other native prairie grasses could be mixed with the switchgrass as long as the switchgrass dominates the site. Fast-growing trees species such as cottonwood

Fig. 1. Layout for a multi-species riparian buffer strip management system that includes streambank bioengineering and small constructed wetlands at the end of field drainage tiles.

hybrids (*Populus* spp., e.g., *Populus clone* NC-5326, a designated clone by the North Central Forest Experiment Station), silver maple (*Acer saccharinum* L.), willow (*Salix* spp), and green ash (*Fraxinus pennsylvanica* Marsh.) are used in this model. Also, slower growing species such as black walnut (*Juglans nigra* L.), red oak (*Quercus rubra* L.), bur oak (*Quercus macrocarpa* Michx.), white oak (*Quercus alba* L.), swamp white oak (*Quercus bicolor* Willd.) and hackberry (*Celtis occidentalis* L.) may be planted if the soils are moderately well drained and the seasonal water table does not stay above three feet for more than one month during the early growing season.

There are numerous tree combinations that can be planted in the four or five rows of trees. The fastest growing trees such as willow, silver maple, and/or poplar hybrids should occupy the first two or three rows closest to the stream bank. These species would become established quickly and begin to provide filtering and stabilizing effects within the first 3 years. Any of these three species could be planted immediately adjacent to the stream. But where steep, potentially eroding streambanks are a problem, willow, because of its root system and its ability to root sprout, would be the best choice. In these situations, a willow-stake/soil bioengineering system also would be an appropriate component of the MSRBS system. Species should be mixed either by row or by blocks within rows to maintain diversity.

The next two rows also could be planted to any of the other species already mentioned. These species can be slower growing species because they are placed further from the streambank where soil stability is less of a concern. Figure 1 shows a 1.8 m spacing between tree and shrub rows. That spacing

Spacing between trees in the rows is 1.2 m and between shrubs is 1 m. A 20 m wide by 500 m long MSRBS on one side of a stream occupies 1.0 ha of land. Five rows of trees would include ~2,085 trees per 1.0 ha (4 rows of trees would need ~1,667 trees). For two rows of shrubs at 1.0 m between shrubs, there would be an additional 1,000 plants for a total of 3,085 woody plants (2,557 for the 4 row design) per 1.0 ha or 500 m of length on one side of a steam. This MSRBS model assumes designing and placing the system on both sides of a stream.

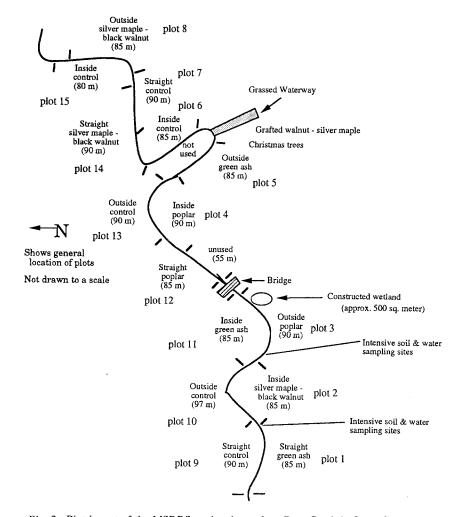
Fig. 2. Plot layout of the MSRBS project located on Bear Creek in Story County, IA.

To objectively evaluate the MSRBS, sections of the Bear Creek riparian zone reach were divided according to a split block statistical design. The reach of the creek under study was divided into three blocks: inside bend, outside bend, and straight reaches (Fig. 2). Five 90-m plots were located within each block. Treatments consisting of three combinations of planted trees, shrubs, grass, and two controls, were randomly assigned to the plots within each block. The planted treatments consisted of five rows of trees planted closest to and parallel to the creek at a 1.2×1.8 m spacing. Different species of trees were used in each of the three treatments. One treatment consisted of a poplar hybrid (*Populus* × *euramericana* 'Eugenei') which has been extensively field tested and is readily available in Iowa. The second treatment contained green ash and the third treatment contained a mixture of four rows of silver maple with

a center row of black walnut. Upslope from the trees are a row of red-osier dogwood and a row of ninebark. The shrubs were planted at a 1.0×1.8 m spacing. Finally, a 7.3-m-wide strip of switchgrass was planted upslope from the shrubs. Controls consist of pasture grasses similar to those that were present on areas that were grazed prior to the study. Most trees are being grown on a 8- to 10-year rotation, depending on the species. Black walnut is being grown on a 45- to 55-year rotation.

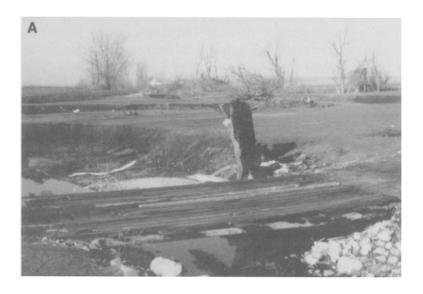
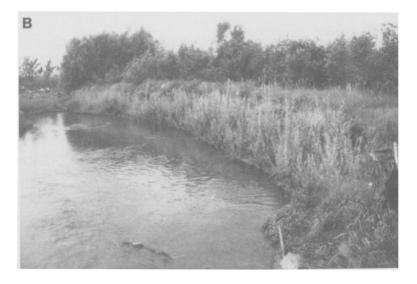
The two of photos shown in Fig. 4 were taken from the bridge, looking down stream to the southwest into plot 11. For reference note the old cottonwood tree stump in the center of A and the bottom right corner of B. The bridge in A was washed out by the flood of 1990. Numerous planks from the replaced bridge also have been washed out by subsequent floods. The bridge is substantial enough to support large tandem wheeled gravel and concrete trucks as well as large combines. Photo A was taken in March, 1990. Note the bare streambanks of this area which was previously grazed.

Photo B was taken in June of 1994. Plot 11 is an ash plot with an Austree® willow plot planted at the end and soil bioengineering live willow stakes pounded into the bank. At the end of the 1993 growing season the ash and willow were 2.4 m and 5.0 m tall, respectively. All of the grass and herbaceous plants that are seen in the photo were either already on site or seeded in naturally. Only trees, shrubs, and willow cuttings were planted. The switchgrass strip which was planted is hidden by the trees in photo B. This site was

Fig. 4. Looking downstream to the southwest from the bridge across plot 11 (green ash) (A) before planting, March 1990; (B) June, 1994.

subjected to a 500 year and 5 other out-of-bank floods during the 1993 growing season. The results show how effective the MSRBS is as a frictional buffer.

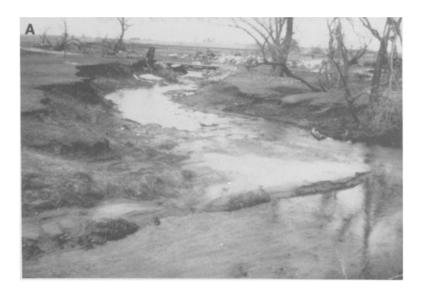
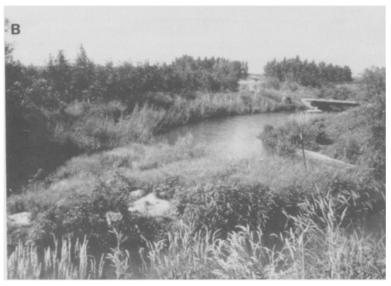
The two photos shown in Fig. 5 also were taken looking downstream toward the bridge (toward the southwest) from the east end of plot 12 on the north-

Fig. 5. Looking downstream to the southwest from the end of plot 12 (poplar hybrid) (A) before planting, March, 1990; (B) June, 1994.

west side of the creek with plot 4 on the southeast side of the creek. Photo A was taken in March 1990 and photo B was taken in June 1994. Notice the fence along the right side of the creek in photo A identifying the grazed and cultivated areas along the creek. The bridge is located just beyond the farm equipment standing near the center of the photo. Also notice the very steep,

bare banks and the point bar on the southeast side of the creek. Without the cattle grazing the sandbar and the banks grass and herbaceous cover have been restored. No willow cuttings have been planted along this portion of the creek. Even after the floods of 1993 the streambank integrity was maintained. The trees on both sides of the creek are poplar hybrids which averaged 4 m in height at the end of the 1993 growing season.

Notice the growth of the silver maple through the 1993 season (Fig. 5). Silver maple grows slower than the popular hybrids during the first several years but after the third growing season it begins to accelerate growth dra-

matically. At the end of the 1993 season the silver maple in the background averaged 3 m in height.

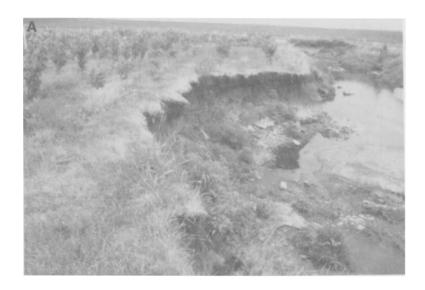
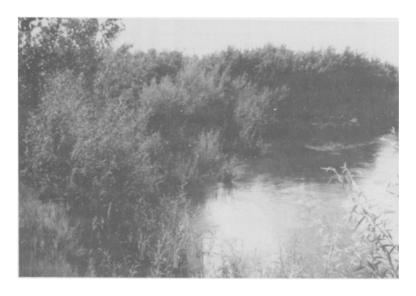
Figure 6 shows the willow post streambank bioengineering for bank stabilization. Photo A was taken near the end of the growing season in 1991 looking north along the edge of plot 2. The floods of 1990 and 1991 caused excessive bank erosion in this bend. In photo A, notice that two rows of silver maple can be seen at the far end of the eroded segment of the bank. The photographer was standing in the middle of where these trees had been machine-planted in 1990. Spacing between the tree rows is 1.8 m. The smaller, lighter colored walnut seedlings can be seen to the left of the eroded bank. A total of about 4.5 m of streambank was eroded from this location during the first two years of the project.

The results of the planting exceeded expectations, especially considering the extensive flooding that occurred in 1993. Photo B shows the planting in June 1994. A visit to the site in late November, 1993, after the leaves had fallen from the trees, indicated that the posts were trapping sediment from the stream as well as sediment from further collapse of the bank. Only an additional 0.3 m of bank has been lost since the willow posts were installed. What had been a straight wall now has an angle approaching 45°. The slope of the bank should continue to become more gentle as the permanent woody as well as herbaceous vegetation become established. It has been very encouraging to observe how well this system withstood the intense flooding of 1993. Several large logs and two bridge planks were caught in the willow thicket. Although some of the stems were skinned and did not resprout, most survived and continued to grow. The placement of willow cuttings in the vertical bank and in the streambed seems to be a viable method of stabilizing streambanks, especially before the other buffer strip tree root systems become established to the point that they also stabilize the bank.

Fig. 6. Looking downstream toward the northwest along plot 2 (silver maple) (A) before soil bioengineering live stakes were installed, September, 1991; (B) June, 1994.

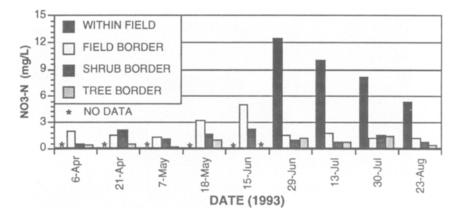
The impact of the developing MSRBS on water quality demonstrates its effectiveness at reducing NPS pollutants. Results for nitrate nitrogen (NO_3 -N) and atrazine are shown in Figs 7 and 8. As can be seen the NO_3 -N

Fig. 7. Mean 1993 nitrate-nitrogen concentrations in the field and at the field-switchgrass, switchgrass-shrub, and tree-streambank borders in plots 1 and 3 of the MSRBS.

concentrations in the MSRBS never exceed 2 mg l⁻¹ even though levels of NO₃-N exceed 12 mg l⁻¹ in the field. The field measurements are not collected until the end of June almost two months after the fertilizer and herbicide are applied because lysimeters are not installed until after the last cultivation. Atrazine concentrations were high during the rainy months of June through August and exceeded the EPA Maximum Contaminant Level (3 mg l⁻¹) in the field and at the field border with the MSRBS after application in the beginning of May. In each of the measurement periods, atrazine concentrations decreased in the field and across the buffer strip. These data suggest that the buffer strip is effective in reducing NPS pollutants in the vadose zone. Similar data from minipiezometers located at 3 m below the MSRBS in each of the instrument nests confirms that these chemicals also are not moving below the buffer strip.

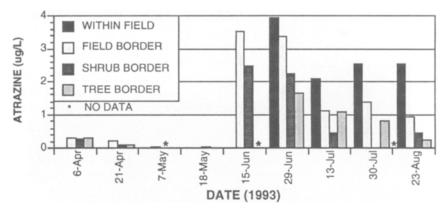
Fig. 8. Mean 1993 atrazine concentrations in the field and at the field-switchgrass, switchgrass-shrub, and tree-steambank borders in plots 1 and 3 of the MSRBS.
