Field Surveys and Numerical Simulation of the 2018 Typhoon Jebi: Impact of High Waves and Storm Surge in Semi-enclosed Osaka Bay, Japan

Abstract—Typhoon Jebi made landfall in Japan in 2018 and hit Osaka Bay on September 4, causing severe damage to Kansai area, Japan's second largest economical region. We conducted field surveys around the Osaka Bay including the cities of Osaka, Wakayama, Tokushima, Hyogo, and the island of Awaji-shima to evaluate the situation of these areas immediately after Typhoon Jebi struck. Jebi generated high waves over large areas in these regions, and many coasts were substantially damaged by the combined impact of high waves and storm surges. The Jebi storm surge was the highest in the recorded history of Osaka. We used a storm surge–wave coupled model to investigate the impact caused by Jebi. The simulated surge level was validated with real data acquired from three tidal stations, while the wave simulation results were verified with observed data from four wave monitoring stations. The high accuracy of the model demonstrates the usefulness of numerical simulations to estimate the heights of storm surges and wind waves at specific locations, especially

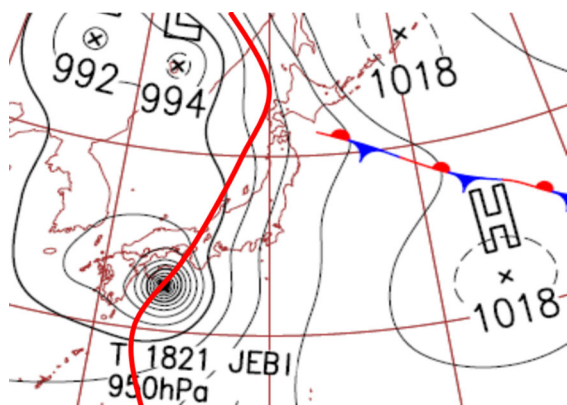
Figure 1

Japan Meteorological Agency's weather map immediately before Jebi made landfall (September 4, 2018, 09:00, Japan Standard Time, UTC + 9) (The red line is Jebi track)

A wind radius of 50-kt was estimated around 220 km (in the longest axis) when Jebi was about to make landfall (Fig. 1). Jebi maintained maximum wind speed of 75–85 kt (139–157 km/h) when it hit Osaka. The sea level pressure during the passage of Jebi over Osaka Bay was of 950–975 hPa. As Typhoon Jebi swept through the Osaka Bay and the south of Honshu Island, it caused heavy rainfall, high

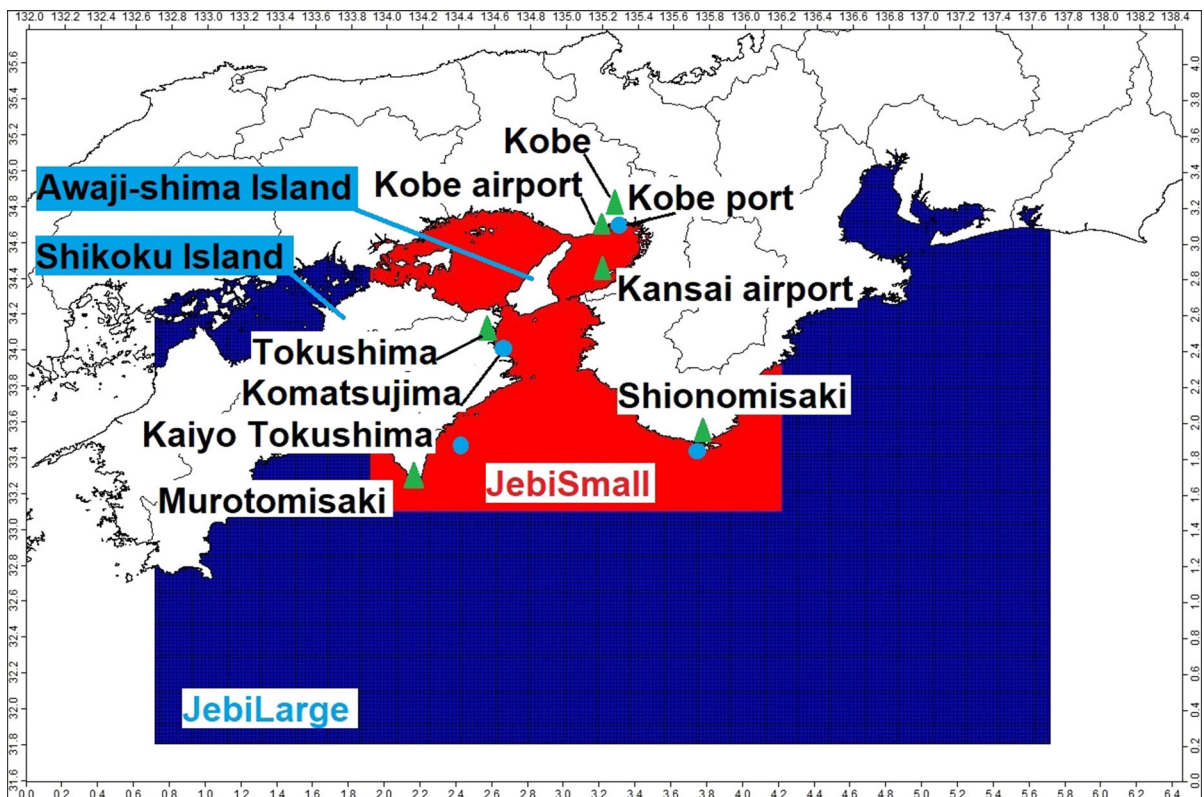
Figure 2

Simulation domains for simulating wind waves during Typhoon Jebi. The indicated locations have wave monitoring stations of the NOWPHAS and wind observation stations from JMA, whose data were used in this study for model verification (circle, wave monitoring station; triangle, wind monitoring station)

The wave simulation was performed by nesting two computational domains. Domain *JebiLarge* (Fig. 2) covers the deep sea outside Japan mainland as parent grid with resolution of $0.02^\circ \times 0.02^\circ$, being used for both hydrodynamic and wave models, whereas domain *JebiSmall* (Fig. 2) includes the inner bay stretch from the Kii Strait to Osaka Bay as nested internal grid with resolution of approximately $500 \text{ m} \times 500 \text{ m}$, being used for detailed wave simulation. The bathymetric data at 500 m intervals and retrieved from the Japan Oceanographic Data Center (JODC) (<http://www.jodc.go.jp/jodcweb/>) was used for both Delft3D-FLOW and Delft3D-WAVE model simulations to incorporate the detailed bathymetry from the study areas. Both models relied on wind fields from the hourly grid point values (GPVs) of numerical weather prediction based on the mesoscale spectral model of the JMA. The forecasting of the mesoscale spectral model is known as the JMA nonhydrostatic model (Saito et al. 2006). The forecast domain is the rectangular area including the entire Japan territory and surrounding area with approximate grid spacing of 5 km (a grid resolution of $0.065^\circ \times 0.05^\circ$ covers the domain from 120°E to 150°E and from 22.4°N to 47.6°N). Data of GPVs are available from the server of the numerical weather prediction/observation data of the JMA (Japan Meteorological Agency. The numerical forecast data/observed data). The data contain many variables including sea-level pressure, surface pressure, and eastward/northward components of wind.

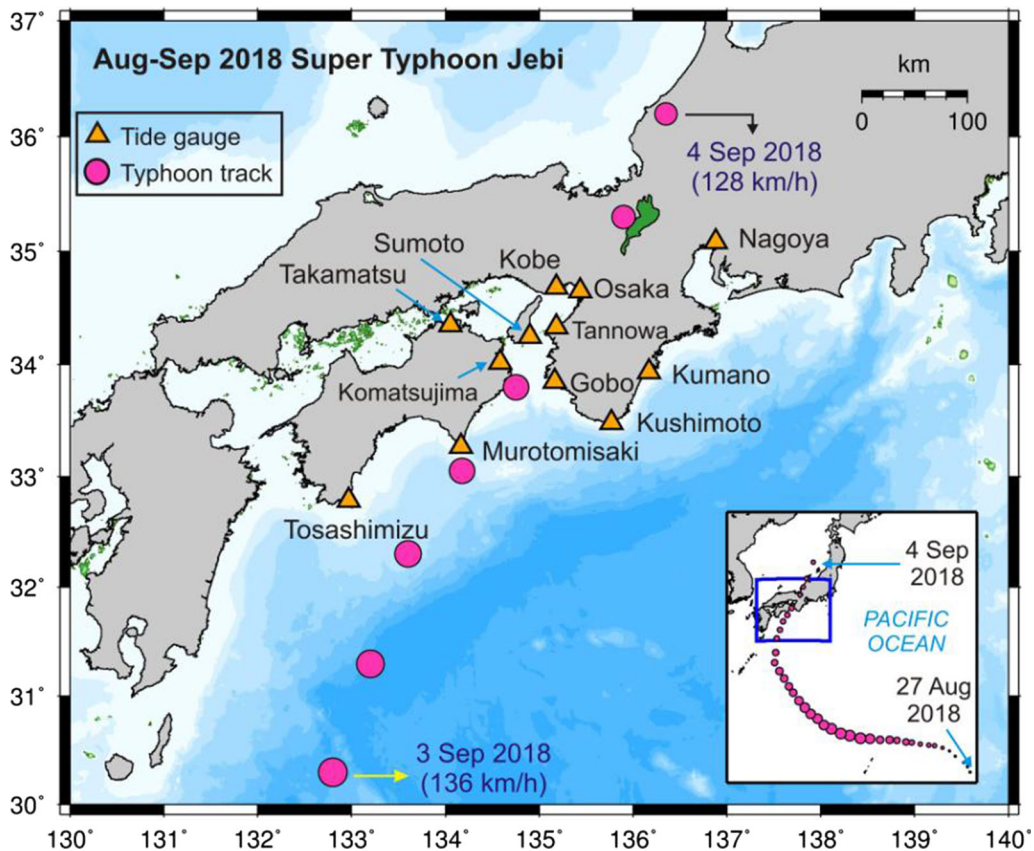
Figure 3

Map of west Japan showing the locations of tide gauge stations (orange triangles) considered in this study and trajectory (pink circles) of Typhoon Jebi from August to September of 2018

We analyzed the sea level data at 12 tide gauge stations along the trajectory of Typhoon Jebi (Fig. 3). The original data were sampled at intervals of 15 s and provided by the JMA. Tidal signals were estimated using the MATLAB Tidal Fitting Toolbox (Grinsted 2008), and sea level references were removed to produce detided waveforms. In addition, we applied a 15 min

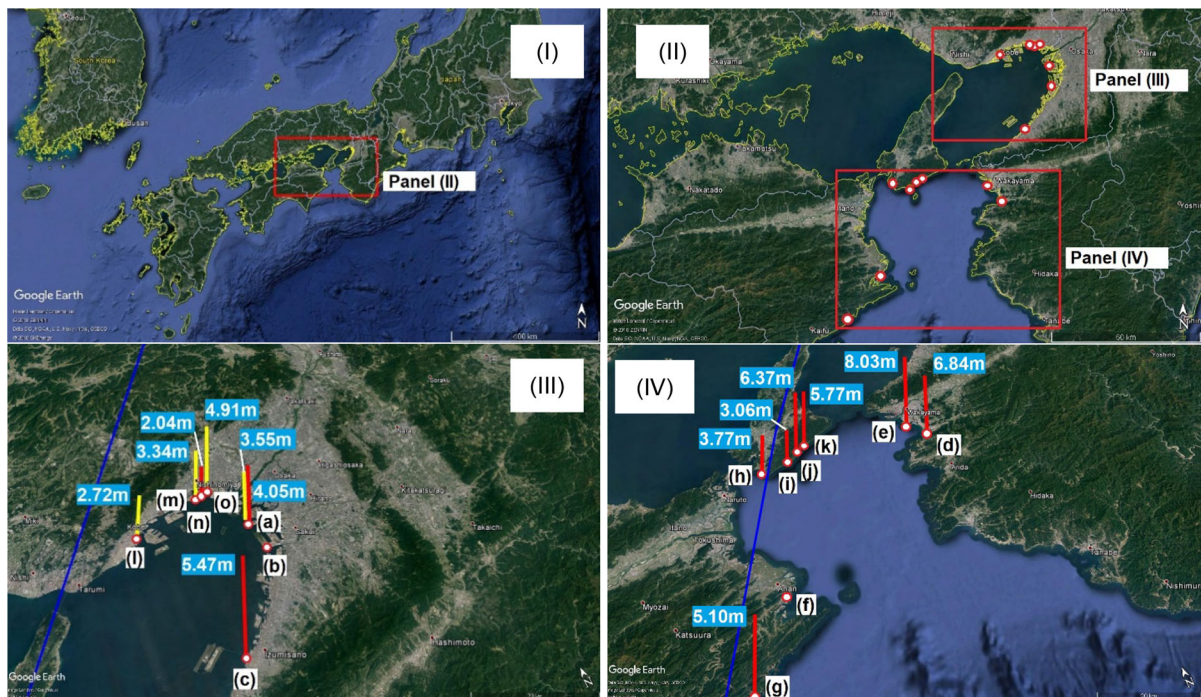
I Large view of field survey area, II location of survey points, III storm surge and overtopping height measurements inside Osaka Bay and IV around Kii Strait. Primary mechanism of elevated sea level: wave overtopping (red) and storm surge (yellow). The blue line indicates the trajectory of Typhoon Jebi. Locations (a–o) indicate the sequence of survey points

Fifteen locations along the coastline of the four most affected prefectures, namely, Osaka, Wakayama, Tokushima, and Hyogo (including Awaji-shima island) were surveyed (Fig. 4, Table 1). Evidence of storm surges, damage of coastal protection, and overtopping induced by high waves were observed. Figure 4 shows the field survey locations with the corresponding storm surge and wave overtopping heights. Although the total water level should have been determined by the combination of waves and storm surge, Fig. 4 distinguishes the primary mechanism for elevated sea level as being either wave overtopping or storm surge based on our onsite observations.

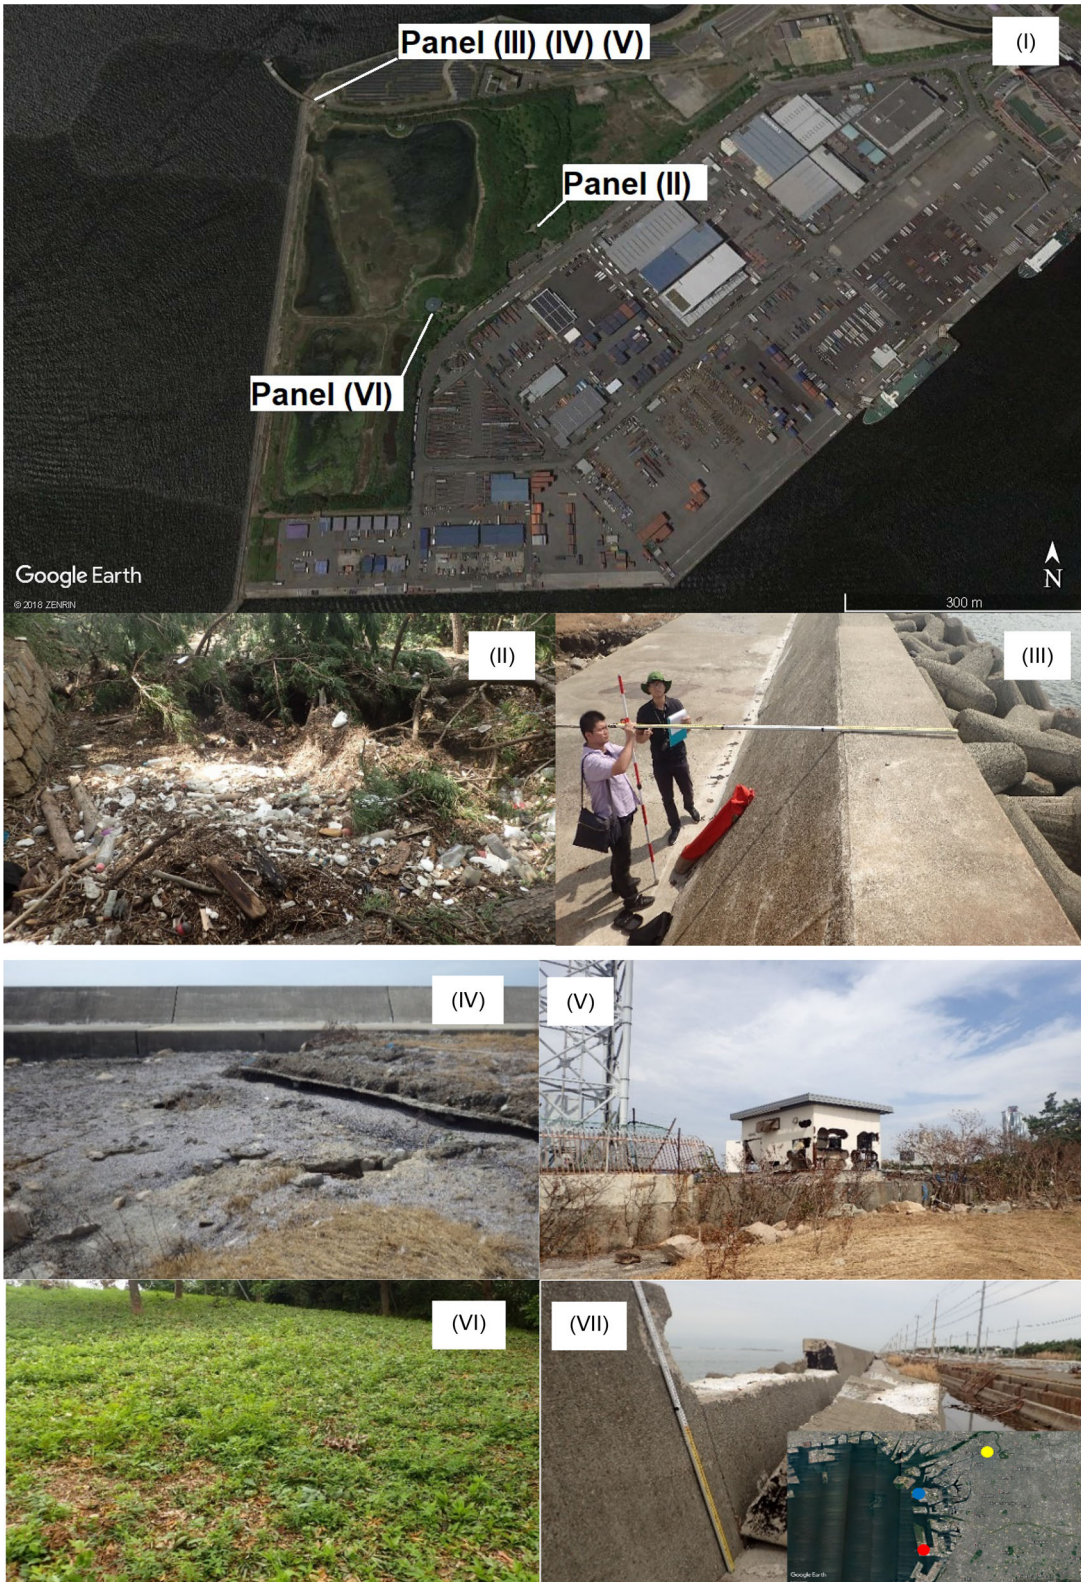
Field survey at Nanko Bird Sanctuary and Sakai [locations (a, b) in Fig. 4III]. **I** Survey locations at the sanctuary, **II** trash accumulated over the main route, **III** sea dyke, **IV** scour behind the dyke due to wave overtopping, **V** damaged building near the dyke, **VI** difference in grass color demonstrating that seawater reached a height up to the withered grass and **VII** broken parapet at Sakai City outside (red dot: Sakai, blue dot: Nanko bird filed, yellow dot: Osaka)

The Nanko Bird Sanctuary is located at the northwest corner of Sakishima artificial island in Osaka Bay and is a stopover for migrating birds on their way from the Arctic Circle to Southeast Asia to avoid winter (Fig. 5I). A broken statue surrounded by several fallen tree branches was observed at the main entrance, and many cracked big trees obstructed the main route. The soil was still wet and slippery due to the coastal flooding. Trash was gathered by the wind and floodwater (Fig. 5II). We started to investigate the site immediately behind the seashore, where a dyke with tetrapod blocks was constructed (Fig. 5III). Severe scour behind the dyke was observed (Fig. 5IV). Hence, waves should have overtopped the dyke with a height of 4.05 m relative to TP. Likewise, strong winds should have caused partial damage to the building next to the sea, evidenced by

the broken metal fence and broken windows (Fig. 5V). We measured the elevation from the sea surface to the place where a watermark evidencing the inundation height remained, as we found an obvious visible line distinguishing the inundation on a grassy hill (Fig. 5VI). We observed small white flowers on top of the hill, whereas grass had withered and disappeared (brown color ground can be seen at that place) below the line where seawater had likely reached. Given that this line was almost horizontal, seawater should have been brought by storm surge, whose height relative to TP was estimated to be approximately 3.55 m. At Sakai, the port/industrial city located at the south of Osaka, several sections of coastal dykes with a-2 m high parapet were torn apart most likely due to impressively high wave pressures (Fig. 5VII).

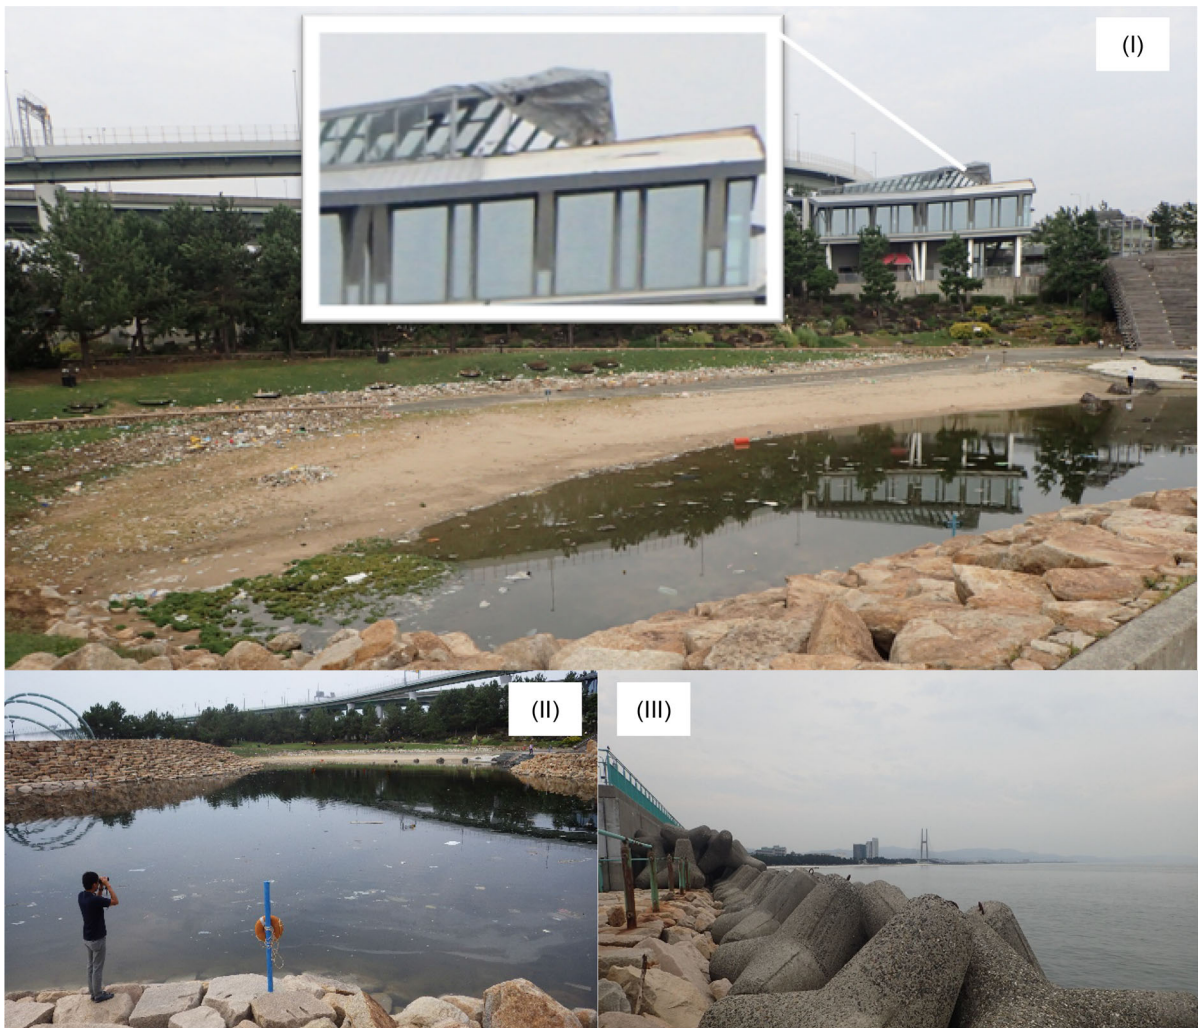
Figure 6

Field survey at Rinku Park [location (c) in Fig. 4III]. **I** Park overview two days after Typhoon Jebi impact showing trash and a damaged roof. We measured the elevation of the ground where trash remained. **II** Inner and **III** outer protection layers of the park

We conducted a survey at the Rinku Park located on the opposite side of Kansai International Airport (Fig. 6). The Rinku Park attracts tourists who arrive from the airport and local people by its greenery, seaside seeing spots, and long walking trails. However, Typhoon Jebi severely damaged the park, and the access for visitors was suspended. When we visited the park 2 days after Jebi, several fallen tree branches remained on the ground near the entrance. Trash was scattered everywhere, though no visible damage to the park infrastructure was observed, except for a roof damage caused by strong winds (the roof cover panels were blown away) (Fig. 6I). No residences are located around the park area. The inundation height was evidenced by the remaining trash on the artificial beach of the park. We measured the elevation from the sea level at the time of our survey to the highest line of visible trash (Fig. 6II),

estimating an inundation height of 5.47 m relative to TP. The park was well protected from the sea by a two-layer infrastructure comprising an outer thick tetrapod layer and an inner large stone barrier. Both layers did not suffer any considerable damage showing that the wave force was not significantly strong, and only wave overtopping caused inundation (Fig. 6II, III). The elevation of the stone dyke is about 1.8 m above the mean sea level.

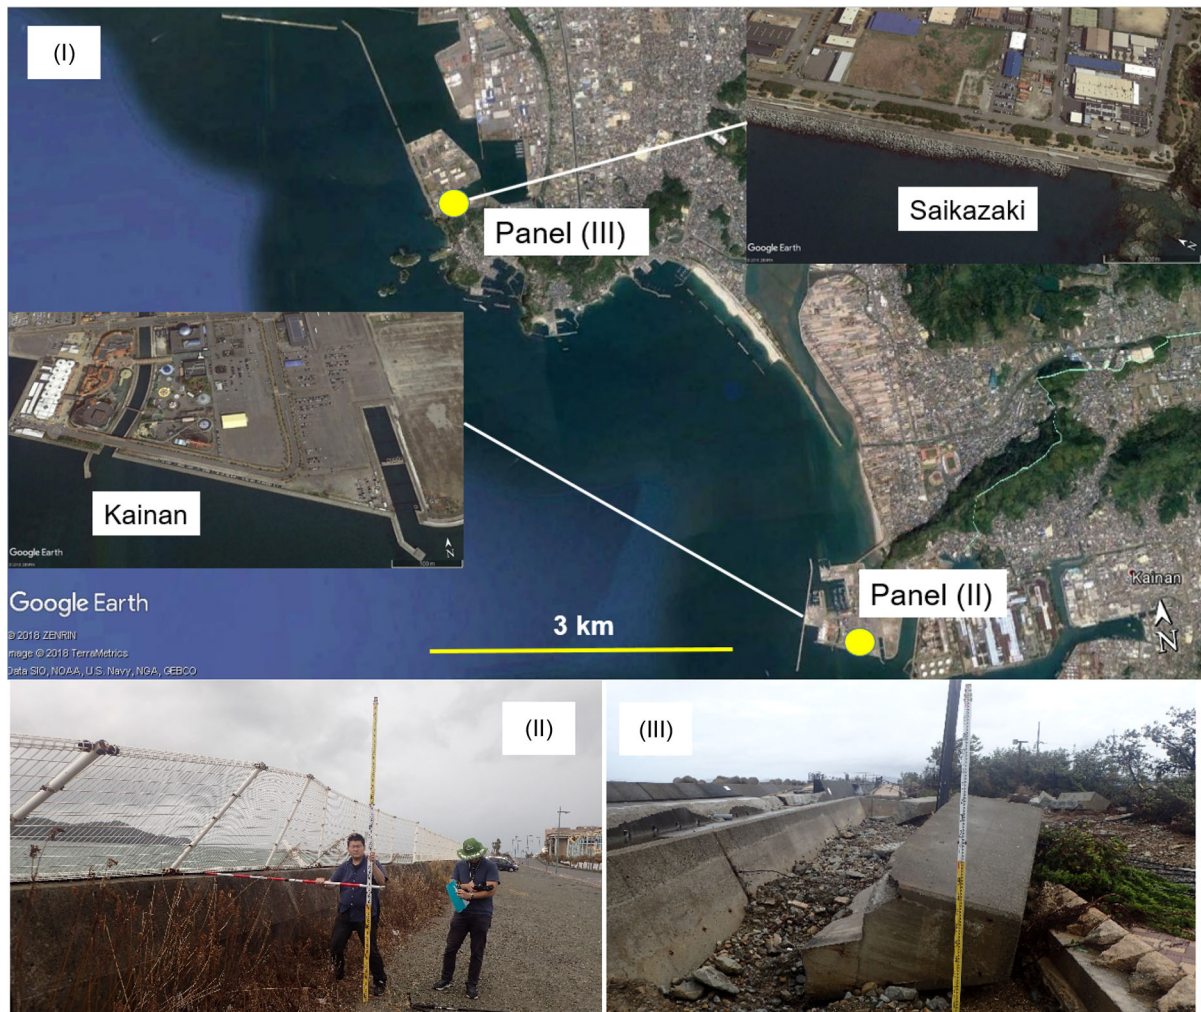
Figure 7

Field survey at Wakayama [locations (d, e) in Fig. 4IV]. **I** Localization of Kainan and Saikazaki, **II** coastal fence smashed by high waves at Kainan, **III** broken parapet by overtopping waves at Saikazaki

Kainan and Saikazaki are located at the northwest coast of the Wakayama Prefecture (Fig. 7I). We found no clear evidence of extensive inundation induced by storm surges in the typhoon aftermath. However, damage caused by wave overtopping were observed at many locations. At Kainan, we visited an entertainment park (Wakayama Marina City), and all

the buildings looked robust against strong winds and exhibited no visible damage. However, we found evidence of wave overtopping in a coastal fence of 1.2 m high, which was smashed by high waves. The waves reached at least 2.7 m above the sea level (Fig. 7II). By using the GPS receivers, we measured elevations relative to TP of 4.14 and 6.03 m at Kainan and Saikazaki, respectively.

One of the coastal protection structures in Saikazaki seemed to be sufficiently strong against waves, but this area has two dyke layers, each with approximately 2-m parapets and armoring brocks supporting the first dyke. However, the parapet of the second dyke was smashed by overtopping waves, causing a deep hole due to scouring (Fig. 7III). The damage at this place was much severer than that at Kainan, suggesting that even neighboring coasts may have experienced different levels of wave impact by multiple factors such as the presence of offshore

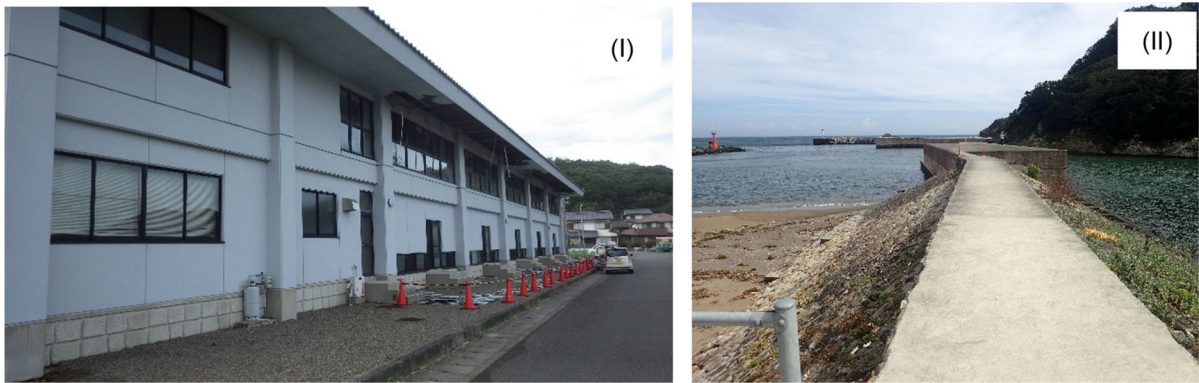
Figure 8

Field survey at Tokushima [locations (f, g) in Fig. 4IV]. **I** Damaged roof in a village from Anan, **II** high sea dyke at Minami Awa

We visited a coastal village of Anan City, Tokushima (Fig. 8). This place is naturally protected by several islands. Although roofs and windows of a public sports hall were broken by strong winds (Fig. 8I), no serious damage was caused by coastal floods. A resident witnessed a quickly raising water level

during Typhoon Jebi. Although the waves did not exceed the dike, seawater intruded through a sewage pipe and partially flooded her house. A beach in Minami Awa Town located at the Southeast coast of Shikoku island has a sea dyke at approximately 4.7 m high from the ground, which effectively protected the village against high waves during Typhoon Jebi. According to another resident, high waves ran up and left many driftwoods on the sandy beach, but there was no considerable damage (Fig. 8II). Our measurements revealed that waves carried woods at least 5.1 m higher than TP.

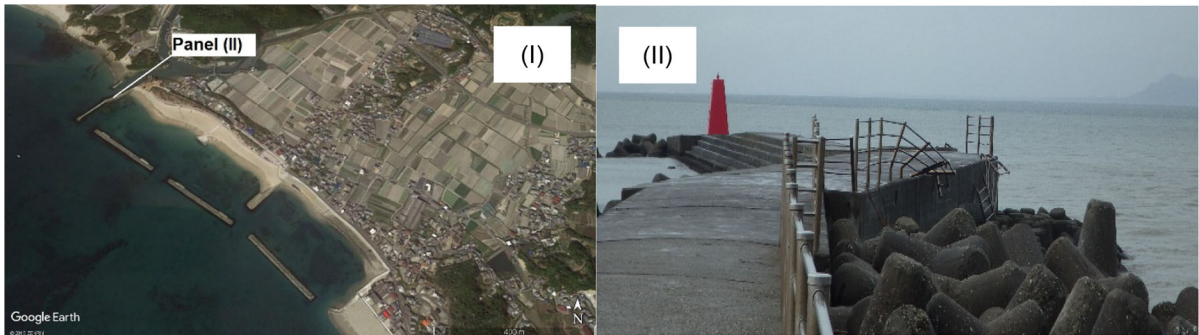
Figure 9

Field survey at Honjo river mouth [location (h) in Fig. 4IV]. **I** Location of training wall and **II** smashed handrail of the training wall

The Awaji-shima island is a remote island located next to Osaka Bay. We began the field survey at the Honjo river mouth located at the southern part of the island. There is a sandy beach separated from the Honjo river by a training wall (Fig. 9I). Several breakwaters parallel to the beach protect the coast. Trash, sand, and broken tree branches were on the beach, and the handrail of the training

wall had been apparently smashed by high waves and fell to the river (Fig. 9II). The direction of the fallen handrail suggests the primary direction of high waves, and the height from the local sea level to the top of the training wall was 3.77 m relative to TP, but we found no clear evidence of coastal inundation here.

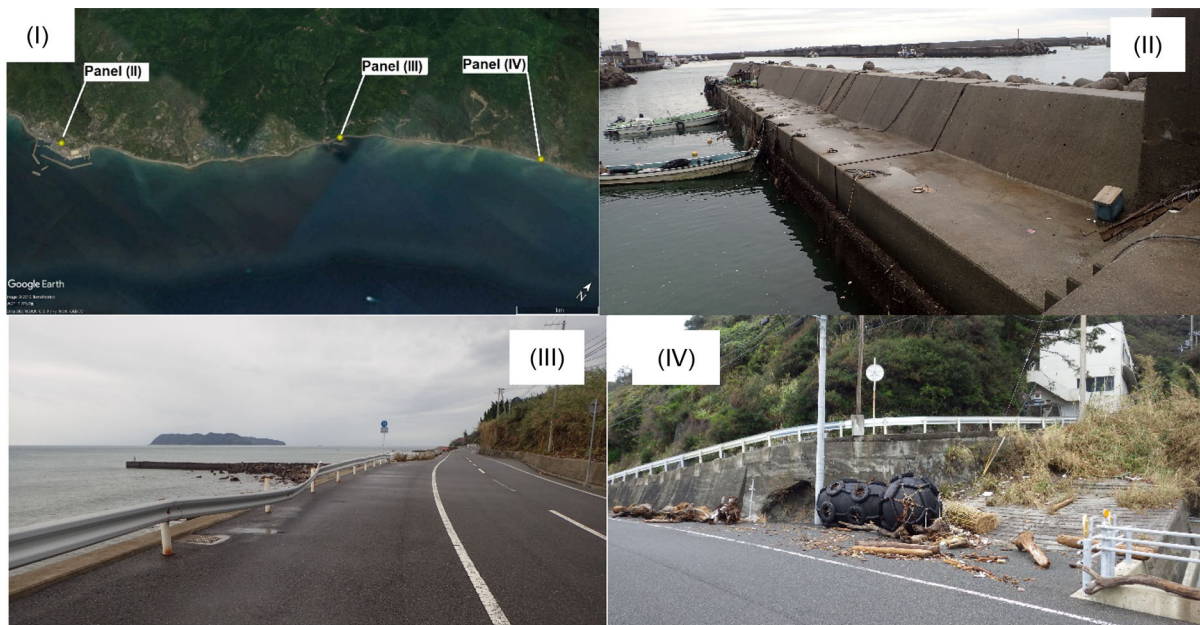
Figure 10

Field survey at eastern coast of Awaji-shima island [locations (i–k) in Fig. 4IV]. **I** Location of surveyed places, **II** armored breakwater at Minami Awa Fishing Port, **III** smashed guardrail at Awa Nadakuroiwa, **IV** rubber fenders found at Awa Nadashirosaki caused a large punching hole on a wall

The authors focused on the eastern coast of the island and carried out the field survey at several locations (Fig. 10I). The Minami Awa Fishing Port was protected by breakwaters with armor brocks on the sea side (Fig. 10II). Scattered fishing tools

indicated that the internal breakwater was overtopped. However, no considerable damage was observed at the port. Close to the fishing port, we found a road guardrail (reaching 6.37 m relative to TP) that was bent towards the land (Fig. 10III). Two large rubber fenders ($3 \text{ m} \times 1.3 \text{ m} \times 1.7 \text{ m}$) were washed away along with driftwoods by high waves and found on the coastal road at 5.77 m relative to TP. The wave force was strong enough to create a hole of $3.7 \text{ m} \times 2 \text{ m}$ on the wall behind the road (Fig. 10IV).

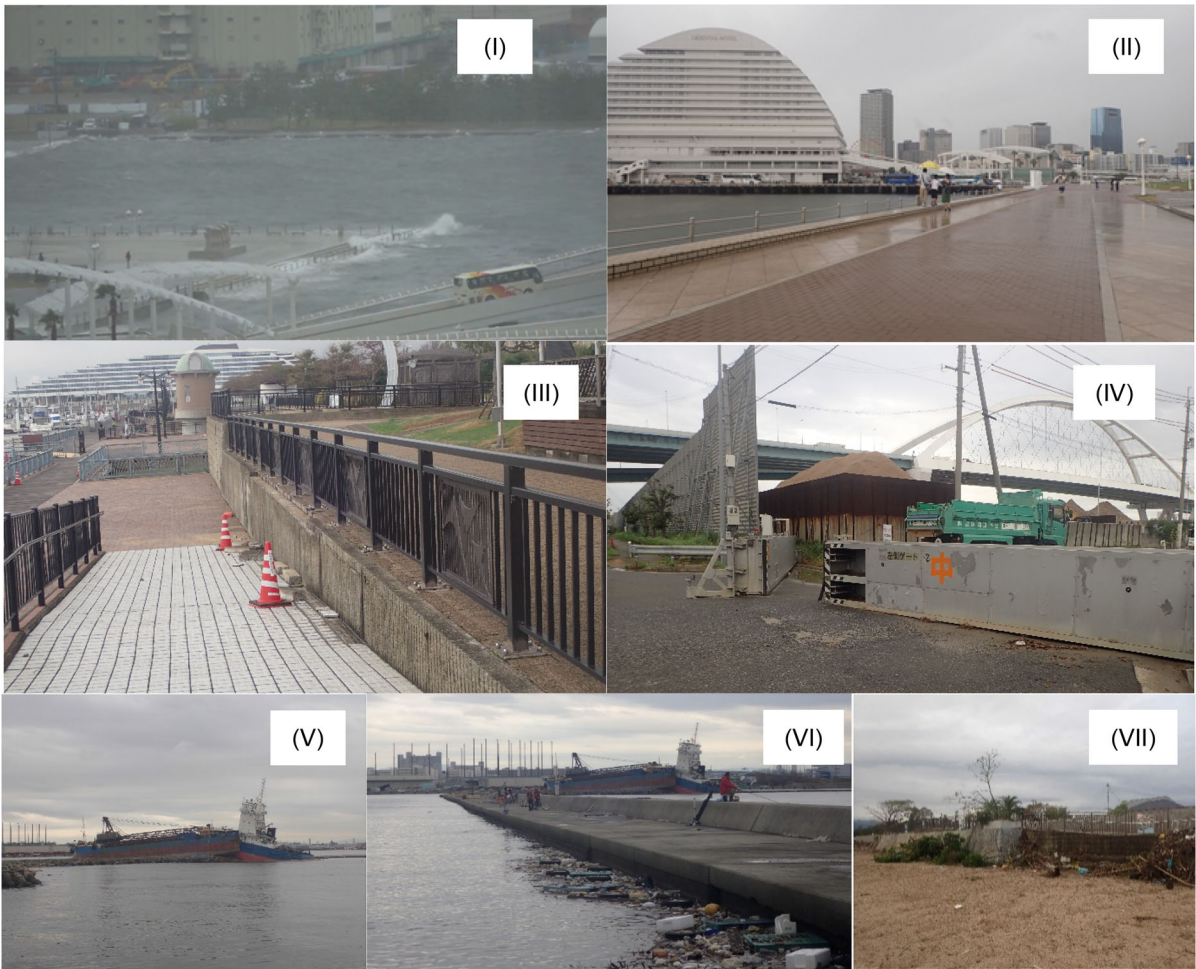
Figure 11

Field survey at Kobe city [locations (I–o) in Fig. 4III]. **I** Kobe Meriken Park storm surge and high waves during Typhoon Jebi (rough sea screenshot from online live camera at 14:17, September 4, 2018, Japan Standard Time) (<https://www.youtube.com/watch?v=lCupBcgCuO8>), **II** situation after 4 days of the typhoon at Kobe Meriken Park, **III** fallen bricks at Nishinomiya Yacht Harbor, **IV** destroyed inland floodgate at Amagasaki Port, **V** stranded large vessel at Amagasaki Port, **VI** trash gathered behind breakwater, **VII** Koshienhama Artificial Beach, where wave overtopping was confirmed

The Meriken Park in Kobe City was flooded due to high waves and storm surge, which overtopped the terrace of the park with elevation of 2.72 m relative to TP (Fig. 11I). Typhoon Jebi with strong winds of around 34.6 m/s (at Kobe airport) coincided with the flood tide period. Trash and debris had been already cleared when we visited the park 4 days after the typhoon (Fig. 11II). The building around the Meriken Park did not suffer considerable damage. We also investigated the Yacht Harbor in Nishinomiya, Hyogo Prefecture. The breakwater protected the harbor, preventing consequences from waves. However, there was a small damage on the wall at

approximately 3.34 m above the sea level (TP), as confirmed by fallen bricks (Fig. 11III). We observed the inland floodgate destroyed (Fig. 11IV) and a stranded large vessel on the top of the breakwater inside the Amagasaki Port, which is located next to the harbor (Fig. 11V). As this location belongs to the innermost part of the Osaka Bay, waves appear to be small under normal weather conditions. Therefore, the breakwater was constructed relatively low in height at only 2.04 m relative to TP. A high amount of trash was also accumulated on top of the breakwater, demonstrating wave overtopping (Fig. 11VI). An artificial beach in front of the residential area, named Koshienhama, was also damaged by high waves (Fig. 11VII). Based on the observed trash and driftwood left on top of the dyke, we confirmed that waves reached at least 4.91 m relative to TP, just

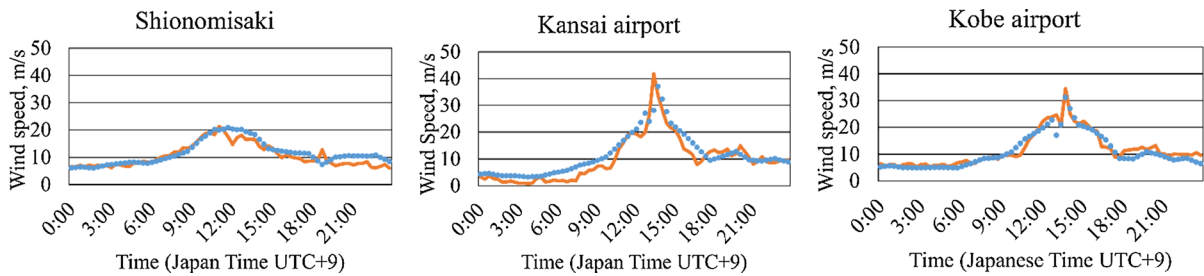
Comparison between wind speed obtained from the JMA mesoscale spectral model (blue dotted line) and observed data (orange solid line) on 4 September 2018 (time in Japan Standard Time, UTC + 9)

Before importing the wind speeds derived from the JMA GPVs as input to the hydrodynamic and wave model, we verified them with observed data from the stations. The observed data were measured at the relevant weather observation stations operated by the JMA (see Fig. 2). Figure 12 compares the observed and calculated wind speed at three stations, namely, Shionomisaki, Kansai airport, and Kobe airport. Despite the discrepancies between the measurements and estimations, the data from the GPVs show good agreement with the observed data at the peak time, with a slight underestimation (3–5 m/s). Air pressure measurements were taken from Shionomisaki, Tokushima, and Kobe stations due to the missing functions at some stations. The GPV air pressure data (988 hPa) at Shionomisaki retrieved a slight

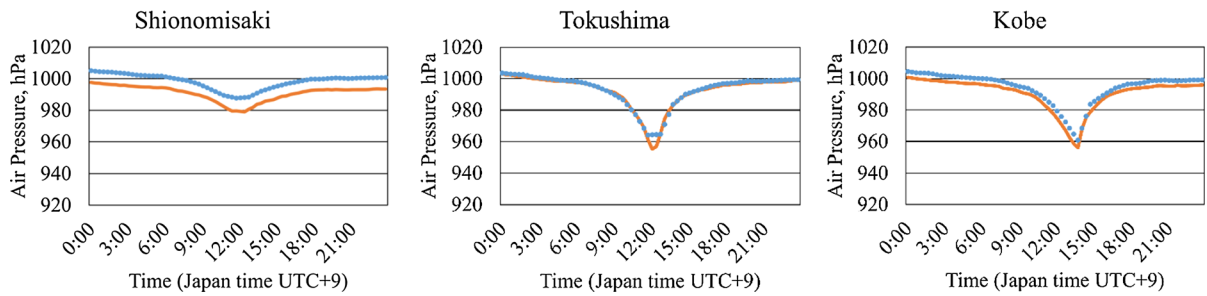
Figure 13

Comparison between air pressure obtained from the JMA mesoscale spectral model (blue dotted line) and observed data (orange solid line) on 4 September 2018 (time in Japan Standard Time, UTC + 9)

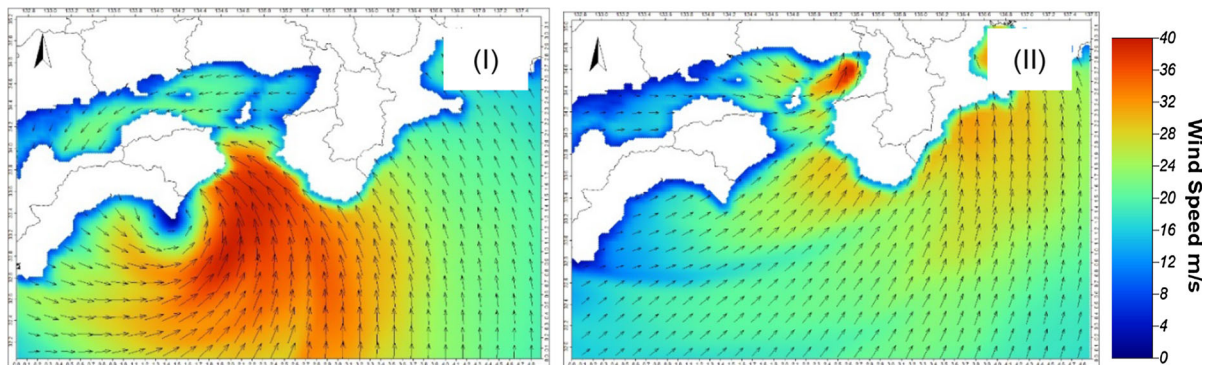
Figure 14

Wind field distribution during Typhoon Jebi passage **I** over Kii Strait on September 4, 2018 at 11:00 and **II** inside Osaka Bay at 14:00 (Japan Standard Time, UTC + 9)

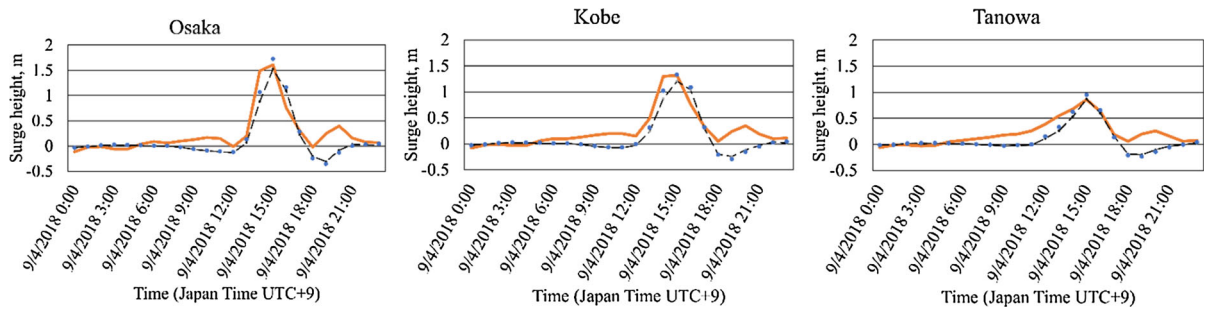
Comparison of calculated surge level with flow–wave interaction (blue dotted line), no interaction with wave (black dash line), and observed values (orange solid line) during Jebi passage

the water level in Osaka Bay by approximately 10%. Results from numerical simulations of the surge component caused by Jebi and using the coupled model are compared with real data at Tanowa, Kobe, and Osaka respectively in Fig. 15. The increasing water level during the passage of Jebi is suitably reflected by Delft3D-FLOW model (maximum difference was about 10% at Tanowa, RMS values of 0.23, 0.21, and 0.18 at Osaka, Kobe, and Tanowa, respectively). Figure 15 shows that the simulated surge height reached up to 1.75 m in Osaka, while the observed data was 1.61 m from the tidal gauge. This small overestimation can be partially attributed to the land-boundary condition in the model, which does not consider overflow, whereas coastal floods took place in some port areas (Takabatake et al. 2018). The water surface elevation at Osaka started increasing at 13:00 and reached its peak at 15:00, while 47.4 m/s of maximum wind speed was recorded in

Osaka at 14:10. Thus, there is about a 1-h lag between the growth of wind speed and water level. Similar lag times were observed at Tanowa and Kobe. The spatial distribution of the maximum surge level when Jebi crossed the Kii strait and hit land at Osaka are shown in Fig. 16.

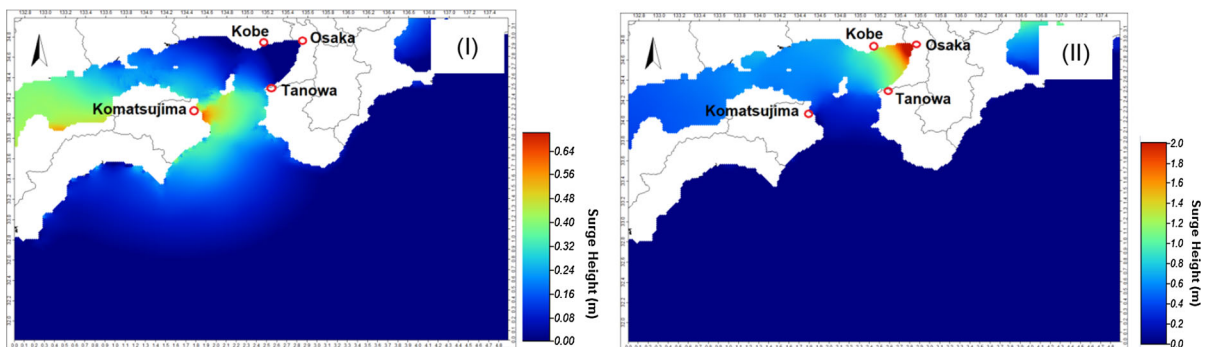
Figure 16

Storm surge distribution during Typhoon Jebi passage **I** over Kii Strait on September 4, 2018 at 12:00 and **II** inside Osaka Bay at 15:00 (Japan Standard Time, UTC + 9)

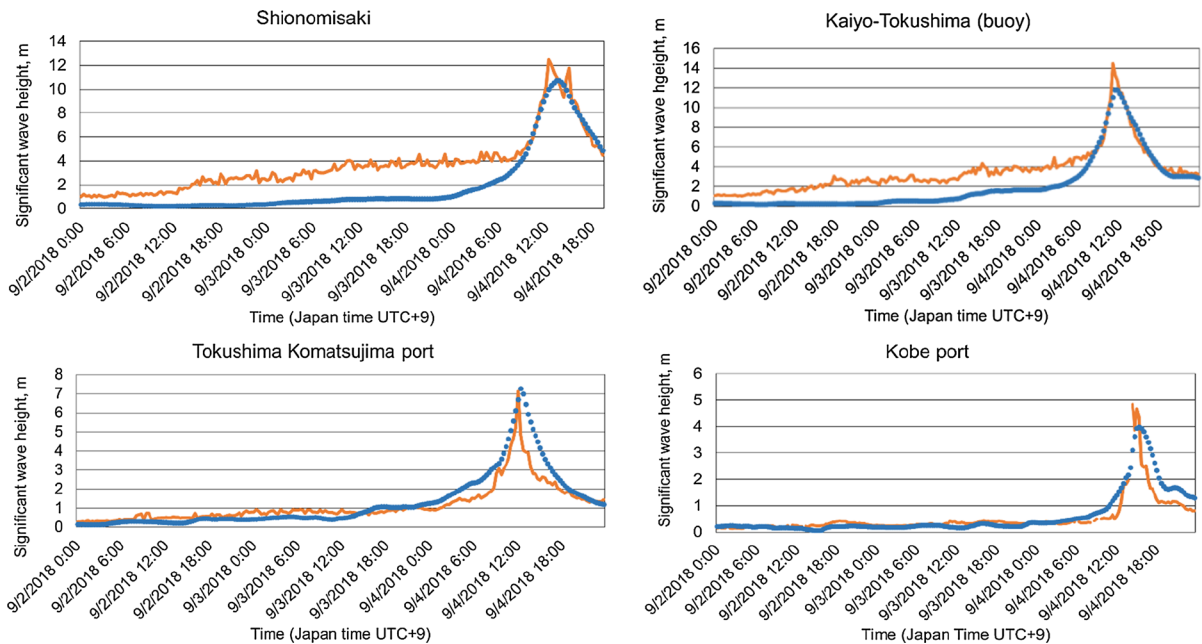
Significant wave height obtained from our surge-wave model (blue dotted line) and observed data (orange solid line). Time is expressed in Japan Standard Time, UTC + 9

depth-limited condition is relaxed due to the increased water depth. Hereafter, the wave simulation coupled with the flow simulation is considered to account for the influence of the wave–flow interaction. Figure 17 shows the simulation accuracy by comparing the estimated significant wave height with data measured from NOWPHAS, showing a reasonable agreement especially at the peak values at all stations. The model underestimates the significant wave height by up to 2.7 m at the Kaiyo Tokushima buoy likely by the difference in wind speed. The measured wind speed at Murotomisaki station (Fig. 2) near Kaiyo Tokushima was 47.7 m/s, which was much higher than the 30.3 m/s obtained from the GPV model. The simulation results also underestimated the real data at Shionomisaki and Kobe, while a slight overestimation (0.1 m) was found at Komatsujima. The mesoscale model has a limitation to

estimate the wind field, particularly near the center of typhoons (Tanemoto and Ishihara 2013, 2015). As the Murotomisaki station and Kaiyo Tokushima buoy were closer to the Jebi track than other stations, the wave height tends to be underestimated. Simulation waves at Tokushima-Komatsujima and Kobe port show better RMS values (0.62 m and 0.37 m, respectively) than the other two offshore stations, Kaiyo-Tokushima and Shionomisaki (2.98 and 2.04, respectively).

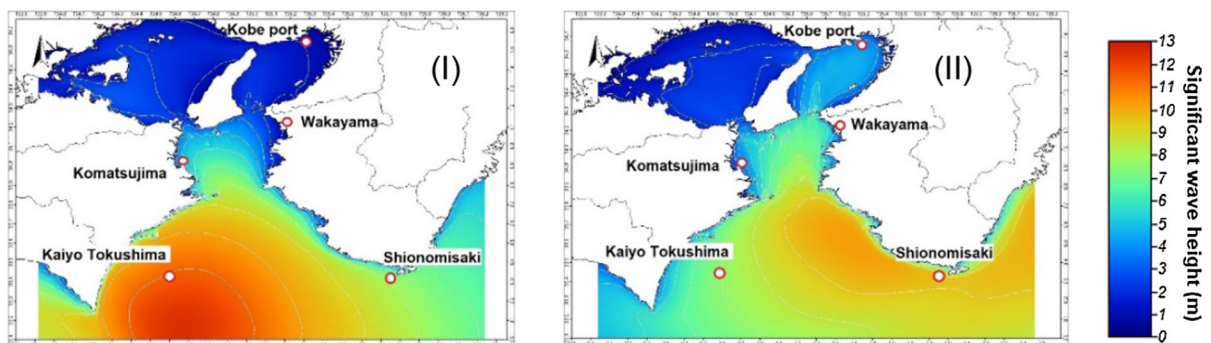
Figure 18

Significant wave height distribution during Typhoon Jebi passage **I** over Kii Strait on September 4, 2018 at 11:00 and **II** inside Osaka Bay at 14:00 (Japan Standard Time, UTC + 9)

Figure 18I shows that the maximum significant wave height was nearly 13 m in the strait between Shikoku and Honshu island when the typhoon made landfall at the coast of the Tokushima Prefecture. The east coast of Shikoku island suffered the highest wave about 2 h before the west coast of Wakayama Prefecture was affected. The simulation also shows

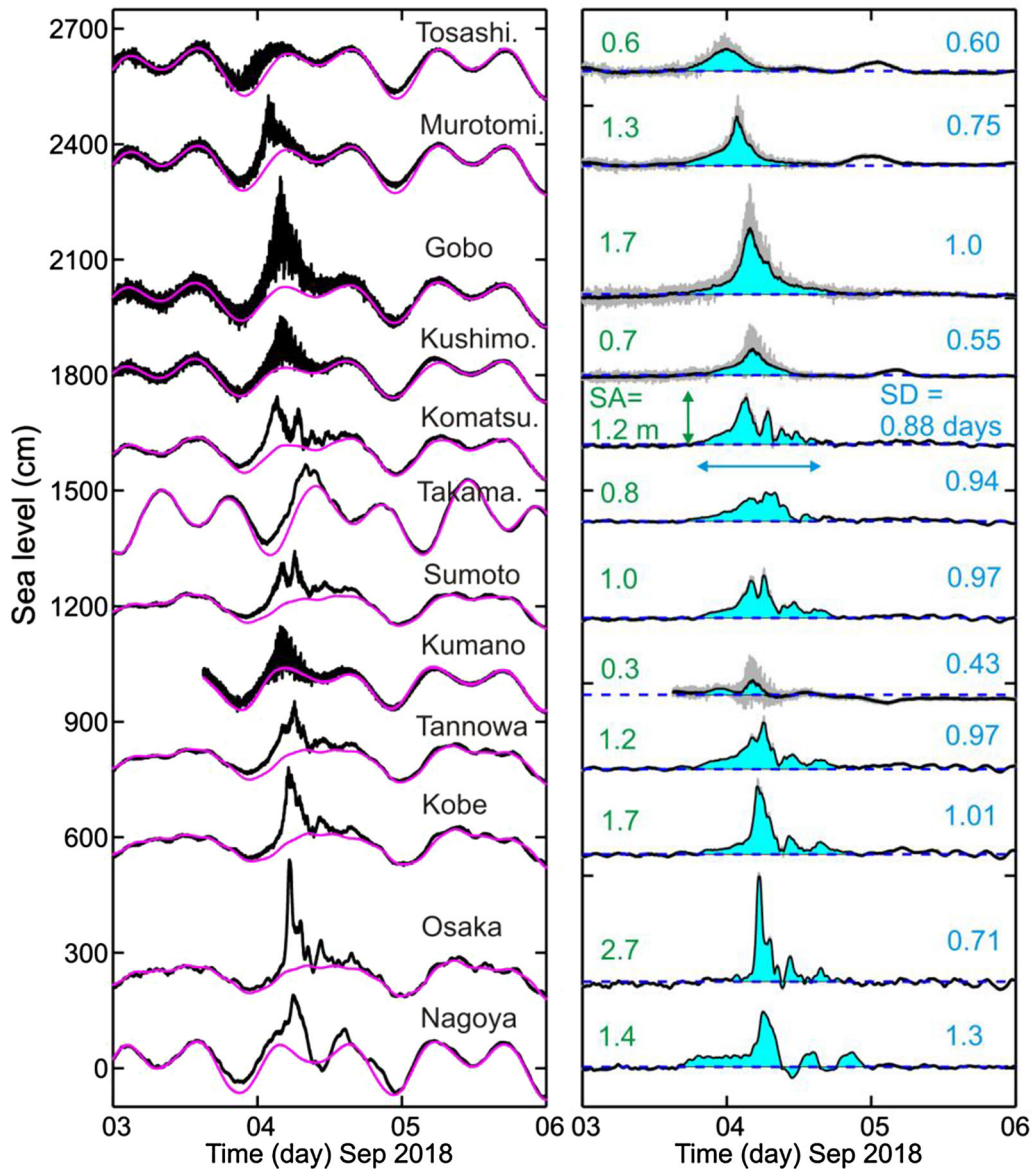
Figure 19

Sea level in September 2018 affected by Typhoon Jebi based on analyses of tide gauge data. **a** Original tide gauge records (black) and tide prediction (pink). **b** SA and SD at different tide gauge stations (black solid lines, 15-min average waveforms to remove wave effects)

in this study, the SA and SD were in the ranges of 0.3–2.7 m and 0.43–1.3 days, respectively. The highest SA and SD were observed in Osaka (2.7 m) and Kobe (1.3 days), respectively. The two locations experiencing the highest SA were Kobe and Osaka, located at the end of Osaka Bay. This can be likely due to the funneling of the storm surge at the end of the bay. Stations located very close (< 50 km) to the typhoon trajectory (e.g., Murotomisaki, Komatsujima, Sumoto, and Tannowa) recorded SAs above 1 m, whereas farther locations (e.g., Kushimoto, Kumano, Tosashimizu, and Takamatsu) experienced SAs below 1 m (Fig. 3). The only exception is Nagoya, which registered a SA of 1.4 m despite of being located at approximately 80 km from the typhoon trajectory.

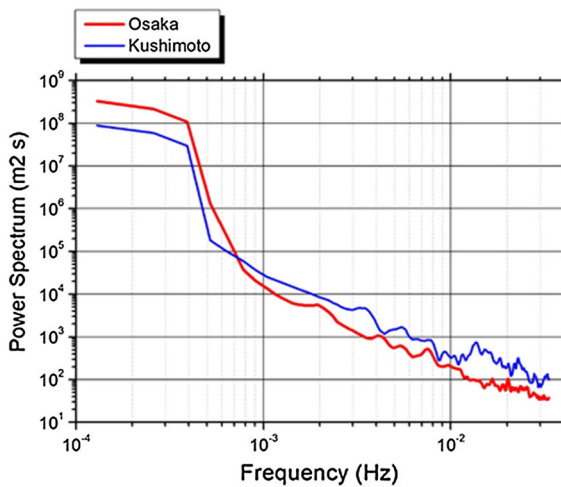
Figure 20

Power spectrum of component waves during 12 h including the arrival time of Typhoon Jebi

typhoon that propagates over the open ocean may also amplify water levels near the coast through specific resonance mechanisms (i.e., Proudman, Greenspan, or shelf resonance) (Monserrat et al. 2006). For example, a very strong seiche-type oscillation, locally known as *abiki*, was observed in Nagasaki Bay, Japan, during the event of 31 March 1979, causing an abnormal tidal fluctuation of 2.78 m excited by a moving low-pressure system (Hibiya and Kajiuura 1982). Although we did not investigate this phenomenon, it is possible that the present coastal flood might have been partially exacerbated by this kind of resonance mechanisms in Osaka Bay.
