# A characterization of laser cleaning painting layer from steel surface based on thermodynamic model

In this study, the environmentally friendly nanosecond ultraviolet (UV) laser is an innovatively employed laser cleaning to remove the painting layer from the AH36 steel substrate. The feasibility of UV laser cleaning the painting layer is innovatively proposed and it has been calculated by the model theoretically, followed by elaborating the prominent interaction mechanism of UV laser exactly. The initial cleaning threshold and completely cleaning threshold are  $2 \text{ J/cm}^2$  and  $5 \text{ J/cm}^2$ , respectively. Afterwards, the UV laser-cleaned surface quality is evaluated by the scanning electron microscopy (SEM), energy dispersive spectroscopy (EDS), optical microscopy (OM), and optical profiler (OP), respectively. The mechanical properties have enhanced dramatically after laser cleaning and characterized by the Vickers hardness tester and universal testing machine. By varying laser fluences ( $2, 5, 7 \text{ J/cm}^2$ ) during laser cleaning, microstructures registering various sizes of corrugated shaped, craters, and ring shaped could be acquired. In addition, the mec

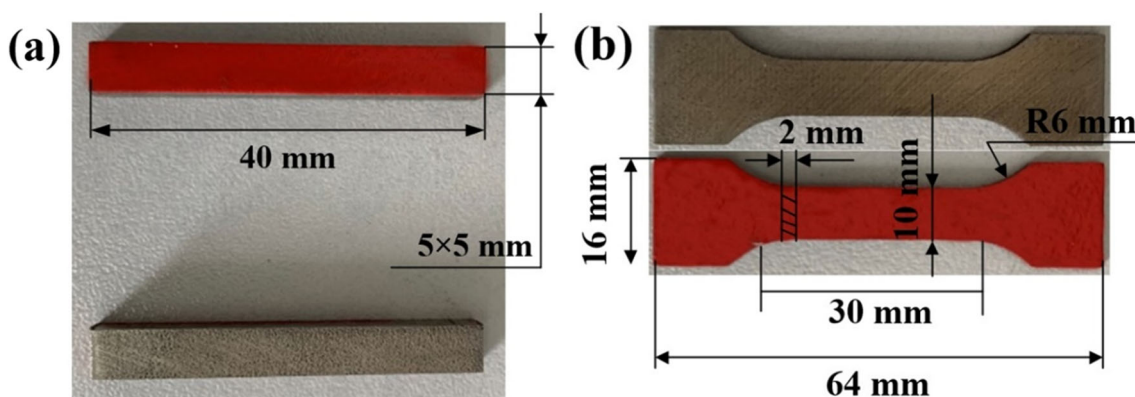
**Fig. 1** a Standard tensile samples and b standard bending samples

are now presented in Table 1. A locally supplied paint comprising chlorinated rubber was used to coat the substrate twice. Note here that the inter layer (white color) registered a thickness of 70  $\mu\text{m}$  while the outer layer (red color) was as thick as 100  $\mu\text{m}$ . The dimensions of specimens, as being used to experience laser cleaning and further characterization including SEM-EDS, OP, and OM, were set as 40 mm  $\times$  40 mm  $\times$  5 mm. In addition, another two batches of specimens, respectively sized as 40 mm  $\times$  5 mm  $\times$  5 mm and 30 mm  $\times$  10 mm  $\times$  2 mm, were prepared as well for tensile and bending tests, conforming to ASTM E8 and ASTM E290. The representative samples are illustrated in Fig. 1.

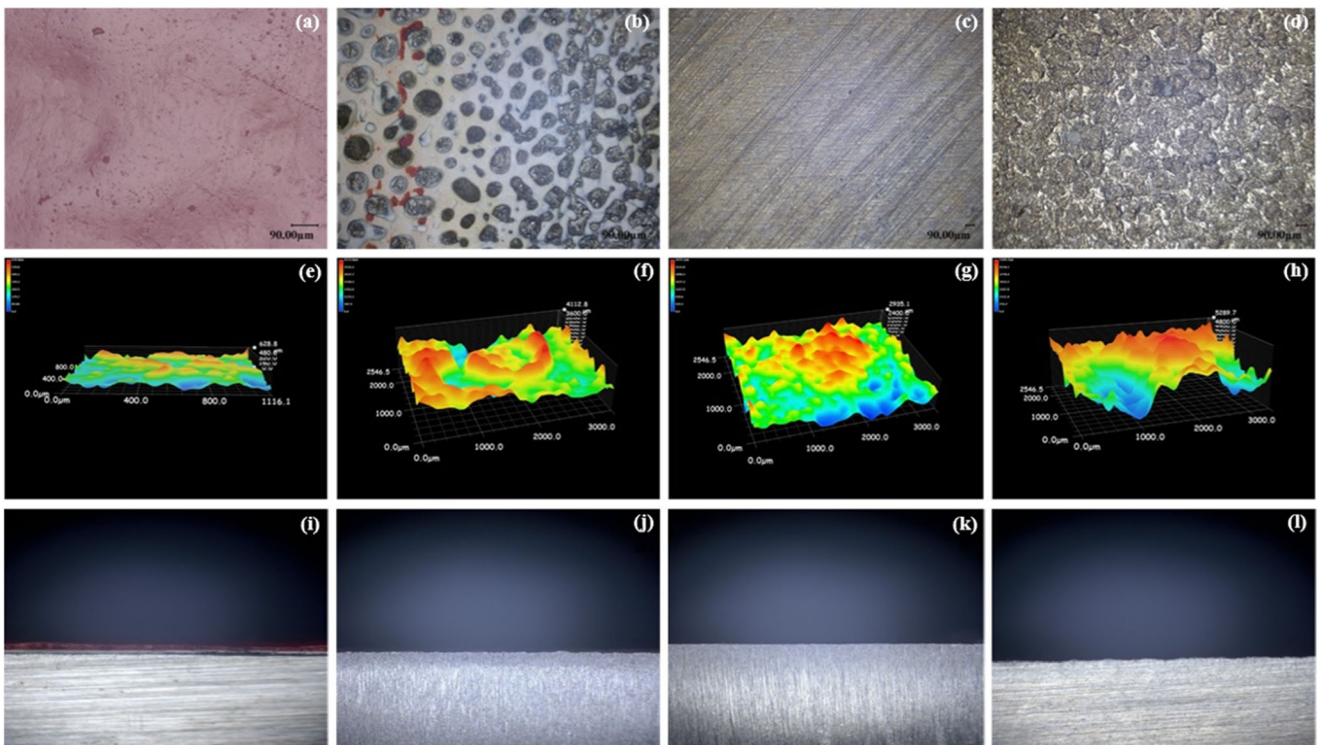
**Fig. 2** Macroscopic three- and two-dimensional optical images of original surface (a, e, i) and laser-cleaned surface at scanning speed of 1000 mm/s with different fluences, among them b, f, j at laser fluence of 2 J/cm<sup>2</sup>, c, g, k at laser fluence of 5 J/cm<sup>2</sup>, and d, h, l at laser fluence of 7 J/cm<sup>2</sup> respectively

One notes from Fig. 2 that the representative images of laser-cleaned surface are exhibited at varying laser fluences upon the painting layer adhered on the surface of AH36 steel substrate. It is noteworthy that there exists a strong smell of burning and a huge sound of vibration during the period of laser cleaning, which is mainly due to the interactions of the UV laser and the painting layer. Aside from this, it can also be inferred that both photothermal and photochemical reactions trigger on the surface of the painting layer. It is coincidence with the aforementioned theoretical analysis, namely there exists both the photochemical and photothermal interactions showing up in the laser cleaning process, along with breaking molecular bonds chemically. Typically, Fig. 2a, e, and i display the original painting layer surface before laser cleaning, while Fig. 2 (b, f, j), (c, g, k), and (d, h, l) indicate laser-

cleaned surface at varying laser fluences of 2 J/cm<sup>2</sup>, 5 J/cm<sup>2</sup>, and 7 J/cm<sup>2</sup> respectively. Interestingly, seen from the Fig. 2b, it can be shown that the superficial color changes on the surface, viz., different from red painting layers, which is due to the fact that there exist two kinds of painting layer (red and white) adhering on the substrate surface. After the laser cleaning at laser fluence of 2 J/cm<sup>2</sup>, the red painting layer has almost been peeled off from the surface, whereas the white one left on the surface, as evident from Fig. 2a. This may attribute to the laser fluence that cannot reach the threshold of the painting layer and the energy is not strong enough to remove the painting layer directly. Notably, the laser fluence at 2 J/cm<sup>2</sup> is called initial cleaning threshold. Aside from that, it worth mentioning here that there are some uncleaned areas at the edge of specimen after laser cleaning, which is mainly due to the laser-satisfied Gaussian distribution in space, namely the energy in the middle is evidently higher than the edges. As expected, the laser fluence distributed at the edges is not strong enough to strip the painting layer, which coincides with the prior mentioned phenomena. One notes from Fig. 2c that it

can be presented as a superficial color variation from the zebra-like color to bar-shaped grey-black color in the macro at a laser fluence of  $5 \text{ J/cm}^2$ . Specifically, UV laser cleaning induces a prominently complete removal and manifests as a metallic luster on the surface of the substrate. This may infer that improving the laser fluence could help enhance the laser cleaning effects and complete cleaning threshold of laser cleaning painting layer is  $5 \text{ J/cm}^2$ . The resulting surface indicates that the cleaning effects have a positive correlation with laser fluence. Moreover, if the laser fluence increases to initial cleaning threshold, the painting layers begin to remove and there exists some traces on the surface. In contrast, if the laser fluence enhances to complete cleaning threshold, the corresponding painting layers are peeled off thoroughly. As noted earlier, the enhancement of laser fluence could promote the behavior of molecule thermodynamics and a host of process, the resultant surface is agreed well with previous study [11]. Compared with the laser-cleaned surface at fluence of  $5 \text{ J/cm}^2$ , craters and tracks are clearly found in black color after the laser cleaning at a laser fluence of  $7 \text{ J/cm}^2$ , which is mainly due to the existing excessive ablation upon laser-cleaned surface. This may be attributed to the photothermal effects playing a prominent role in the laser cleaning at a laser fluence of  $7 \text{ J/cm}^2$  and the resultant surfaces may experience the

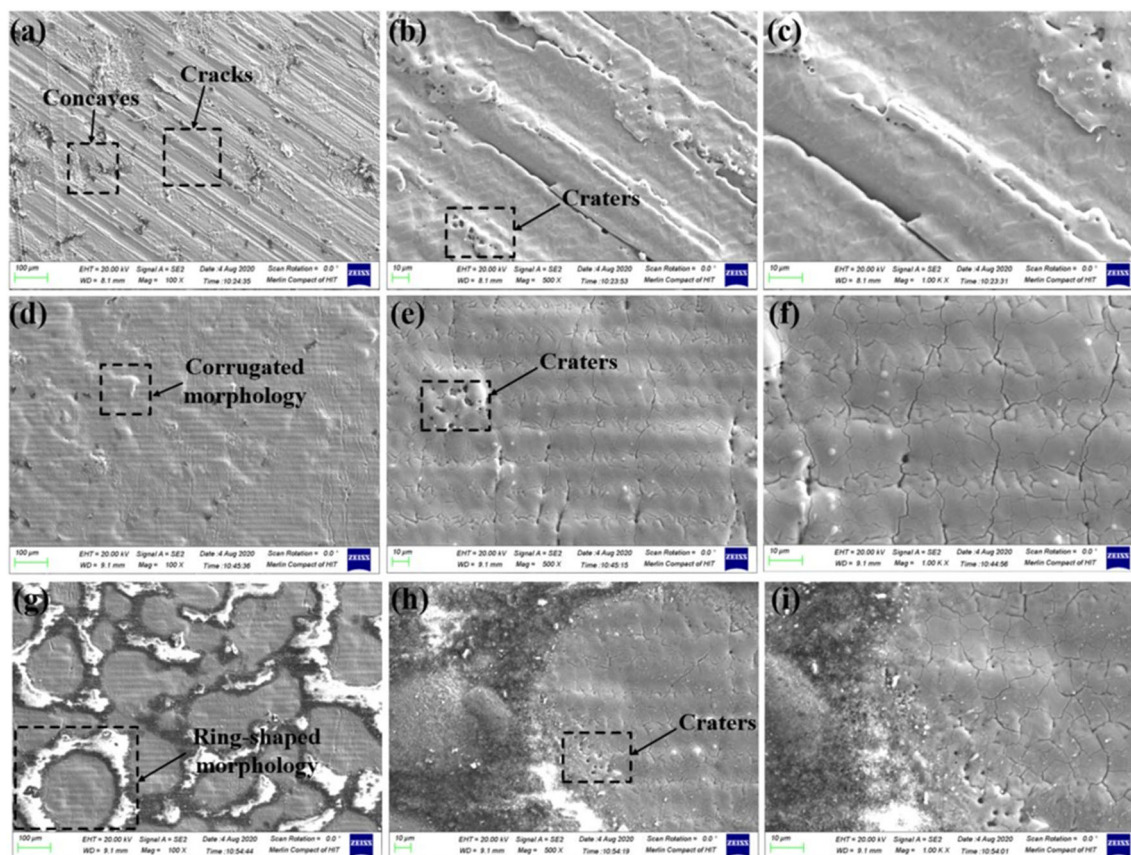
**Fig. 3** SEM images of laser-cleaned surface at different fluences **a**  $2 \text{ J/cm}^2$ , **d**  $5 \text{ J/cm}^2$ , and **g**  $7 \text{ J/cm}^2$ ; **b**, **c**, **e**, **f**; and **h**, **i** are the accordingly magnification images, correspondingly

Figure 3 exhibits a low-magnification secondary electron SEM image of the micro-morphology of laser-cleaned painting layer at varying laser fluences, including  $2 \text{ J/cm}^2$ ,  $5 \text{ J/cm}^2$ , and  $7 \text{ J/cm}^2$  respectively. For the captured surfaces observed in Fig. 3a the employed laser fluence was  $2 \text{ J/cm}^2$  and it can be found that there are some cracks and concaves exposed on the surface of laser-cleaned surface, which is mainly due to the local temperature increase, viz., the enhanced lattice vibration-induced cracking result in the temperature enhancement, which coincides with the mechanism of the UV laser cleaning, namely the photochemical interaction reactions between the laser and the painting layer. As noted from Fig. 3d instead of concaves and cracks, relatively smooth and evenly surface, viz., some corrugated shape morphology, can be presented from the images, which indicates laser fluence reaching the cleaning threshold of the painting layer and without destroying the underlying substrate. The corrugated shape morphology is well agreed with a metallic luster surface of the substrate noted in Fig. 2c which is suggested that it is a thoroughly complete removal. As well, it is worth mentioning here that there are some ring-shaped microstructures showing

up in Fig. 3g. It is mainly due to the fact that the laser fluence exceeding the theoretical threshold considerably triggers the phase change of the substrate, followed by production of the ring-shaped microstructures. This is supported by the previous results [46]. As noted in Fig. 3, there are many craters in each laser-cleaned surface and the craters cannot be filled with the liquid metal immediately; therefore, it generates various crater microstructures on the surface of AH36 steel substrate.

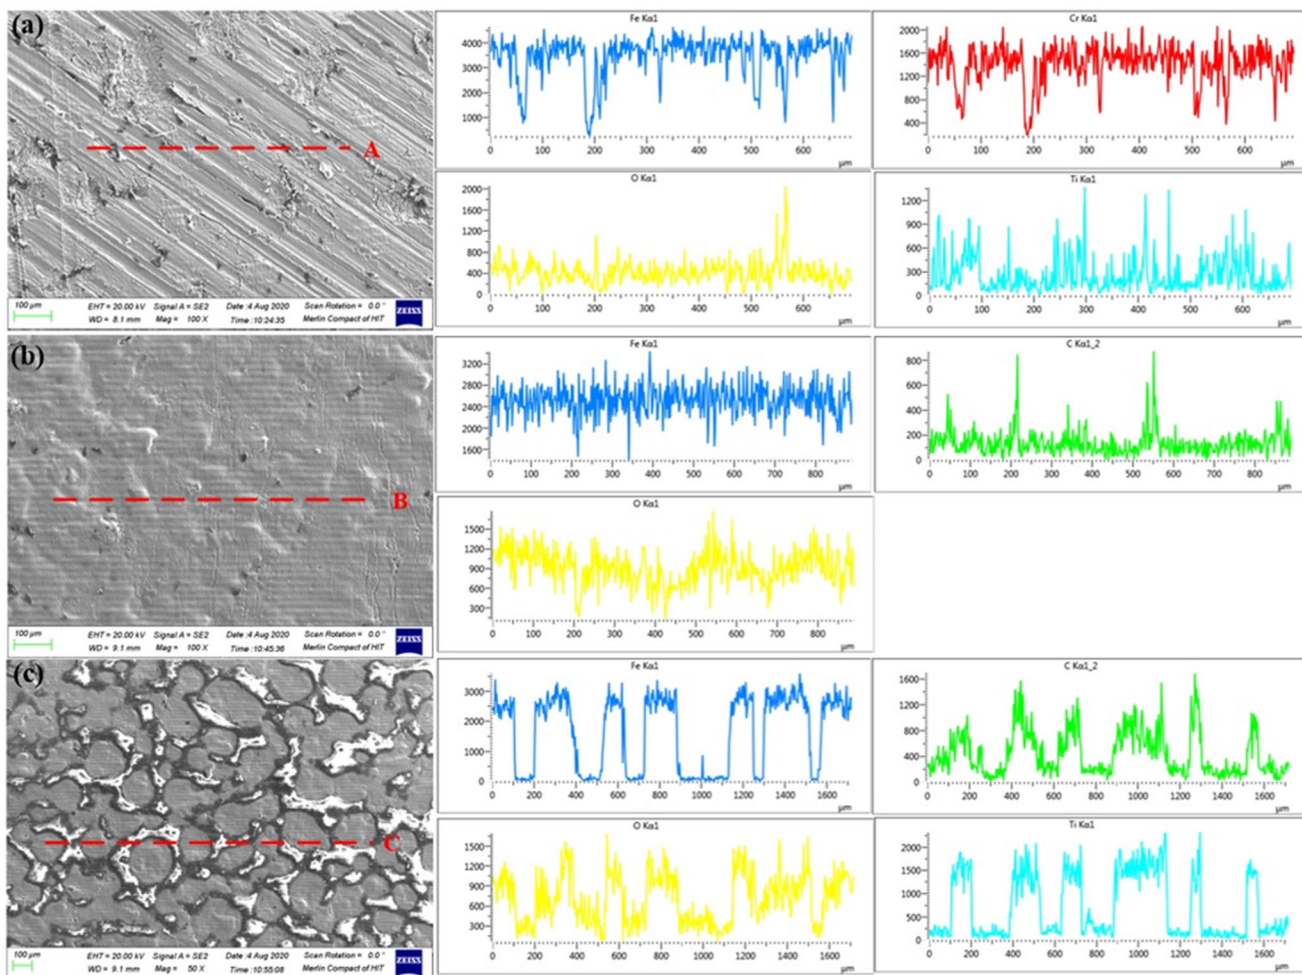
**Fig. 5** Line EDS images of laser-cleaned surface with different laser fluences: **a**  $2 \text{ J/cm}^2$ , **b**  $5 \text{ J/cm}^2$ , and **c**  $7 \text{ J/cm}^2$ , respectively

To reveal the surface element distribution more clearly, the line EDS is performed to investigate changes of Fe, O, and C contents along with some trace amounts of Cr and Ti. Figure 5a, b, and c exhibit the line EDS report of element changes in the resulting laser-cleaned area at varying laser fluences of  $2 \text{ J/cm}^2$ ,  $5 \text{ J/cm}^2$ , and  $7 \text{ J/cm}^2$  respectively. From the curves, it can be observed that the Fe  $K\alpha_1$  appeared in (a) and (c) oscillates significantly more than (b), which is mainly due to the laser-cleaned surface (b) is relatively flat, viz., painting layer has been peeled off from the substrate completely. Interestingly, it can be found there are some periodic curves appearing in the line EDS-examined surface in Fig. 5a. This indicates that the produced ring-shaped microstructure, namely iron oxide, is approximately periodic, which is due to the UV laser satisfying the Gaussian distribution.

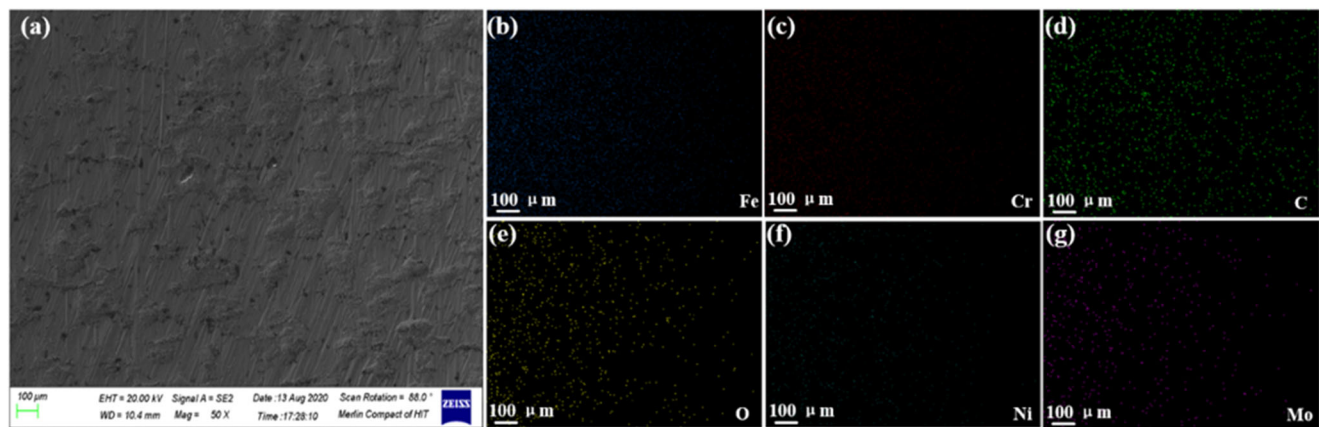
**Fig. 6** SEM images of laser-cleaned surface and **b–g** are the accordingly elemental distributions after laser cleaning, respectively

One notes from Fig. 6a that presents a secondary electron SEM image of UV laser-cleaned surface morphology and manifests as disparate contrast areas thoroughly. In Fig. 6b–g, it can be observed that certain specific elements including Fe, O, C, Ni, Cr, and Mo are distributed on the surface with various colors. From the mapping of the AH36 steel substrate surface, it is presented the distribution of Fe, O, and C is the major elements on the surface, which is mainly due to Fe and C elements which are the prominent elements of substrate and there may exist a laser ablation during the laser cleaning period. Clearly, from the mapping, it can be seen that the distribution of the O and C is relatively homogeneous. As per the surface morphology of laser-cleaned surface, it is suggested that the convex exposed on the laser-cleaned surface is rich in the O and C elements, whereas they are almost absent in the center. This may be attributed to the UV laser-satisfied Gaussian distribution and the energy density at the center of the spot is greater than that at the edge, which results in the O element exposed in the center much more the edges. That is the reason why the microstructure could generate the ring-shaped microstructure and corrugated-shaped morphology

respectively. Herein, the present findings are very encouraging and it can also infer that the nanosecond UV laser could successfully strip off the painting layer thoroughly.

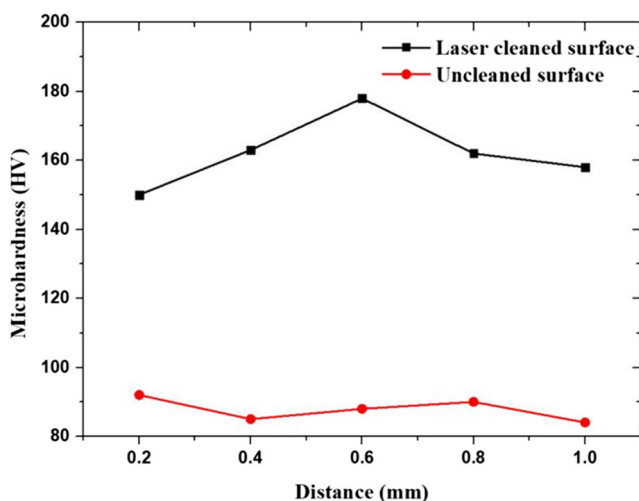
**Fig. 7** The microhardness characterization after UV laser cleaning

It is widely recognized that in the exact evaluation of the mechanical properties, the hardness characterization is an indispensable, essential evaluation index, which needs to be considered during the UV laser cleaning the painting layer. In this study, the Vickers microhardness test is performed to investigate the mechanical properties, the details including the load of 290 g and holding time duration of 15 s, which can be demonstrated in Fig. 7. As such, from the curves, it can be noticed that the UV laser-cleaned surface increases to 150 HV while the uncleaned surface is 92 HV. The dramatically microhardness enhancement can be attributed to the fact that the UV laser-cleaned surface shows up rapid melting and

quenching, which is followed by generating the microstructure, including ring shaped and corrugated shaped. The other reason is due to the fact that the UV laser cleaning could induce the resultant surface producing dislocation density, while the traditional cleaning techniques are not available. This is supported by the previous results [17, 47, 48]. Specifically, the standard deviation of laser-cleaned surface and uncleaned surface microhardness is 2.875 and 0.525, respectively. Due to the uneven painting layer, the maximum Vickers microhardness UV laser-cleaned surface is 178 HV and the minimum is 150 HV. Thus, it is suggested that UV laser cleaning painting layers could enhance the surface microhardness considerably. Aside from the environmentally friendliness, this is another reason why authors take this prospective method to remove the painting layer.

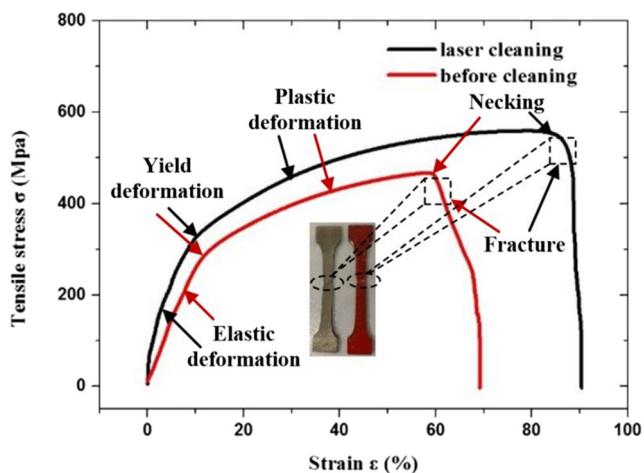
Fig. 8 The relationship between the strain and tensile stress

For further investigation of the tensile and bending properties of laser-cleaned surface, there are batches of standard tensile and bending test specimen produced by UV laser cleaning method. The commensurately tensile stress and strain curves are illustrated in Fig. 8. From the curves, it exhibited five stages in these tensile curves, such as elastic deformation, yield deformation, plastic deformation, necking, and fracture respectively [49–55]. The curves are just like the parabolic shape and there is a rapid increase in the elastic and yield deformation stages. Followed by gradually enhanced plastic deformation stage, there exist maximum values, viz., ultimate strength, appearing before reaching necking period, along with the reduction to fracture stage sharply. Notably, the tensile strength of laser-cleaned surface is much stronger than that of before cleaning, which is mainly due to the fact laser treatment is conducive to enhance the elastic and plastic deformation properties of the substrate.

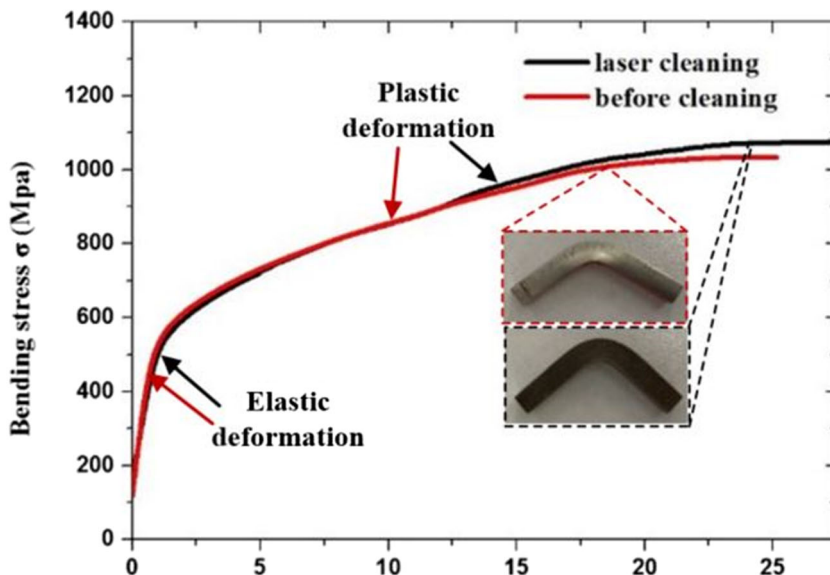
Fig. 9 The relationship between the bending displacements and bending stress

As for bending properties, it is widely recognized that bending displacements and bending stress are essential factors, exhibited in Fig. 9. As noted in the curves, it can be observed that

both of the resulting laser-cleaned surface and uncleaned surface experience complete elastic deformation and plastic deformation stage, whereas the fracture stage does not exist in the sample, in spite of the bending angles exceeding 90° and bending stress over 1000 MPa. In this regard, it indicates that both of the laser-cleaned surface and uncleaned surface have excellent bending strength and plasticity. Yet, laser-cleaned surface manifests as better plasticity in the plastic deformation stage. Thus, the laser-cleaned surface conduces to improve the bending strength and plasticity properties.

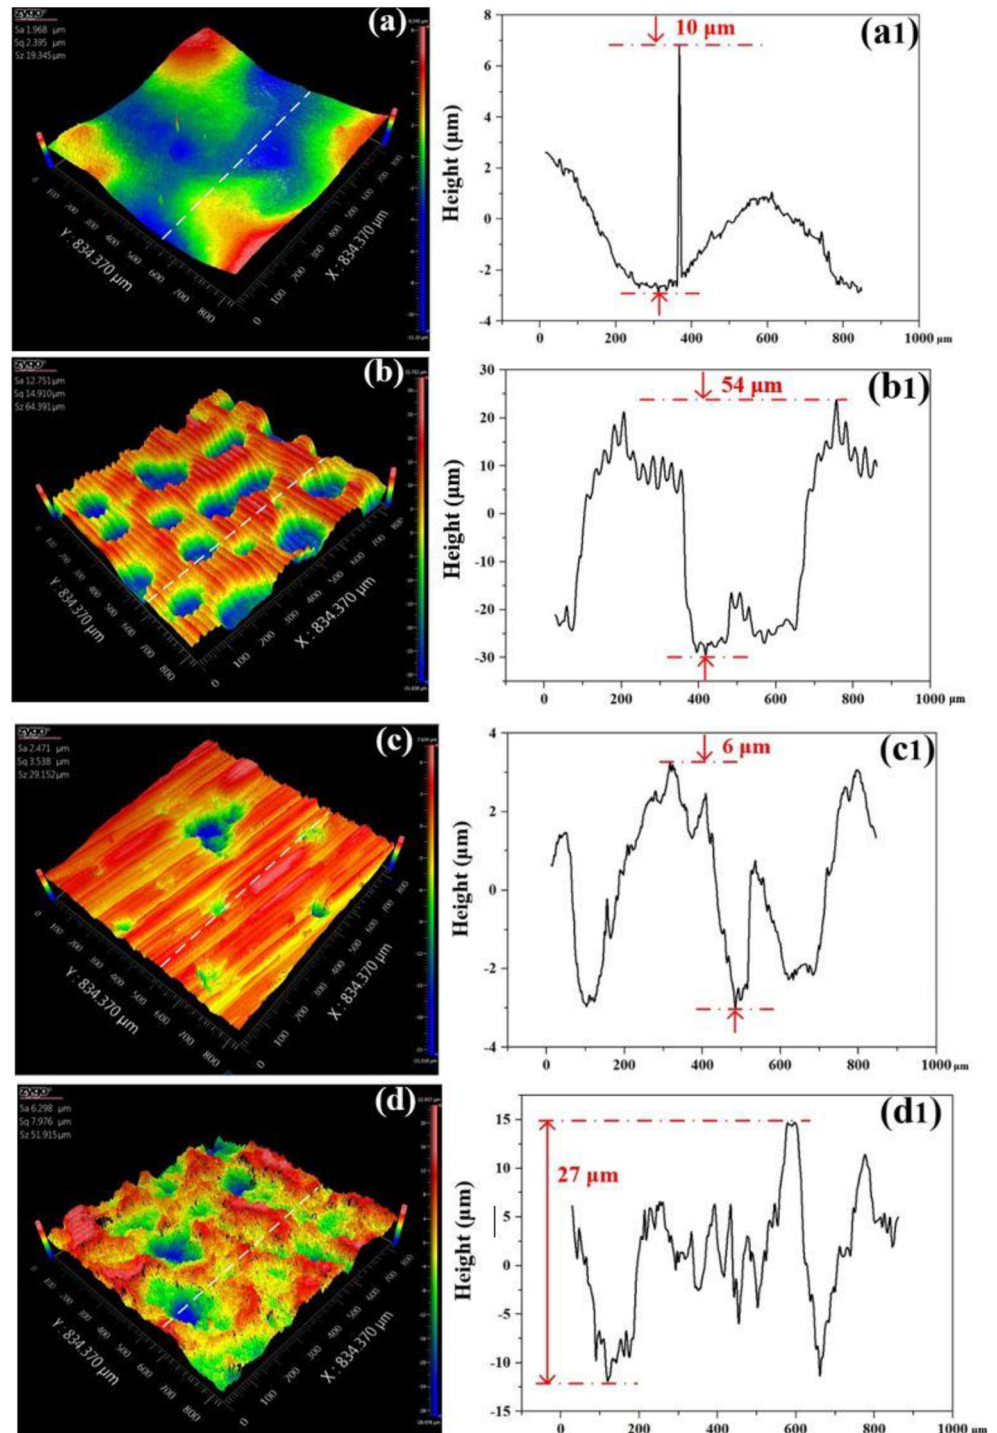
**Fig. 10** Optical profiler 3D height images of laser-cleaned painting layer surfaces **(a)** and original painting layer **(b)** laser-cleaned surface at laser fluence: **2 J/cm<sup>2</sup>**, **c**, **5 J/cm<sup>2</sup>**, **d** **7 J/cm<sup>2</sup>**, and **(a1)–(d1)** are the accordingly line-scanned profiles, respectively

As seen in Fig. 10, it presents typical 3D morphologies along with corresponding line-scanned profiles of original painting layer and resulting laser-cleaned surface, which is examined by optical profiler and commensurately captured zone is

840 μm × 840 μm. As evident from Fig. 10a, it can be seen that the original painting layer is relatively evenly and smooth, along with the surface roughness 1.968 μm. Of particular note, white lines indicate maximum height difference is approximately 10 μm at original surfaces. With regard to the laser fluence 2 J/cm<sup>2</sup>, the maximum height difference is five times larger than that of the original painting layer surface and corresponding surface roughness is 12.751 μm. This may be contributed to the laser energy is less capable to remove the painting layer directly and there exists laser cleaning-induced cracks and concaves in this layer, which is well agreed with the prior mentioned Fig. 3a. Thus, the roughness of laser-cleaned surface at laser fluence 2 J/cm<sup>2</sup> increases dramatically. Specifically, as for laser-cleaned surface at laser fluence of 5 J/cm<sup>2</sup>, the resultant surface is pretty smooth, viz., the surface roughness is 2.471 μm and relevant maximum height difference is approximately 6 μm, which indicates laser fluence at 5 J/cm<sup>2</sup> is the most suitable for UV laser cleaning painting layers. As such, it is suggested that laser-cleaned surface at this fluence without destroying the underlying substrate and the thermal ablation is minimal from the aforementioned surface morphology in Fig. 3d. Therefore, laser fluence at 5 J/cm<sup>2</sup> is regarded as the threshold of UV laser cleaning painting layer. To be noted here, the melted layer flowing and re-solidification forms a corrugated shape morphology, which coincides well with Fig. 3d. In comparison, the laser-cleaned surface at laser fluence 7 J/cm<sup>2</sup> has a relatively rough surface (6.298 μm) and the maximum height difference is about 27 μm, which is suggested that the surface experiences the excessive ablation and it is consistent with the captured images in Fig. 3g. Thus, it is imperative to avoid the ablative conditions that occurred during UV laser cleaning painting layer as far as possible.

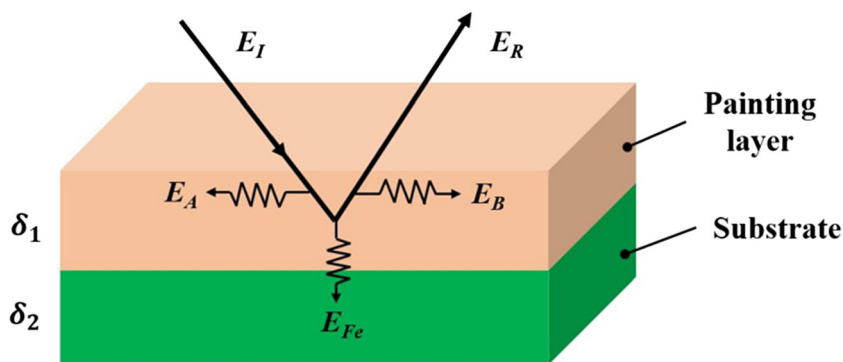
**Fig. 11** Schematic diagram of laser cleaning painting layer model

One notes from Fig. 11 the schematic diagram of laser absorption and reflection. Wherein,  $E_I$ ,  $E_R$ ,  $\delta_1$ , and  $\delta_2$  indicate incident laser energy, reflection laser energy, thickness of painting layer, and substrate correspondingly. As well,  $E_{Fe}$ ,  $E_A$ , and  $E_B$  are energy absorption of Fe substrate, incident laser, and reflection through painting layer respectively.  $A_a$  and  $A_b$  stand for laser absorption coefficients of painting layer and Fe substrate respectively. The detailed equations are shown as follows:
