Evaluation of thirty eight cemented pegged glenoid components with variable backside curvature: two-year minimum follow-up

Florence Dauzère¹ · Marine Arboucalot¹ · Julie Lebon¹ · Fanny Elia¹ · Nicolas Bonneville¹ · Pierre Mansat¹

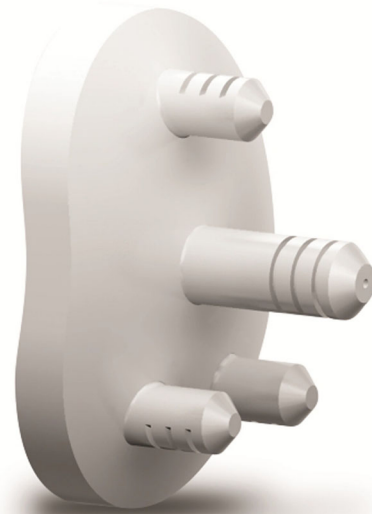
Fig. 1 The PERFORM™ pegged glenoid component

The PERFORM™ pegged glenoid component (Wright-Tornier, Inc., Edina, MN, USA) has been used in our institution since 2012. This implant has a convex back, with a long central peg, and three peripheral pegs, one superiorly and two inferiorly, all for cement fixation (Fig. 1). Available sizes include five radii of curvature (30, 35, 40, 50, 60 degrees), and two sizes per radius (small/medium for 30°; small/medium for 35°; small/medium for 40°; large/extra-large for 40°; large/extra-large for 50°; and large/extra-large for 60°) or 12 components. The radial mismatch between the radius of curvature and the humeral head is variable according to the size of the humeral head and the glenoid component.

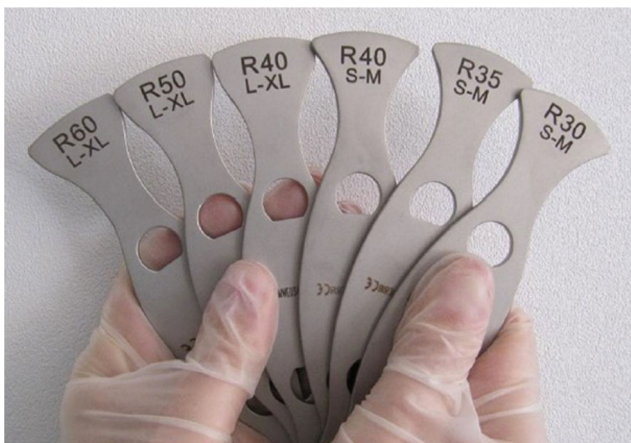
**Fig. 2** The six different gauges used to evaluate the glenoid curvature

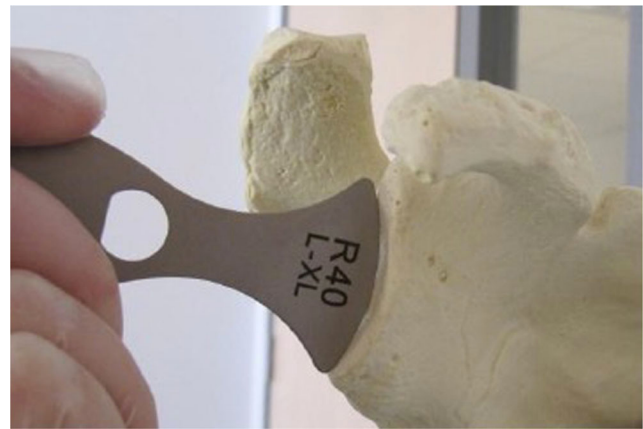
**Fig. 3** The glenoid radius of curvature was identified

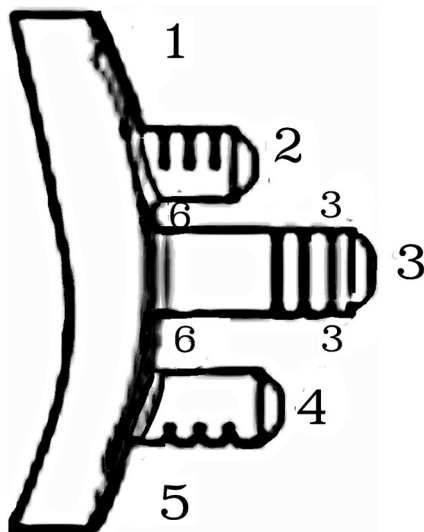
Fig. 4 The six zones defined around the component to evaluate the incidence of RLL

Post-operatively, specific attention was focused on the presence of radiographic lucent lines (RLL) around the glenoid component according to the six zones described around the component (Fig. 4). Using the system described by Molé et al. [13], score ranged from 0 point for no radiolucency, to 18 points for RLL exceeding 2 mm in the six zones (Table 2). Correct seating of the glenoid component on the glenoid surface was also evaluated according to the method of Lazarus et al. on a scale of A to E [9] (Table 3). Finally, the presence or absence of penetration of the pegs through the scapula cortex was also noted. A resident (FD) and a fellowship-trained shoulder surgeon (JL), who were familiar with the grading systems and who were not involved in the surgery or the post-operative care of these patients, evaluated the radiographs.

than 1-mm thickness and very limited. Localization of the lucent lines were mainly in zone 6 in 62.5% of the cases, and in zone 3 in 50%. According to Molé [13], the average RLL score was 0.36 ± 0.8 points (0 to 3). At the last follow-up, RLL were observed around the glenoid component in 16 cases (42%). Localization were essentially in zone 3 in 75% of the cases, and in zone 6 in 56% of the cases. However, the RLL score was only 1.3 ± 2 (0 to 10) ($p < 0.001$). In one case, RLL score reached 10, but with an asymptomatic patient. Radiographic results are summarized in Table 3 (Fig. 5).

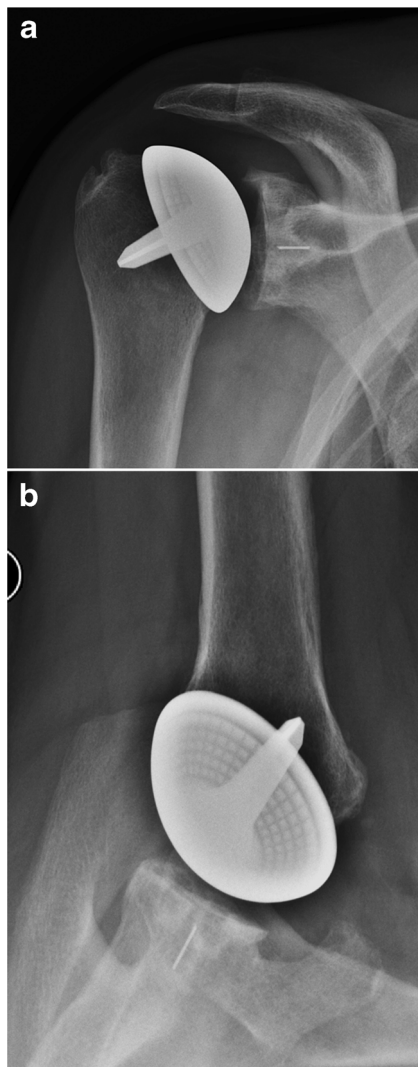
Fig. 5 Anterior-posterior view (a) and axillary view (b) of a resurfacing shoulder prosthesis with a perfectly seated and centered PERFORM™ pegged glenoid component

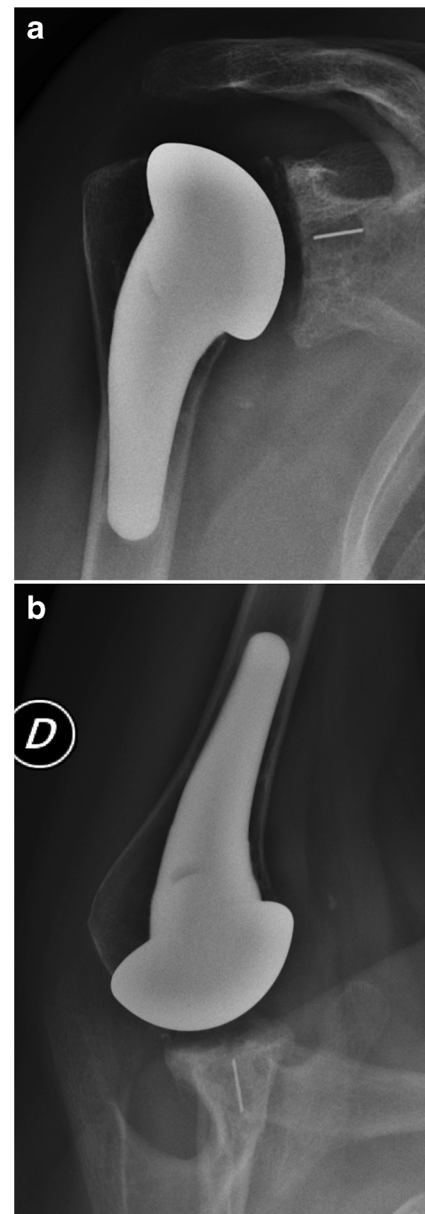
Fig. 6 Anterior-posterior view (a) and axillary view (b) of a short stem uncemented prosthesis with a perfectly seated and centered PERFORM™ pegged glenoid component

According to the Lazarus grading system, 29 components were staged grade A, two grade B, five grade C, and two grade D. There was no grade E in our study. No correlation could be found between glenoid seating and aetiology, pre-operative range of motion, type of glenoid wear, and type of humeral

prosthesis used. However, it was correlated with the post-operative RLL score ($p < 0.05$) (Fig. 6).
