The role of sediment composition and behavior under dynamic loading conditions on slope failure initiation: a study of a subaqueous landslide in earthquake-prone South-Central Chile

Gauvain Wiemer · Jasper Moernaut · Nina Stark · Philipp Kempf · Marc De Batist · Mario Pino · Roberto Urrutia · Bruno Ladrón de Guevara · Michael Strasser · Achim Kopf

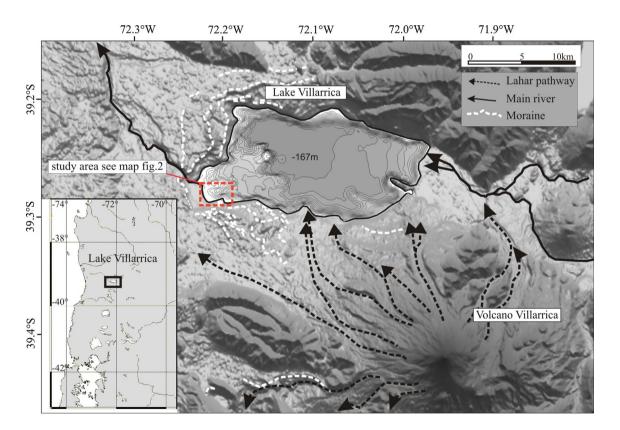
Fig. 1 Morphological setting of Lake Villarrica modified after Moernaut et al. (2009). Lake-surrounding topography is derived from SRTM data. Sun illumination is from the North. Moraine locations ("Llanquihue" moraine belt) are based on Laugenie (1982). Lahar

pathways are derived from Laugenie (1982) and satellite imagery. Lake Villarrica: Bathymetric contours are shown every 10 m. The deepest part is 167 m below lake level (based on SHOA 1987)

Lake Villarrica (Fig. 1) is located in South-Central Chile. A previous seismic-stratigraphic analysis performed in the southwestern region of the lake revealed voluminous mass-wasting deposits and indicated the presence of vertical subsurface fluid flow in the region (Moernaut et al. 2009). Large earthquakes occur regularly in South-Central Chile and are one of the most cited short-term triggering mechanisms for landslide initiation (Sultan et al. 2004). Earthquake shaking has been suggested as the most probable cause for slope failure in Lake Villarrica (Moernaut et al. 2009).

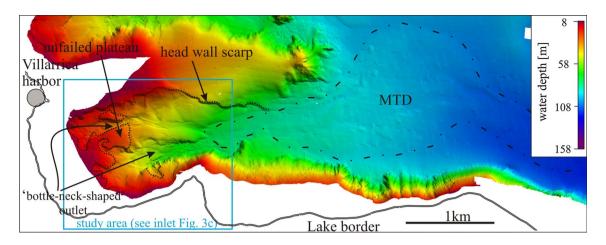
Fig. 2 Multi-beam bathymetric map for the SW part of Lake Villarrica (location: see Fig. 1) with indication of the geotechnical study area (*blue frame*). MTD: Mass transport deposit described in detail in (Moernaut et al. 2009)

Core VillaR 3 was sampled within the upper stratigraphy of the slide scar (Fig. 2). It is about 4 m long and covers the post-failure sediment drape (~1.35 m of U1), the upper failure plane, approximately 1.25 m of unfailed U2, and ~1 m of U3 sediment. By assuming a sedimentation rate of 0.8 mm/year for the post-failure U1 (see Sect. 7.1.1), we infer a slide age of ~1.6 ka BP. The upper failure plane is distinct and located just above the sandy silt tephra layer, already named SFPT (Fig. 6). A marked increase in bulk density within the layer (Fig. 4) is associated with the impedance contrast that gives rise to the strong reflection in the seismic profiles (Fig. 3a, b). The sediment that was moved during slope failure is marked as "slide mass A" in Fig. 4. Figure 5b shows the composite data plot of CPT and coring site 3. The lower section of the core (i.e., U3) was kept as a whole-round sample for further geotechnical experiments. U1 and U2 are separated by a mass transport deposit (MTD) (see also Fig. 6) of ~25 cm thickness and are further distinguished by differences in grain size similar to those described for core VillaR 1. We are confident to have cored the basal shear plane although some uncertainty remains due to possible erosion during the deposition of the overlying MTD. However, the existence of a distinct failure plane giving rise to a clear seismic reflection with the length of the entire slide scar renders previous erosion unlikely.

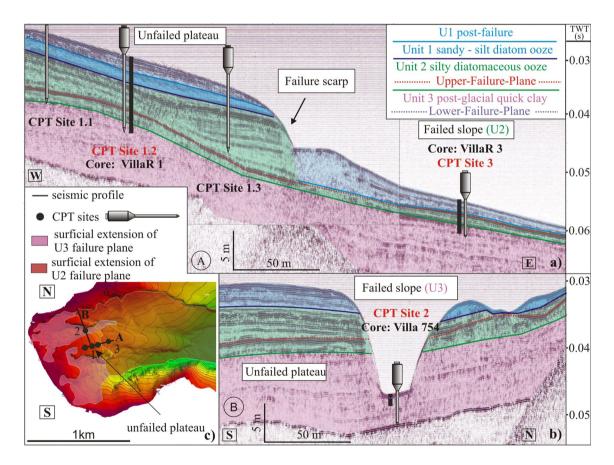
Fig. 3 a E–W orientated, seismic profile A including CPT sites 1.1, 1.2, 1.3, and 3, and coring location of VillaR 1. CPT sketch illustrates CPT position and penetration depth. *Thick vertical black line* indicates coring locations and depth. *Light blue zone*: post-failure Unit 1. *Dark blue*: pre-failure Unit 1. *Green zone*: Unit 2. *Dusky pink zone*: Unit 3. *Red dotted line*: upper failure plane. b Seismic profile

B including CPT site 2 and coring location of Villa 754. c Bathymetric map of the SW part of Lake Villarrica including location of seismic profile A and B and CPT positions. Isobaths every 5 m. *Reddish area*: extent of the "upper failure plane" that developed within silty diatomaceous ooze (Unit 2), immediately overlying a tephra (SFPT). *Dusky pink area*: extent of the quick clay (U3) sliding surface

Two perpendicular seismic profiles (A and B) are presented in Fig. 3a, b. The profiles represent cross sections that run in approximately the E–W (A) and N–S direction (B) and are showing parts of the unfailed plateau, the failure scar, and a portion of the failed slope. The unfailed plateau as seen in Fig. 3a, b comprises the entire "uppermost seismic unit" as identified by Moernaut et al. (2009). This seismic unit is uniformly draped on top of an irregular basement morphology. The uppermost seismic unit spans 17.5–17.15 ka BP to present (McCulloch et al. 2000).

From top to bottom, three seismic subunits (U1–U3) are distinguished on both profiles. Unit 1 (U1) is characterized by continuous reflections running parallel to the slope. U1 represents plateau sediment and reveals little change in thickness. Unit 2 (U2) equally shows continuous, but subparallel reflectors with spatial differences in the down-slope direction. Both units (U1 and U2) build a drape with low-to-high reflection strength, hence alternating low-to-high

Judging from the seismic images, it seems that the stratigraphic horizon corresponding to the failure plane is much deeper in profile B (i.e., within U3) compared to profile A (i.e., within U2). This fact indicates that the landslide event took place at two distinct stratigraphic levels (U2 and U3) (Fig. 3a, b). The spatial extents of these stratigraphic levels are mapped in Fig. 3c. The upper part of the slide scar (i.e., the area surrounding the unfailed plateau) is characterized by an irregular head scarp and a "bottle-neck-shaped" outlet. The lower head scarp area, where the upper stratigraphic level acted as a failure plane, is more regular and confined.

In the following, these two failure horizons will be termed "lower failure plane" (in U3) (see profile B Fig. 3b) and "upper failure plane" (in U2) (see profile A Fig. 3a). However, the location of failure initiation cannot be inferred from seismic data alone. Competing interpretations are (1) retrogressive failure or (2) that failure initiated up-slope at a deeper stratigraphic level and stratigraphically stepped-up to a shallower level when progressing down slope [stratigraphic "step-up" see (Moernaut and De Batist 2011)].

Coring site VillaR 1 serves as reference site and is located at the centre of the unfailed plateau (Fig. 3c). This core (VillaR 1) provides intact samples from the upper and lower stratigraphic levels that acted as failure planes on the slope. The core VillaR 3 (site 3 Fig. 3a) and the gravity cores (site 2 Fig. 3b) were taken within the failure scars.

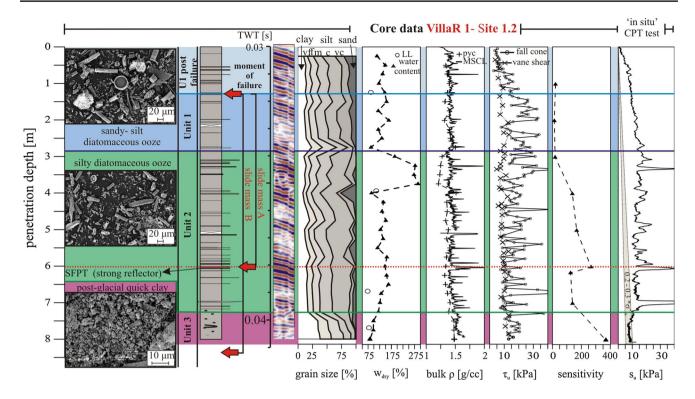
Fig. 4 Index properties of the sediment core VillaR 1 (site 1) including (from *left* to *right*): a SEM image of each unit, a litholog after visual core description, an indication of the slide sediment portions A and B, a short segment of seismic reflection data, results of: grain size analysis, natural water content (w_n) , bulk density (ρ) , laboratory-

based measurements of undrained shear strength ($\tau_{\rm u}$), sensitivity, and "in situ" undrained shear strength ($s_{\rm u}$). Shear strength data are clipped at 40 kPa. Horizontal lines separate the different units whereby U1 is divided in a pre- and post-failure deposit. Dashed horizontal red line: location of the "upper failure plane" right above the SFPT

Figure 4 shows the composite plot of all data obtained at the reference site 1.2 including a short segment of reflection seismic data of profile A (Fig. 3a). The sediment core VillaR 1 is ~8 m long. Three distinct units were identified based on abrupt changes in physical and lithological properties measured in cores. These units correspond to specific features in the depositional geometry and correlate with acoustic facies observed in reflection seismic data (U1-U3) (Figs. 3a, b, 4). Tephra layers found in the sequence suggest that it covers the past ~13 kilo years. These tephra deposits include the ~3.8 kilo year Pucón event (Silva Parejas et al. 2010; Heirman 2011) and the ~11 kilo year Neltume pumice (Echegaray et al. 1994). Furthermore, AMS radiocarbon dating was performed at the Ion beam Physics Laboratory of ETH Zürich (Switzerland) on a leaf found in VillaR 1 at a sediment depth of 7.29 m (ETH-52078), very close to the U2–U3 boundary. It provided a 14C age of 10.841 \pm 42 years BP which corresponds to a calibrated age (ShCal13) of 12,670-12,755 cal. years BP (2σ) . This led to inferred sedimentation rates in the range of 0.4-0.8 mm/year in U1 and U2 sediment at this specific location. Deposition of U3 is believed to have started around 17.5-17.1 kilo years BP, with regional deglaciation (McCulloch et al. 2000). By applying this date to U3, we obtain a sedimentation rate of about 3 mm/yr at site 1.2.

Unit 3 (U3) comprises the lowermost portion of core VillaR 1. It consists of proglacial extra-quick clay characterized by an increase in clay size fraction by ~20 %. Sensitivity reaches its maximum with a value of 370. $w_{\rm n}$ % is <100 % and decreases with depth. LL reaches ~80 %

The only observed anomaly of the failure horizon within U2 is a peak in sensitivity (Fig. 4). Indeed, the upper failure plane is located immediately above a tephra layer (SFPT) (Figs. 4, 5b, 6). However, there are several other tephra layers within U2 with properties comparable to that of the SFPT (Fig. 4; based on macroscopic observation). Therefore, the location of the upper failure plane can neither be

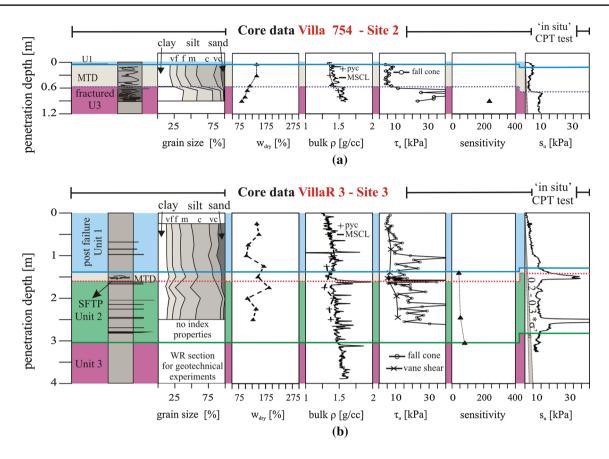
Fig. 5 Index properties of the sediment cores **a** Villa 754 (site 2) and **b** VillaR 3 (site 3) including (from *left* to *right*): a litholog after visual core description and results of grain size analysis, natural water content (w_n) , bulk density (ρ) , laboratory-based measurements of und-

rained shear strength (τ_u) , sensitivity, and "in situ" undrained shear strength (s_u) . Shear strength data are clipped at 40 kPa. Horizontal lines separate the different units. *Dashed horizontal red line*: location of the "upper failure plane" right above the SFPT

The sediment core Villa 754 is a short gravity core of 0.9 m length. It was recovered within the "deep slide scar," and it covers parts of the post-failure sediment drape (U1) and about 0.3 m of intact sediment belonging to U3. The

latter represents an interval of brittle "in situ" deformation. Here, U1 and U3 are separated by a MTD of ~38 cm thickness and are further distinguished by differences in grain size, water content, and bulk density similar to what was observed on the undisturbed plateau. The excavated slope sequence comprises parts of U1, all of U2, and parts of U3, and is marked as "slide mass B" in Fig. 4. Figure 5a shows the composite data plot of the core Villa 754. It is certain that the lower failure plane involved in the slope failure of slide mass B is located within the quick clay of U3. However, it is not clear whether core Villa 754 (Fig. 3b) contains a sample of this failure plane since part of the basal shear surface could have been eroded by the overlying MTD. The deposition of the overlying MTD may have entailed erosion of the basal shear surface.

In the following, we will keep the term "lower failure plane." In seismic reflection data, the failure plane can be seen as the limit between clearly stratified reflectors of U1 and the more chaotic facies, U3. Comparing core Villa 754 with the seismic image of site 1.2 (Fig. 3a), we concluded that the lower failure horizon was not recovered at the reference coring site 1.2.

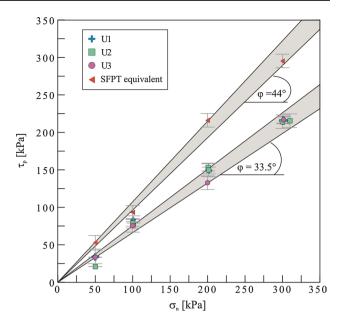
Fig. 9 Peak shear strength determined in a direct shear apparatus is plotted against effective normal stress. The error in peak shear stress is related to cell friction. Diatomaceous sediments (U1 and U2) have very high drained shear strength values similar to quartz sand, and the SFPT shows even higher values expected in highly angular sands (Bolton 1986)

Drained direct shear tests did not reveal significant differences between the different units (Fig. 9). The internal friction angle of U1, U2, and U3 sediment range from $\varphi \sim 33.5^{\circ}$

to 37°. There are no major differences in the drained shear strength of the lower and upper failure plane sediment. For comparative reasons, we also tested the SFPT equivalent for its drained shear strength, which proved to be high with $\omega \sim 45^{\circ}$.

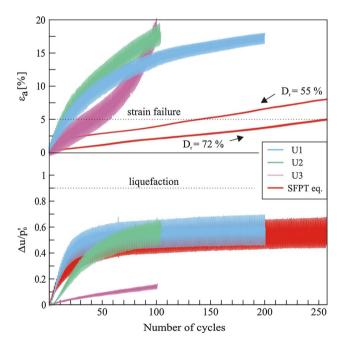
Fig. 10 Cyclic triaxial shear tests on units 1–3 (U1, U2, and U3) samples and the failure plane tephra (SFPT) equivalent. $D_{\rm r}$ stands for relative density. $D_{\rm r}=55~\%$ is a medium dense sample, $D_{\rm r}=72~\%$ is a dense sample. See Table 1 for details

In cyclic triaxial tests, an earthquake of MM Intensity of VIII (i.e., PGA = 0.25 g) was simulated. Figure 10 shows the resulting pore pressure ratio (PPR) and axial strain (ε_{o}) measured in all three units as well as in the material equivalent to SFPT. The test conditions are listed in Table 1. During cyclic loading, the PPR increases rapidly in U1 and U2 samples and in the SFPT equivalent. Within the first 20 loading cycles, PPR reaches 40–50 % of p_0 . After 50–70 cycles, the PPR reaches their maximum of ~65-75 %. However, these samples did not reach the liquefaction criteria (PPR = 90%), which is related to the anisotropic testing conditions (Erguvanil 1980). In contrast to the behavior of U1, U2, and the SFPT equivalent material, the pore pressure build up in U3 quick clay is slow, reaching ~20 % of p_0 after 100 loading cycles. The $\varepsilon_a = 5$ % failure criterion (Garga and McKay 1984) is first reached by the U2 sample, followed by U1 and U3, and finally the SFPT equivalent. Although pore pressure evolution within the U1, U2, and tephra samples is similar, the axial strain evolution differs significantly. After an initial settling phase, ε_a of the tephra samples increases approximately linearly and reaches 5 % ε_a after more than 100 cycles. U1 and U2 sediment build up strain and pore pressure rapidly within the first 0–20 cycles and subsequently reduce the PPR and ε_a increase per cycle. U3 sediment increases its ε_a gradient with increasing number of cycles. Progressive failure and inherent remolding of the sediment seem to favor ε_a accumulation so that 20 % ε_a is first reached by U3 quick clay and then by U2 diatomaceous ooze, which is consistent with the observations made on sensitivity.

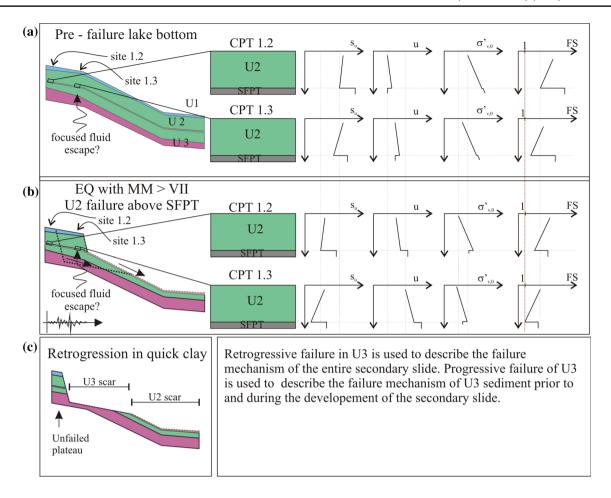
Fig. 11 Left **a**, **b** and **c** Simplified model for landslide process. Right illustration of undrained shear strength (s_u) , sediment excess pore pressure (u), effective overburden (σ'_{v0}) , and factor of safety (FS) at

the interface of the SFPT and U2 at site 1.2 and 1.3 (a) prior to earth-quake shaking and (b) after earthquake shaking

Retrogression may explain the observed scarp geometries and the existence of two failure planes (Fig. 11): After the destabilization of the upper failure plane, the subsequent mass movement removed the material serving as backstop for the quick clay unit (U3) and local strain started to accumulated (Fig. 10). With the gradual increase in strain (brittle failure) and shear strength reduction in U3 sediment, progressive slope failure was initiated. Mass movement led to the complete remolding of the entire sediment sequence and ended in the transportation of material along the "bottle-neck-shaped" channel. The time that may
