Scanning electron microscopy study of cavity preparation in deciduous teeth using the Er:YAG laser with different powers

Abstract Using scanning electron microscopy (SEM) we evaluated the morphology of cavity surfaces in deciduous teeth prepared *in vitro* with the Er:YAG laser with different power parameters. Eight extracted cavity-free deciduous teeth with an intact crown were prepared using a traditional handpiece or an Er:YAG laser with different parameters (10 Hz/200 mJ, 10 Hz/300 mJ and 10 Hz/400 mJ). Samples were then processed and cavity surface morphology was evaluated by SEM to detect open dentinal tubules, or melting or cracking of the dentin. SEM showed that laser cavity preparation in deciduous teeth using different parameters left no smear layer and the dentinal tubules were clear. Dentin melting was not seen after cavity preparation at 200 mJ or 300 mJ, while visible dentin melting and cracks were detected at 400 mJ. The use of the laser at 10 Hz/200 mJ and 10 Hz/300 mJ for cavity preparation in deciduous teeth is safe and effective, but higher powers may damage the dentin.

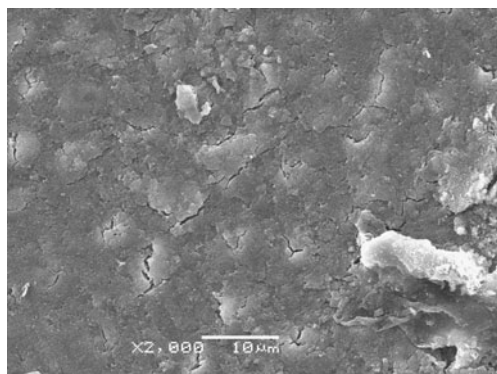
Fig. 1 Control group. Representative scanning electron micrograph of the smear layer produced on the dentin surface by a diamond burr in a high-speed drill ($\times 2,000$)

The cavity surfaces in the control group were covered by a smear layer, with scattered irregular debris, and dentinal tubules could be seen occasionally (Fig. 1).

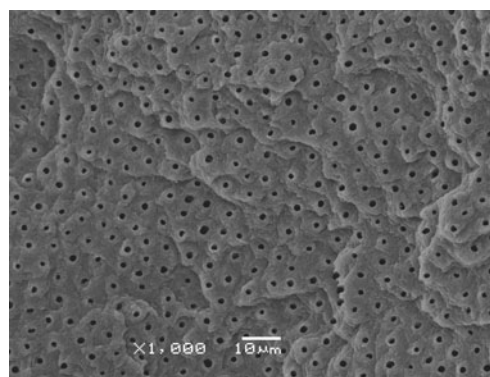
Fig. 2 Experimental group 1. Representative scanning electron micrograph of dentin irradiated with the Er:YAG laser (10 Hz/200 mJ) showing the absence of a smear layer and open dentinal tubules ($\times 1,000$)

No smear layer was seen on the dentin surface in the three laser groups. The surfaces were scale-like and uneven with open dentinal tubules. The density of the peritubular dentin was seen to be higher than that of the intertubular dentin, and

there was no plugging of the tubules. There were no obvious cracks or melting of the dentin in groups 1 and 2. In group 3, (i.e. the 10 Hz/400 mJ laser group) the cavities showed a significantly more uneven surface, visible cracks and partial dentin melting locally. Longitudinal profiles of the dentinal tubules could be seen in the lateral walls, and showed irregular dentin particles (Figs. 2, 3, 4, 5, 6).

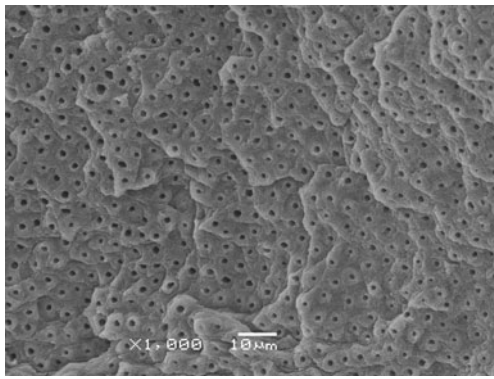
Fig. 3 Experimental group 2. Representative scanning electron micrograph of dentin irradiated with the Er:YAG laser (10 Hz/300 mJ) showing the absence of a smear layer and open dental tubules ($\times 1,000$)

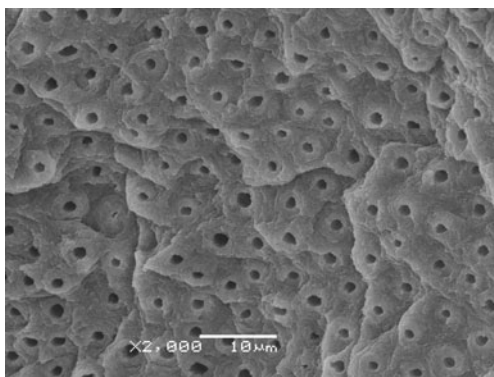
Fig. 4 Experimental group 2. Representative scanning electron micrograph of dentin irradiated with the Er:YAG laser (10 Hz/300 mJ) showing the absence of a smear layer and open dental tubules ($\times 2,000$)

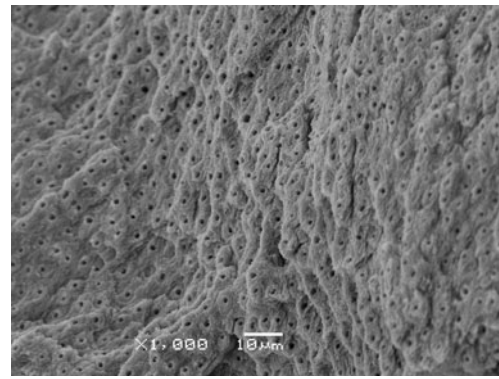
Fig. 5 Experimental group 3. Representative scanning electron micrograph of dentin irradiated with the Er:YAG laser (10 Hz/400 mJ) showing the absence of a smear layer, open dental tubules, visible cracks and an area of partial dentin melting ($\times 1,000$)

contains more water than the intratubular dentin. Lasers of the same power will remove more tissue in deciduous teeth than in permanent teeth. Thus, the parameters used should be lower than those used in permanent teeth. In brief, The higher the power, the more distinct the layer at the cavity floor. In group 3 irradiated at a power of 4 W, more obvious waves were present at the cavity floor and small cracks were seen. As the laser's cutting ability is proportional to its power [21], more small cracks and a deeper melting layer at the cavity surface are formed with higher power lasers. This study found that the cavity surfaces irradiated at 10 Hz with energies of 200 mJ and 300 mJ were similar, but those irradiated at 10 Hz with an energy of 400 mJ show cracks and melting of the dentin, indicating that the use of a power of 4 W in the dentin of primary teeth is too high and may damage the dentin.

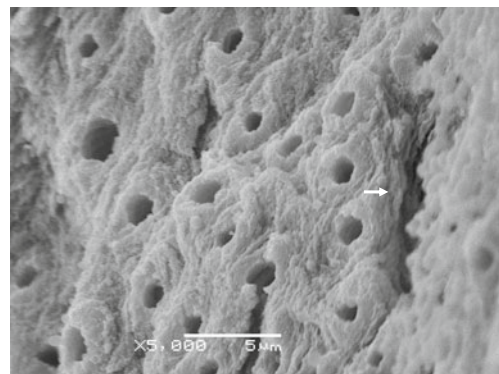
Fig. 6 Experimental group 3. Representative scanning electron micrograph of dentin irradiated with the Er:YAG laser (10 Hz/400 mJ) showing a crack (*arrow*) ($\times 5,000$)
