Influence of Horizontal and Vertical Barriers on Fire Development for Ventilated Façades

Abstract. Although using various innovative materials for ventilated facade systems positively contribute to the energy efficiency of buildings, the application of such materials can also pose a certain risk of fire propagation through the façade. In the last decade, medium and large-scale tests, as well as numerical analysis have been performed to assess the impact of fire barriers on fire propagation through ventilated façades. However, the number of fire barriers and their specific positions can also have an effect on the fire safety of facades, which has not been studied. Consequently, the question arises whether real fire exposure on a façade can be adequately simulated and analysed in sufficient detail, by using large-scale testing methods. This paper aims to conduct a parametric analysis on a broader range of large-scale samples by using the procedure given in the standard BS 8414-1:2015 + A1:2017. To understand better the impact of the number and position of cavity barriers for different types of insulation materials (stone wool/PIR/phenolic foam) used in modern façade systems with non

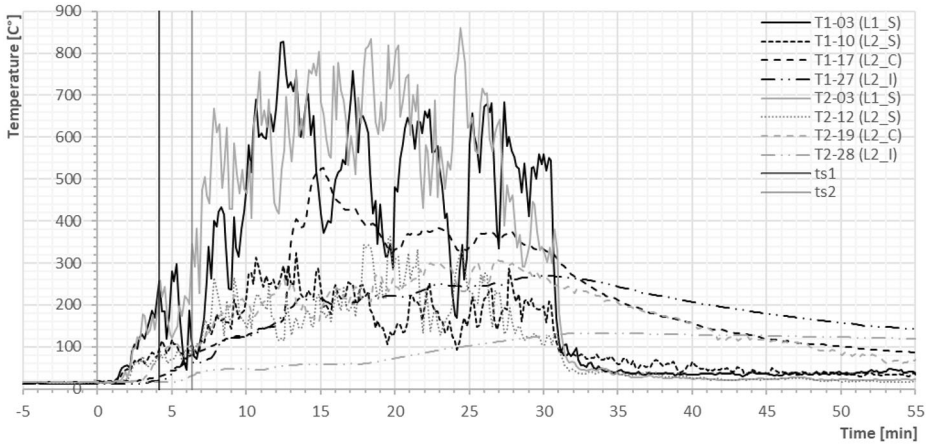
Figure 5. Temperature development in 60 min on thermocouples with Tmax for both levels—Sample 1 and 2.

The influence of horizontal barriers was observed by comparing the maximum temperature in L2_C that appears in the Sample 1 without horizontal barrier ($T_{\max (t=15:11)} = 526.46^\circ\text{C}$) with the temperature on Sample 2 on the same thermocouple ($T_{(t=15:51)} = 215.6^\circ\text{C}$) which is two times lower. The effect of buoyancy is dependent on the amount of surrounding 'fresh air' entrained through the cav-

ity with hot gases. The ambient temperature of Sample 1 was $15,1^{\circ}\text{C}$ and for Sample 2 $13,6^{\circ}\text{C}$ which at the position of the ignition (chamber) makes similar initial conditions. The temperature difference between L1_S and L2_S for Sample 1 is $323,36^{\circ}\text{C}$ (thermocouple T1-9–T1-1), and for Sample 2 it is $172,26^{\circ}\text{C}$ (thermocouple T2-9–T2-1). The bigger difference in temperatures leads to the bigger difference in the pressures affecting the force of the buoyancy. Since the temperature in the cavity at the first level was not measured, the buoyancy is observed in correlation with the surface and it is expected that the fire propagation in narrow “unprotected” cavity in Sample 1 has been supported by the chimney effect because the air density differences on level 2 and level 1 resulted from temperature differences. In Sample 2, the chimney effect is physically disabled with the hori-

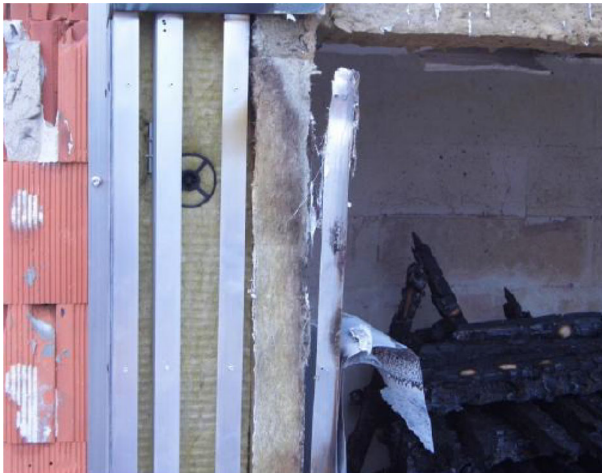
Figure 6. Sample 2- influence of vertical barrier on fire spread.

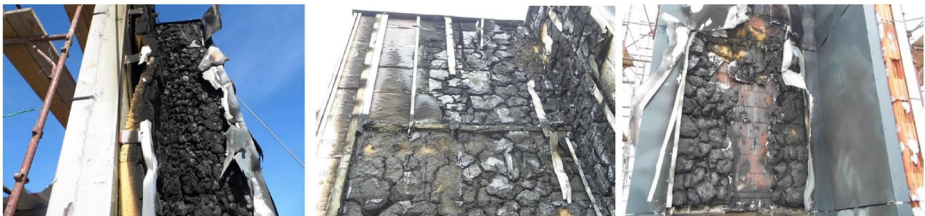
Figure 8. Sample 3,4,5—influence of vertical barrier on fire spread.

The influence of the vertical barrier on the left side of the chamber is visually demonstrable. The combustible insulation on the left side of the vertical barrier that was not protected has lost its properties (Sample 3) and it has partially burned out while ones protected by a vertical barrier (Sample 4 and 5) remained undamaged in both cases Fig. 8.

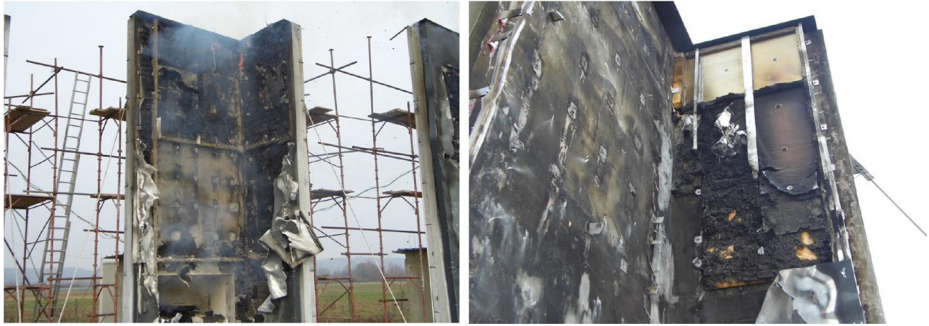
Figure 12. Sample 6 and 7- influence of vertical barrier on fire spread.
