The tropical storm Noel and its effects on the territory of the Dominican Republic

Michela Izzo · Pietro Patrizio Ciro Aucelli · Yudith Javier ·
Caridad Pérez · Carmen Maria Roskopf

Received: 9 November 2008 / Accepted: 17 June 2009 / Published online: 3 September 2009
© Springer Science+Business Media B.V. 2009

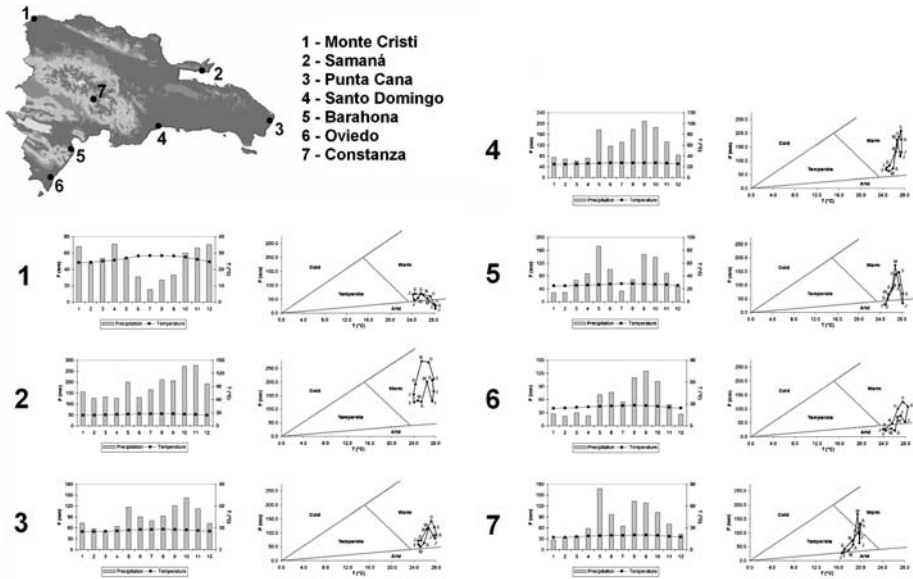
Fig. 3 Thermo-pluviometric diagrams of some stations in the country: Bagnolus-Gausson on the left; Peguy on the right

The analysis of the spatial distribution of some of the main climatic parameters, such as air temperature and precipitation, allowed to define, as shown in Fig. 3, the Bagnouls–Gausson and Peguy diagrams for the weather stations, which represent the main climatic regions of the country. In particular, the Bagnouls–Gausson diagram (Gausson and Bagnouls 1957; Bagnouls and Gausson 1953) shows the relation between average monthly rainfall amounts (in mm) and relative air temperatures (in °C) calculated for the 30-year period 1971–2000 for the considered weather stations. The diagram allows to define a dry period when the amount of average monthly precipitation is lower than the double of the monthly mean temperature. The Peguy diagram (Peguy 1970) is based on the representation of segments, which join the monthly average values of air temperature and precipitation. Four sectors (*C* = Cold months; *T* = Temperate months; *H* = Hot months; *D* = Dry months) are identified as the intersection of three straight lines: $y = 1.71x$; $y = 13.3x$; and $y = -19x + 485.7$.

The presented diagrams evidence a gradual reduction of precipitation from east to west. For the eastern zones, even though a typical reduction of precipitation is clearly evident during winter and spring, no arid period can be identified. The western zones, instead, are characterized by a more or less pronounced aridity. In particular, within the south-western sector (Barahona), aridity characterizes the periods from December to February and from July to August, while it extends for the whole summer period (May–September) within the north-western sector showing similarities to Mediterranean climate (Monte Cristi).

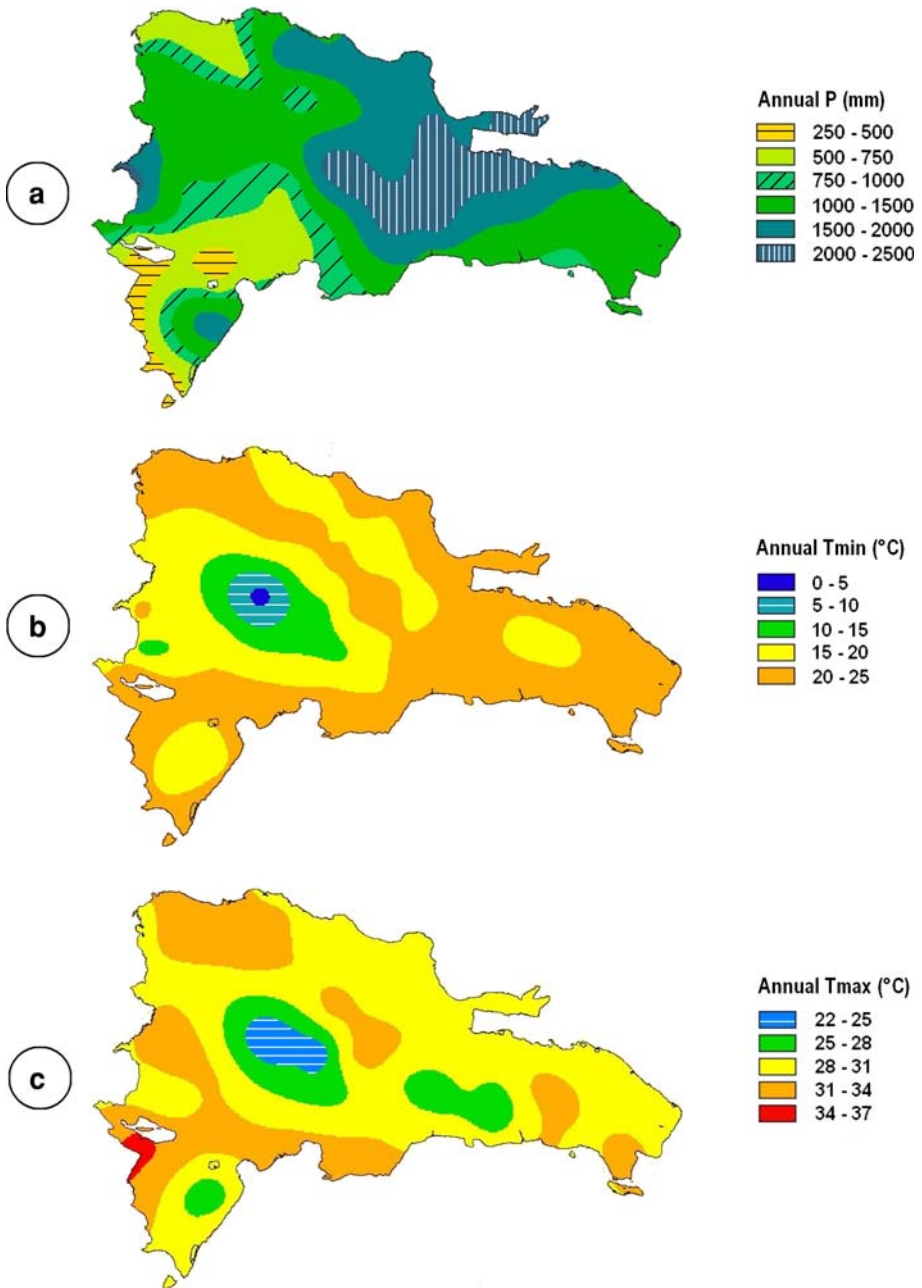
Fig. 4 Territorial distribution of mean annual precipitation (a), mean annual minimum temperature (b) and mean annual maximum temperature (c) (reference period 1971–2000)

Typical elements of temperate climate appear in mountainous zones (Constanza), where the elevation causes a considerable reduction of mean annual air temperature. As a matter of fact, the mean annual air temperature, which is about 26°C for the country as a whole, at altitudes above 1,200 m in some areas of the Cordigliera Central drops down to less than 18°C. Figure 4 shows the spatial distribution of mean annual precipitation (A) and that of annual minimum and maximum temperatures (B and C) for the 30-year period 1971–2000.

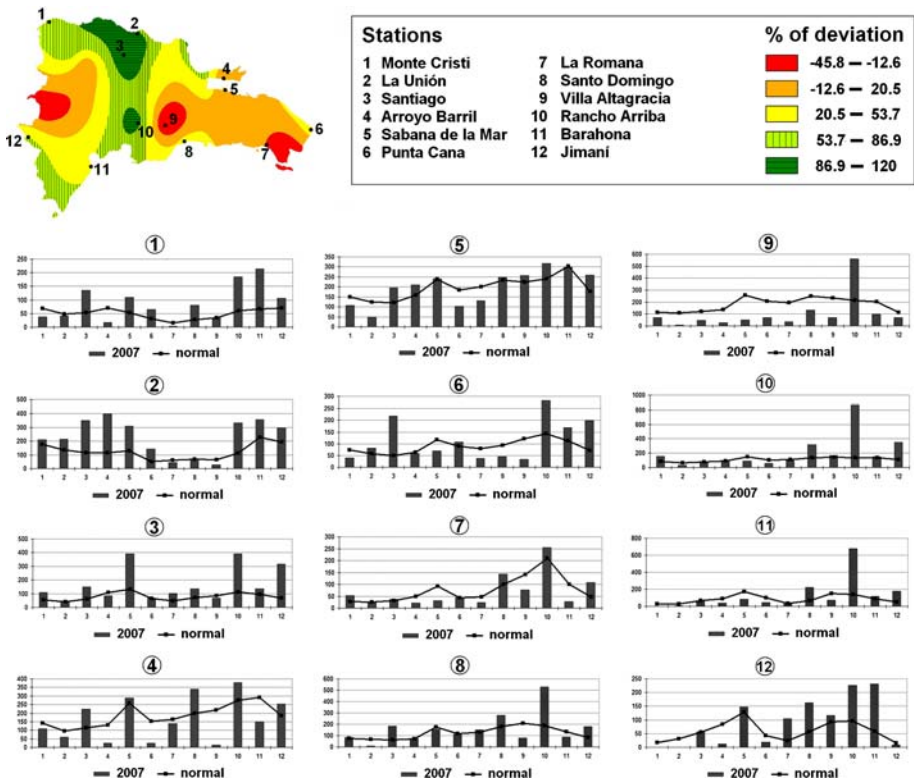
Fig. 8 Trend of precipitation in 2007 and comparison with the average of the period 1971–2000 for some stations of ONAMET network. Deviation was calculated as described in the text of the article

Confronting monthly precipitation occurred in the Dominican territory during 2007 with the mean values (normal) registered during the 30-year period 1971–2000 (Fig. 8), two main anomalies can be evidenced: the central and southern weather stations registered monthly precipitation inferior or equal to the normal, while the northern stations show a very inhomogeneous distribution of their rainfall amounts, significantly higher than the normal in the majority of months, separated by one or more months with precipitations similar to considerably lower than the normal (Arroyo Barril and Sabana de la Mar stations). Deviations of total average rainfall amounts and those registered during 2007, calculated as percentage of [(total precipitation 2007–average annual precipitation)/average annual precipitation], produce a typical zonation of the Dominican territory (Fig. 8), which highlights the zones that were characterized in 2007 by an excess (over all the central sector) and by a deficit of total annual rainfall (the north-western and eastern sectors) with respect to the normal.

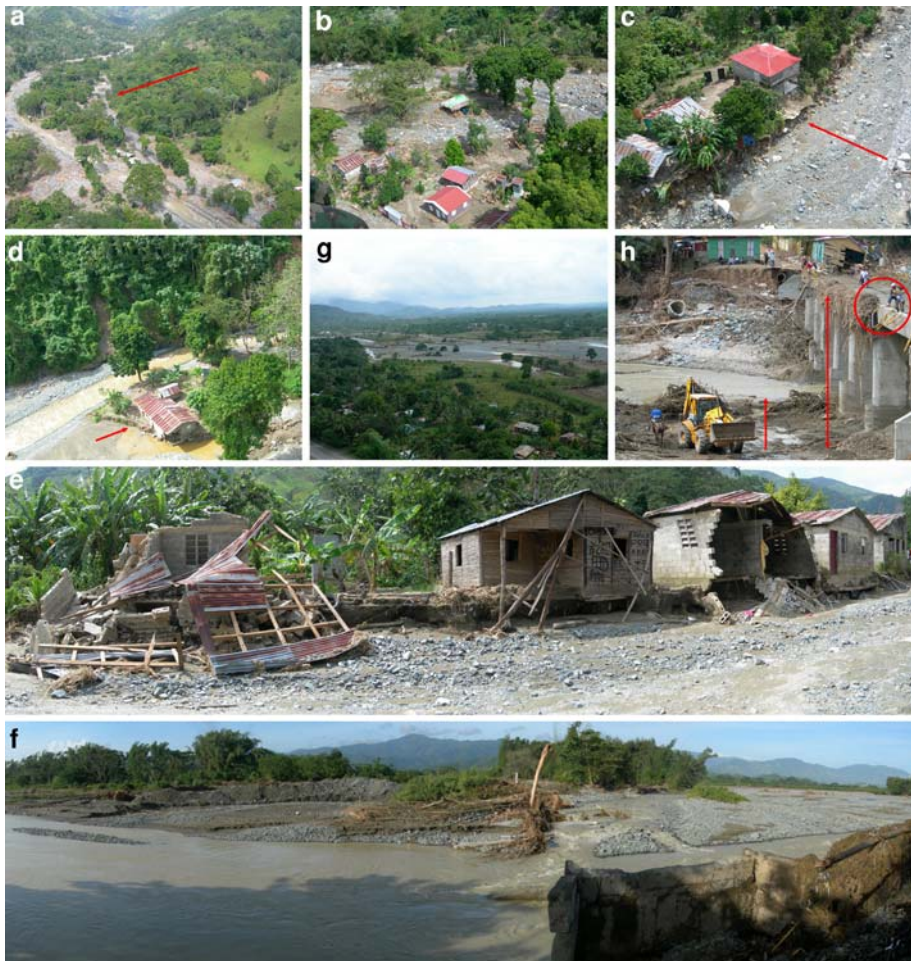
Fig. 10 Impacts of stream erosion on anthropic structures provoked by the flood during the passage of the tropical storm Noel. Note that within the surveyed fluvial reaches the damaged houses are located or on the flood plain or within the active channel (a–e); flood effects related to elevated hydrometric levels during the storm event: the collapse of the bridge on the Haina river within the Villa Altagracia municipality (f); a view from the Duarte highway, locally reached by the flood (g); evidence of the elevated hydrometric level reached by the Mahomita river within the town of Los Cacaos, San Cristóbal province (h)

Many roads and communication infrastructures were severely affected by flooding. In particular, flooding caused the collapse of a lot of bridges (Fig. 10f), while a stretch of the Duarte highway was inundated by water and closed to transit of vehicles for various hours (Fig. 10g). In the area where the Basima river joins the Haina river, water flow inundated large portions of the floodplain and reactivated abandoned river channels (Fig. 10g).

Also in urban centers, flooding caused huge damage as for example in the town of Los Cacaos (San Cristóbal Province), located in the medium sector of the Nizao basin along the middle course of the Mahomita river, whose hydrometric level locally rose more than 6 m (Fig. 10h). In this specific case, it is important to put in evidence the inadequate technique,

which was adopted to build the bridge: short spans are not adequate for this kind of river, which is characterized by significant solid loads and very variable flows.

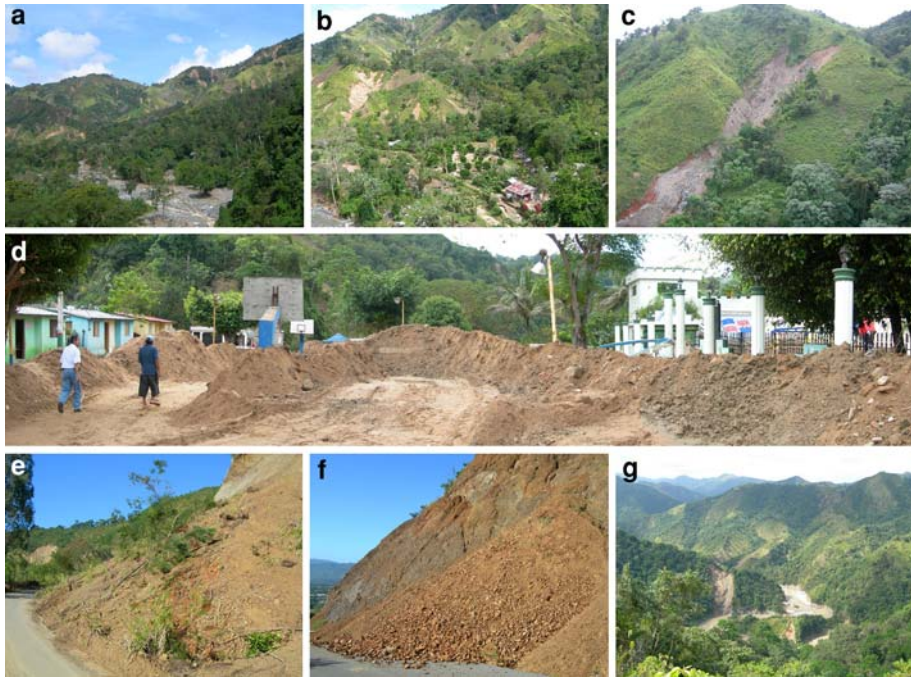
Fig. 11 Steep, mainly deforested, slopes affected by diffuse shallow earth-slides and earthflows triggered by the rainfall during the storm event (a–c); evidence of huge debris flow impacts within the town of Los Cacaos (San Cristóbal) (d); rock and earthfalls occurred on very steep slopes along road cuts (e, f) and triggered by stream undercutting (g), respectively

Debris flows and mudflows typically involved the soil and regolith mantles of steep slopes (generally exceeding 30°) and affected mostly slopes, which had undergone recent denudation due to the clearing of the original forest cover (Fig. 11a–c). In the investigated basins, such flows produced a high negative impact on agriculture, based prevalently on coffee. As a matter of fact, damage consisted not only in the loss of production, related to the occurrence of the storm during the harvesting season, but also in the extensive land degradation generated by soil loss or its burial due to debris accumulation.

Landslides of minor dimensions but widely diffused were rock and earthfalls which typically occurred along scarps characterized by excessive steepness due to artificial cuts (for instance road cuts, Fig. 11e, f) or river undercutting during the event (Fig. 11g).
