Investigating the Roles of Protein on the Cobalt Alloy Surface Degradation for Biomedical Implant Through Tribocorrosion Mechanisms

Abstract

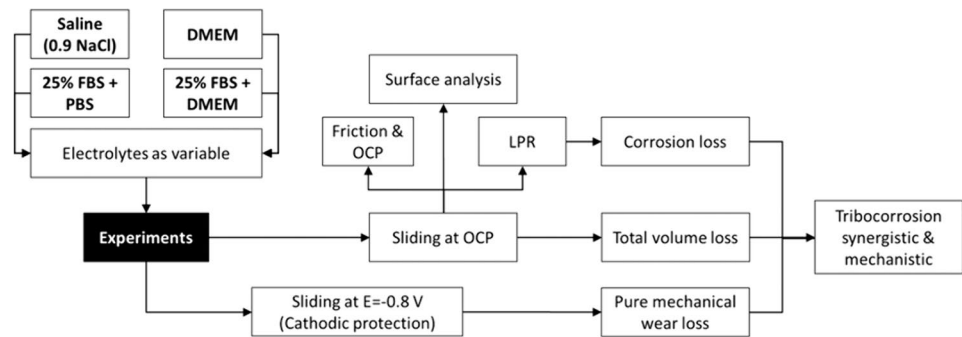
Fig. 1 Schematic of tribocorrosion tests, surface analysis protocols, and components to achieve tribocorrosion approaches

Figure 1 shows a schematic of the overall experimental procedures employed in this study, including the list of testing electrolytes, tribocorrosion testing methods, surface analysis, and measurements to obtain tribocorrosive degradation components and then analyzed by tribocorrosion approaches.

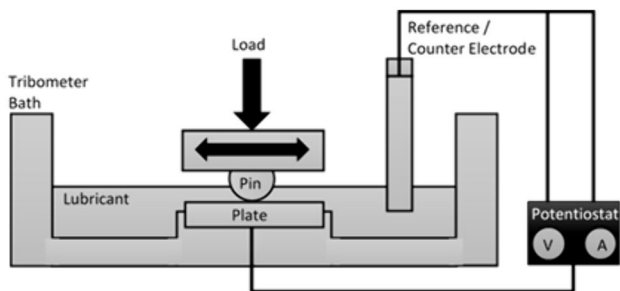
Fig. 2 Instrumented reciprocating tribometer scheme (image was reproduced from the previous study [11])

silver chloride (Ag/AgCl) as the reference electrode (RE), and a platinum (Pt) disk as counter electrode (CE).

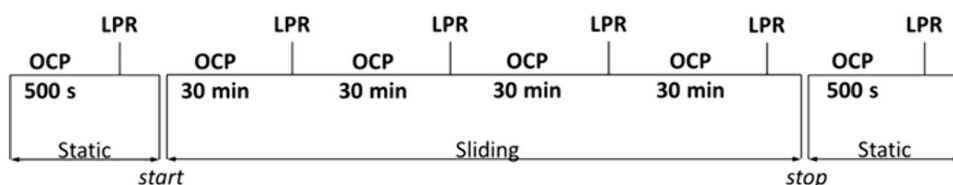
Fig. 3 Schematic of the tribocorrosion tests’ procedure in OCP condition

and finally at 500 s after the test to assess the material’s resistance to polarization and subsequent corrosion current. To calculate the polarization resistance (R_p), the potential of the WE were shifted ± 10 mV versus OCP with a scan rate of 0.25 mV/s, and the resulting current was measured. The LPR technique, operating within a few millivolts (mV) of the sample OCP, is considered non-destructive. Conducting LPR measurements intermittently avoided potential changes within the system that might arise from sustained over-potential application. ASTM G119-09 [70] and G59-97 [57] outline the use of the LPR technique and Stern–Geary coefficients to determine corrosion currents in tribocorrosion systems [60]. Figure 3 provides an overall schematic of the tribocorrosion tests in OCP conditions.

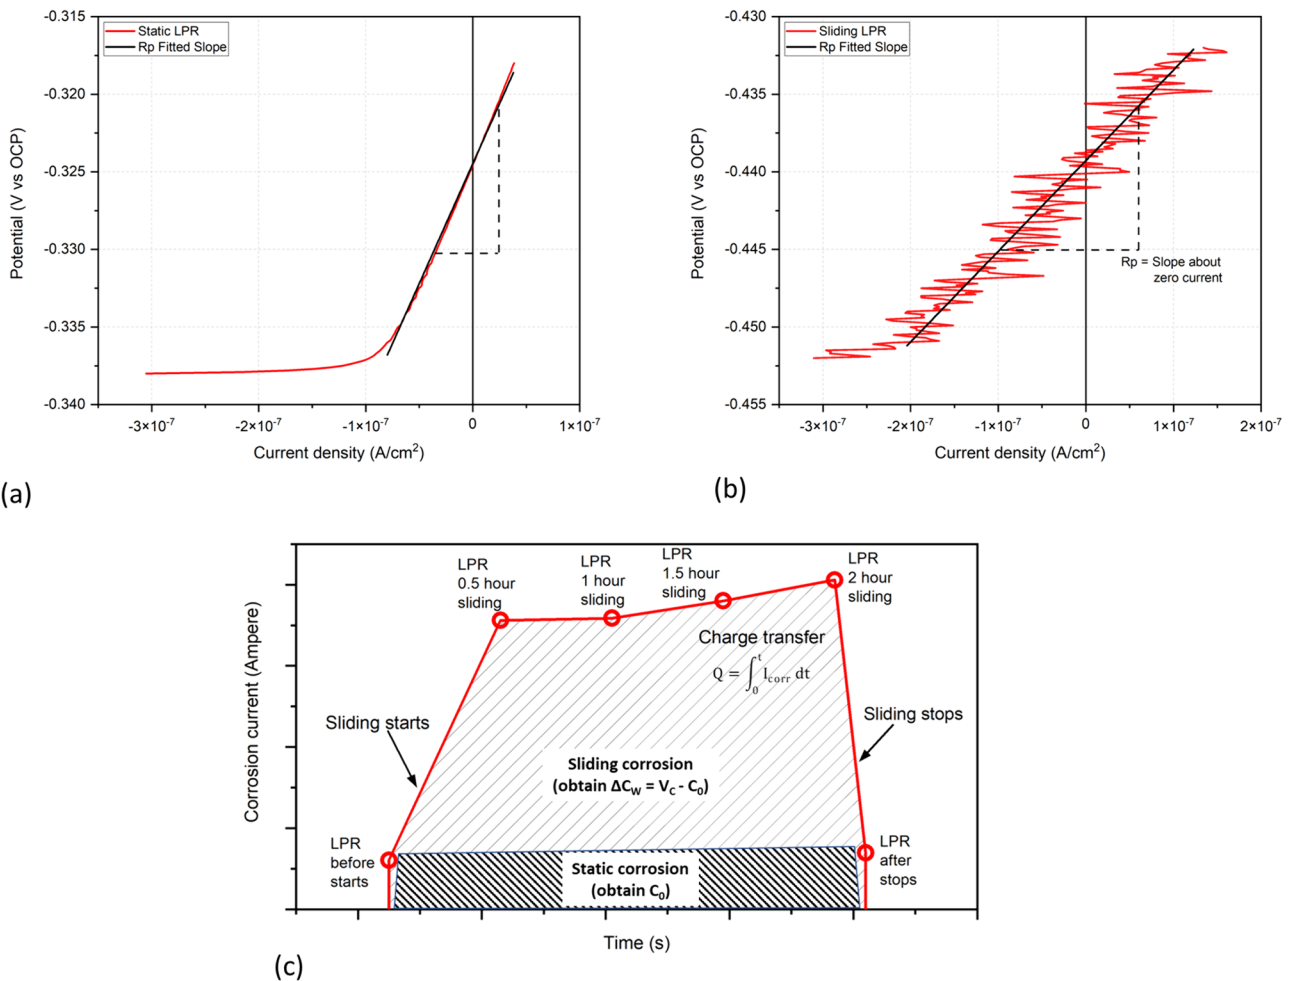
Fig. 4 Example of polarizations during LPR scan at **a** static and **b** sliding conditions in 0.9% NaCl, as well as **c** plotted I_{corr} values over testing time to obtain the total charge transfer

Figure 4 presents example plots of current versus potential obtained from LPR tests under (a) static and (b) sliding conditions (example tested in saline) [29]. A linear E–I response was observed around zero net current. The slope of the measured current as a function of applied potential represents the polarization resistance, calculated using a voltage window of ± 5 mV around zero net current, consistent with previous studies [11, 29, 71]. The R_p values were then converted into corrosion current density (I_{corr}) in Amperes using the Stern–Geary formula (Eq. 1) and standard Tafel constants (β_a and $\beta_c = 120$ mV/decade) obtained through extrapolation of the Tafel plot. In this study, the values of both R_p and I_{corr} were plotted and obtained by CorrWare and CorrView software (AMETEK Scientific Instruments, USA). The obtained I_{corr} values were integrated over the tribocorrosion test time (t) in seconds to determine the total charge transfer of ion removal (Q) in Coulombs, as described in Fig. 4c and Eq. (2) [71].

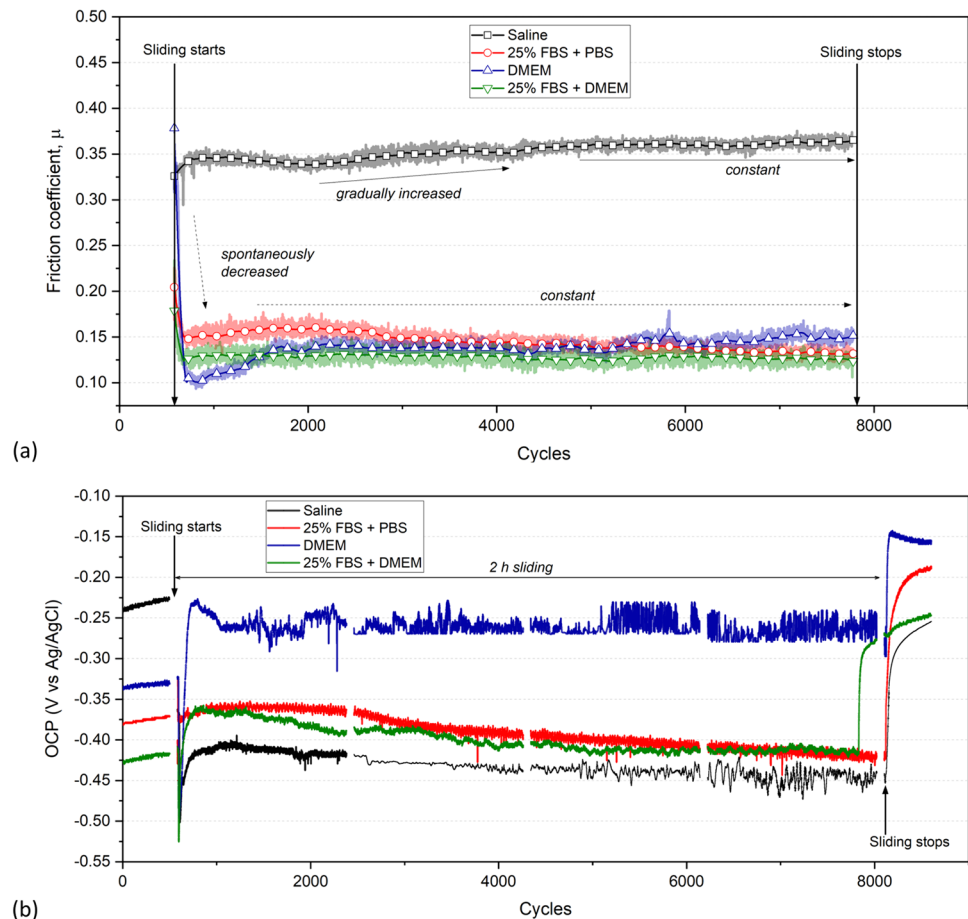
Fig. 5 The evolution of the transient **a** μ and **b** OCP voltages over 2-h sliding cycles under OCP conditions

Regarding open-circuit potential (OCP), in the pre-sliding stage, CoCrMo in saline exhibited the highest (more noble)

OCP at above -0.25 V followed by DMEM and both 25% FBS-containing electrolytes, which had less than -0.33 V. When sliding started, all samples had a spontaneous reduction in the OCP voltages due to the de-passivation process and then followed by the gradual increase until reaching some points on the voltages due to re-passivation. Interestingly, different electrolytes showed various trends; the sliding OCP in saline were still significantly lower than the pre-sliding condition at -0.40 V at start with slightly decreased until the end of sliding. The sliding OCP in 25% FBS + PBS were seen to be recovered back to the state, whereas like the pre-sliding voltages, at around -0.36 V with gradual decreased until the sliding stopped. In the contrary, DMEM and 25% FBS + DMEM showed higher sliding OCP voltages compared to the trends during pre-sliding. However, the samples in 25% FBS + DMEM (-0.36 V) had similar trend with the 25% FBS + PBS sample, in which did not show re-passivation OCP as significant as in the pure DMEM solution (-0.26 V) during sliding. After the sliding stopped, OCP voltages in all electrolytes had a spontaneous increase reaching points even significantly higher (more noble) compared to the pre-sliding voltages.

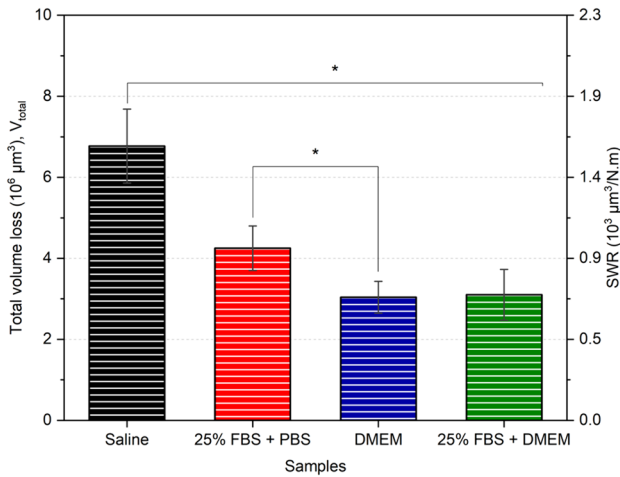
Fig. 6 Total volume loss (V_{total}) and SWR of the wear scar on CoCrMo in all electrolytes over the 2-h tribocorrosion tests at OCP ($n=3$; SD bar; $*p < 0.05$)

Figure 6 compares the total volume loss (V_{total}) at the OCP condition and its conversion into specific wear rate (SWR) on CoCrMo after 2 h of tribocorrosion testing in all electrolytes, as previously reported. The V_{total} in saline electrolyte ($6.77 \pm 0.91) \times 10^6 \mu\text{m}^3$ was the highest after 2 h of sliding

compared to the organic-containing electrolytes. A gradual increase in V_{total} was observed in 25% FBS + PBS compared to the DMEM sample, while no significant difference was found between V_{total} in samples tested with 25% FBS + PBS and 25% FBS + DMEM. These V_{total} values will later be split into the four components of volume loss to observe tribocorrosive degradation behavior in each electrolyte as explained earlier.

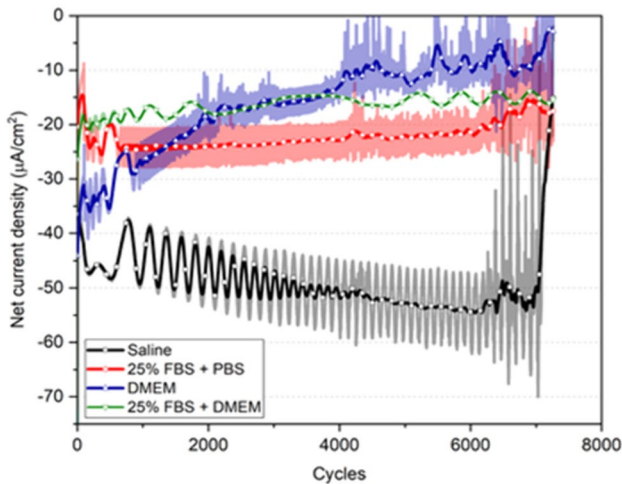
Fig. 7 Transient net current during 2-h sliding tests at a potentiostatic $E = -0.8$ V (cathodically protected) condition in all electrolytes

Figure 7 illustrates the evolution of the transient net current during the 2-h sliding at $E = -0.8$ V (vs. RE Ag/AgCl) potentiostatic condition, where negative values indicate the

cathodically protected state. The current data shown is as evidence that the electrochemical degradation from corrosion on the CoCrMo surface can be disregarded. Therefore, the material loss obtained is solely due to mechanical wear degradation. The volume losses obtained by VSI on the CoCrMo at $E = -0.8$ V_{Ag/AgCl} (pure wear volume loss or W_0) after 2 h of sliding in all electrolytes are presented in Fig. 8.

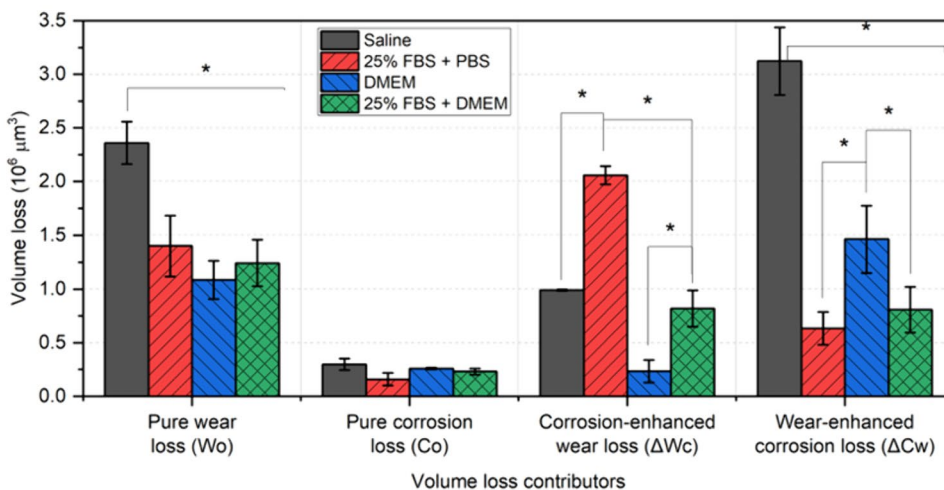
Fig. 8 Compilation of the volume loss components when using the synergistic approach over the 2-h tribocorrosion tests ($n = 3$; SD bar; $*p < 0.05$)

The V_{total} values were subtracted by the obtained values of C_0 , W_0 and ΔC_W to estimate ΔW_C values in various electrolytes, compiled in Fig. 8. Table 3 presents the obtained tribocorrosion contributors based on the synergistic approach (C_0 , W_0 , ΔC_W and ΔW_C), while the mechanistic components (V_C and V_W) are included to complement the analysis. It shows that the W_0 in saline electrolyte was significantly higher than in the organic-containing electrolytes. No significant difference in W_0 was observed between the 25% FBS + PBS, DMEM and 25% FBS + DMEM samples during the 2-h sliding. The C_0 was significantly lower than the other volume loss contributors in all electrolytes, and no significant difference was observed in the C_0 between the samples in all electrolytes.

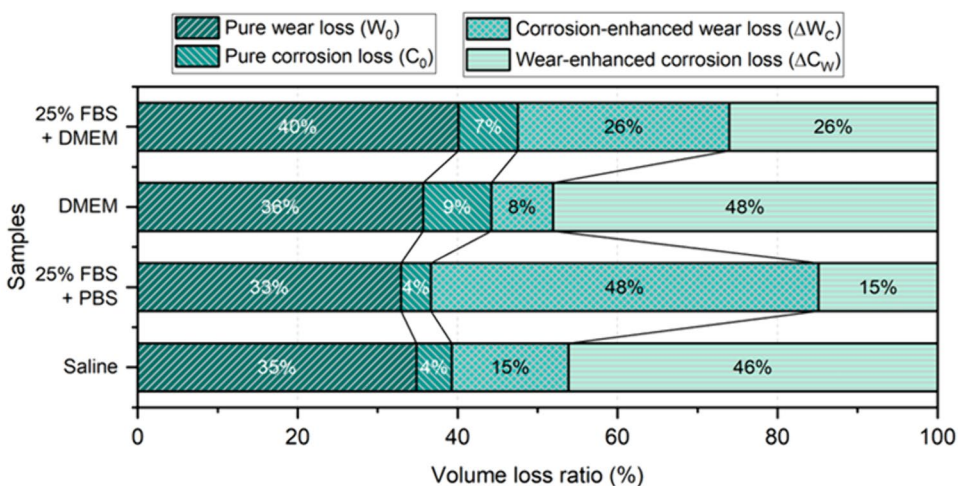
Fig. 9 Ratio of each component using the synergistic approach over the 2-h tribocorrosion tests

In Fig. 9, the contributing ratio (%) of each degradation component from their V_{total} is shown. In the saline electrolyte and DMEM, the total volume loss was mainly dominated by ΔC_W accounting for approximately ~45%, followed by W_0 at ~35%. Additionally, C_0 and ΔW_C contributed to less than ~15% each in the saline electrolyte and DMEM. Conversely, a different behavior was observed in the protein-containing electrolytes. In the 25% FBS + PBS, the total volume loss was mainly dominated by ΔC_W at ~48%, followed by W_0 at ~36%, ΔC_W and C_0 . For the CoCrMo tested in 25% FBS + DMEM, the

contributions of ΔW_c and ΔC_w were similar, each accounting for $\sim 26\%$ of the V_{total} . As a result, the total volume loss in the 25% FBS + DMEM was mainly dominated by W_0 at $\sim 40\%$, while the contribution of C_0 was only $\sim 4\%$.

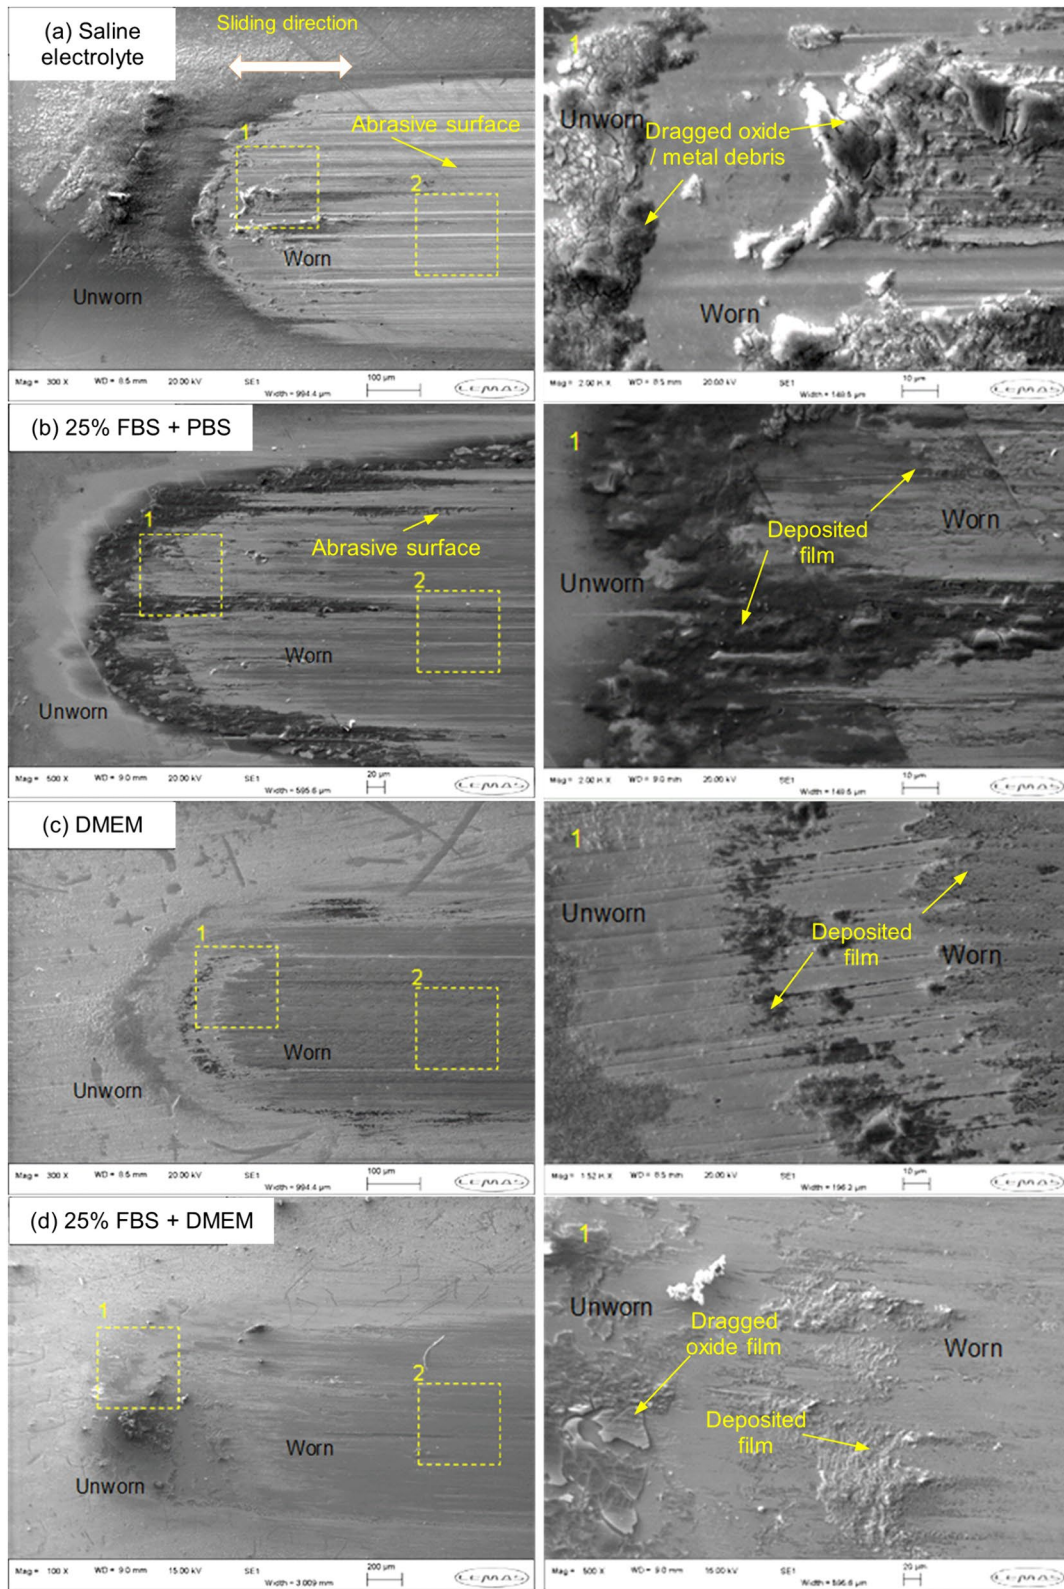
Fig. 10 SEM images of the wear tracks on CoCrMo alloy after a 2-h sliding test at OCP in **a** saline, **b** 25% FBS + PBS, **c** DMEM, and **d** 25% FBS + DMEM electrolytes

Figure 10 displays SEM images of the CoCrMo wear scars following the tribocorrosion tests in different electrolytes. The wear scar from the saline test exhibited a width ($\sim 509.73 \mu\text{m}$) and displayed distinct traces of abrasion

compared to the others ($\sim 367.67 \mu\text{m}$ for the 25% FBS-containing electrolyte). The wear track in the saline electrolyte sample showed dominating layers at the tip corner and outside, suggesting the removal and reformation of the passive film during sliding. In contrast, the wear scars in organic-containing electrolytes exhibited clear indications of layers covering the abrasive wear both on the inside and edges of scar. The chemical analysis of the tribofilm structure has been presented in the previous paper [11].

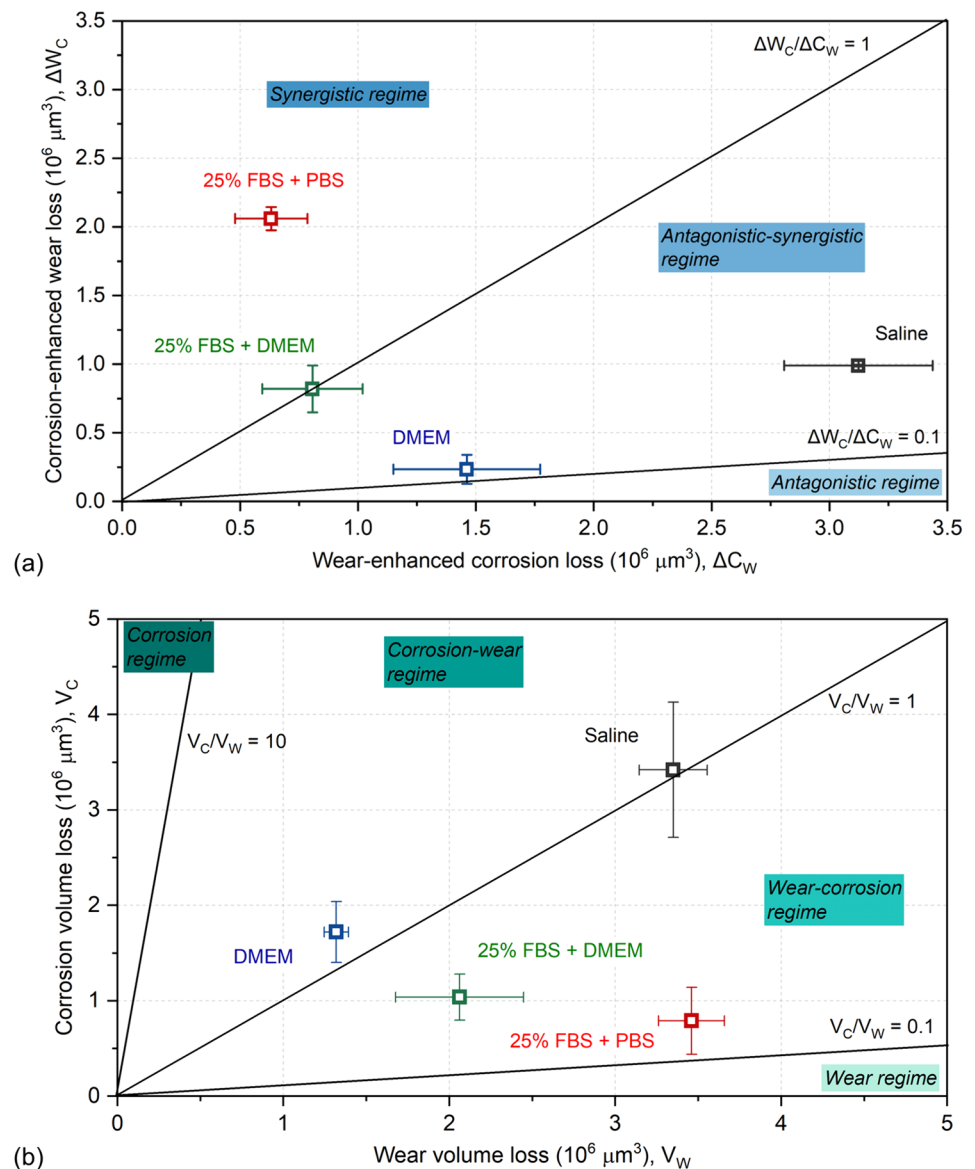
Fig. 11 The impact of electrolytes on the tribocorrosive behavior using both the **a** synergistic and **b** mechanistic approaches after the 2-h sliding tests ($n = 3$; SD bar)

To evaluate the interaction categories of mechanical wear and electrochemical losses with respect to the effect of electrolytes, the tribocorrosion mappings are shown in Fig. 11 for both modes. These mappings provide a thorough understanding of the degradation mechanisms and their relative contributions under different test conditions.

between corrosion and wear processes ($\Delta W_C/\Delta C_W$) using the tribocorrosion synergistic approach [23] for all investigated electrolytes in this study. The results revealed a synergistic interaction ($\Delta W_C/\Delta C_W > 1$) in the 25% FBS + PBS samples, while the saline electrolyte and DMEM samples exhibited an antagonistic-synergistic interaction ($1 > \Delta W_C/\Delta C_W \geq 0.1$). Interestingly, the CoCrMo tested in 25% FBS + DMEM displayed an intermediate behavior, lying between the synergistic and antagonistic-synergistic regimes, suggesting a contrasting role between the FBS and DMEM solutions. This suggested the beneficial role of protein in both 25% FBS + PBS and 25% FBS + DMEM decreases corrosive (electrochemical) surface degradation, unlike non-protein as in saline and DMEM solutions. As summarized by Fuentes et al. [79], the concept of metal passivity explains the autonomous formation of a passive oxide layer in passive type metals, known as passivation process and acting as a natural protection against corrosion. When two articulating surfaces experience rubbing under varying loads, velocities and directions, the passive oxide layer experience disruption and removal, triggering de-passivation. This exposes fresh material at the de-passivated surface to the surrounding electrolyte, rendering it susceptible to corrosion, leading to wear-enhanced corrosion denoted as ΔC_W . Hence, the findings of this study suggest that the presence of protein has altered the exposed surface properties once the de-passivation took place, likely by suppressing the dissolution of metal ions even before the reformation of the passive film. Mathew et al. [2] confirmed the role of bovine serum protein in generating protective films against corrosion. Yang et al. [80] employed an in situ electrochemical hip joint simulator to investigate a metal-on-polyethylene (MoP) THR's behavior during long-term walking with 30-g/L protein. To note that these results might be affected if using different contact conditions during the tribocorrosion testing, such as linear tribometer or higher load given as in this study. Their findings revealed the development of two passivation films on the interface surface along with an adsorbed protein layer, originating from precipitated and aggregated proteins. These aligned with other previous studies by the authors [29, 40] when using pre-denatured protein in FBS diluted saline compared to the ones in as-received FBS with various concentration, whereas showing that tribofilm emerged from denatured proteins and wear debris. This dual-layer formation likely contributed to reduced corrosion, promoting the corrosion inhibitory capability of both layers. SEM imaging in this study confirmed their similarity, aligning with the common assumption of a denatured protein-based tribofilm [12, 29, 81], primarily composed of graphitic carbon [11, 82]. This mechanism correlates with the de- and re-passivation process during rubbing. Protein seemed to have an active role in stabilizing OCP voltage during

in the FBS-containing electrolytes was predominantly governed by the wear-corrosion mechanism, with a ratio of $0.1 < V_C/V_W \leq 1$. This is expected to provide a deeper insight into the underlying degradation mechanisms, helping to understand the relative contributions of electrochemical corrosion and mechanical wear in different electrolytes. This is also linear with results in a synergistic context, in which this trend is confirmed by the elevated ΔW_C values observed in 25% FBS + PBS and 25% FBS + DMEM, in comparison to the saline and DMEM samples, respectively. Following the outlined process of metal passivity [79], when the freshly exposed material on the de-passivated surface comes into contact with the electrolyte, it becomes susceptible to metal ion dissolution, leading to surface roughening and concomitant corrosion-enhanced wear, referred to as ΔW_C . Simultaneously, the wear debris, comprising oxide layers,
