Quantifying the Impact on Stormwater Management of an Innovative Ceramic Permeable Pavement Solution

Jesica Tamara Castillo-Rodríguez 1 · I. Andrés-Doménech 1 · M. Martín 1 · I. Escuder-Bueno 1 · S. Perales-Momparler 2 · J. Mira-Peidro 3 · J. Mira-Peidro 4 · J. Mira-Peidro

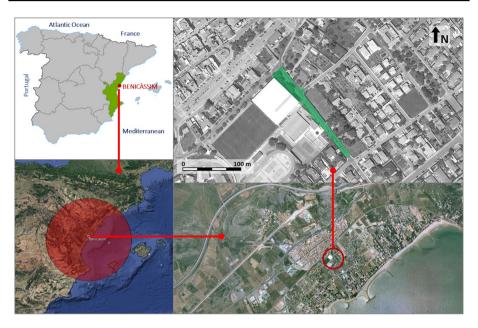
Fig. 3 Location map of the study site: (upper-left) Benicàssim (Comunitat Valenciana, Spain); (down-left) influence area, and (right) demonstration site in Torre Sant Vicent street

The study site is located in Benicassim (Spain). Benicassim is on the east coast of Spain (Fig. 3a), in the core of a ceramic cluster which represents the 90% of Spanish ceramic tile production. The surrounding influence area was considered for potential replicability of the proposed solution and project outreach actions (Fig. 3a, down-left corner, red circle).

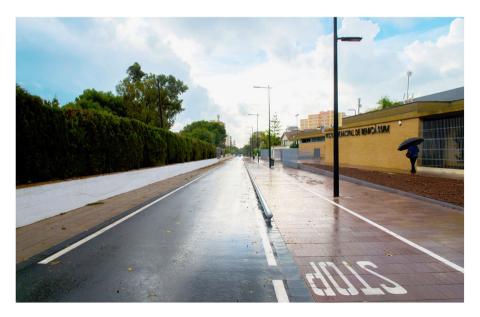
Fig. 4 View of the urban retrofitting action executed in Benicàssim as demonstrator case. Copyright: Milena Villalba, for LIFE CERSUDS project

The demonstrator, executed between February and June 2018 (Fig. 4), is 200 m long and has a variable width ranging from 10 to 27 m and a 1.5% descending longitudinal slope. The demonstration site is located in a low-density residential area, characterized
