The Wreck of the *Pettu* as an Example for Nineteenth Century Rural Shipbuilding in South-Western Finland

Abstract Although the design and construction of wooden merchant vessels in the nineteenth century is generally considered to be well understood, the excavation and subsequent analysis of the wreck of the wooden Finnish topsail schooner *Pettu* (1865) revealed a number of unexpected features, which prompted the authors to take a closer look at the ship. In the following study, it will be attempted to gain an insight into the society that produced and used the merchant vessel through a detailed analysis of its construction and an investigation into the concept behind its design. The wreck of the *Pettu*, which, considering its loss in 1893, is barely covered by the 100 year rule in Danish heritage legislation, is a good example for the archaeological potential of even relatively ‘modern’ wreck sites, adding to their significance.

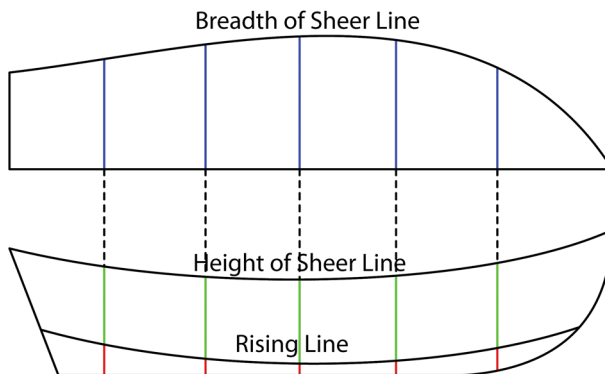
Fig. 13 Schematic representation of a possible outlines plan that could be used as a basis for whole-moulding. The sections are used to extract the different sirmarks on the moulds. The red lines give the sirmarks for the rising square. The blue lines provide the rising line sirmarks on the breadth mould for the narrowing. The green lines give the breadth sirmarks on the breadth mould Ditta (2013) (Color figure online)

Of the geometrical ship design methods, the “moulding with adjustable templates” is probably the most common. This method with its variations can be found from the Mediterranean to the Atlantic coasts. It uses a number of simple geometrically-based devices to generate smooth curves suitable for the adjustment of frames along a hull, provided that the interval between stations is uniform for each curve (Auer et al. 2013a). In the English shipbuilding tradition a similar method to the “moulding with adjustable templates” is known under the name of “whole-moulding”. McKee describes this method as “a stage between building by eye and the preparation of a draft using sweeps, the radii of which change every station” (McKee 1983). In its simplest form, this method only needs a two-dimensional outline of the vessel consisting of sheer line, rising line and maximum breadth of sheerline, as well as a mould for the master frame and three aids (Fig. 13): The rising square is a batten with the heights of floors taken from the rising line marked for every station. The breadth mould has the shape of the midship section and three sets of marks for rising line, floor heads and breadth. The rising line marks give the narrowing of the mould and align with the ones of the “rising square”. The rising line sirmarks are taken from the breadth of the sheer line on the plan. The sirmarks for the breadth are taken from the height of the sheer line on

the plan. The hollow mould has its sirmarks set on the rabbet line and is positioned tangentially to the breadth mould in order to form the reverse curve (McKee 1983). Using this system, a whole hull can be drafted without the use of diagrams or geometrical reduction methods. The hull shape can be modified simply by changing the curves of moulds or altering the placing of sirmarks. However, as McKee observes, this system “expresses boat shape in terms of the hull sections rather than in the run of planks and ribbands” (McKee 1983).
