TECHNICAL ARTICLE

High-Velocity Oxygen Fuel-Sprayed WC-10Co4Cr Coatings on AISI 4135 Steel Substrate: Tensile and Fatigue Properties

Yong-kuan Zhou, Jia-jie Kang, Wen Yue, Tian-yang Yue, Zhi-qiang Fu, Li-na Zhu, and Ding-shun She

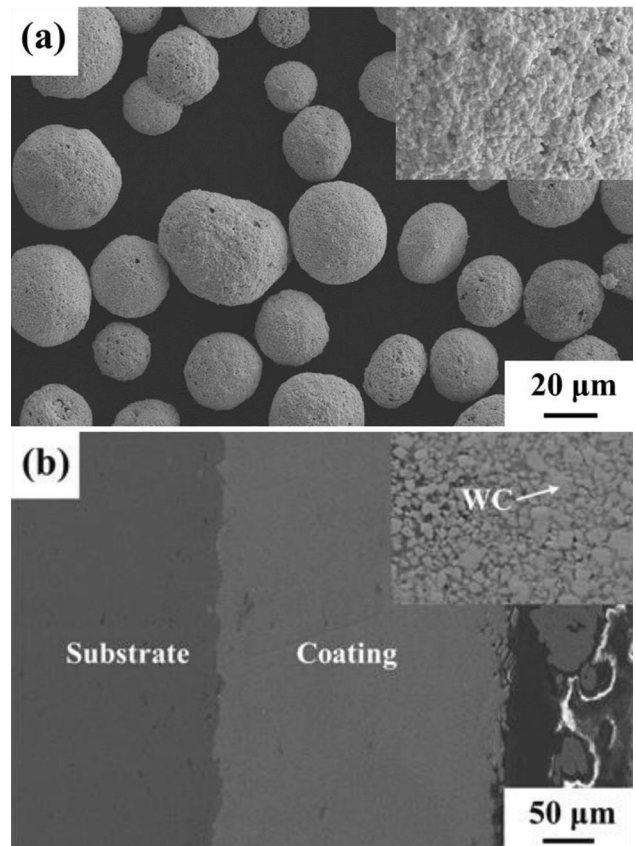
**Fig. 2** Morphologies of the WC-10Co4Cr powders and coatings. (a) The powders; (b) The coatings

Figure 2 shows the morphologies of the WC-10Co4Cr powders and coatings. The upper right corner of the figure is

the enlarged figure. As can be seen in Fig. 2(a), the spray powders exhibit spherical or ellipsoidal shape, and the powder surface is loose and porous. Figure 2(b) shows the cross-sectional of the WC-10Co4Cr coatings; the WC-10Co4Cr coatings bind tightly to AISI 4135 steel substrate. Besides, the coatings have dense microstructure, which consist of block WC phase and CoCr bonding phase. In WC-CoCr cermet system, the WC phase has excellent hardness, and the CoCr phase is a good binder, both of which are indispensable (Ref 8).

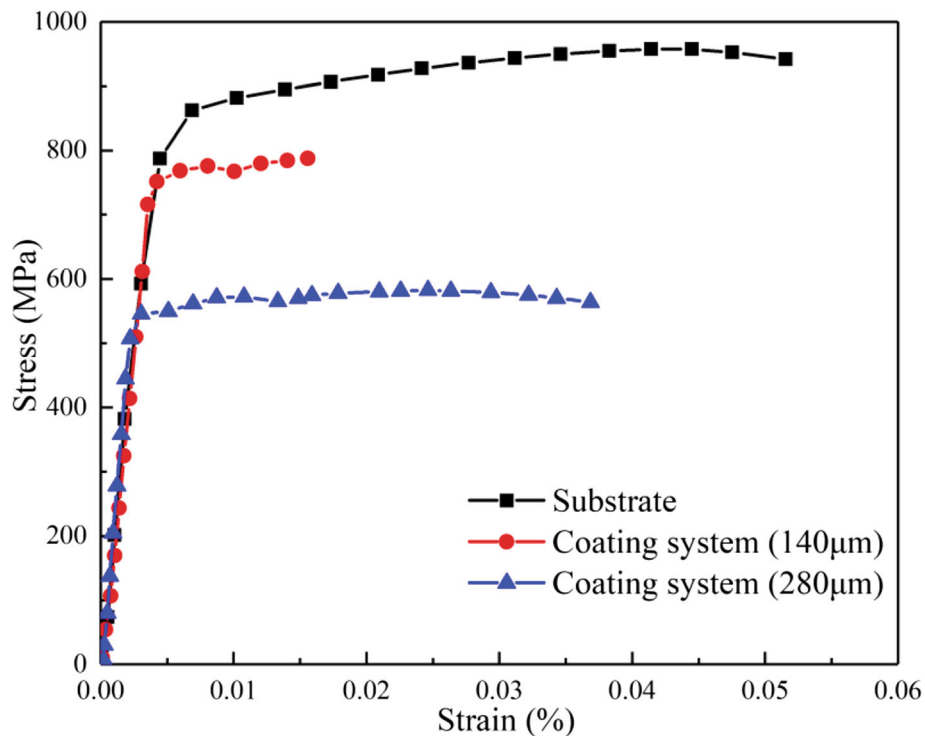
Fig. 3 Tensile stress–strain curves of the substrate and the coating system with different thickness

Figure 3 shows the tensile stress–strain curves of the substrate and the coating system with different thickness at room temperature, and Table 2 shows the corresponding tensile test data. It can be seen that the yield strength, tensile strength and elongation after fracture of the coating system are lower than AISI 4135 substrate (952 MPa). The yield strength, tensile strength and elongation after fracture of the coating system (140 μm) are decreased by 7.8, 19.7; 68.0%, respectively. And the yield strength, tensile strength and elongation after fracture of the coating system (280 μm) decrease by 36.6%, 40.5%; 26.0%, respectively. Because AISI 4135 steel substrate is a plastic material, while the WC-10Co4Cr coating is a brittle

material, that plastic materials generally have greater fracture strain than brittle materials, so the tensile fracture failure of the coating occurs before the substrate, leading to a decrease in the tensile strength of the coating system, and the thicker the coating, the greater the proportion of the coating area in the coating system, the less the area can bear the load when it fails, and the more obvious the tensile strength of the coating system declines (Ref 9, 24, 25).

The coating can be treated as the composite material parallel to the substrate, and both the coating and the substrate are the components that determine the plasticity and brittleness. Since the strain applied in the axial direction is the same, it is assumed that the strain condition of the substrate and the coating is equal strain. According to the mixing law of composite materials, the calculation formula of elastic modulus of coating system is as follows: $E_{cs}A_s + A_c = E_cA_c + E_sA_s$, where E_{cs} , E_s , E_c are the elastic modulus of the coating system, the substrate and coating, respectively, and A_s , A_c are the area of the substrate and the coating. According to the nanoindentation experimental data, the average elastic modulus of AISI 4135 steel substrate is 193 ± 8 GPa, and the average elastic modulus of the coating is 318 ± 15 GPa. The elastic modulus of the coating system (140 μm) is 242 ± 10 GPa derived from

the stress–strain curve. The elastic modulus of the coating system is 234 GPa (140 μm), which is estimated according to the formula. The tensile test value is in good agreement with the theoretical calculated value.

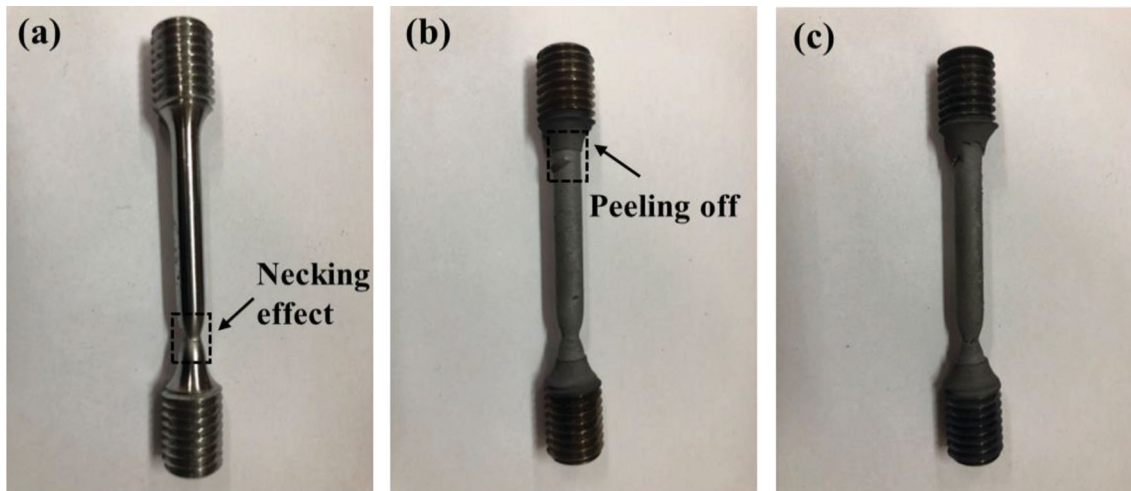
Fig. 4 Macro-morphologies of the substrate and the coating system with different thickness after the tensile test. (a) Substrate; (b) Coating system (140 μm); (c) Coating system (280 μm)

It can be seen from Fig. 4 that the substrate and the coating system with different thickness all have obvious plastic deformation. In the process of tensile, strain hardening cannot keep pace with the development of plastic deformation, so deformation and necking occur at a stress concentration point in the tensile area. In the initial stage of the tensile, WC-10Co4Cr coating can keep consistent with substrate deformation; however, due to the stiffness of the coating is far greater than the substrate, the coating will exfoliate when the stress value exceeds the allowable limit of the coating during the tensile test (Ref 26), and the thicker the coating is, the more thoroughly it exfoliates.

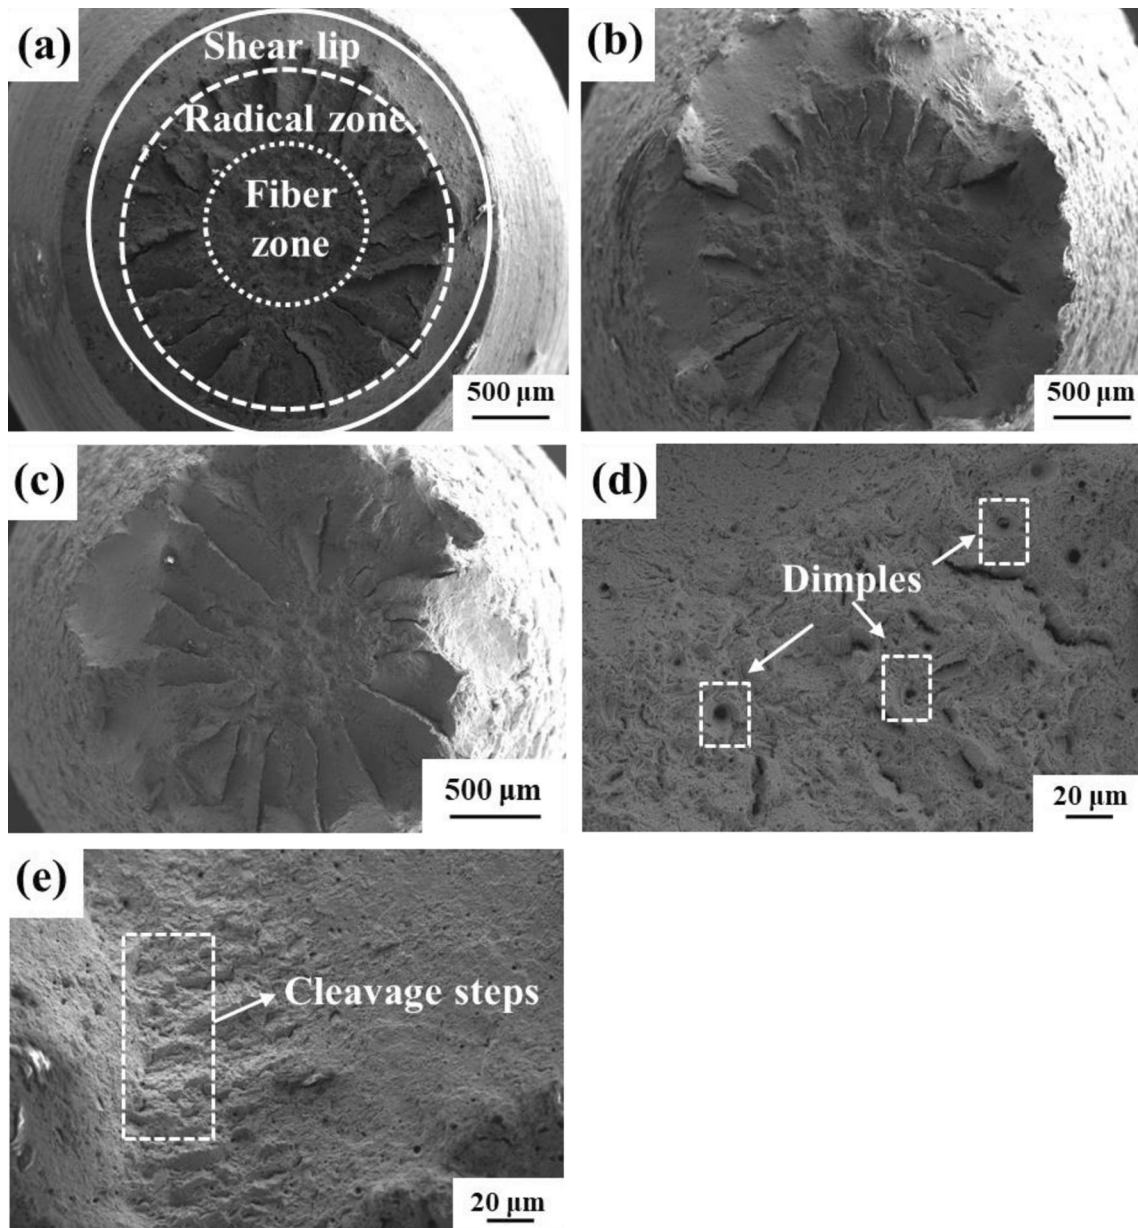
Fig. 5 Micro-morphologies of the fractured tensile specimens. (a) Substrate; (b) Coating system (140 μm); (c) Coating system (280 μm); (d) Dimples; (e) Cleavage steps

Figure 5 shows the fracture morphologies of the substrate and the coating system with different thickness. As can be seen from Fig. 5(a), AISI 4135 steel substrate presents the morphology of ductile fracture, and the fracture area can be divided into typical fiber zone, radical zone and shear lip. The fracture features in the fiber zone are dimples, and the microscopic fracture features in the radical zone are cleavage steps Fig. 5(d) and (e). From Fig. 5(b) and (c), as for the coating system, the coating is brittle material and the substrate is plastic material. The thicker the coating is, the smaller the fiber zone, and the worse the plasticity of the coating system (Ref 27, 28). When the concentrated stress of the coating system exceeds the allowable limit of the coating in the tensile test, the coating will crack. With the increase in the tensile stress, the coating system will fracture eventually.

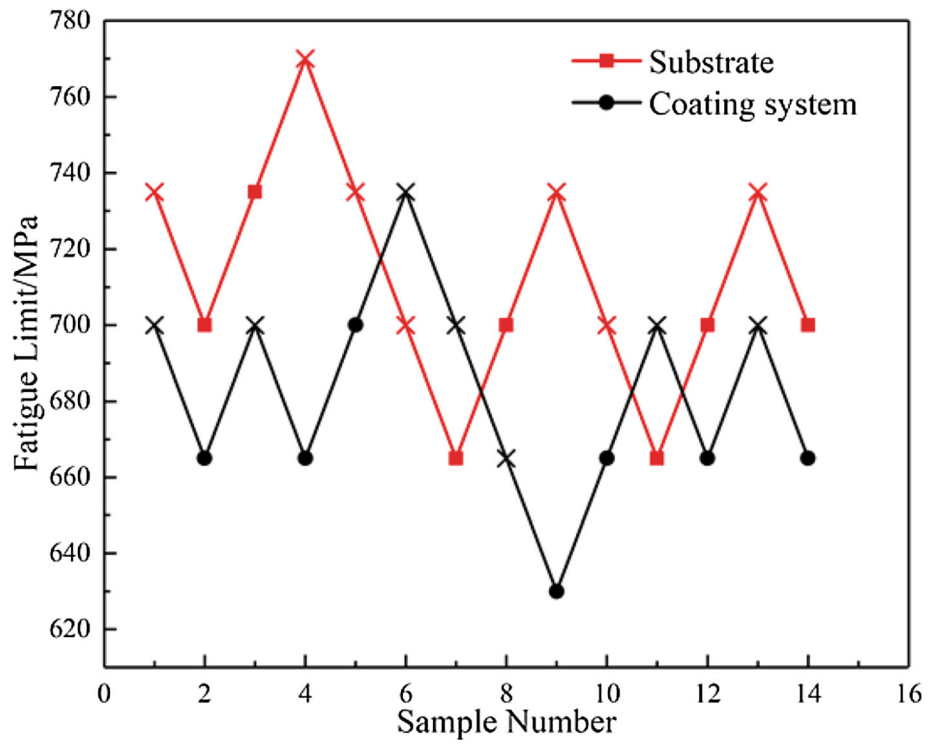
Fig. 7 Conditional fatigue limit $\sigma_{0.1}$ for four-level stress level test method of the substrate and the coating system

Figure 7 shows the conditional fatigue limit curve of the substrate and the coating system. After calculation, the conditional fatigue limit $\sigma_{R(10^6)}$ of the substrate is 712.5 MPa, and that of the coating system is 682.5 MPa, which is lower than that of the uncoated sample. This is because the coating is also subjected to tensile load in the fatigue test, while the WC-10Co4Cr coating is brittle material and will fail rapidly under tensile stress. Considering that the coating cracks under tensile load, its loadbearing capacity drops significantly (it probably becomes negligible) as soon as the cracks are formed. Besides, the effect of sprayed coating on the residual stress of the coating system is complex. On the one hand, the residual compressive stress on the surface of AISI 4135 steel after sandblasting before HVOF process decreases the notch stress concentration factor and fatigue notch sensitivity; thus, the fatigue life of the coating system is improved (Ref 29). But it should be noted that sandblasting process must be controlled; otherwise, sandblasting particles may cause damage to the

substrate surface, thereby reducing fatigue life of the substrate (Ref 11). On the other hand, spraying coating will produce impact effect and thermal stress on the coating system in the spraying process. The impact effect leads to compressive stress on the coating system, and the thermal stress is tensile stress. The final stress state depends on the comprehensive action of compressive stress and tensile stress. The average residual stress of the coating system is -152 ± 10 MPa, showing compressive stress state, which can restrain the crack growth and is beneficial to the fatigue life (Ref 13, 30).

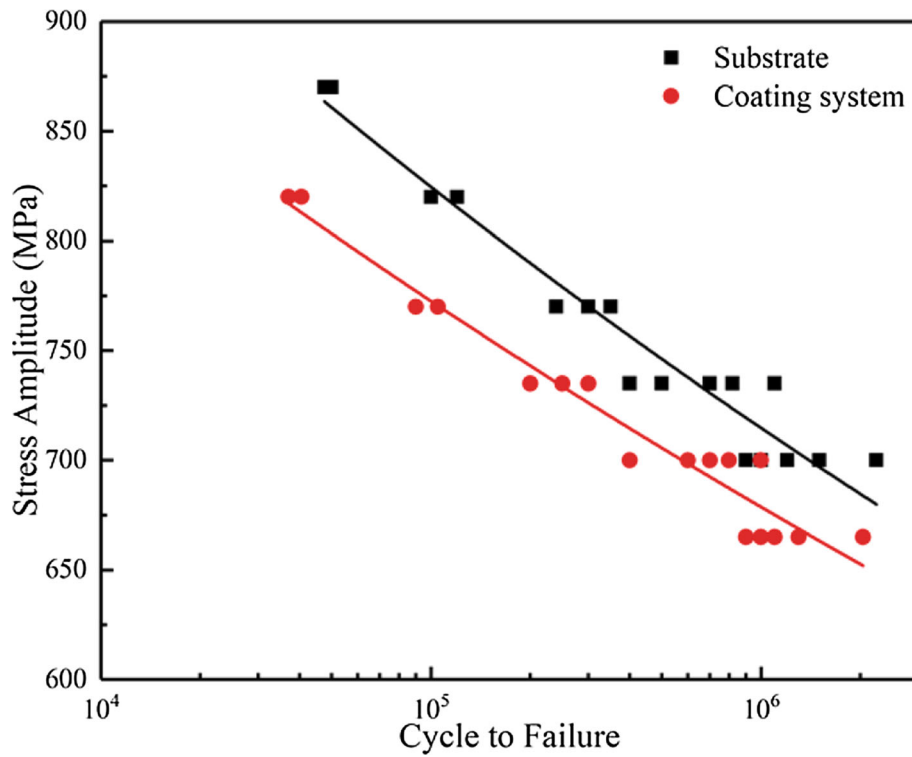
Fig. 8 Simulated S-N curves of the substrate and the coating system with maximum likelihood method

Figure 8(a) shows the S-N logarithmic fatigue life comparison of the substrate and the coating system under overload conditions. According to the conditional fatigue limit obtained by the four-stage lifting method, the fatigue overloads are 700,

735, 770, 820 and 870 MPa, respectively. It can be seen that the fatigue life of the coating system is significantly lower than that of the substrate. This is also caused by the brittleness of the coating, which is difficult to bear the cyclic alternating stress, resulting in the decline of the fatigue life of the coating system.

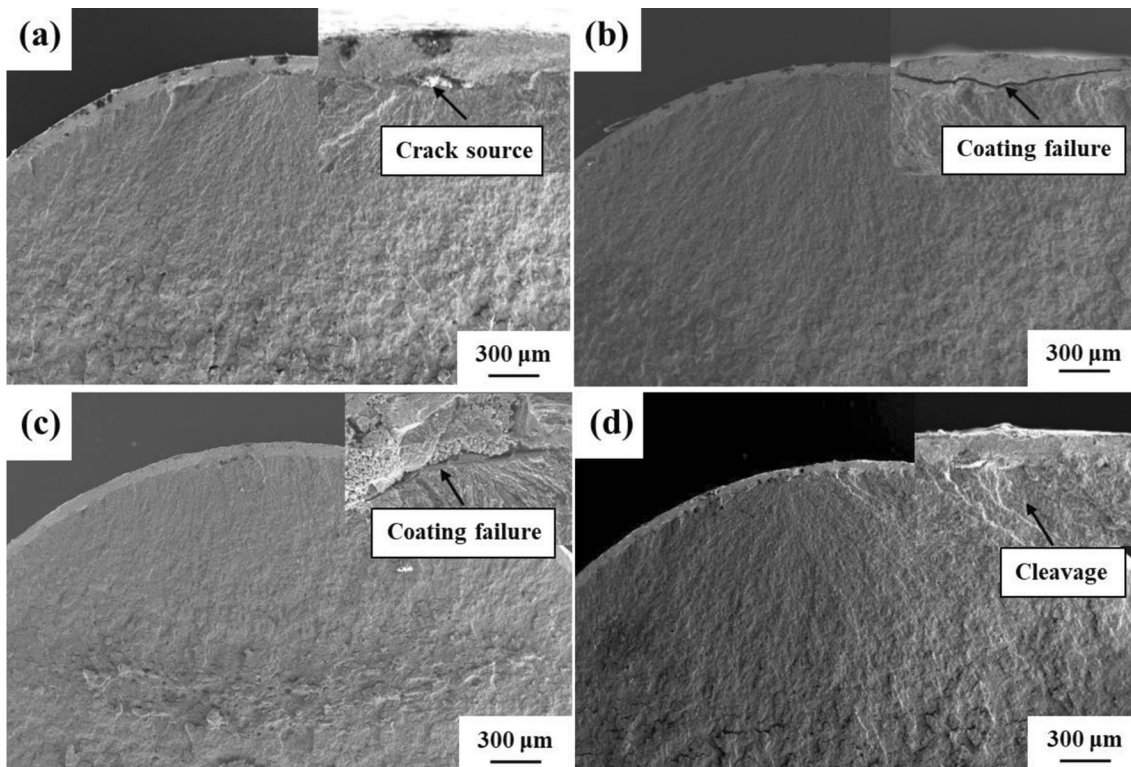
Fig. 9 Fatigue fracture morphologies of the coating system. (a) Crack source; (b, c) Coating failure; (d) Cleavage

Figure 9 shows the typical fatigue fracture of coating system with different cycles. It can be seen from Fig. 9(a) that the crack source of the coating system is mainly generated at the interface between the coating and the substrate, and then expands along the interface or deviates from the interface toward the coating (Ref 23, 31). The coating and substrate separation occurs, resulting in coating failure, as shown in Fig. 9(b) and (d). Crack sources also form cleavage steps along the substrate after initiation at the interface, as shown in

Fig. 9(c). Such cracks may reduce the fatigue life of AISI 4135 steel substrate.
