A Study on the Charpy Impact Response of the Cracked Aluminum Plates Repaired with FML Composite Patches

Faramarz Ashenai Ghasemi · Lotfali Mozafari Vanani · Ali Pourkamali Anaraki

Submitted: 21 January 2016/in revised form: 29 March 2016/Published online: 3 June 2016
© ASM International 2016

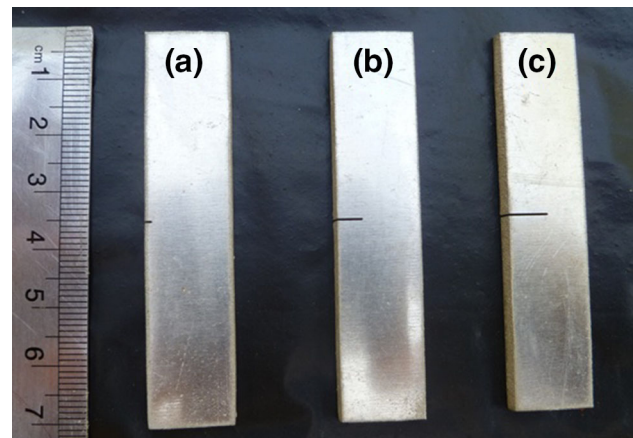
Fig. 1 Cracked specimens with different crack length-to-specimen width ratios: (a) $a/w = 0.1,$ (b) $a/w = 0.3,$ and (c) $a/w = 0.5$

The specimens were made of aluminum AA1035 [10] having dimensions of 70 mm × 15.3 mm × 3 mm as shown in Fig. 1. The mechanical properties of aluminum plates are determined by tensile tests (Fig. 2; Table 1). The specimens were cut with a water jet machine in principle dimensions, and thereafter, using a wire cut machine, the notches were created. Three different crack length-to-specimen width ratios, i.e., $a/w = 0.1, 0.3,$ and $0.5,$ were created on one edge of the specimens (Fig. 1). The value of the crack angles with respect to the width axis of the specimens were chosen as $0^\circ, 30^\circ,$ and 45° (Fig. 3). The

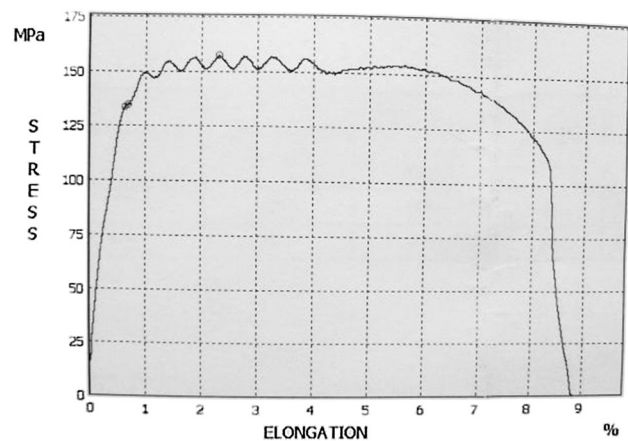
Fig. 2 Stress–elongation curve of aluminum plates

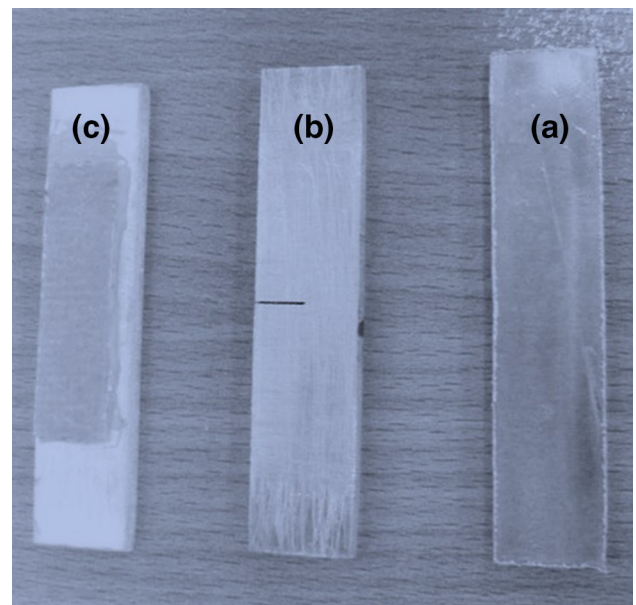
**Fig. 4** Specimens (a) without a crack, (b) with a crack but not repaired, and (c) with a crack and repaired with a composite patch

The content of fiber was about 55 wt.% in glass–epoxy layers. The composite was made by hand, and then the curing procedure according to the recommended cure schedule in two stages was done [14]. The patches dimensions were 40 mm × 10 mm, and after curing, their thickness was 0.8 mm. Figure 4 shows the specimen that is not cracked (a), is cracked but not repaired (b), and finally is cracked and repaired with a patch (c). Araldite 2015 was used for bonding the FML patches to the cracked plates [15]. The thickness of the adhesive layer was about 0.2 mm. Before bonding the patches to the cracked plates,

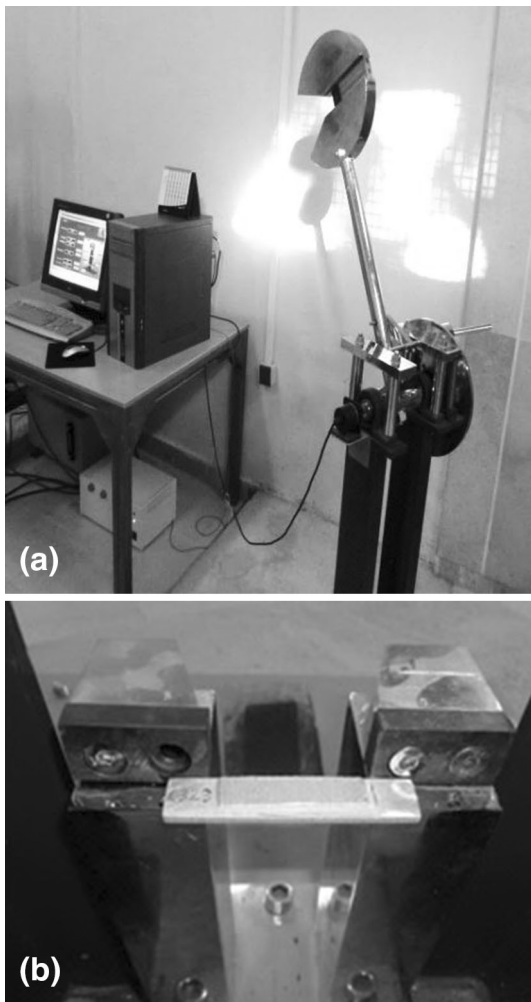
Fig. 5 The Charpy test device and the specimen setup for testing (a) the Charpy test device, (b) specimen setup before testing

Charpy is a dynamic three-point bending experiment of a beam. The experimental setup consists of the specimen, the fixture where the specimen is freely supported, and a pendulum with a defined mass attached to a rotating arm. The pendulum falls following a circular trajectory and hits to the test specimen at the middle span length and transfers its kinetic energy to it [17]. In this research, a Charpy test device (Fig. 5a) was used for impact testing of all

specimens according to ASTM E 23-02a [13]. Each sample was tested three times to verify the repeatability. The pendulum hammer had a mass of 15.200 kg and a disk radius of 150 mm. The swing arm length and mass were 520 mm and 5.270 kg, respectively, leading to a speed at impact point of around 5.033 m/s and a stored energy of 218.5 J. The friction energy loss was about 1.9 J, and the energy loss due to air resistance was neglected. The span distance in the test setup was 45 mm. The final energy absorption of each specimen was the average value of the three same tested samples. Figure 5b shows a typical impact test specimen that is prepared to test. Figure 6 shows the schematic view of geometry and loading of repaired specimens.

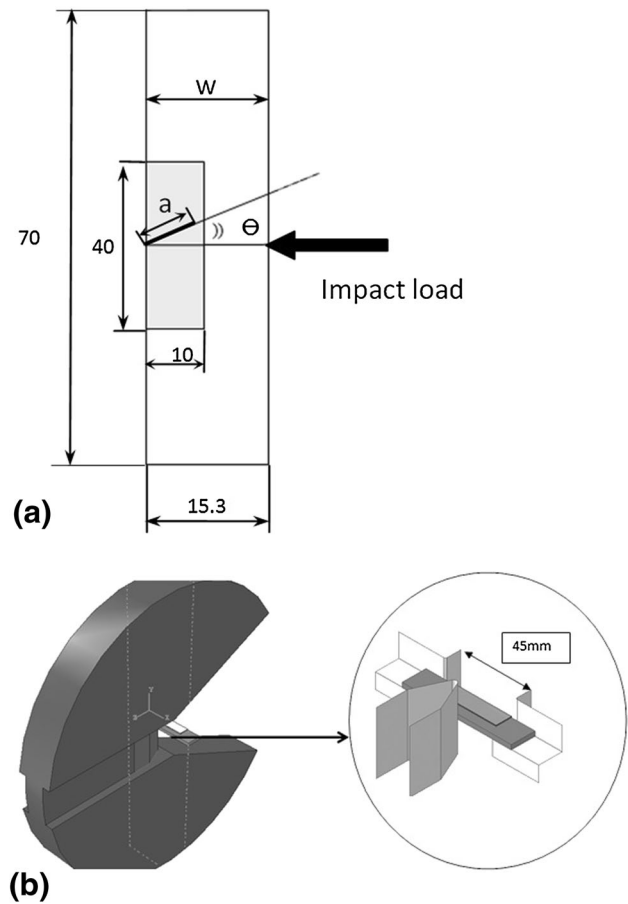
Fig. 6 Schematic view of geometry and test configuration of specimens (a) schematic view of geometry of stiffened cracked panel repaired with a FML patch, (b) schematic view of impact time

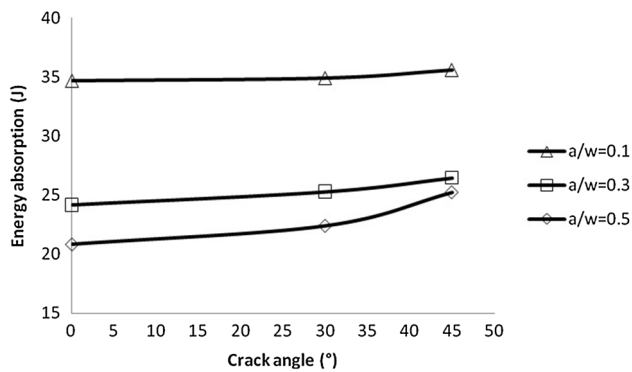
Fig. 7 Energy absorption of the un-repaired cracked specimens

these tests are depicted in Fig. 7 and Table 2. Figure 7 shows that the more the increase in crack angle, the more the increase in absorbed energy no matter what the crack length is. One also sees that in specimens with 45° crack angle, the most energy is absorbed in the structure. This is due to the change of the crack growth path that forces the crack to go in mode I of the fracture. This change in direction leads to a more energy absorption (Fig. 7).
