SOLID FREEFORM FABRICATION

Using Laser Ultrasound to Detect Subsurface Defects in Metal Laser Powder Bed Fusion Components

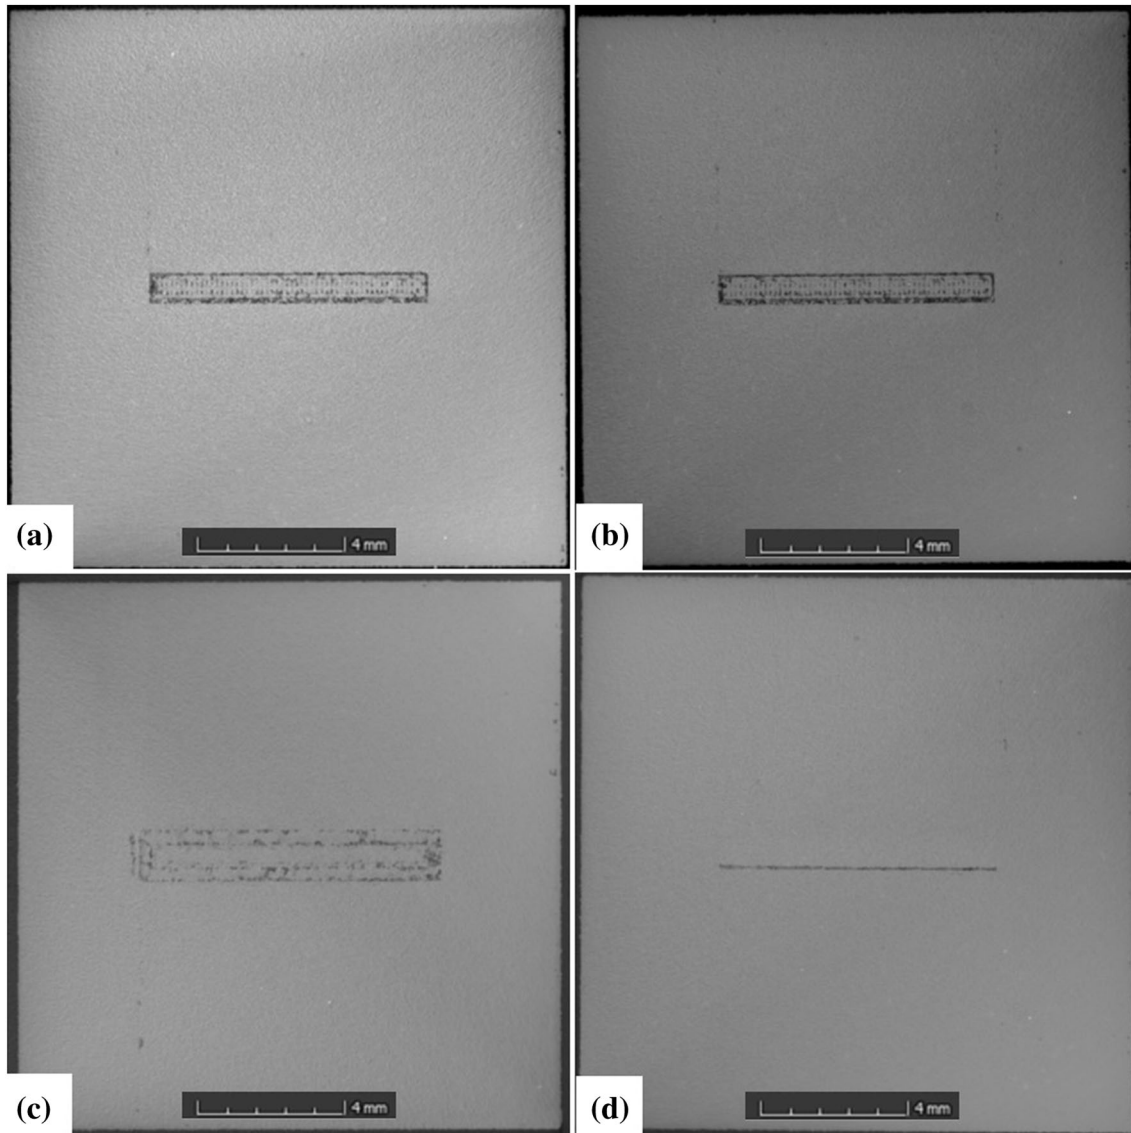
Fig. 1. XCT slices through defect zones (x-y) for (a) sample 1—increased hatch spacing, (b) sample 2—increased hatch spacing repeated, (c) sample 3—undermelting conditions, and (d) sample 4—overmelting conditions.

To visualize the defect zones created, the blocks have been subject to XCT using a Nikon MCT225 XCT machine. A voxel size of $38\ \mu\text{m}$ was achieved. The resulting defect zones for samples 1 to 4 are shown in Fig. 1. The slices show the x - y plane 300 microns below the top surface.

The defect zones in samples 1 and 2 (Fig. 1a and b) are very similar, as expected. The increase in hatch spacing by a factor of three leaves areas in between scanning tracks that could contain unmelted powder. It is more likely, though, that these zones become denuded, leaving strings of pores.¹⁶ The conditions selected for sample 3 (Fig. 1c), were to promote undermelting. A scanning speed of double the optimum was desired. The scanning speed (mm/s) is equal to the point distance (μm) divided by the exposure time (μs), so for a desired scanning speed of 1000 mm/s, a point distance of $20\ \mu\text{m}$ and an exposure time of $20\ \mu\text{s}$ were selected.

Unfortunately, research carried out in this area since the experiment has shown that this equation does not hold true for this equipment. Instead, where a scan speed of 500 mm/s was desired, 333 mm/s was achieved. Where 50 mm/s was desired, 33 mm/s was achieved. Although these shortfalls are not so significant, for the undermelting condition desired for sample 3, only 493 mm/s rather than 1000 mm/s was achieved. As such, even though some porosity can be seen in sample 3, this was not as extreme as desired and cannot be considered to be caused by undermelting alone, but it also likely to be attributed to a poor scan strategy. Although the achieved scanning speed for sample 4 was close to desired, porosity caused by overmelting is not evident (Fig. 1d).

Generally, the bulk material in all four samples displays a low level of porosity. Nevertheless, there are lines of pores visible on some samples that correspond with the scanning strategy generated by the software used. In addition, lines of porosity can be seen along the right-hand edge of most samples; again, this is probably because of a flaw in the scanning strategy. Although this porosity was not intended, LU scans of the walls were carried out to see whether it could be detected.

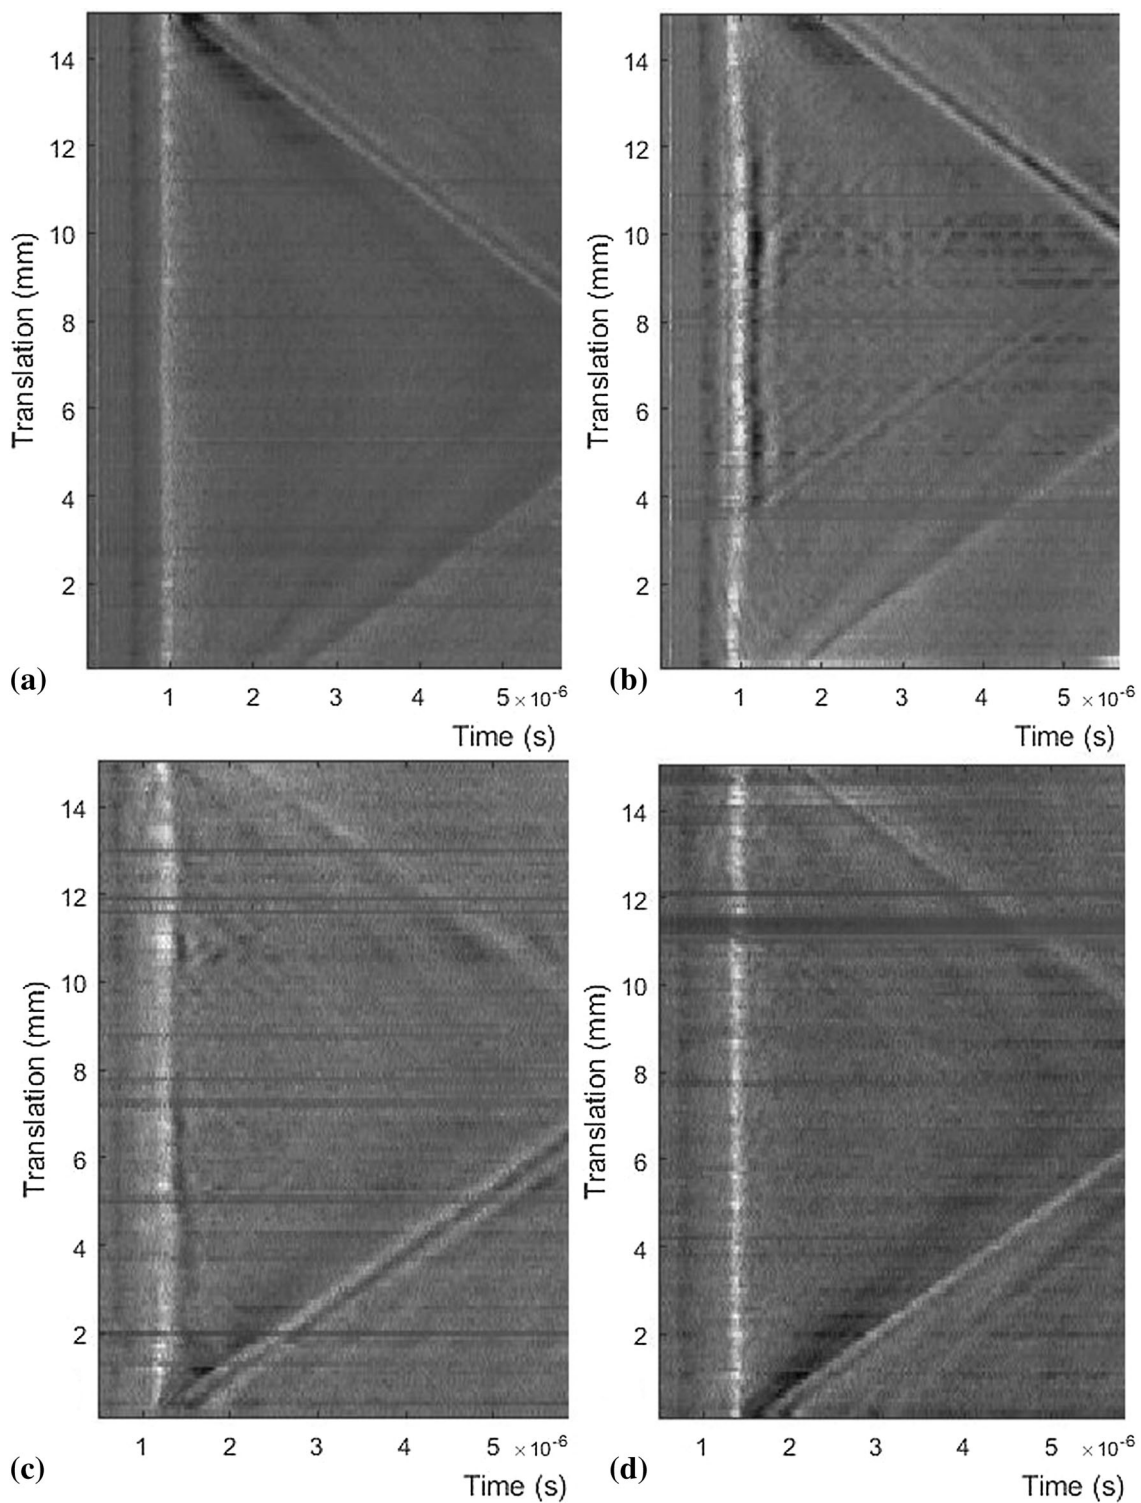
Fig. 2. B-scans comparing (a) bulk material (Sample 1—scan path 1), (b) increased hatch spacing (Sample 1—scan path 2), (c) undermelting conditions (Sample 3—scan path 2), and (d) overmelting conditions (Sample 4—scan path 2).

An example B-scan taken on sample 1 along scanning path 1 is shown in Fig. 2a, on which no indications are visible in the region of the Rayleigh wave arrival (approximately $1\ \mu\text{s}$). DC compensation and filtering have been applied to enhance the details for all LU scans. Figure 2b shows a LU scan taken along scanning path 2, along the defect zone of sample 1. Several overlapping parabolic indications are visible in the region between translations of 3 mm and 13 mm, but these are too muddled to extract any further information. Figure 2c shows a LU scan taken along scanning path 2, along the defect zone of sample 3. The indications are less visible than in the case of sample 1. Nevertheless, it

is possible to determine that a series of defects could be present. Conversely, Fig. 2d shows very little in the way of indications to suggest the presence of defects, which is supported by the XCT data.

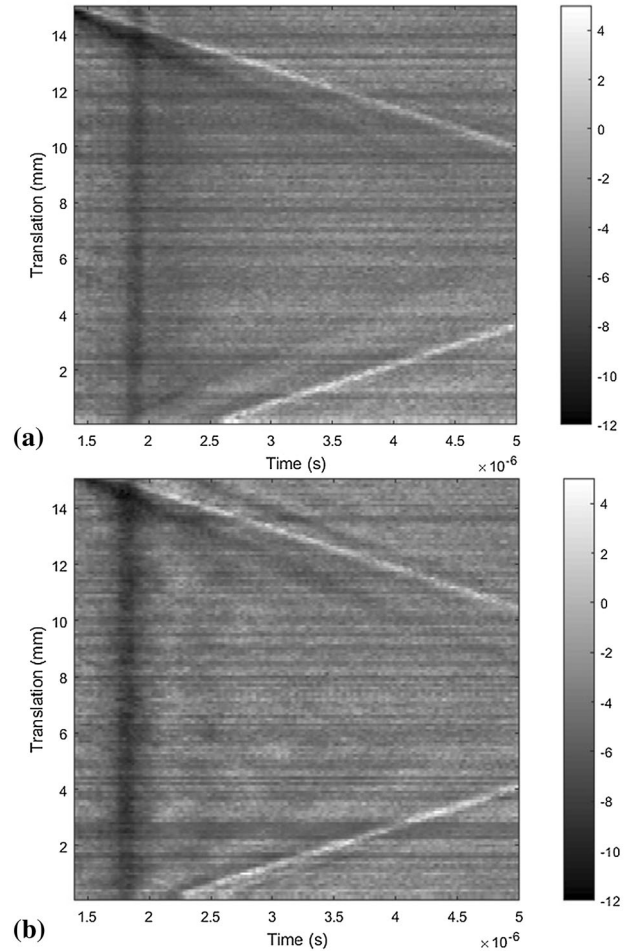
Fig. 3. B-scans comparing (a) left wall of sample 1 (scan path 3) and (b) right wall of sample 1 (scan path 4).

As mentioned, pores were unintentionally generated close to the walls on the right side of the sample blocks. Scans were taken along scanning paths 3 and 4 on sample 1 to see whether this could be detected. As the side walls of the samples have a different surface roughness characteristic to the top surface, the LU

system used here was not optimal. The AC and DC signals returned were of lower magnitude, and consequently, indications are harder to observe in the B-scans. The resulting B-scans are shown in Fig. 3.

The B-scan of the right wall of sample 1 shows indications of porosity in the region between 2 μ s and 3 μ s. At present, it is difficult to quantify the size or position of any pores from this visual analysis. It is anticipated that analysis of this data in the frequency domain will reveal further detail.
