Working with Natural Processes: Restoring a Mining Landscape in the High Arctic, Svalbard, Norway

Abstract

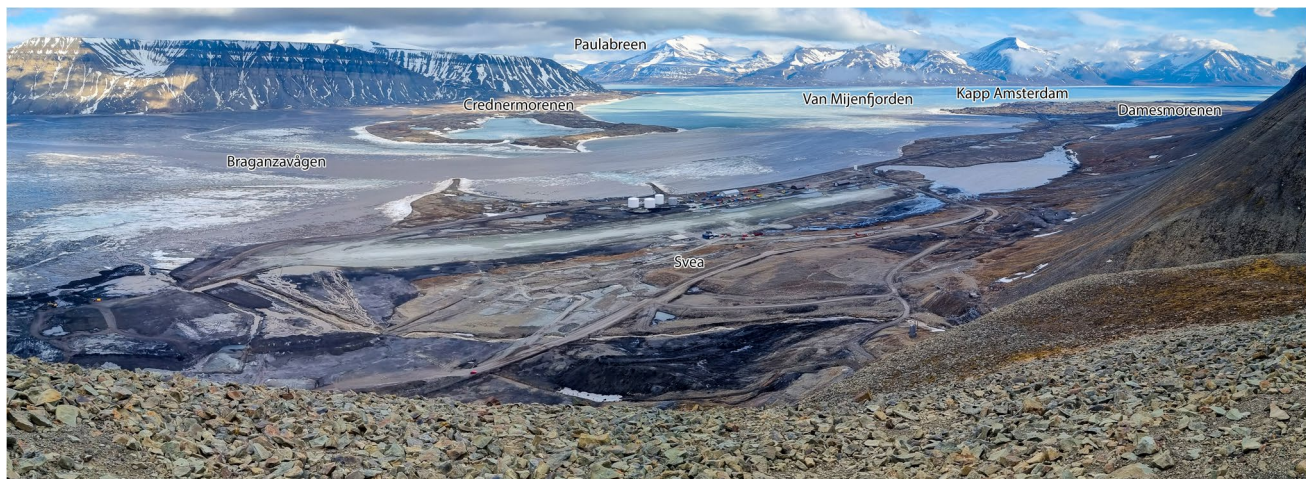
Fig. 3 View down to Svea centre under restoration in 2022. The airport and industrial facilities are visible situated on the section of the Paulabreen moraine complex called Damesmorenen. On the other side of the fjord, Crednermorenen belongs to the same system

The airport runway (Fig. 3) has been constructed on the clay apron distally to the moraine. The terrain has been landscaped to match the former terrain surface. However, the sediments of the clay apron in part of the moraine have been permanently altered and depressed, and marine clay has not been available to use in the construction. Natural recovery of vegetation is extremely slow on marine clay, and as a result, revegetation is expected to develop faster in the restored area than it would on a marine clay surface.

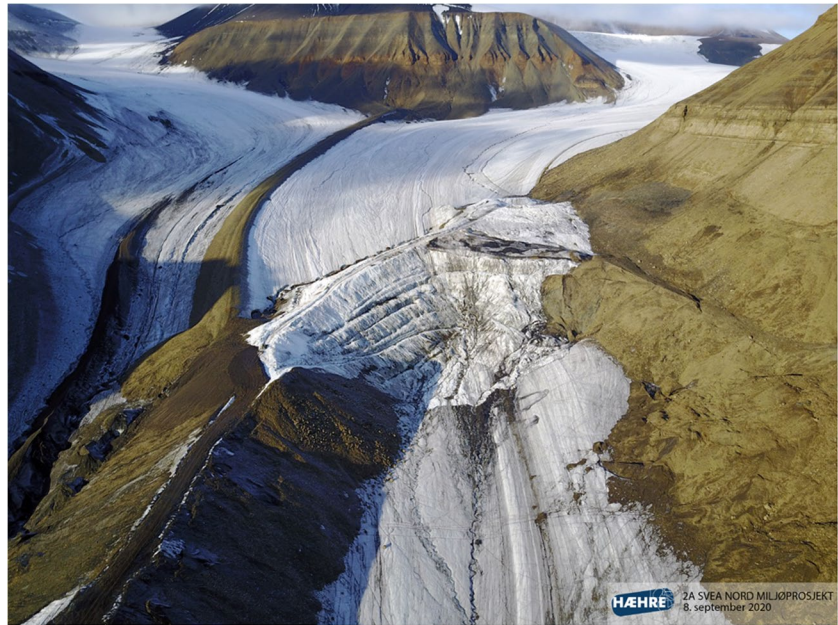
Fig. 5 The road and working platform of the Svea Nord entrance after restoration. The working platform has been cleared for all rock material and the heightening of the ice surface will gradually melt. The mine entrance has been filled in and slope processes will gradually shape the surface of the landfill. The road over the medial moraine is still visible but melting processes will collapse the structure. Photo: Martin Øen, Hæhre Arctic

Glacial environments Roads and landfills over glaciers have been removed (Fig. 5). Remnants of these structures are still visible as the artificial material has protected the ice from melting. These heightening of the ice surface are expected to melt, and the glacier surface will likely be evened out relatively rapidly. One road was constructed on a medial moraine and has been in operation for a long time. Here road material has been removed from the top of the structure, and the whole structure is expected to melt down over time. The section of the medial moraine where the road was located will exist as a higher and more prominent structure than

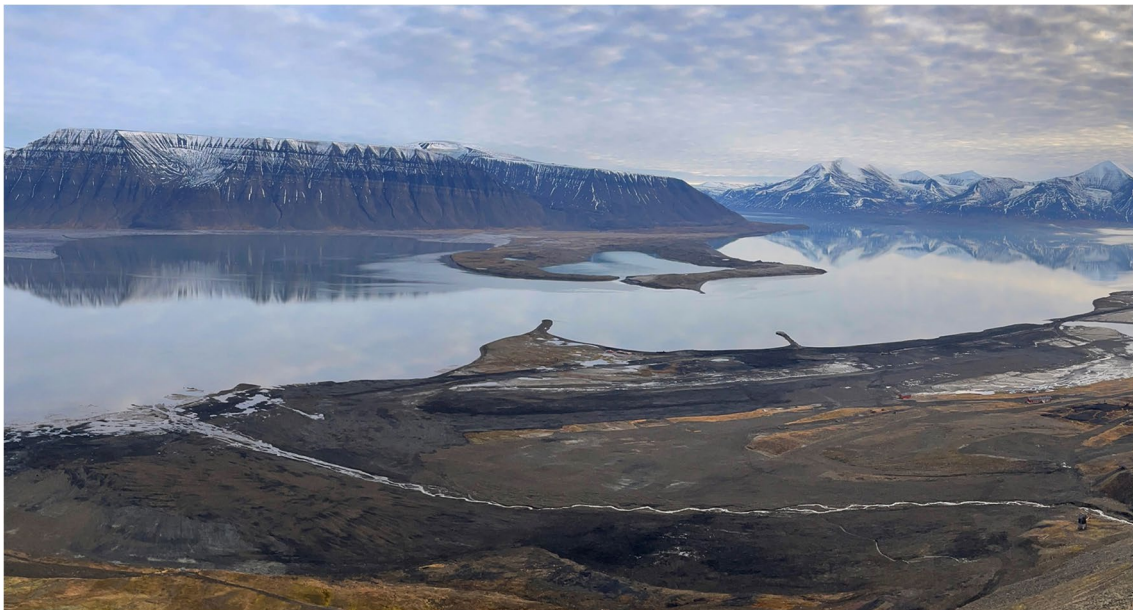
Fig. 7 The centre of the former Svea settlement after restoration. Note the airfield is now restored to approximately the same terrain level as originally, and the free running river has started to build a

new alluvial fan. Also note the remnants of the old port and a couple of houses to the right preserved as cultural heritage. See also Fig. 3. Photo: Ove Haugen

challenging. The terrain has been levelled out, and the outer parts will be modified by the marine processes. The rest will form an artificial terrain surface designed not to dominate the landscape. The area involves the outer part of a fluvial fan (Fig. 4). The fluvial processes here will aid in breaking up the evenness of this adjusted landscape (Fig. 7).

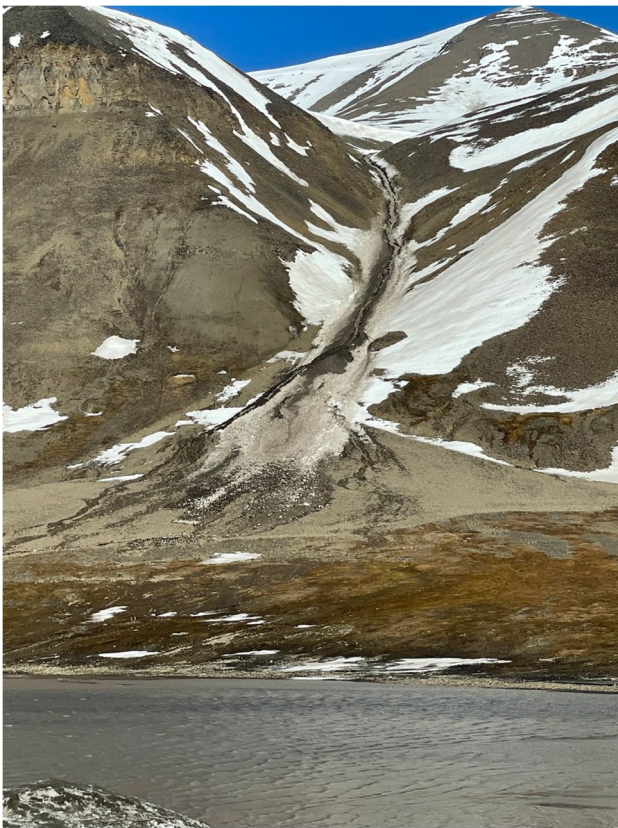
Fig. 9 Resent slush avalanche over a restored avalanche fan surface indicate that natural processes already dominate some restored surfaces

avalanche processes. This has already been observed after the first melting season after restoration (Fig. 9).

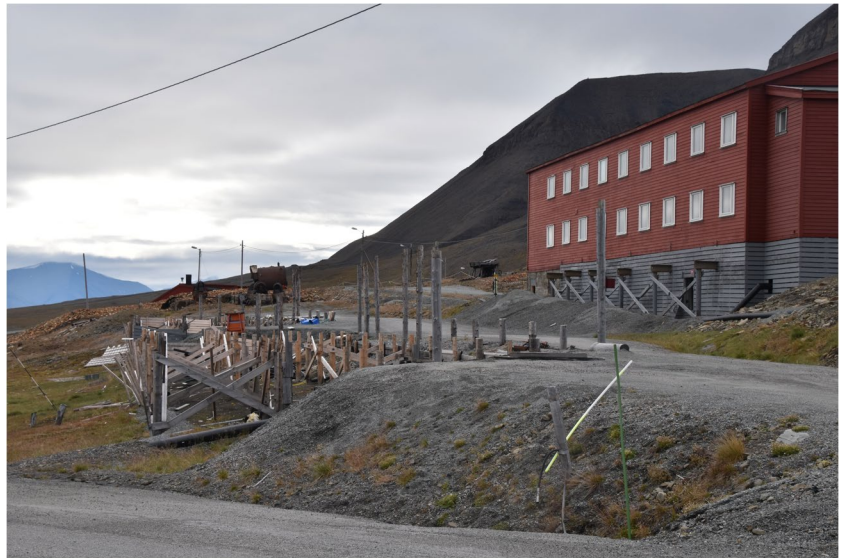
Fig. 10 Removal of houses in Svea in 2021 (left). A typical Svea settlement building to the right

Tundra The settlement of Svea was mostly situated on a gently sloping tundra surface, with the main geomorphic activity linked to permafrost and solifluction. The ground is reasonably stable and covered with tundra vegetation when not affected by buildings, roads, and landfills. Most of the buildings were removed in 2021. They were built on stilts (Fig. 10), and the removal of the stilts without leaving

extensive traces in the permafrost environment has been a challenging issue. Some has been drawn up, but the permafrost makes it difficult for those which is driven deep into the ground. The recommended procedure has then been to cut the stilts. If those stilts over time are lifted by frost action, they could be cut again. This procedure has only partly been followed, and in some cases the stilts are dugged out, causing damage to some of the minor patches of natural terrain under and close to the buildings.
