Case Study

Analysis of soil contamination with heavy metals in (the three) highly contaminated industrial zones

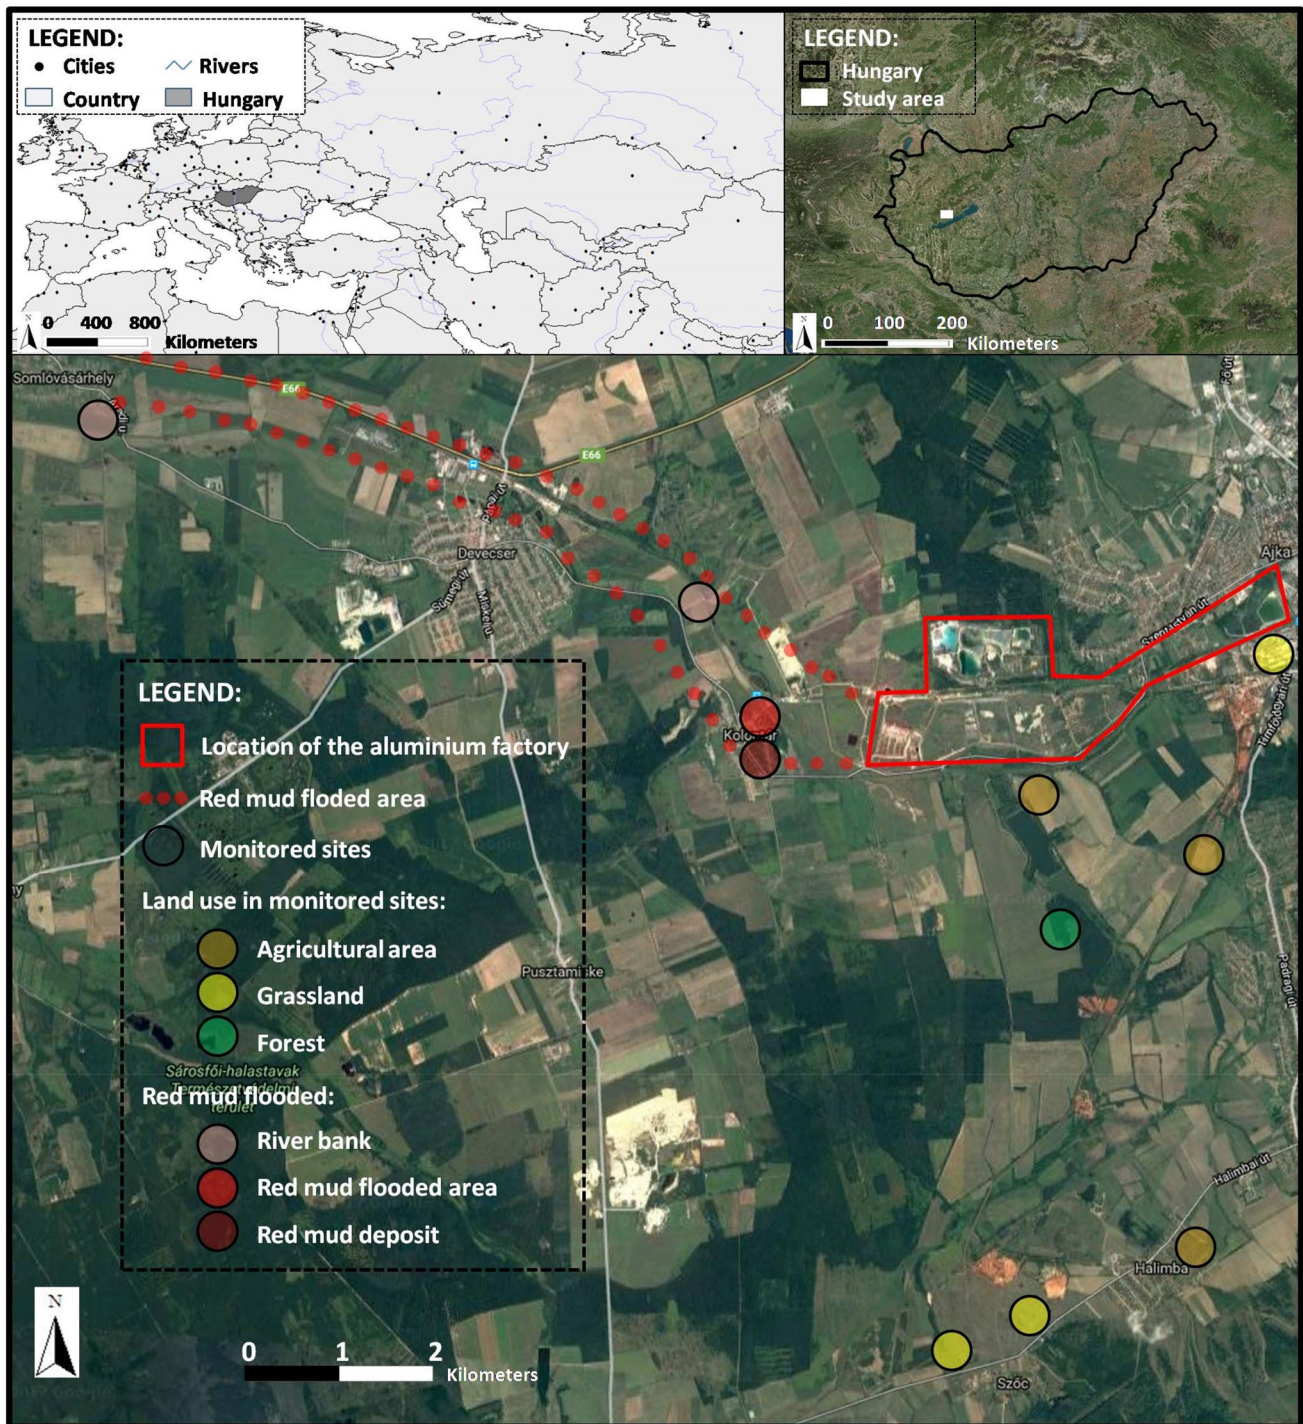
Fig. 3 Location of studied area and the territory of the red mud disaster (Ajka, Hungary). URL: <https://www.google.com/maps/place/Ajka,+Ma%C4%8Farsko/@47.0870216,17.4156361,17208>

Soil samples were collected on several sites at the surroundings of the aluminium plants in Hungary, Slovakia, and Tajikistan as well. Altogether 10 samples were taken from Slovakia and Tajikistan, and 11 soil samples were taken from Hungary. The distance to the farthest point was 12.5 km from the pollution source. The sampling sites had different land use (agricultural area, grassland, river bank, forest) profiles that are shown in Figs. 1, 2, and 3.

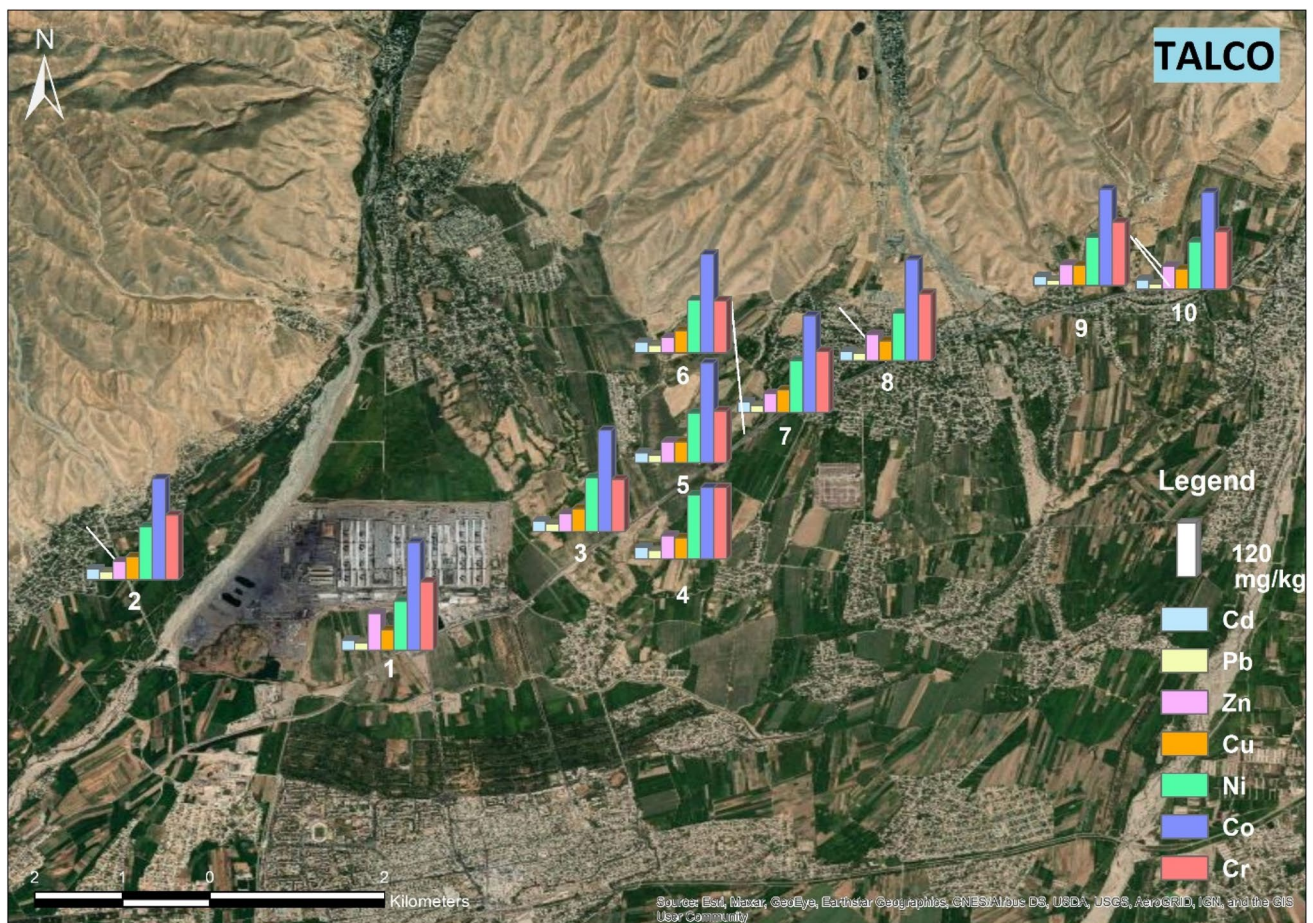
Fig. 4 Distribution of heavy metals around TALCO (Tajikistan)

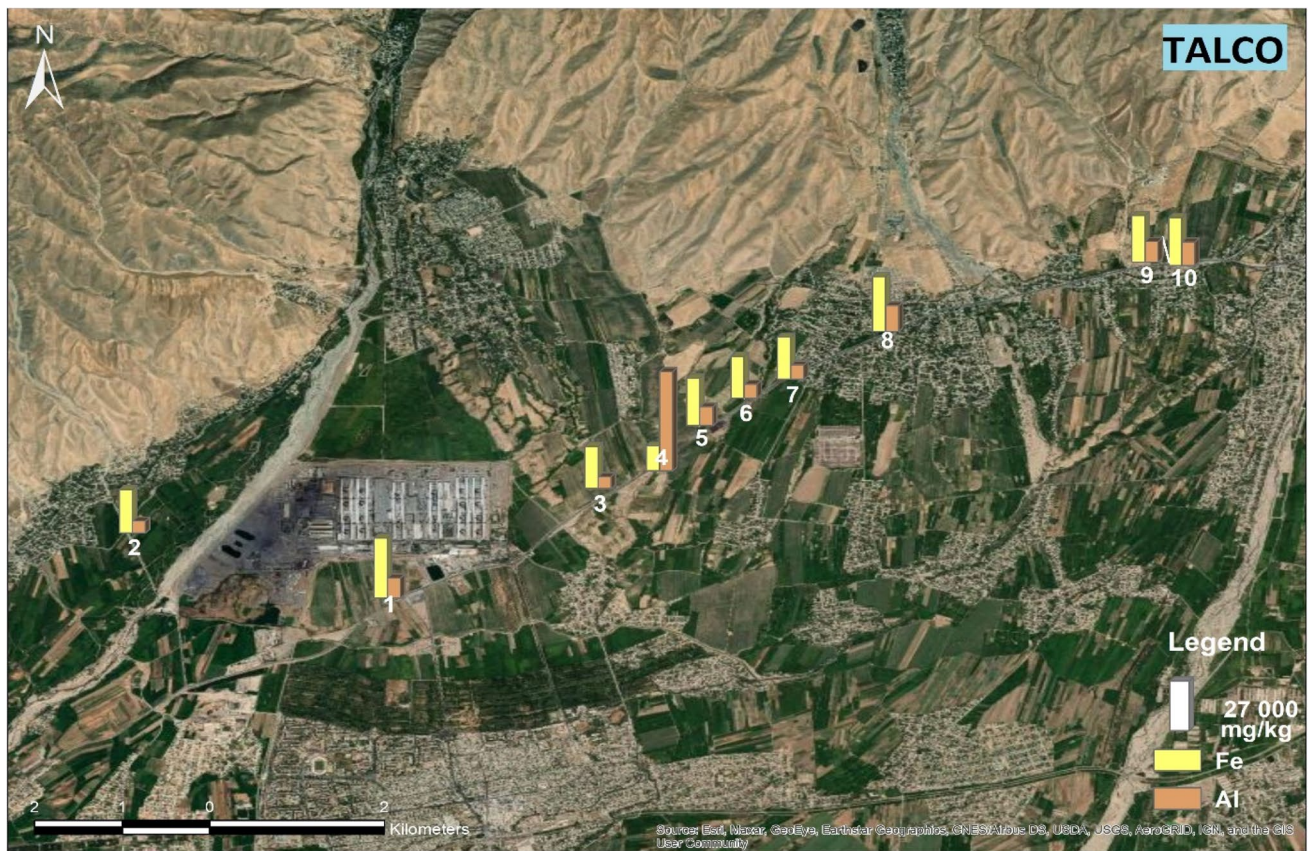
Fig. 5 Distribution of Al and Fe around TALCO (Tajikistan)

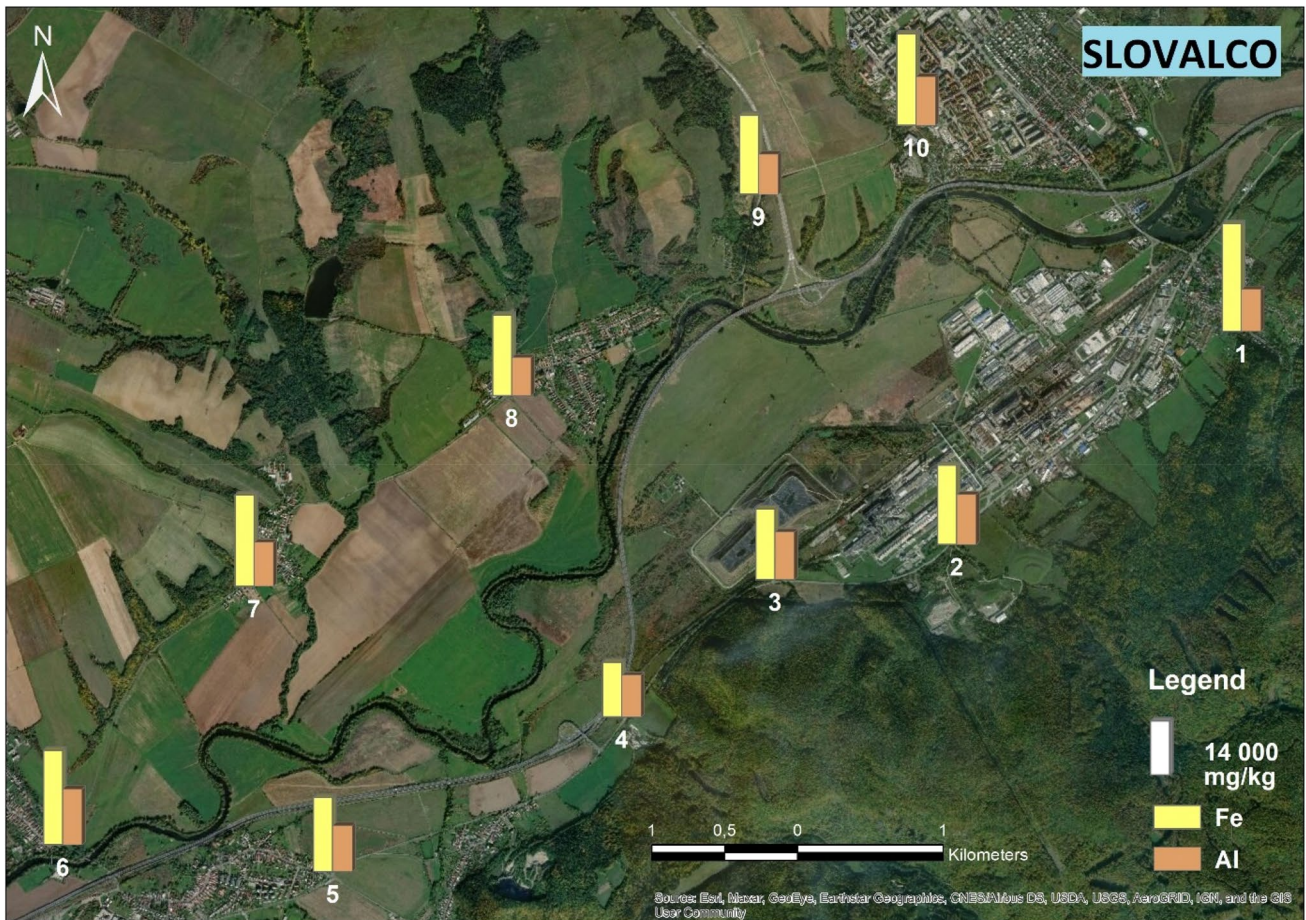
Fig. 7 Distribution of Al and Fe around SLOVALCO (Slovakia)

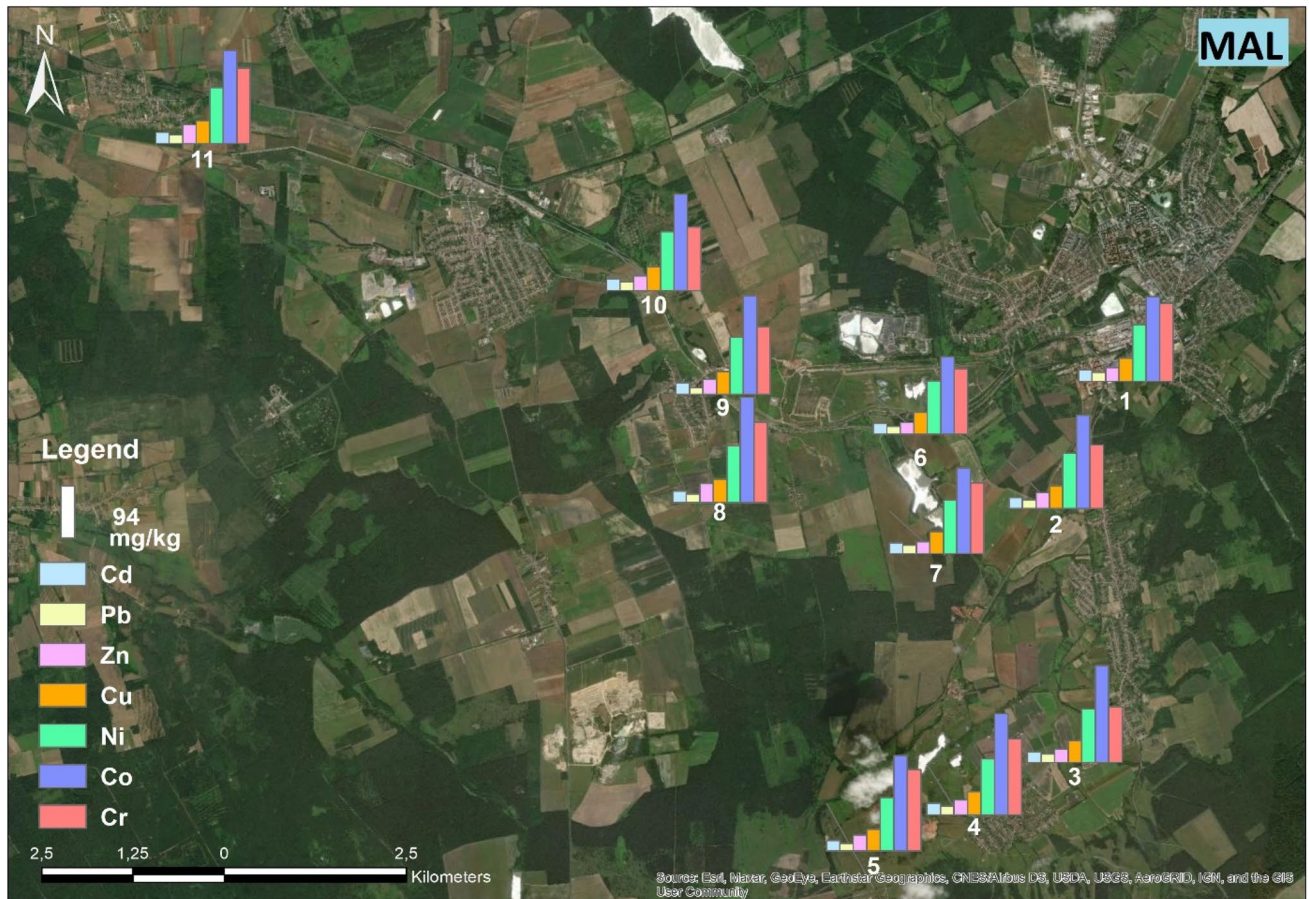
Fig. 8 Distribution of heavy metals around MAL (Hungary)

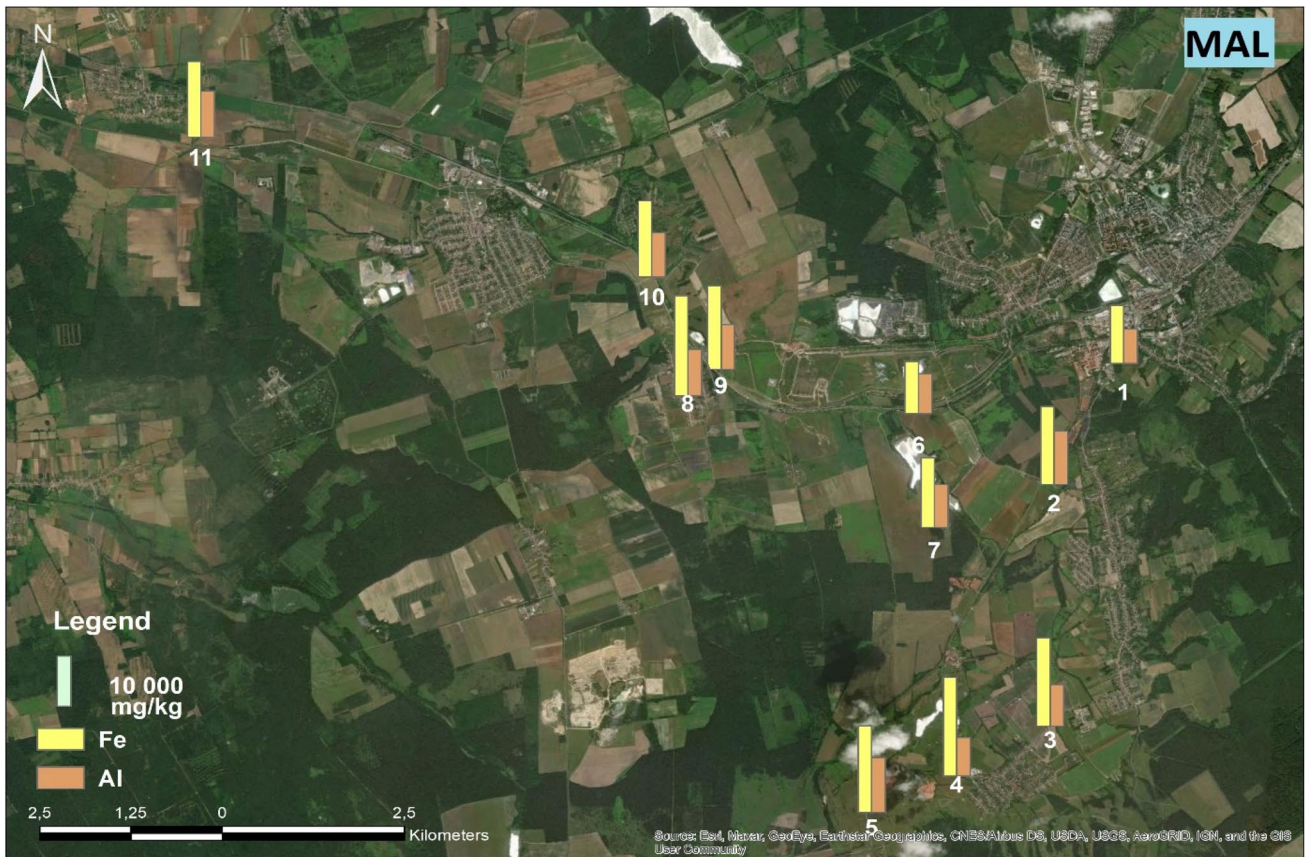
Fig. 9 Distribution of Al and Fe around MAL (Hungary)

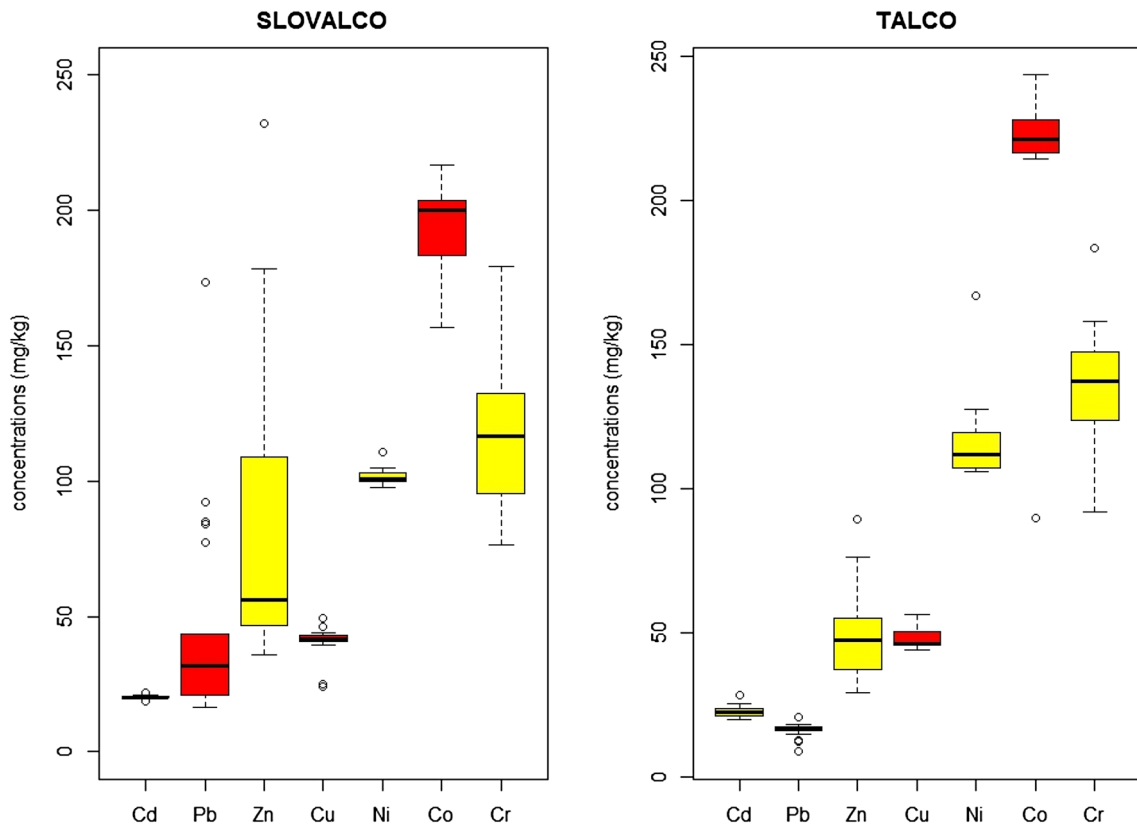
Fig. 10 Mean value concentrations of Cd, Pb, Zn, Cu, Ni, Co, and Cr in soil samples collected around aluminium plants (TALCO, SLOVALCO)

Cd, Ni, Co, and Cr found in the studied areas of Slovakia and Tajikistan were at a level higher than the TLV, but in Hungary all metals were found in concentrations higher than the TLV. However, the TLV is different in each country (Table 1). For instance, the maximum concentration of Zn in Tajikistan was 89.25 mg kg^{-1} , where the TLV is $110 \text{ mg Zn kg}^{-1}$; in Žiar nad Hronom (Slovakia) $232.06 \text{ mg Zn kg}^{-1}$ was found, and the TLV is $100 \text{ mg Zn kg}^{-1}$. Illustration of heavy metals distribution in all studies area is shown in Figs. 4, 5, 6, 7, 8, and 9. A comparison of statistical indicators between SLOVALCO and TALCO is shown in Fig. 10. Heavy metals in Hungary can be seen in Fig. 11.

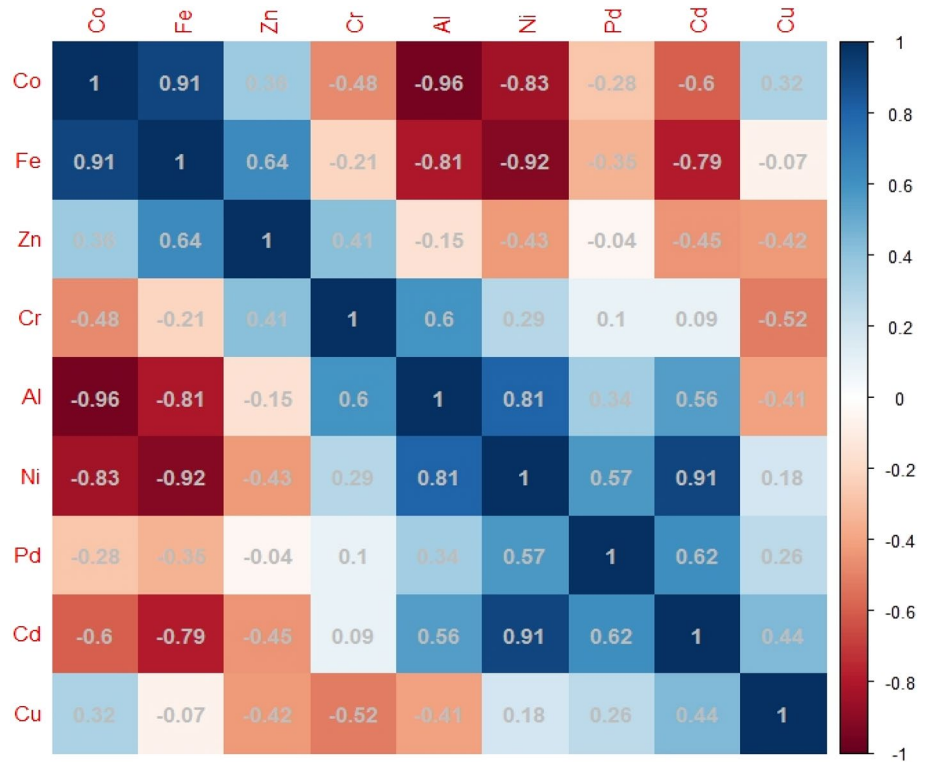
Fig. 13 Correlation coefficient matrix of metals in soil collected around SLOVALCO

In addition, the correlation between elements was calculated to identify their connection and the sources of pollutants in the studied areas. The results of the output correlation matrix can be seen in Figs. 12, 13, and 14. Correlations between metals were very weak in Tajikistan and Slovakia, but some positive correlations were noted for some of the trace metals, such as Cd, Pb, and Zn, in these studied areas.

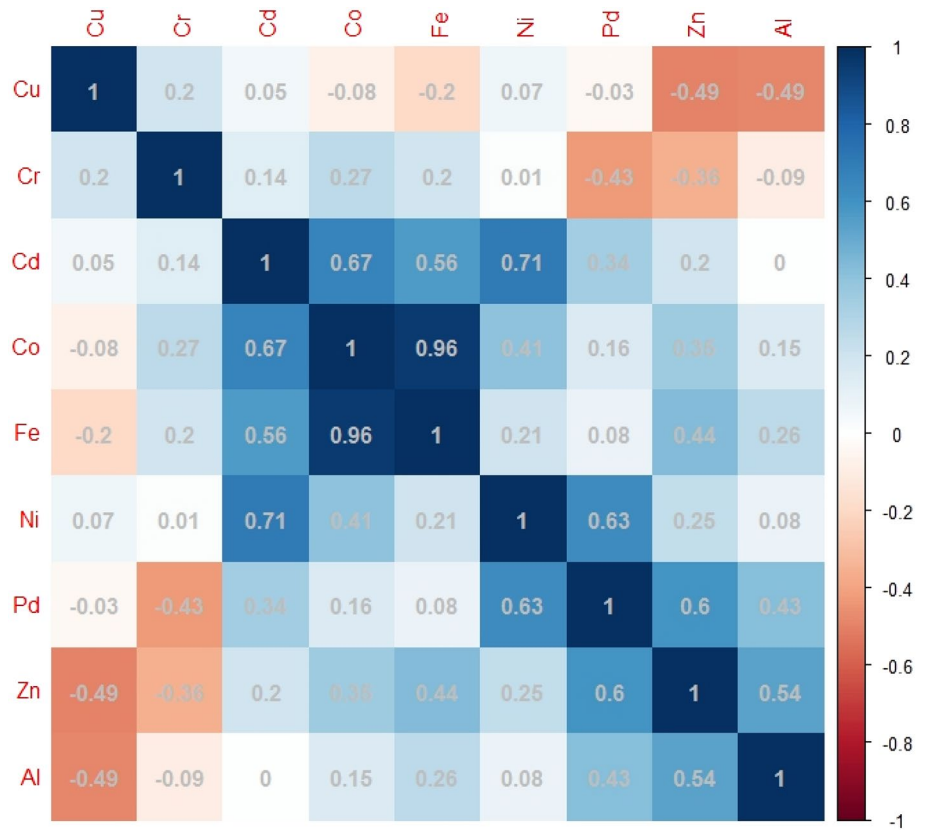
Fig. 14 Correlation coefficient matrix of metals in soil collected around MAL

From Fig. 14, it can be seen that a strong positive correlation was found between many trace elements. This suggests that these trace metals are pollutants from the same source, such as the aluminium plants or from vehicle emissions. However, in the case of Hungary, the main source of soil contamination is thought to be the red mud. Even though the investigation was conducted five years after the accident, the results obtained suggest that the levels of heavy metals are still significant.
