# Acoustic emission monitoring of granite under bending and shear loading

A.C. Mpalaskas<sup>a</sup>, T.E. Matikas<sup>a</sup>, D. Van Hemelrijck<sup>b</sup>,  
G.S. Papakitsos<sup>a</sup>, D.G. Aggelis<sup>b,\*</sup>

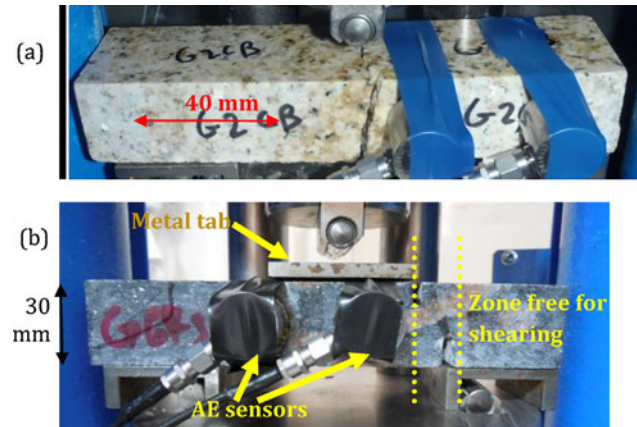
Fig. 1 – (a) Three point bending and (b) shear test of granite with concurrent AE monitoring by two sensors.

AE monitoring took place by means of two piezoelectric sensors (R15, Mistras). Their resonance comes at  $150 \text{ kHz}$  and their positions on the specimens are shown in Fig. 1. One sensor was placed  $15 \text{ mm}$  away from the expected crack, which was secured by a notch. The second sensor was placed

$40 \text{ mm}$  away. Both sensors were positioned at the same side of the crack in order to be able to characterize the distortion of the signals as they propagate for the additional distance of  $40 \text{ mm}$ . Acoustic coupling was improved by silicon grease between the sensors face and the specimens' surface. AE activity was captured by a two-channel PCI-2 Mistras board with sampling rate of  $5 \text{ MHz}$ . The threshold was  $40 \text{ dB}$ , as well as the pre-amplification. A schematic representation of a waveform is seen in Fig. 2. Some of the main features are the maximum amplitude,  $A$  (usually in  $\text{dB}$ ), and the duration (period between the first and the last threshold crossing). The “rise time”,  $RT$  (which is the time between the first threshold crossing and the point of peak amplitude in  $\mu\text{s}$ ) is related to the fracture mode of the crack. It has been shown that shear type of failure like debonding of patches, pull-out of fibers and shear matrix cracking induces signals with longer duration and  $RT$ , mainly attributed to the higher proportion of transverse elastic waves that are triggered by the parallel motion of the crack tips [13,14,16–18]. Frequency content can be measured by  $AF$  (average frequency), which is the total number of threshold crossings divided by the duration while there are other indices based on the spectrum of the FFT.

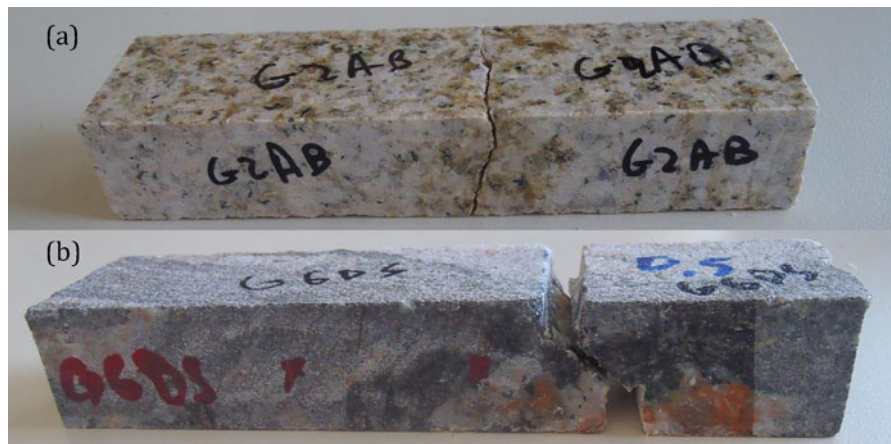
Fig. 4 – Typical specimens after fracture (a) bending, (b) shear.

Table 1 includes the results of the ultrasonic pulse velocity test. Specimens of type G6 exhibited values close or above 6000 m/s, while G2 lower, around 5000 m/s. This implies higher stiffness for G6. Indeed based on the densities of the materials and the measured wave velocities, the elastic moduli values are between 60 and 70 GPa for type G2 and around 90 GPa for type G6, as seen in Table 1. The maximum loads for both bending and shear tests for the intact and the repaired version of the specimens are included in Table 2. The intact Tropical Black (G6) specimens exhibited steadily higher bending load which is in accordance with its higher ultrasonic pulse velocity. In the shear test, there is again a difference in favor of G6 in average (approximately 1 kN), but with overlap between the populations. Concerning reloading after repair, all specimens maintained their initial fracture surface and for the bending test there is a noticeable restoration of approximately 50–75% of the initial strength. For the shear, the restoration is much lower between 30 and 40%. This is for both types of granite indicating that after repair by epoxy, the material is more susceptible to shear, while for bending the order of load that can be carried is quite restored to the “virgin” state, though not completely. Photographs of typical specimens after fracture are seen in Fig. 4.

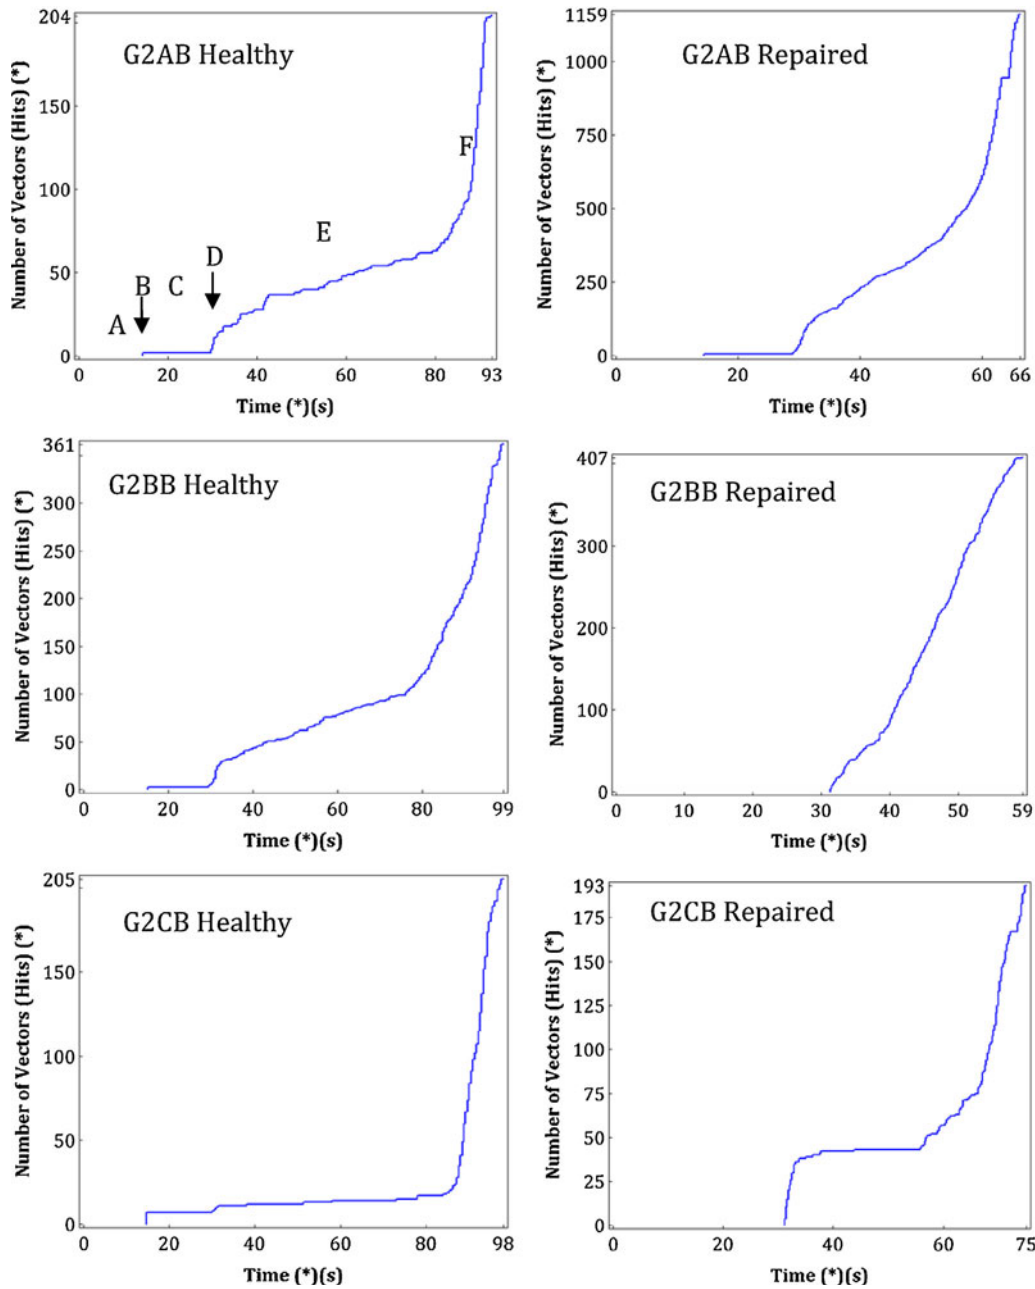
Fig. 5 – Accumulated AE activity of granite G2 vs. time for the bending test: left healthy, right repaired specimens.

Before presenting the differences of AE descriptors based on the mode of test, the curves of the cumulative AE events activity vs. time can be seen in Fig. 5. These curves reveal the rate of nucleation/propagation of cracks and help to assess the time or load during which most of the damage is occurring. The left column concerns bending of three healthy specimens and right concerns the reloading of the same specimens after repair by epoxy. The depicted activity concerns the “events” and not the whole number of recorded AE hits. Specifically, by applying two sensors, it was possible to activate “linear localization”. Practically, by the time delay between acquisitions of two successive signals by the two sensors, the actual location of the source can be calculated. Localization makes use of the ultrasonic pulse velocity that was measured beforehand. This way, the activity concentrated in a zone of 10 mm around the crack was isolated in the specific analysis. This serves two purposes; one is to eliminate possible sources of noise that may contribute to the overall recorded activity but they are not actually due to the fracture in the intended mode and location. The second is to avoid contributions by the attenuation and dispersion of the material: isolating the origin of the events in a narrow zone of 10 mm, it is sure that the path of propagation was very similar for all the different events until being recorded by the sensor. Therefore, possible influence by attenuation and material heterogeneity is kept to a minimum. The information presented in this analysis comes from the sensor closer to the crack in order, as

The plots start at time zero when the central loading point touched the specimen. This contact resulted in a small number of hits, but not in events as it did not originate from the fracture zone and it was not related to the fracture process. After a period (A) of silence indicating no cracking activity due to negligible stresses, a few events were recorded (point B). Another plateau followed (C) and at point D a moderate activity started to be noted, continuing throughout period E. Finally, there is an increase of AE rate (stage F) leading to the final fracture of the specimen. All healthy specimens seem to follow a more or less similar pattern of AE activity. The only remark is that stage “E” for the specimen G2CB exhibits much less activity than the other two specimens. These plateaus in the AE activity have been observed in compression experiments of granite as well [25], and more specifically, two zones of “avalanche-like” activity interrupted by a long period of acoustic silence. This is related to initial micro cracking which is restrained, while the material accumulates elastic energy before mechanisms of larger scale become active.

The behavior of the same specimens at reloading after repair does not seem as uniform and cannot be described with the same stages. This is not surprising as the homogeneity of the material has been irreversibly changed leading to stronger experimental scatter between different samples. Indicatively, the second specimen (G2BB repaired) did not even exhibit a plateau once the emissions started at 31 s, while the last specimen (G2CB repaired) exhibited a large plateau between 35 and 55 s. On the other hand, the first specimen (G2AB repaired) had a stage of moderate activity.

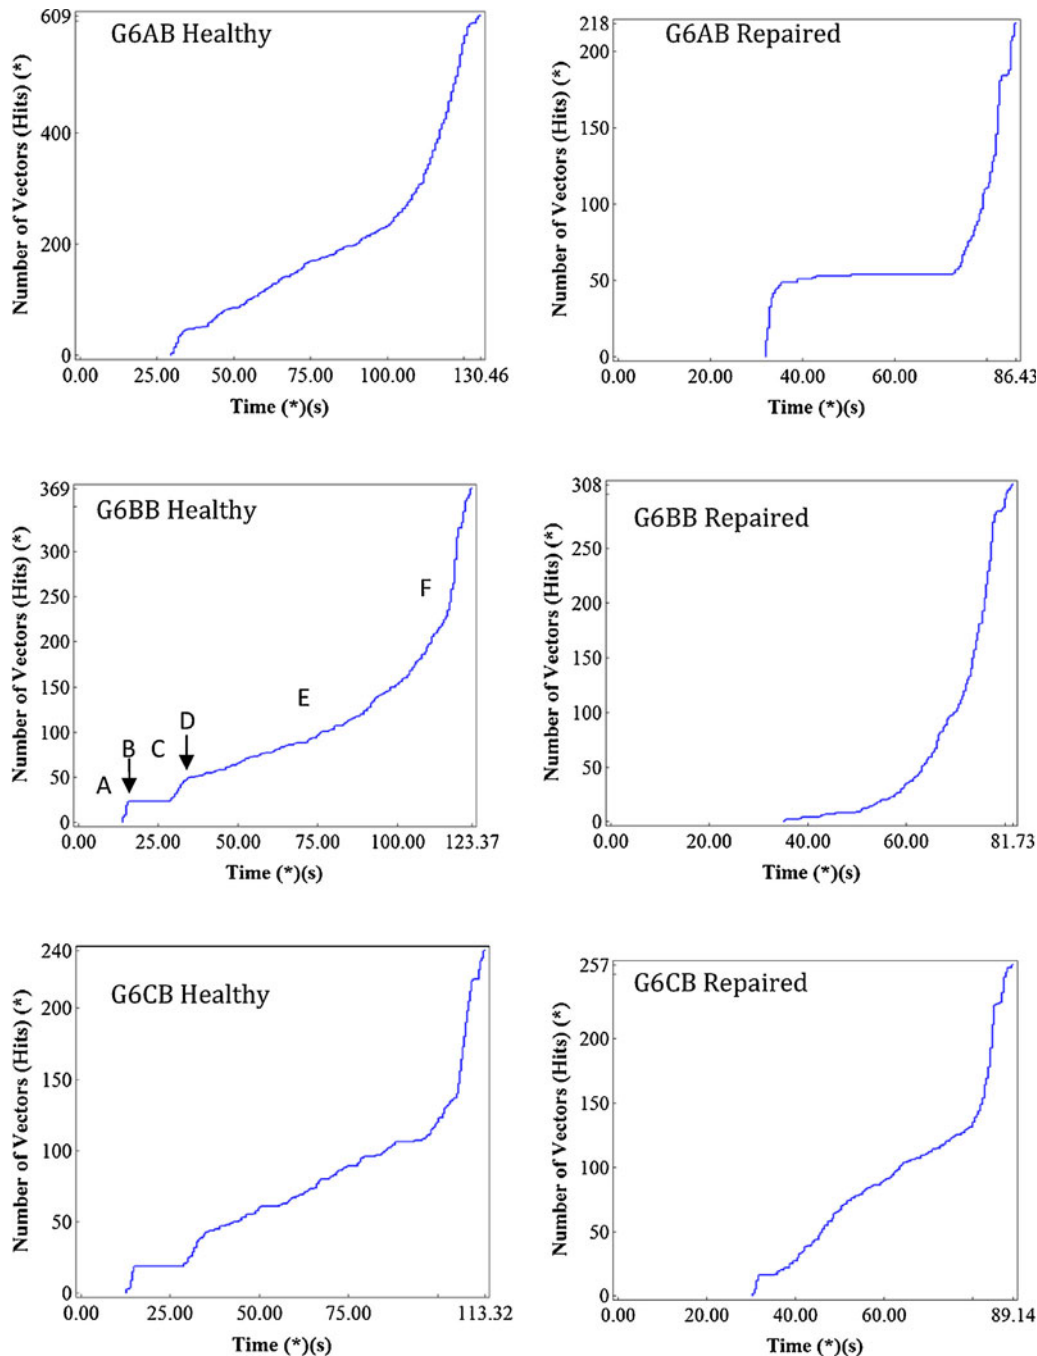
Fig. 6 – Accumulated AE activity of granite G6 vs. time for the bending test: left healthy, right repaired specimens.

The behavior of specimens from granite type G6 is shown in Fig. 6.

For the specimens of this granite type the same succession of stages seems to hold (especially the two last healthy specimens). Concerning the repaired, again there is not a unique trend, as the first specimen exhibited a long silence plateau, the second an exponential increase of AE and the last, a stage of moderate activity instead of plateau or exponential increase. One detail that can be mentioned is that the initial

plateau was slightly longer for the repaired specimens than the healthy in both categories. For the repaired version of the specimens this silent period was between 30 and 40 s, while for the healthy it was equal or shorter than 25 s. This can be attributed to the elasticity of the epoxy resin which is one order of magnitude lower than elastic modulus of granite. Therefore, under a certain displacement rate, it can strain for longer period of time before emitting acoustic signals due to irreversible cracking.

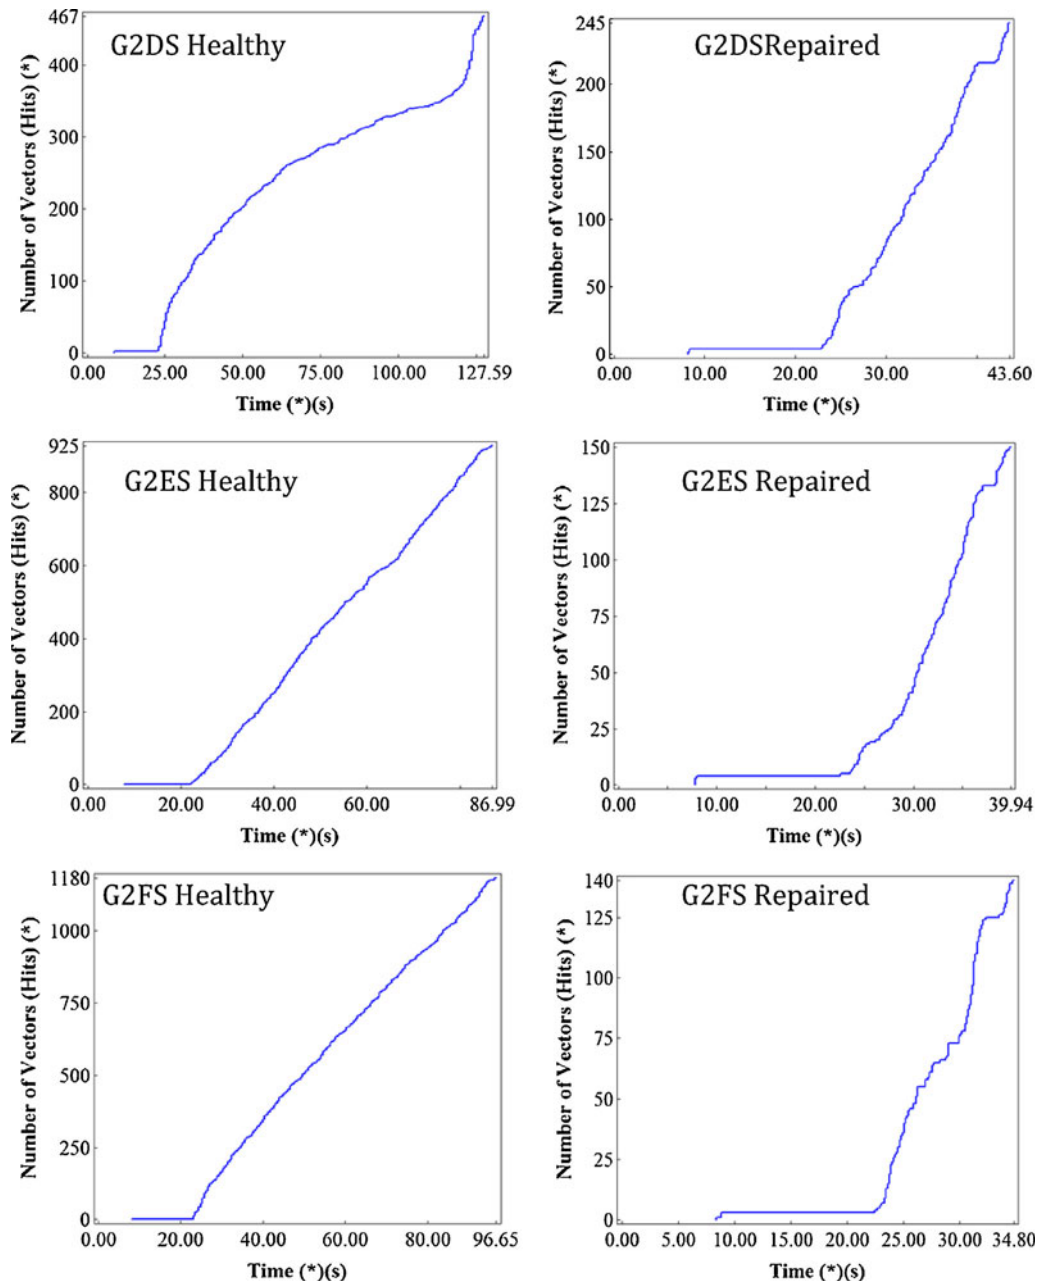
Fig. 7 – Accumulated AE activity of granite G2 vs. time for the shear test: left healthy, right repaired specimens.

The corresponding AE activity for specimens G2 tested in shear is shown in Fig. 7. The behavior of the intact specimens, is shown at the left. All specimens exhibited a continuous line once the activity starts, without plateaus like the corresponding bending tests. It seems that shear micro-cracking was continuous without periods of stress build-up as was the case for bending. For the repaired specimens at the right of Fig. 7, the whole duration was shorter since the specimens failed at much lower load. The initial period of silence remains of the same order followed by a more or less linear path until failure.

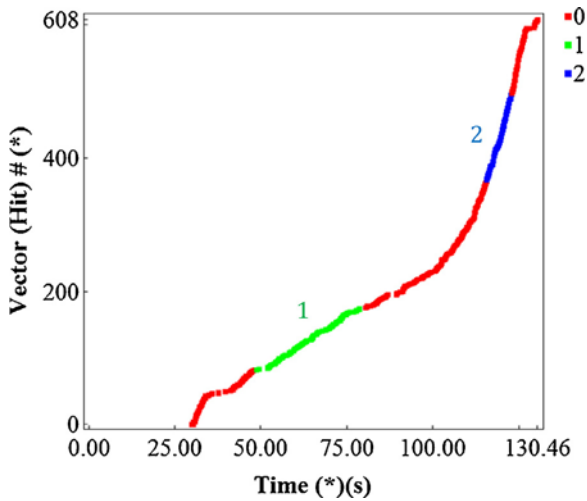
Fig. 9 – Cumulative history of events and indicative class separation using the Noesis software [29].

order to analyze the development of the AE parameters during loading, indicative parts of the whole population were isolated as shown in Fig. 9. One part was taken during the early stage of the loading when the AE rate was still moderate (below 50% of ultimate, class 1, green) and the second just before final failure when the AE recording rate was much faster (class 2, blue).

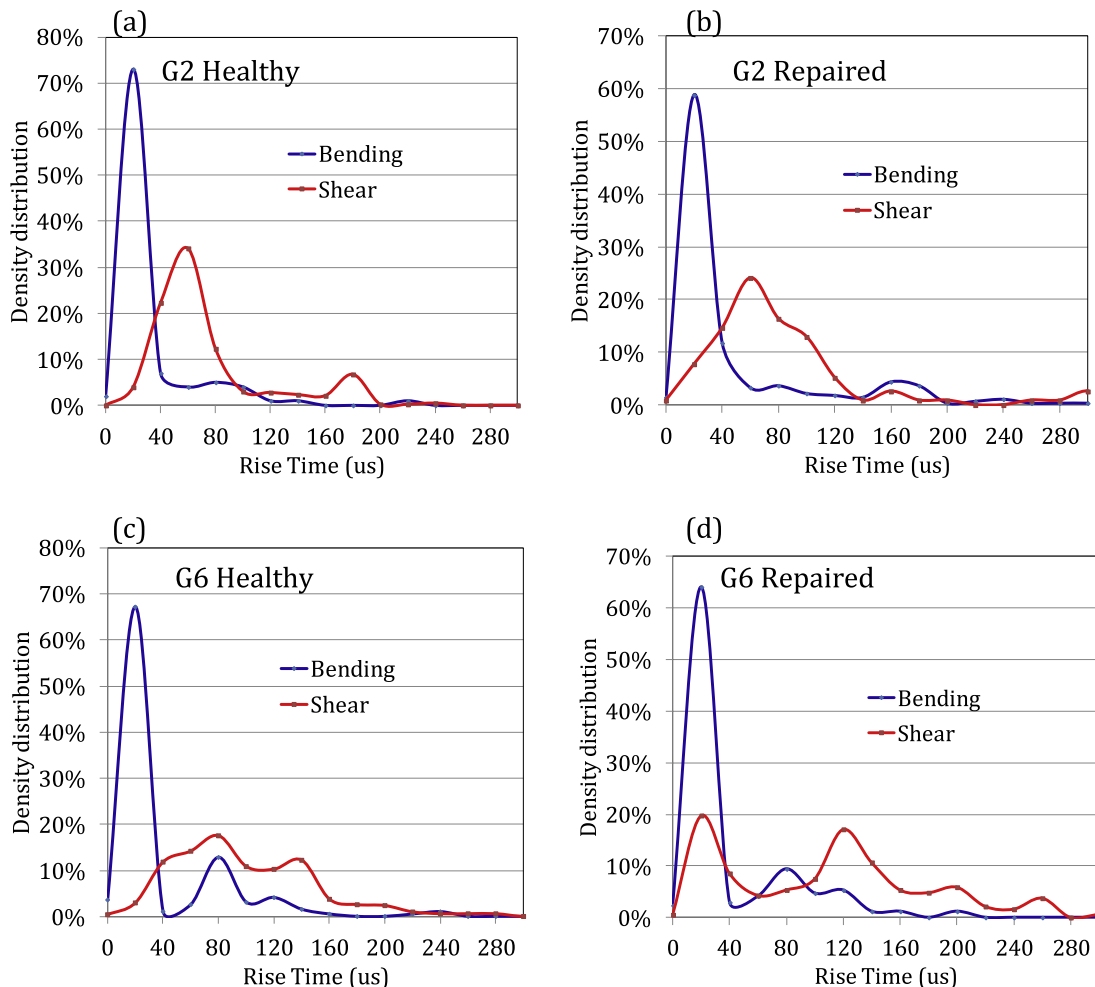
Fig. 10 – Density distributions of RT for AE populations at moderate load (class 1). (a) G2 Healthy, (b) G2 Repaired, (c) G6 Healthy, (d) G6 Repaired.

The populations from all three specimens of each type were added together to produce a larger database of AE signals, received at initial loading stages (class 1) and before failure (class 2) separately for bending and shear loading. Fig. 10 shows the density distribution of the values of RT of the early class 1 for bending and shear of granite G2 (top) and G6 (bottom). Concerning bending of G2, most of the RT values are

below 40  $\mu$ s (see Fig. 10a), having a peak at 20  $\mu$ s. For the shear type of loading, the distribution moves to higher values up to 100  $\mu$ s (again Fig. 10a), while there is also a small peak at 180  $\mu$ s. The picture is quite similar for granite G6 in Fig. 10c; bending load results in RT mostly below 40  $\mu$ s, while the corresponding distribution for shear extends up to 200  $\mu$ s. This is a very direct indication of the influence of the stress tensor (normal-shear) to the AE exhibited during fracture and has never been measured in granite so far. In addition to the whole distributions as depicted in Fig. 10, the averages of the populations are very indicative; Bending of G2 and G6, results in average values of RT of 45.1  $\mu$ s and 42.5  $\mu$ s respectively, while for the shear tests the corresponding average RT values

are  $210.8 \mu\text{s}$  and  $229.7 \mu\text{s}$ , being four to five times higher. The reason can be related to the different wave modes (longitudinal or transverse) that are triggered by the motion of the crack sides under the dominant mode [30]. This enables the assessment of the type of stresses acting on the material by passive AE monitoring of the initial loading stage without inducing serious damage in the material (e.g. less than 50% of maximum load).

For the repaired version of the specimens things do not seem to change considerably (see Fig. 10b and d). For both material types, bending RTs are limited up to 40–60  $\mu\text{s}$ , while

shear ones extend to 200  $\mu\text{s}$  or more. In the case of Fig. 10d concerning granite G6, even though the highest peaks of RT distributions coincide at 20  $\mu\text{s}$ , the shear distribution extends to higher values and the average value is at 126  $\mu\text{s}$  compared to 57  $\mu\text{s}$  of bending. This shows that the intended fracture mode is followed even after repair confirming that AE is a suitable technique for passive characterization of the stress built-up and fracture accumulation. It should be mentioned that apart from the populations up to 300  $\mu\text{s}$  which are shown in the graphs, there are systematic differences in the higher regimes. Specifically, for the bending tests of both granites, only 2% of
